Frederick Hospital
Frederick, OK
Owner: Town of Frederick
Final Remediation Report

SITE CLEANUP ASSISTANCE PROGRAM

Brownfields performed sampling in September of 2024

- Asbestos containing material located in building
- A total of 4,700 sq ft of plaster, flooring, and transite removed
- A total of 2,100 linear ft of pipe runs removed
- Approximately 2500 gallons of hazardous materials
- Abatement completed in April of 2025

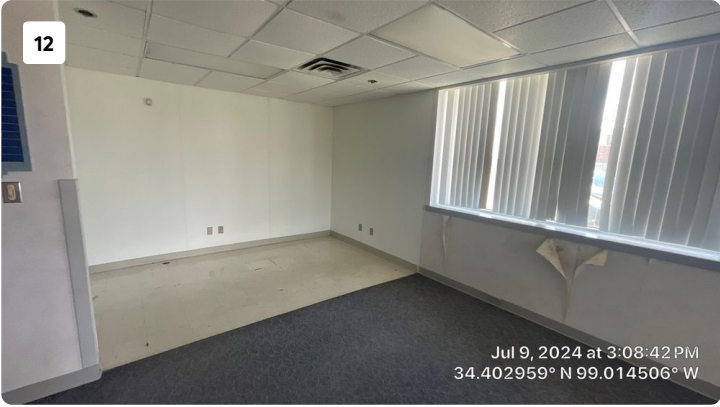
HA 63 Beige Floor Tile
Found throughout the building

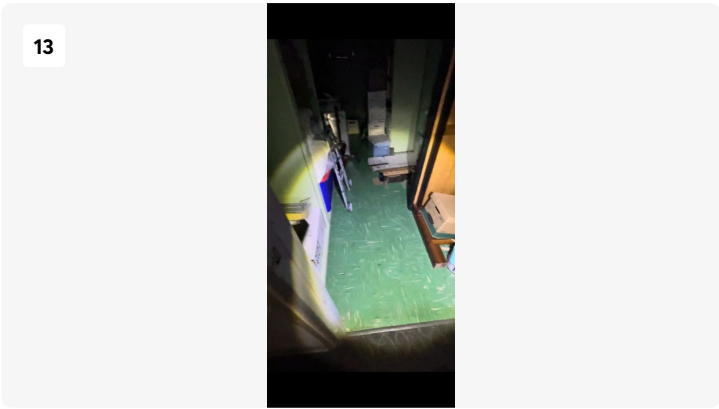
HA 64 9x9 Green Floor Tile Found in Administration and in a closet in the Physical Therapy Wing

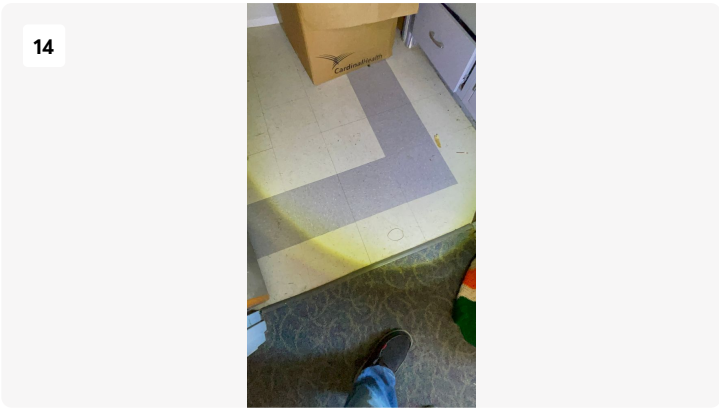
HA 65 - Grey Floor Tile in the Physical Therapy Wing along with HA 63 Beige Floor Tile

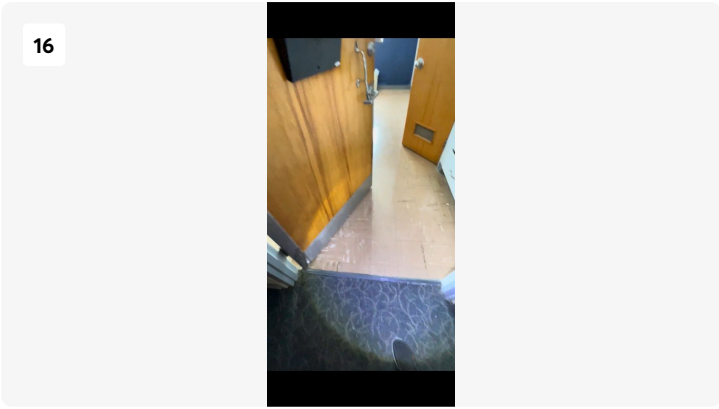
HA 67 9x9 Brown Floor Tile found throughout the Physical Therapy wing

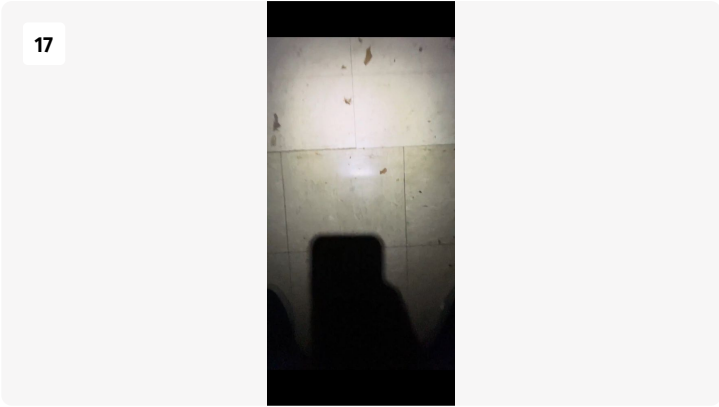
HA 68 Dark Brown Floor Tile in the Linnen Storage Area near the Kitchen
