Thomas Apartment
Thomas, OK
Owner: City of Thomas
Final Remediation Report

SITE CLEANUP ASSISTANCE PROGRAM

- Asbestos and lead-based paint located in building
- Over 5200 sq.ft. of LBP wall and flooring removed
- 11 doors and windows with LBP removed
- Multiple ACM components removed
- Abatement completed in June of 2024 and plan to use space for future housing

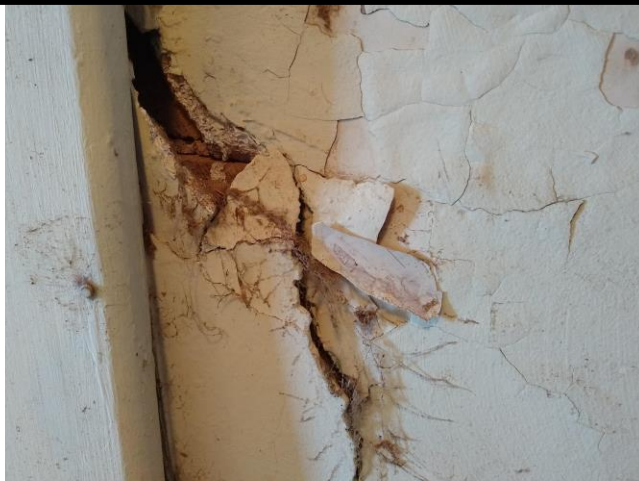
PHOTO 1

City of Thomas Building - Plaster

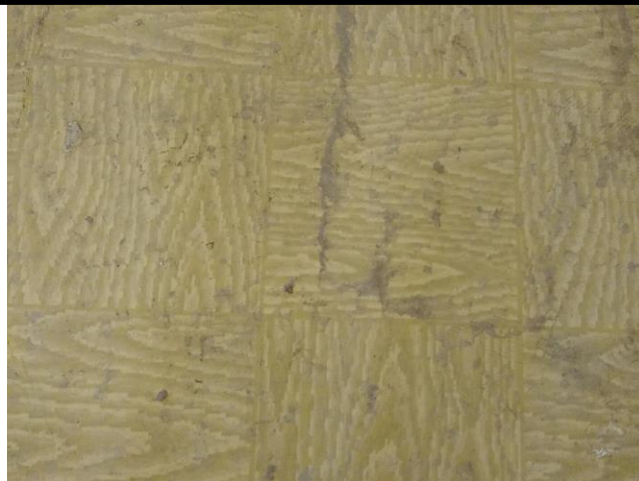
PHOTO 2

City of Thomas Building – Tan Vinyl Flooring

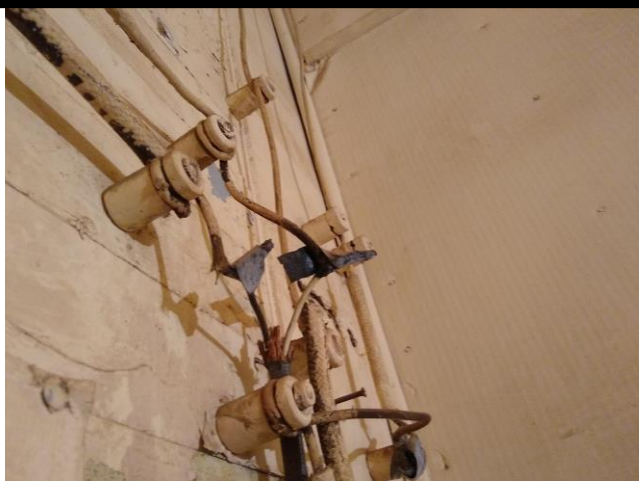
PHOTO 3

City of Thomas Building – Electrical Sheathing

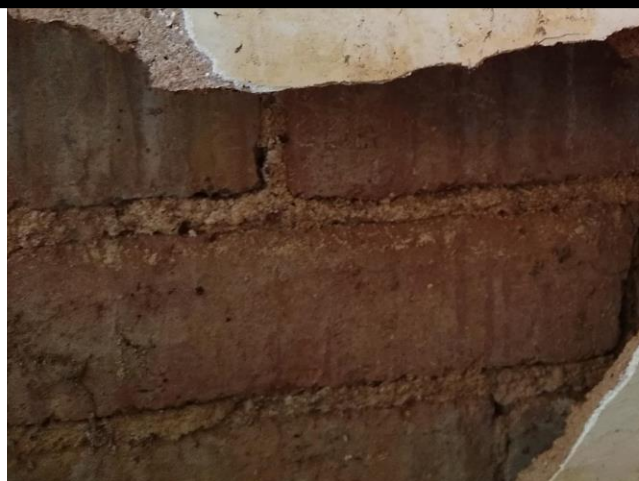
PHOTO 4

City of Thomas Building – Mortar

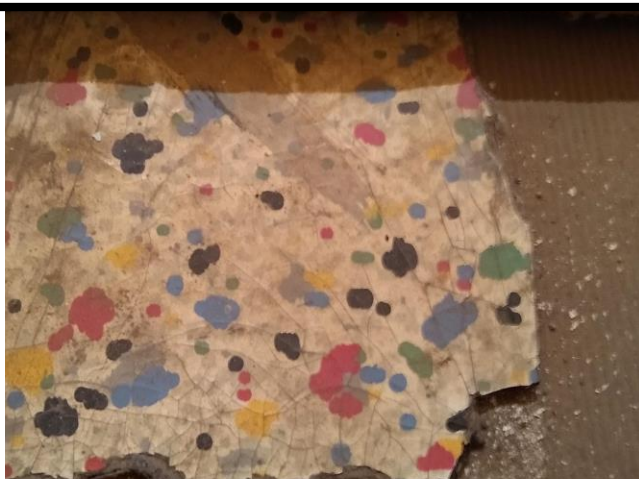
PHOTO 5

City of Thomas Building – Multicolored Vinyl Flooring

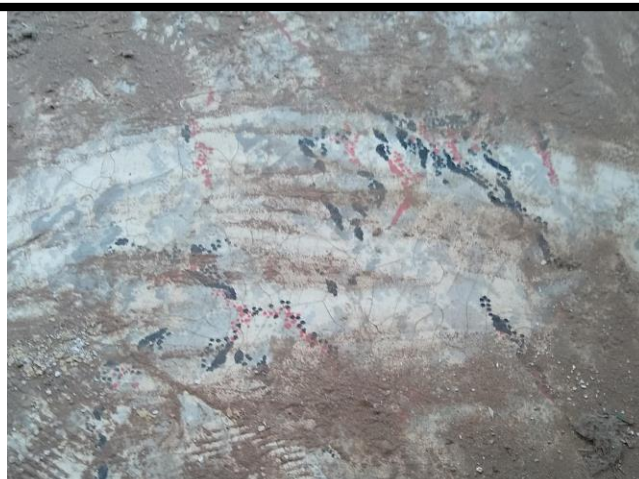
PHOTO 6

City of Thomas Building – Off-White Vinyl Flooring

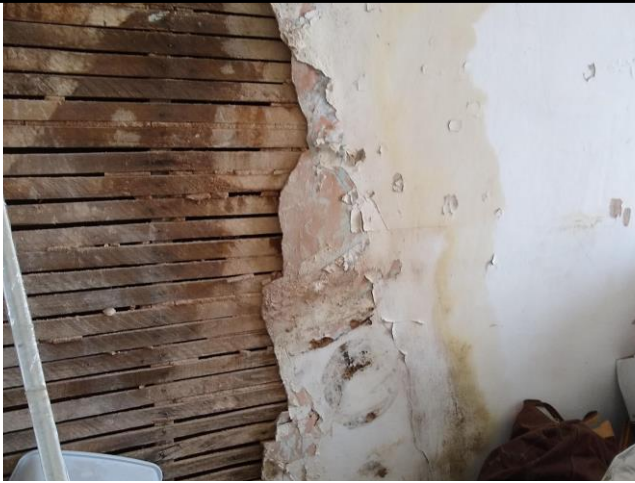
PHOTO 7

Brantwein Building – Plaster

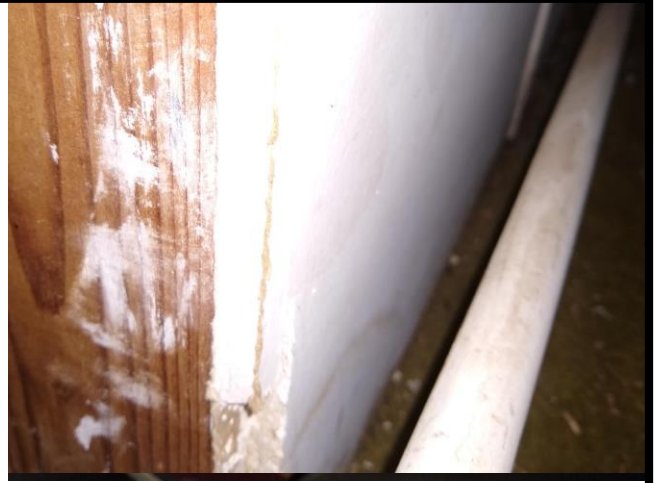
PHOTO 8

Brantwein Building - Drywall

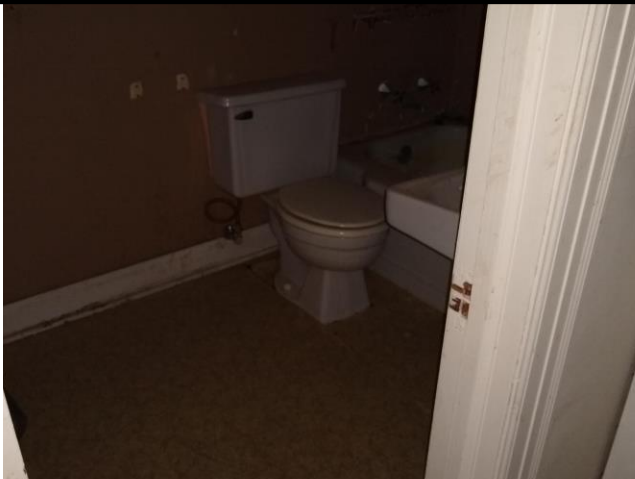
PHOTO 9

Miller Building – Sheet Vinyl Flooring and Drywall

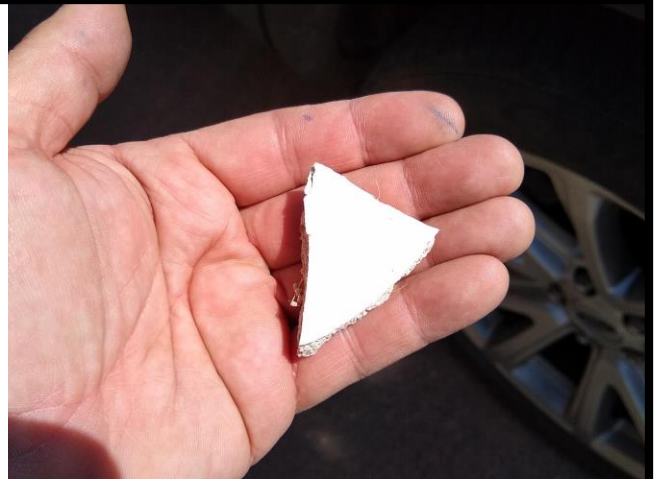
PHOTO 10

Miller Building – White sheet vinyl

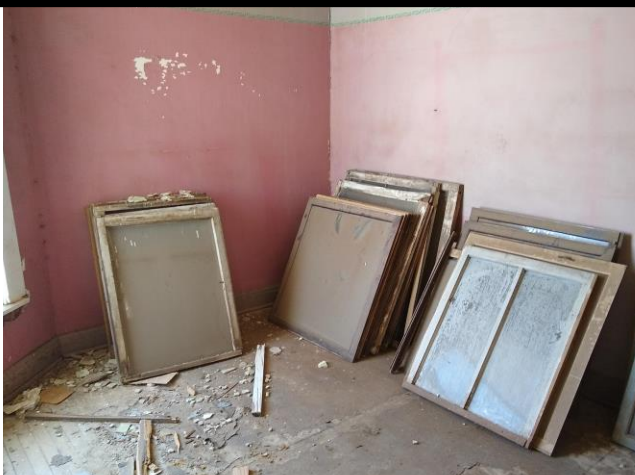
PHOTO 11

Christensen Building - Plaster

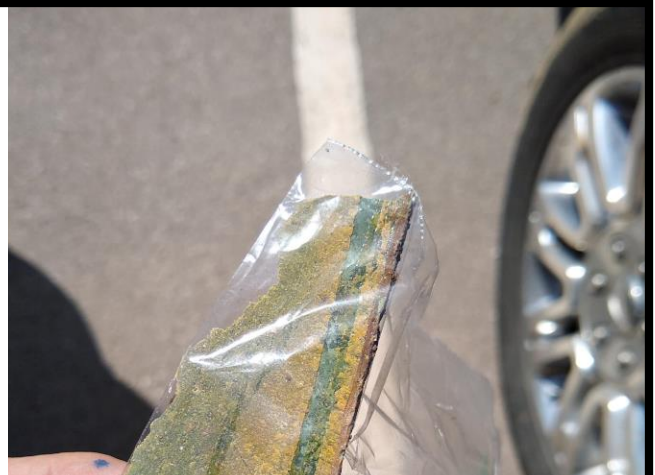
PHOTO 12

Christensen Building – Green Floor Tile

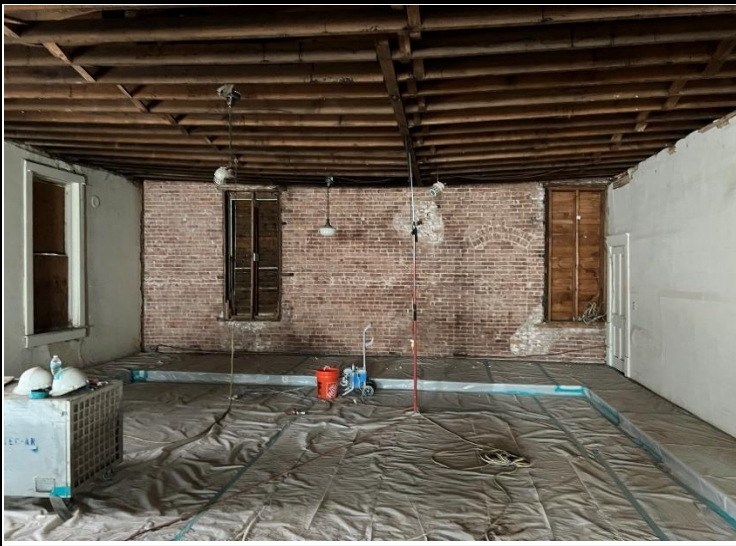
Photo 1: Thomas Apartments LBP Abatement Progress Room 1 North Side

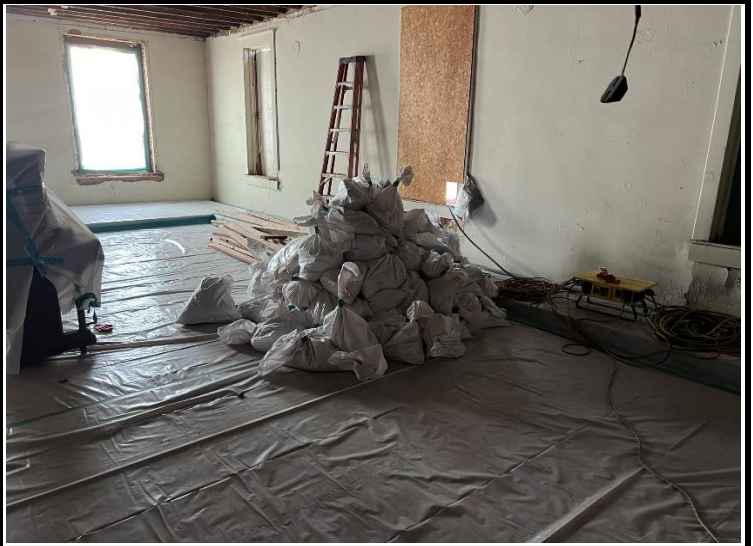
Photo 2: Thomas Apartments Abatement Progress, LBP Debris Room 1 North Wall Demo

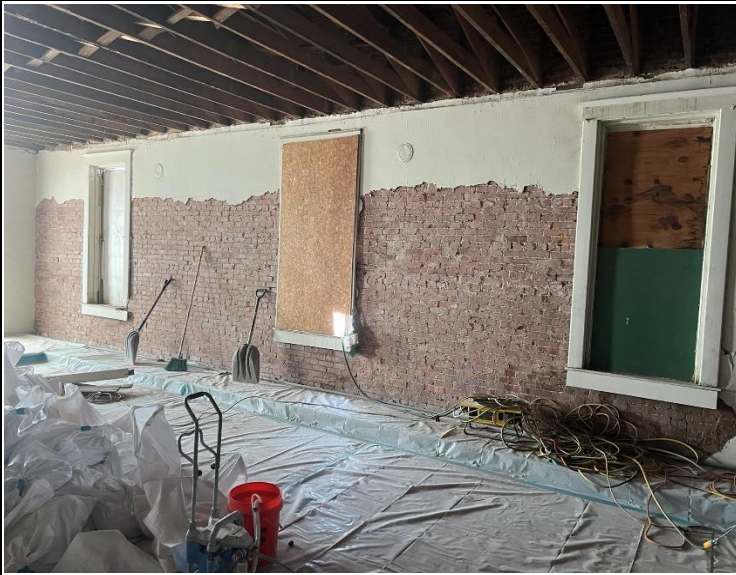
Photo 3: Thomas Apartments LBP Abatement Progress Room 1 West Wall

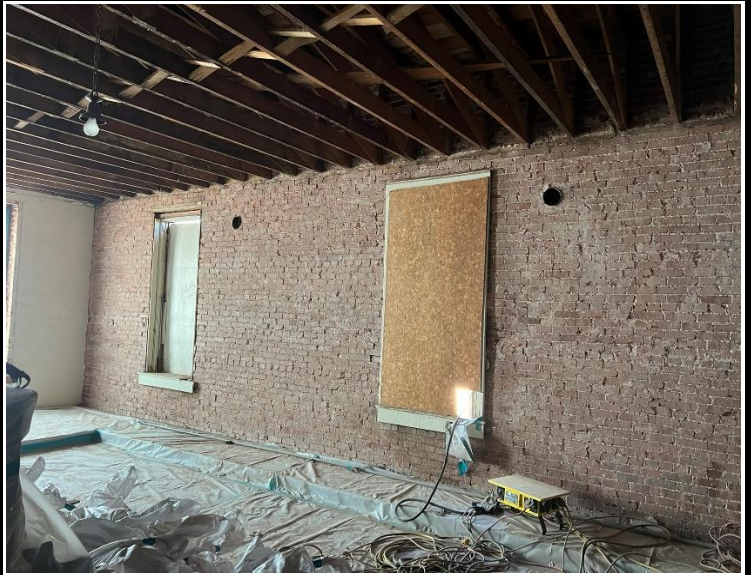
Photo 4: Thomas Apartments LBP Abatement Progress Room 1 West Wall

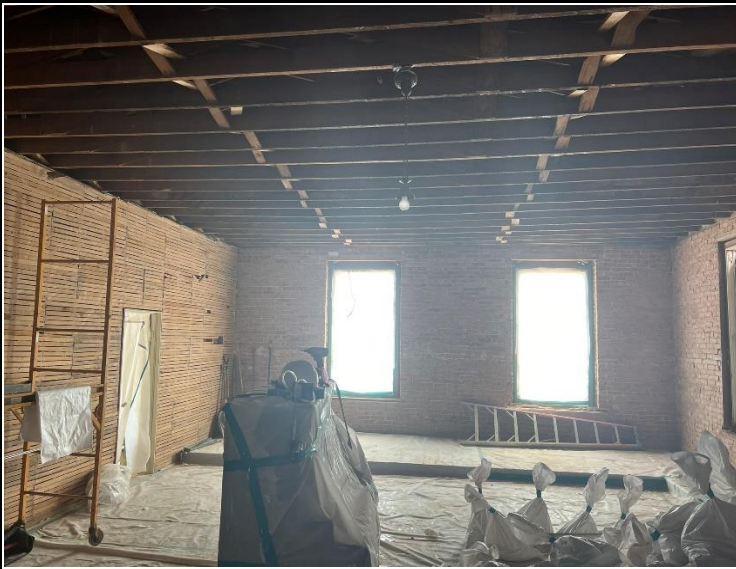
Photo 5: Thomas Apartments LBP Abatement Progress Room 1 Southeast Wall

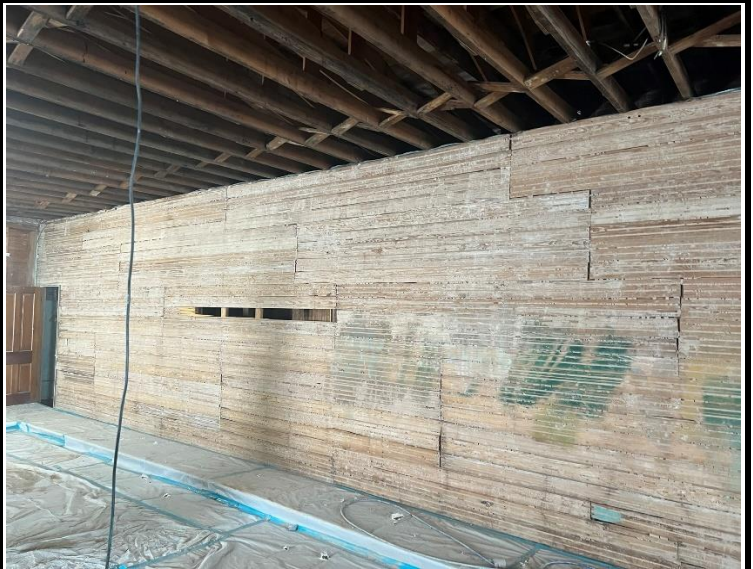
Photo 6: Thomas Apartments LBP Abatement Progress Room 1 East Wall

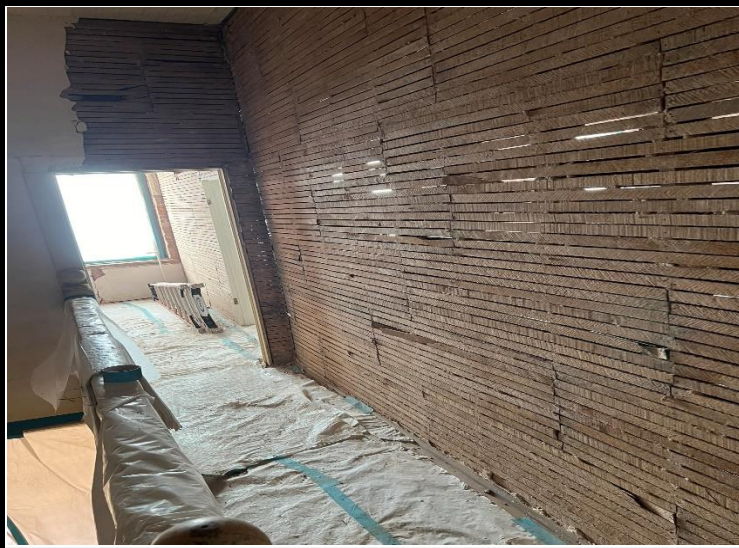
Photo 7: Thomas Apartments LBP Abatement Progress Hallway West Wall

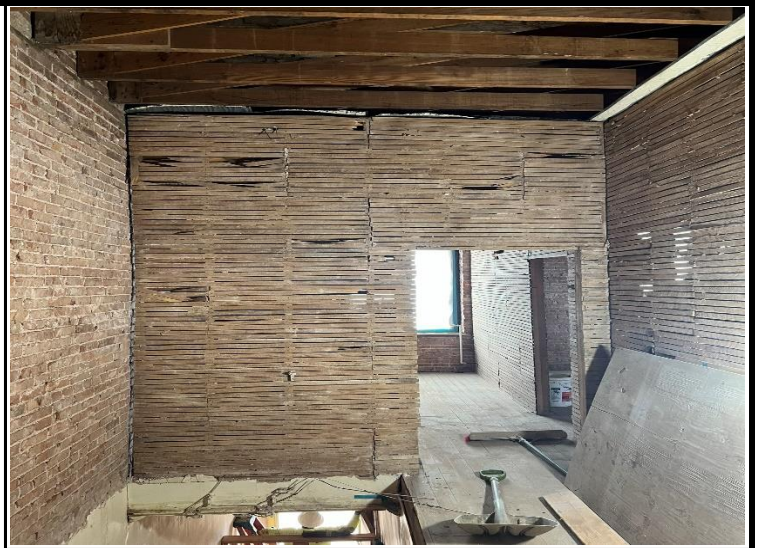
Photo 8: Thomas Apartments LBP Abatement Progress Hallway South Wall

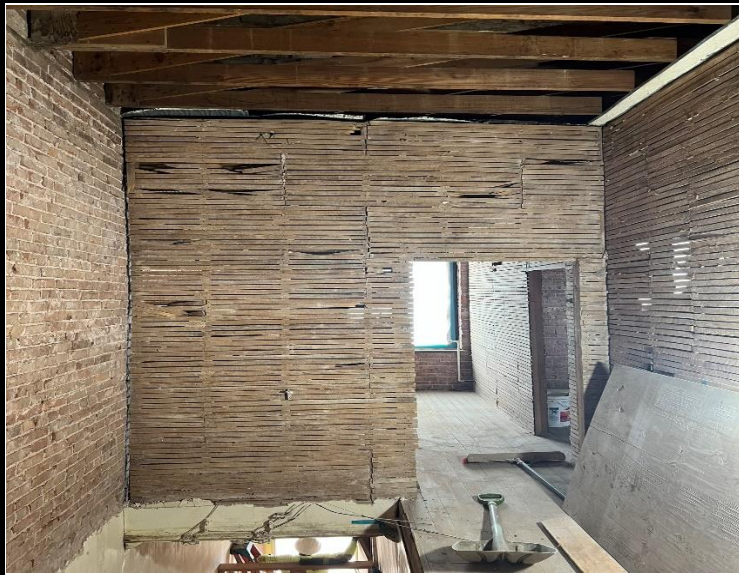
Photo 9: Thomas Apartments LBP Abatement Progress Hallway South Wall

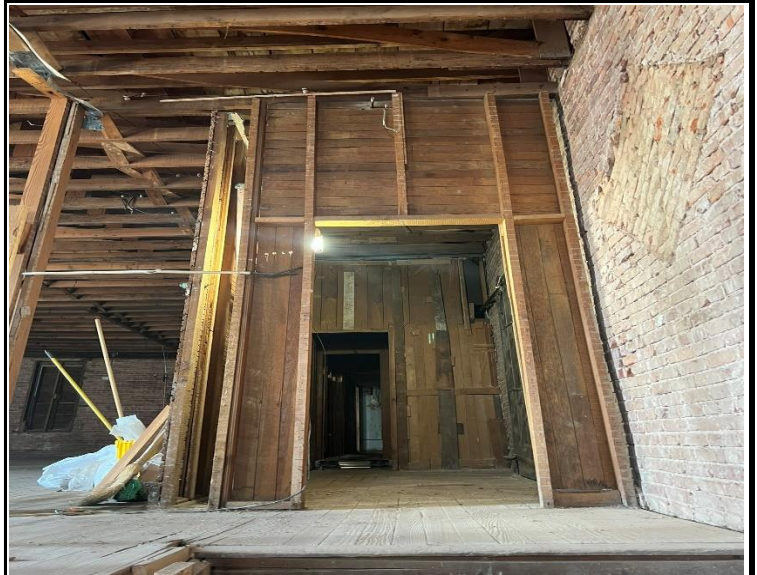
Photo 10: Thomas Apartments LBP Abatement Progress Hallway North Wall

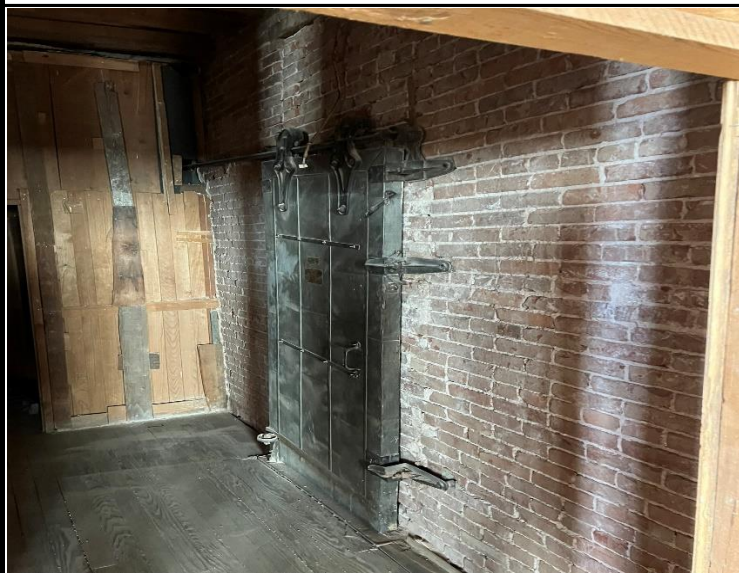
Photo 11: Thomas Apartments LBP Abatement Progress Room 4 West Wall & Fire Door

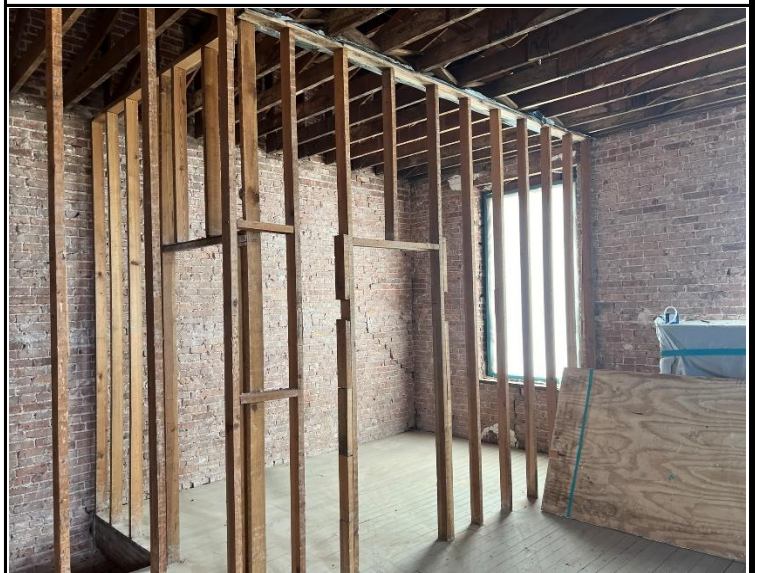
Photo 12: Thomas Apartments LBP Abatement Progress Room 6

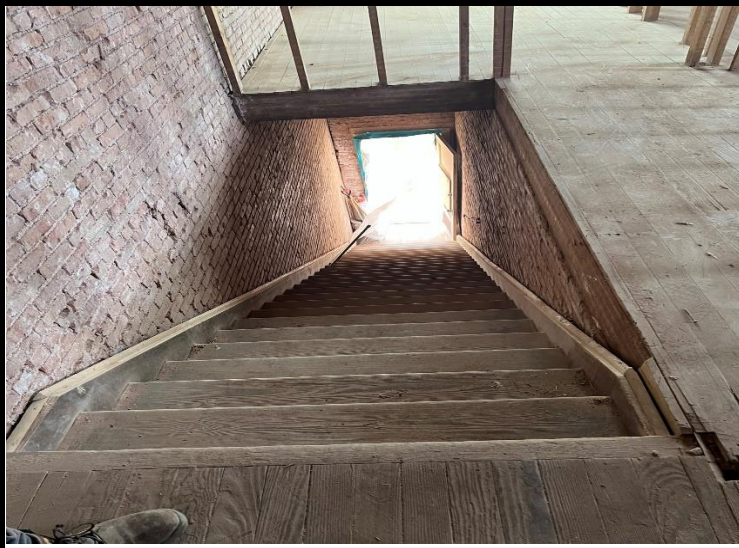
Photo 13: Thomas Apartments LBP Abatement Progress Stairwell

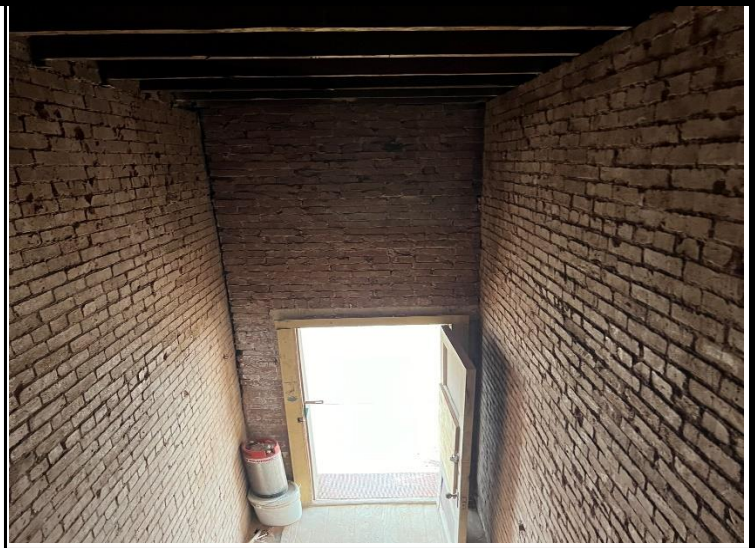
Photo 14: Thomas Apartments LBP Abatement Progress Stairwell

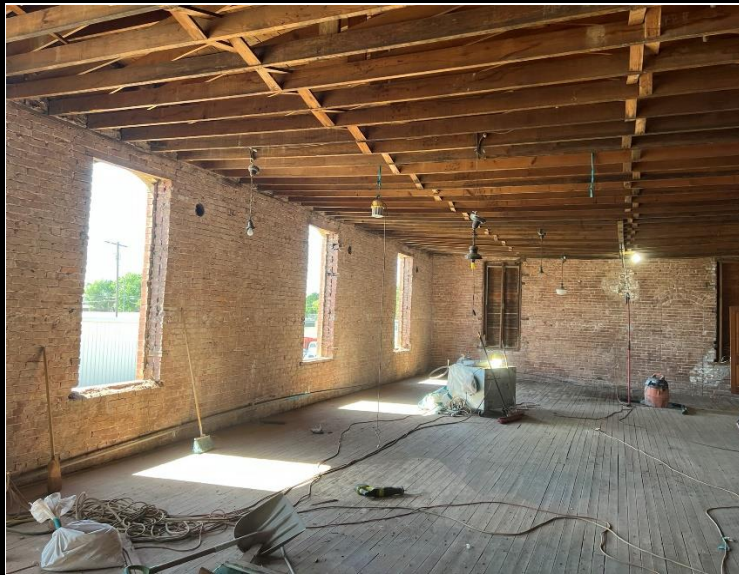
Photo 15: Thomas Apartments LBP Abatement Progress Room 1 West Windows and Frames

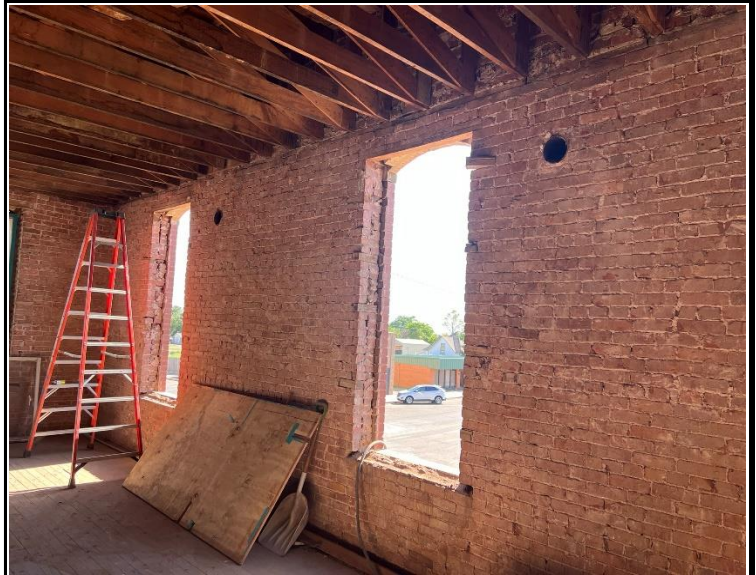
Photo 16: Thomas Apartments LBP Abatement Progress Room 1 West Windows and Frames

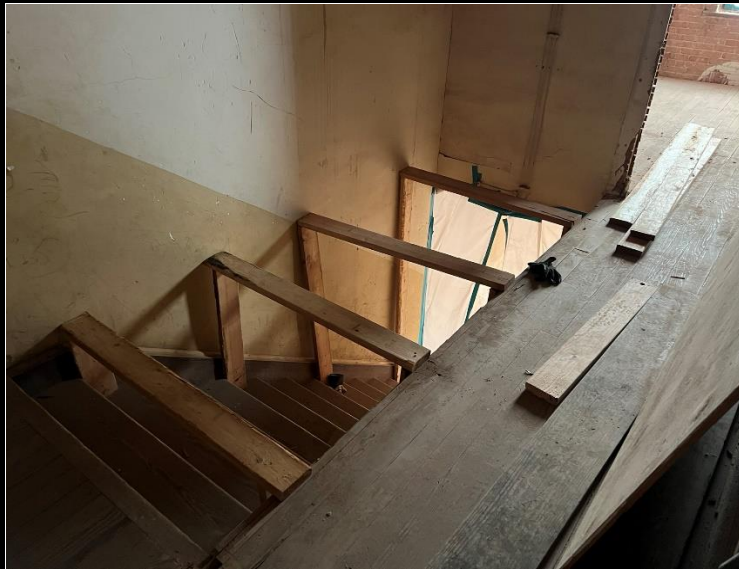
Photo 17: Thomas Apartments LBP Abatement Progress Stair Bannister After Removal

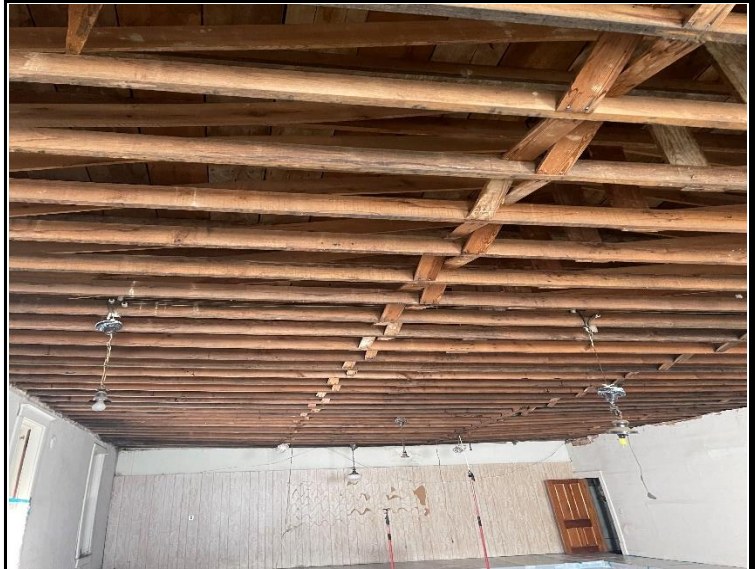
Photo 18: Thomas Apartments LBP Abatement Progress Room 1 Ceiling After Removal

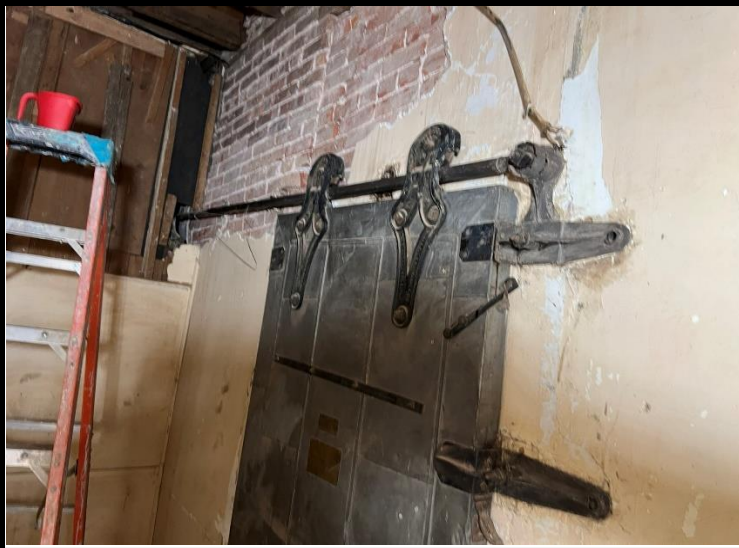
Photo 19: Thomas Apartments LBP Abatement Progress Fier Door After Door Component Scrape

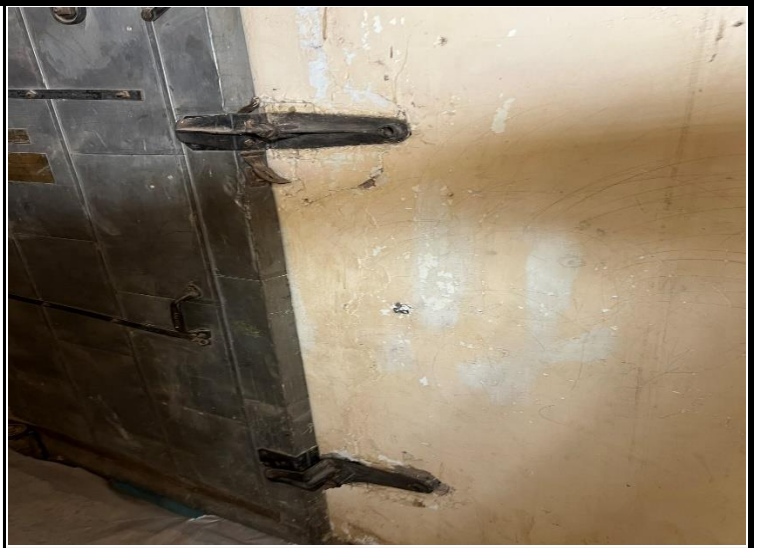
Photo 20: Thomas Apartments LBP Abatement Progress Fier Door After Door Component Scrape

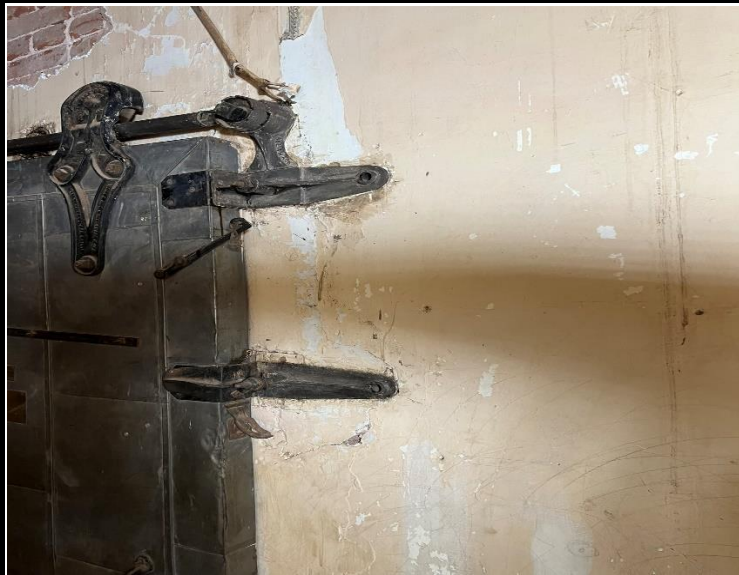
Photo 21: Thomas Apartments LBP Abatement Progress Fier Door After Door Component Scrape

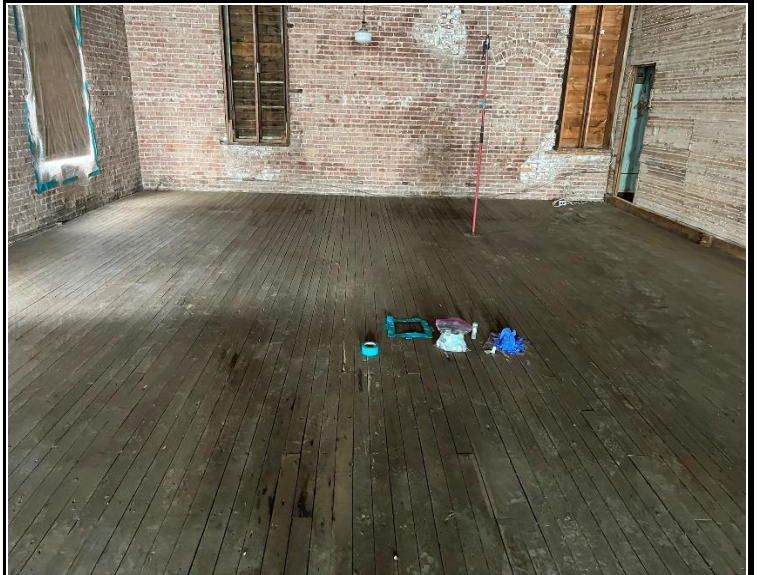
Photo 22: Thomas Apartments LBP Abatement Clearance Sampling Room 1

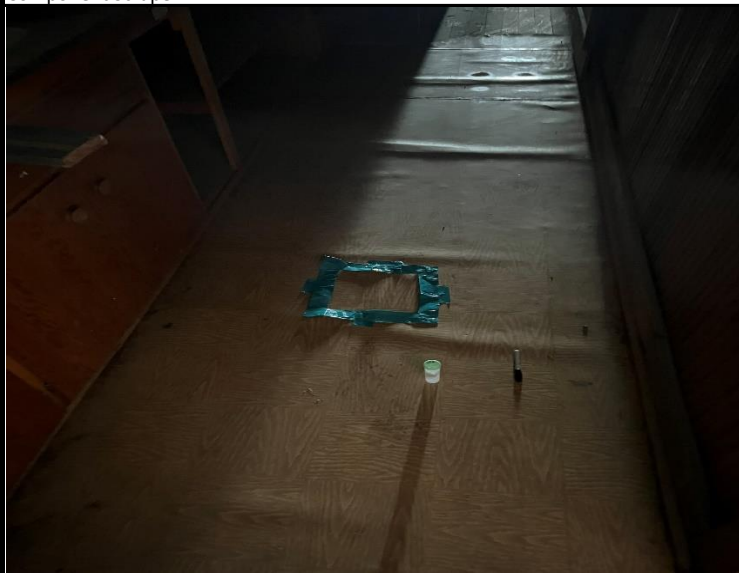
Photo 23: Thomas Apartments LBP Abatement Clearance Sampling Room 2

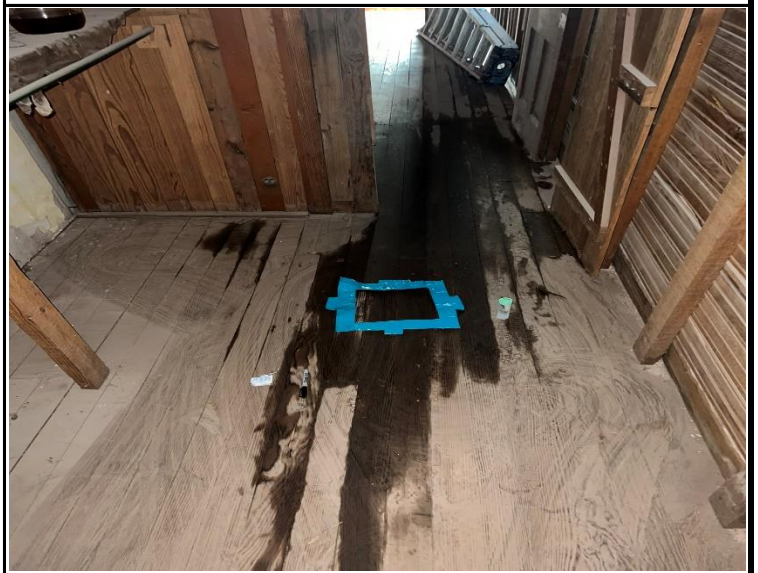
Photo 24: Thomas Apartments LBP Abatement Clearance Sampling Room 3

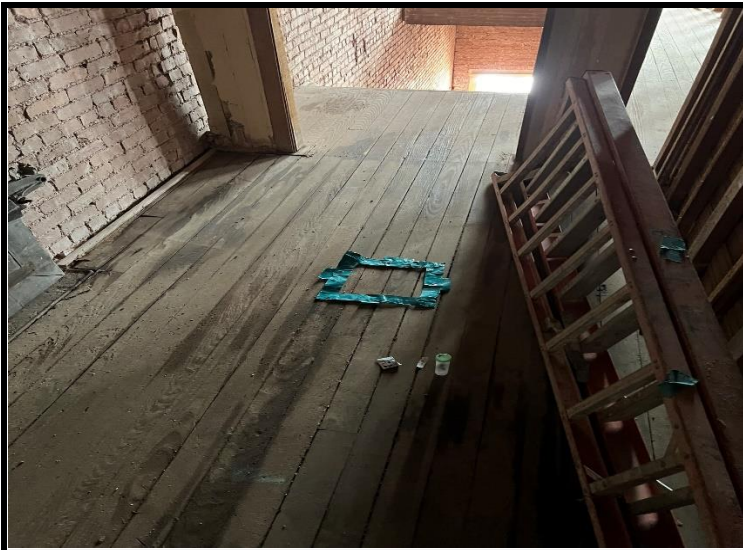
Photo 25: Thomas Apartments LBP Abatement Clearance Sampling Room 4

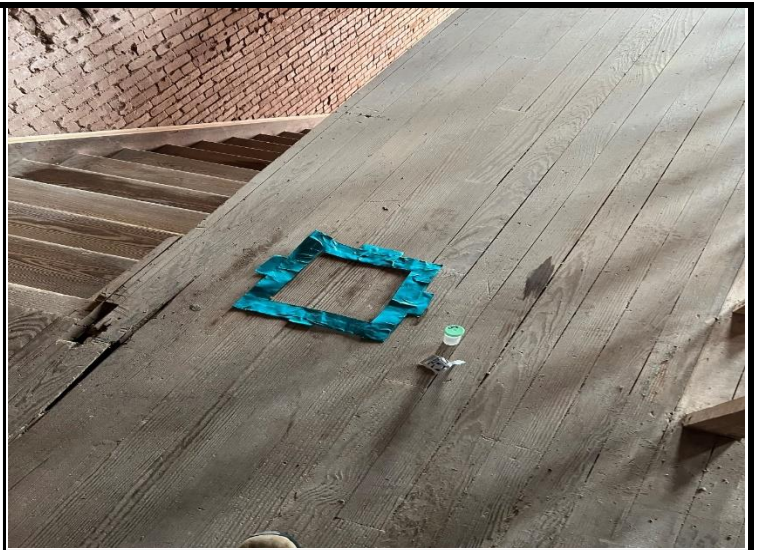
Photo 26: Thomas Apartments LBP Abatement Clearance Sampling Hallway

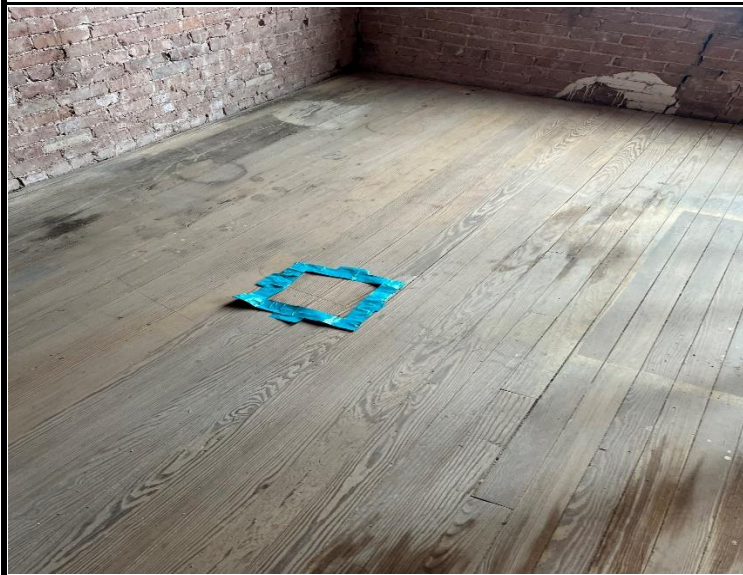
Photo 27: Thomas Apartments LBP Abatement Clearance Sampling Room 6

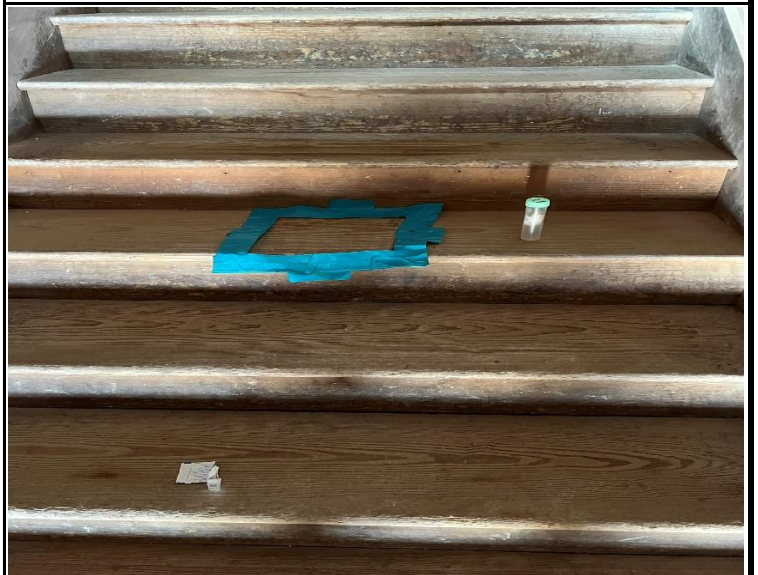
Photo 28: Thomas Apartments LBP Abatement Clearance Sampling Staircase
