# Former Thomas Hospital Building 7

Thomas, Oklahoma

## Final Remediation Report

### Asbestos Remediation Details

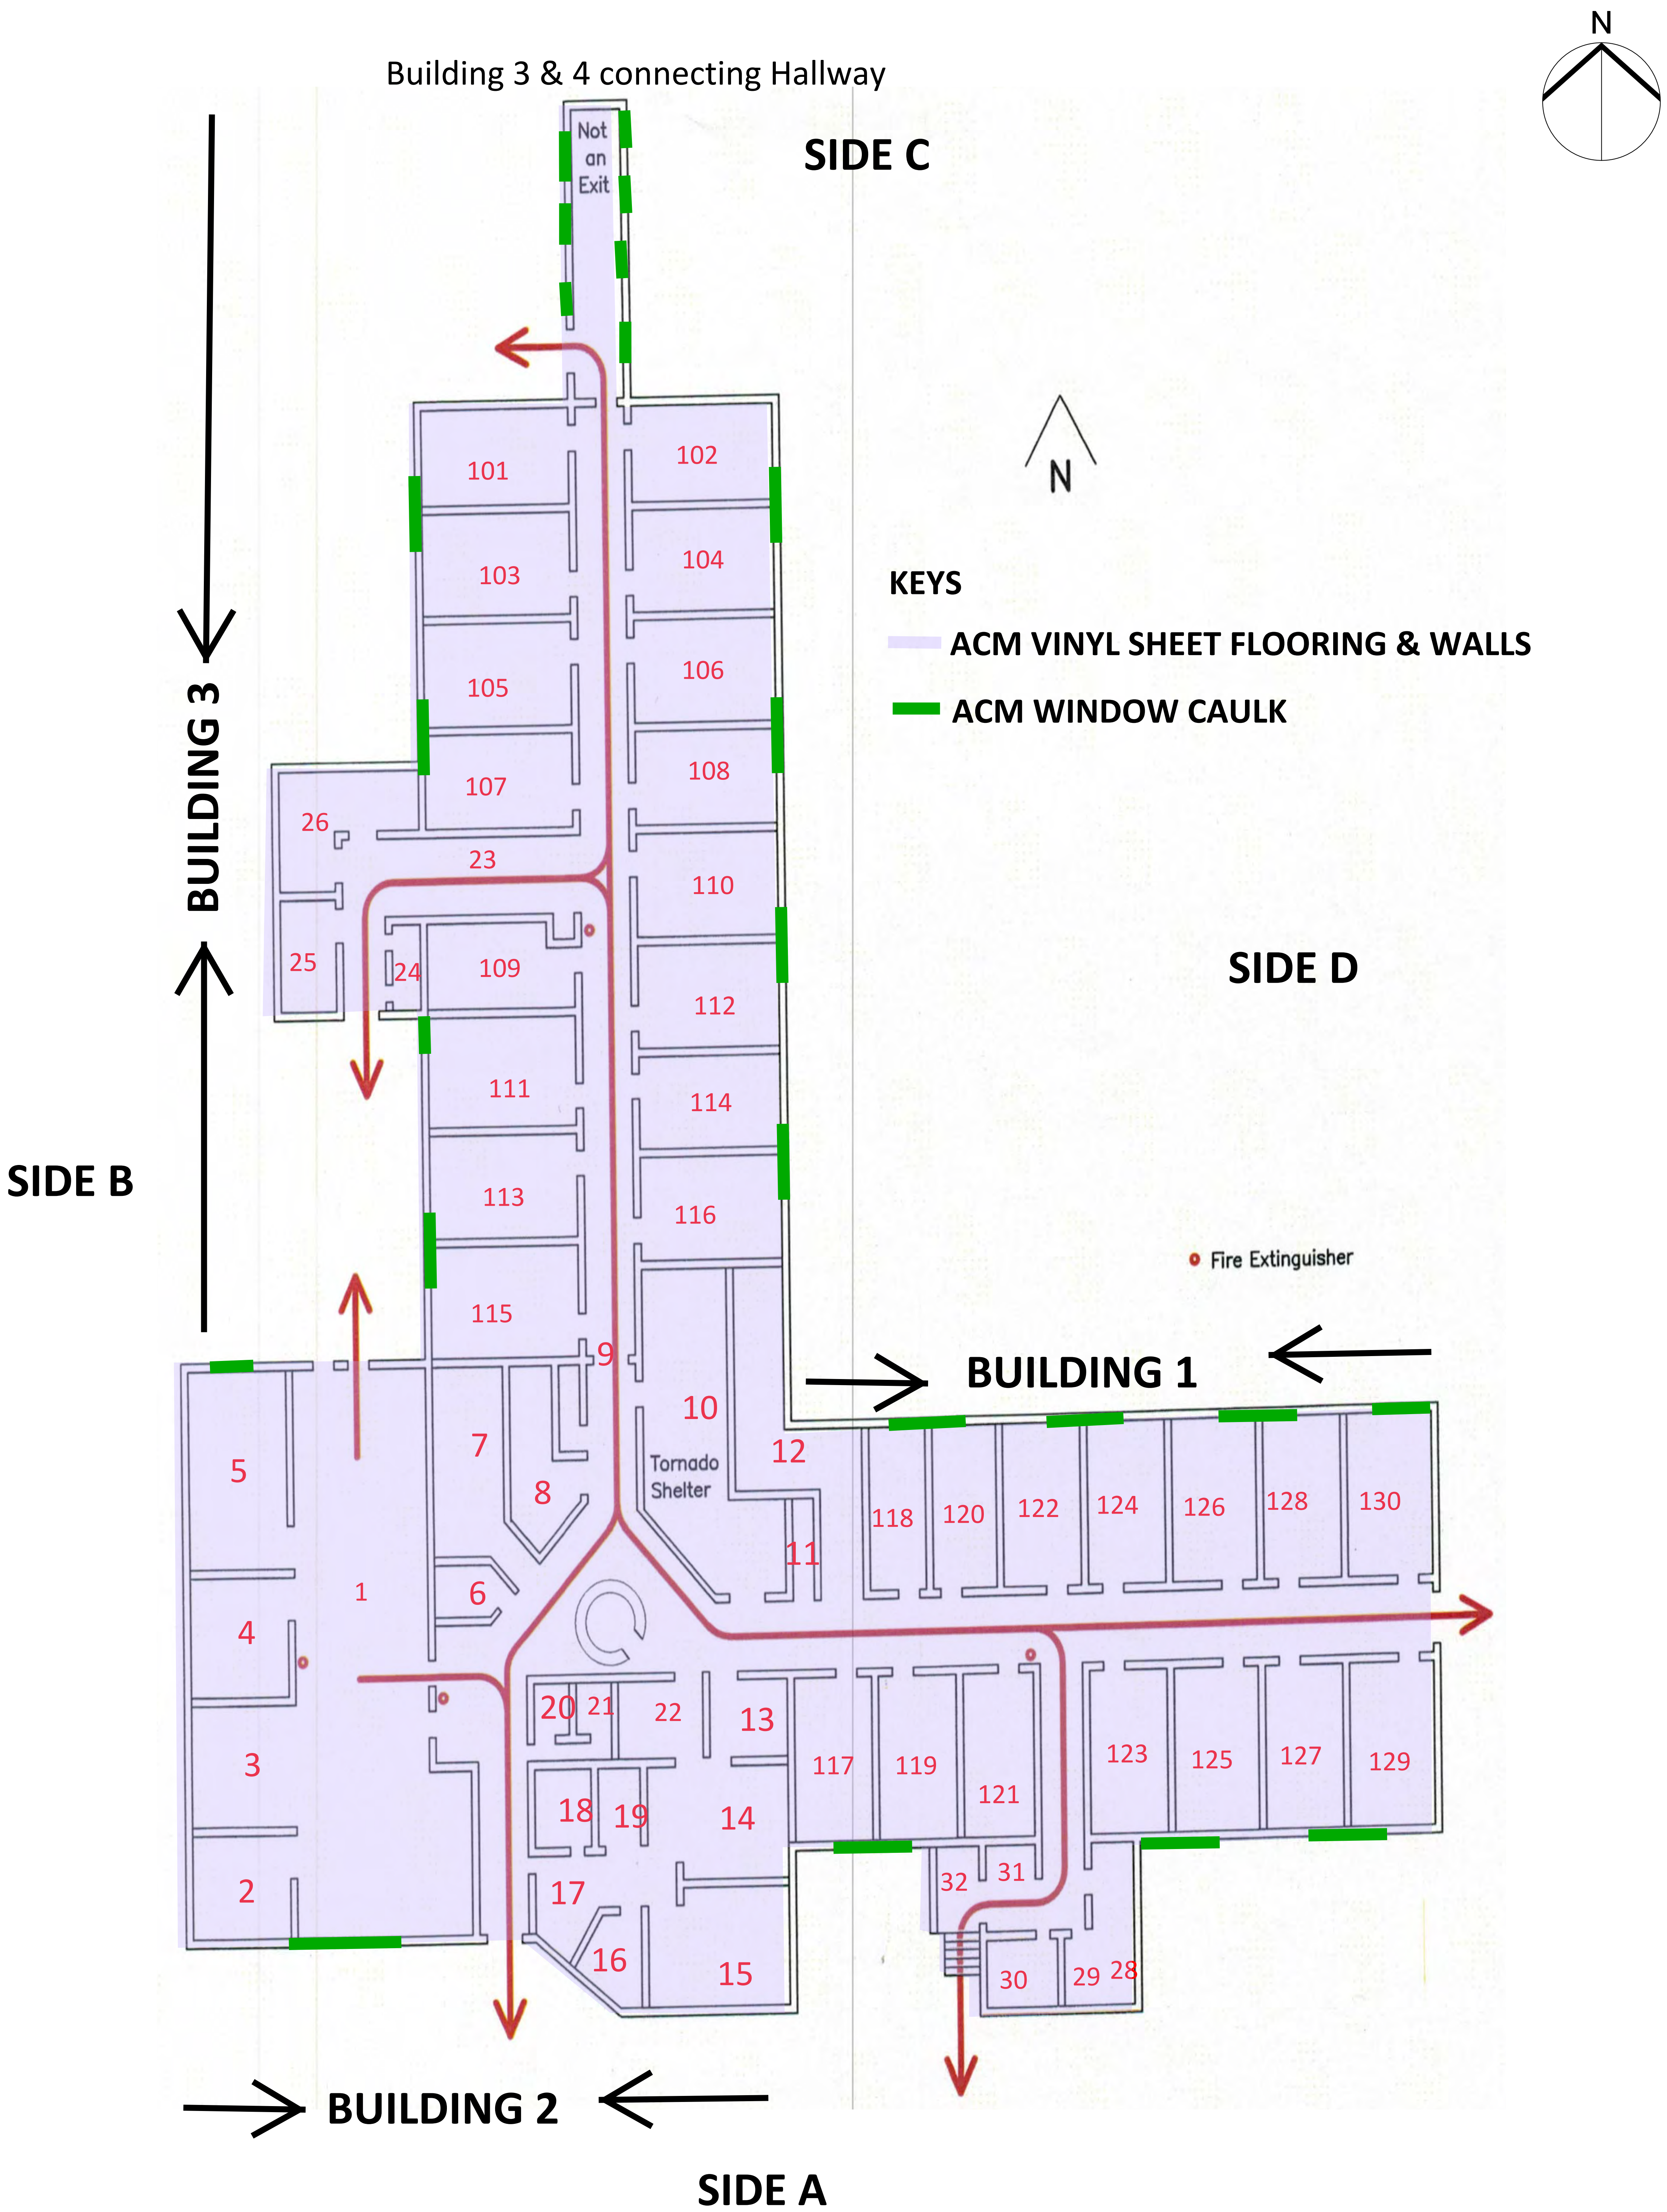
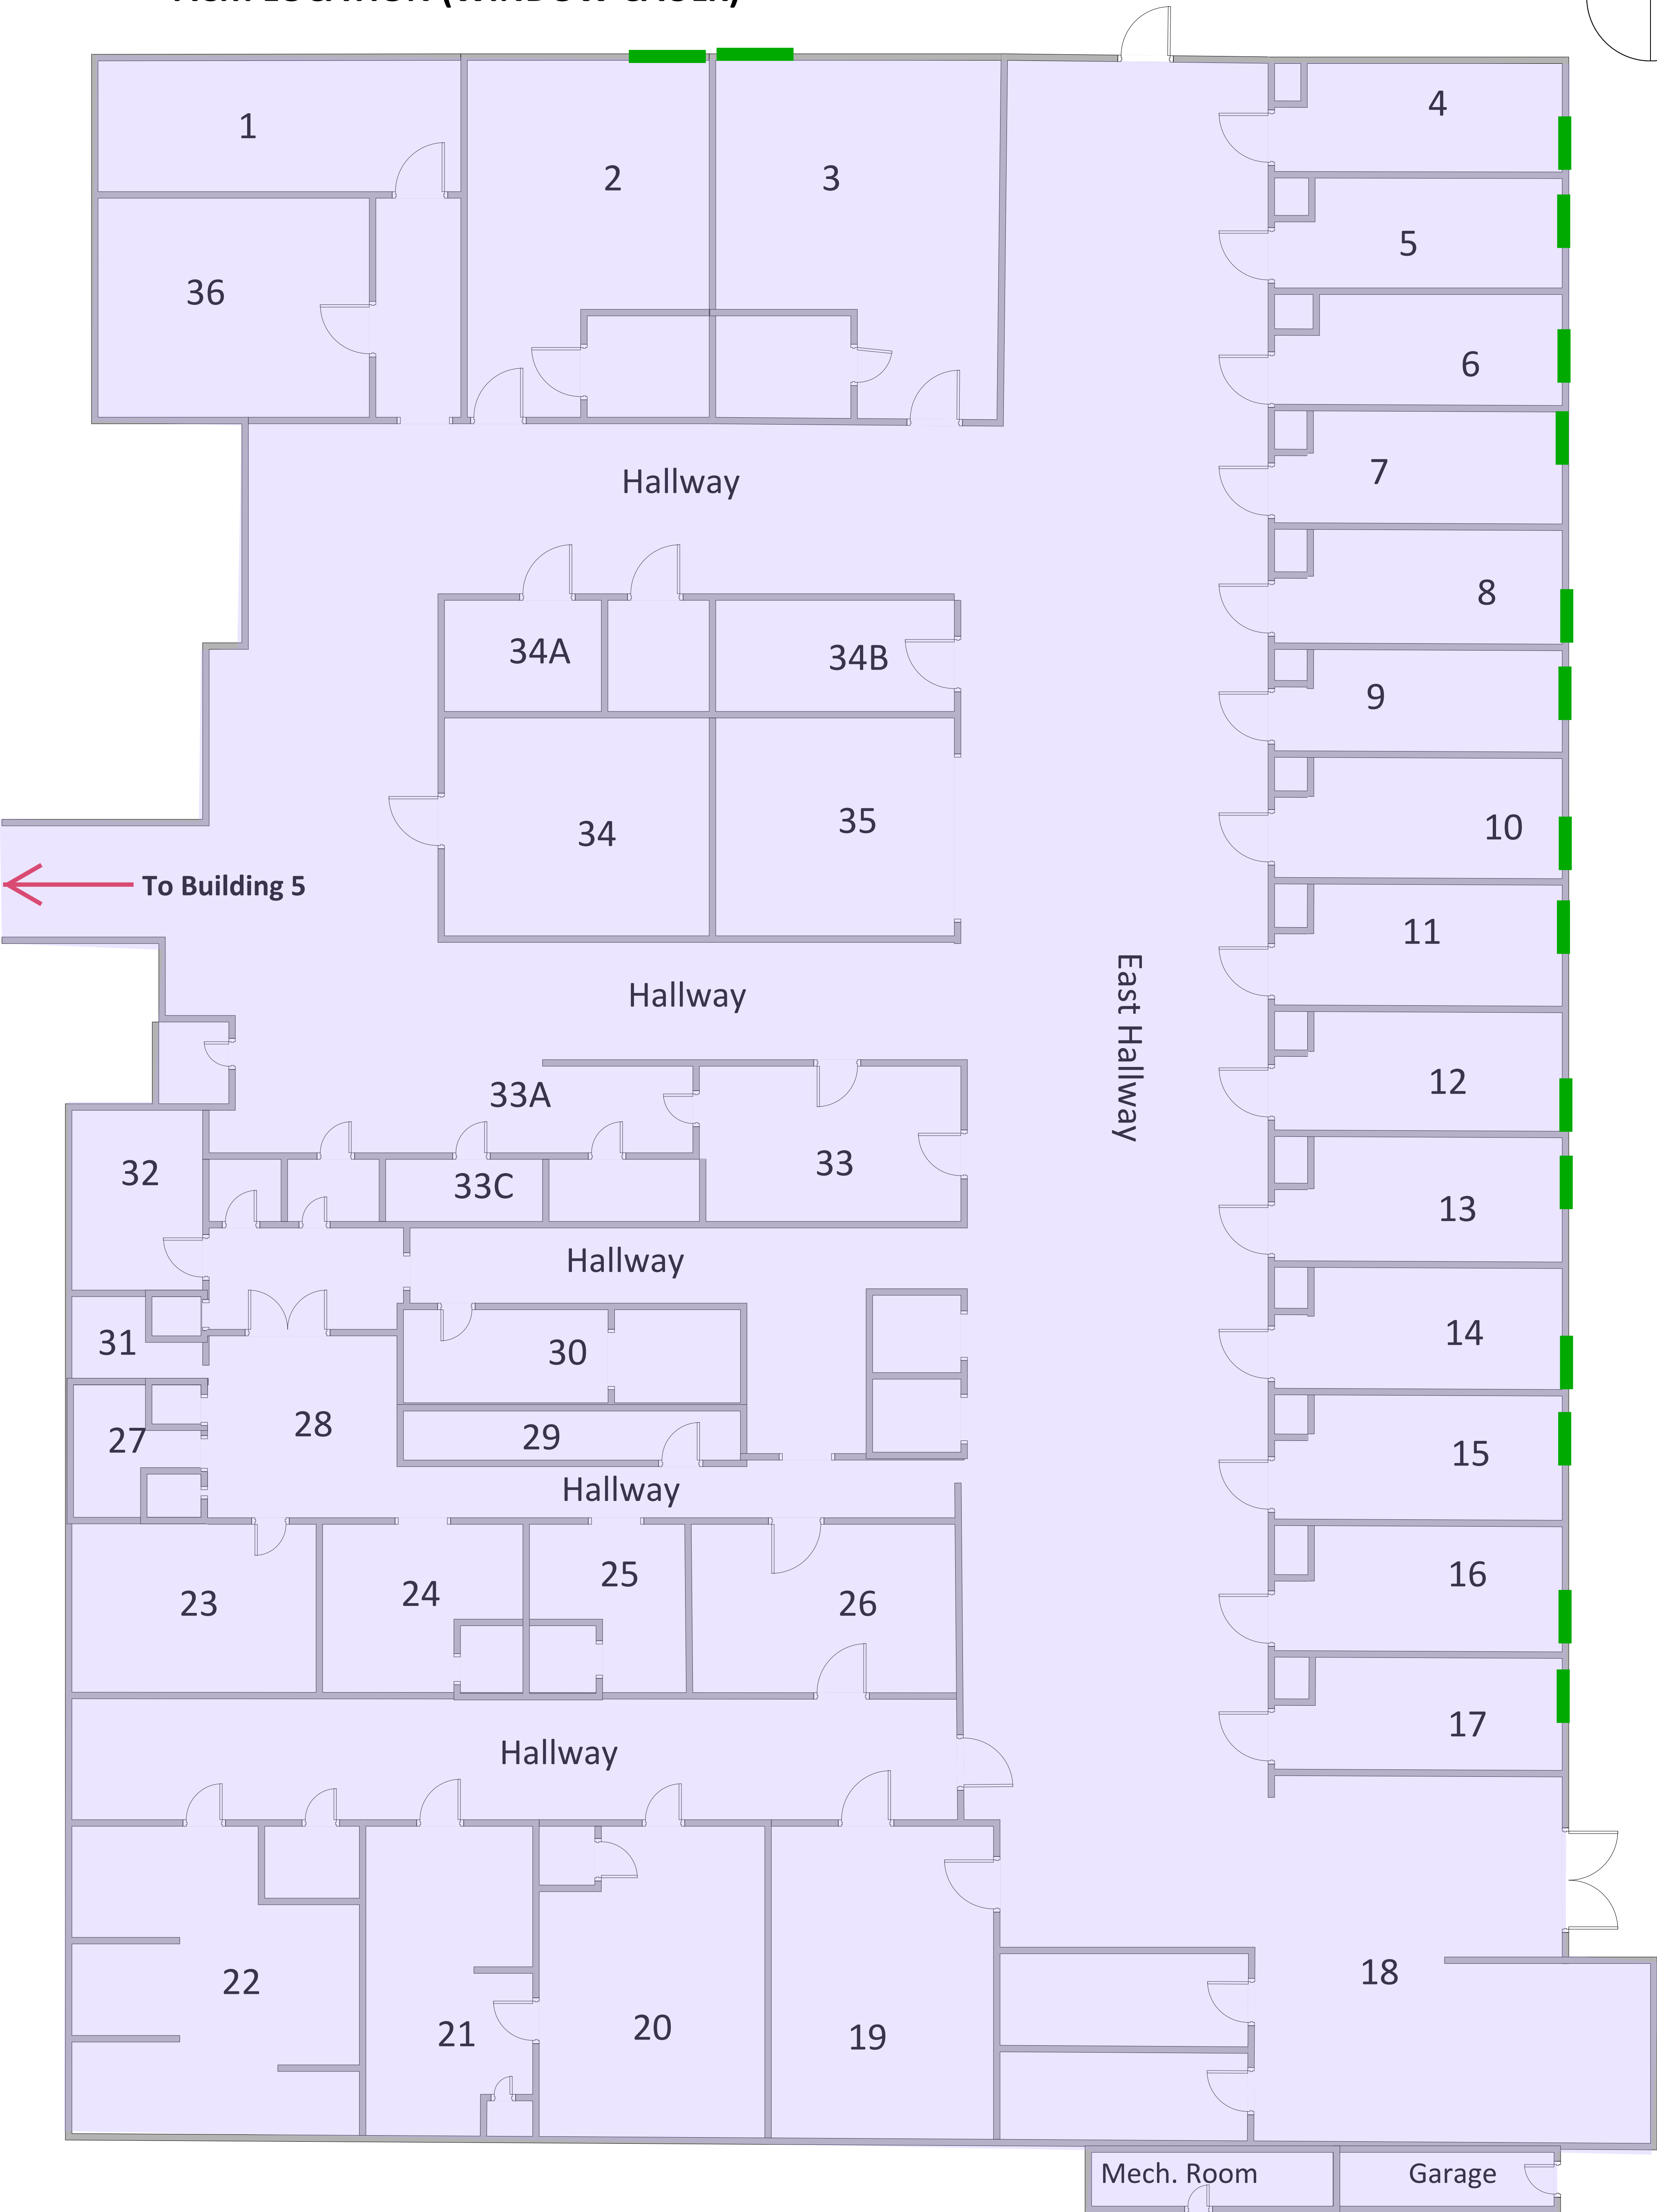
| | BUILDING 7 (EAST WING) - ACM LOCATION | | 7<br>FIGURE<br><br>NOT TO SCALE |

| CHAIN OF CUSTODY<br>SAMPLE NUMBERS | ACM<br>DESCRIPTION | HOMOGENOUS<br>LOCATIONS | CONDITION | TYPE | % ASBESTOS/TYPE | NESHAP<br>CLASSIFICATION | TOTAL<br>QUANTITY | ESTIMATED<br>COST | NOTES |
|---|---|---|---|---|---|---|---|---|---|
| PLM 19-21<br>(Sampled 2/14/20) | Window<br>Caulk | Building 7 exterior | Damaged | Misc. | 8%<br>Chrysotile | Category I Non-<br>Friable | 16 | \$5,856 | All the exterior<br>window units<br>within building 7 |

- ACM LOCATION (VINYL SHEET FLOORING & WALL SYSTEMS)
- ACM LOCATION (WINDOW CAULK)

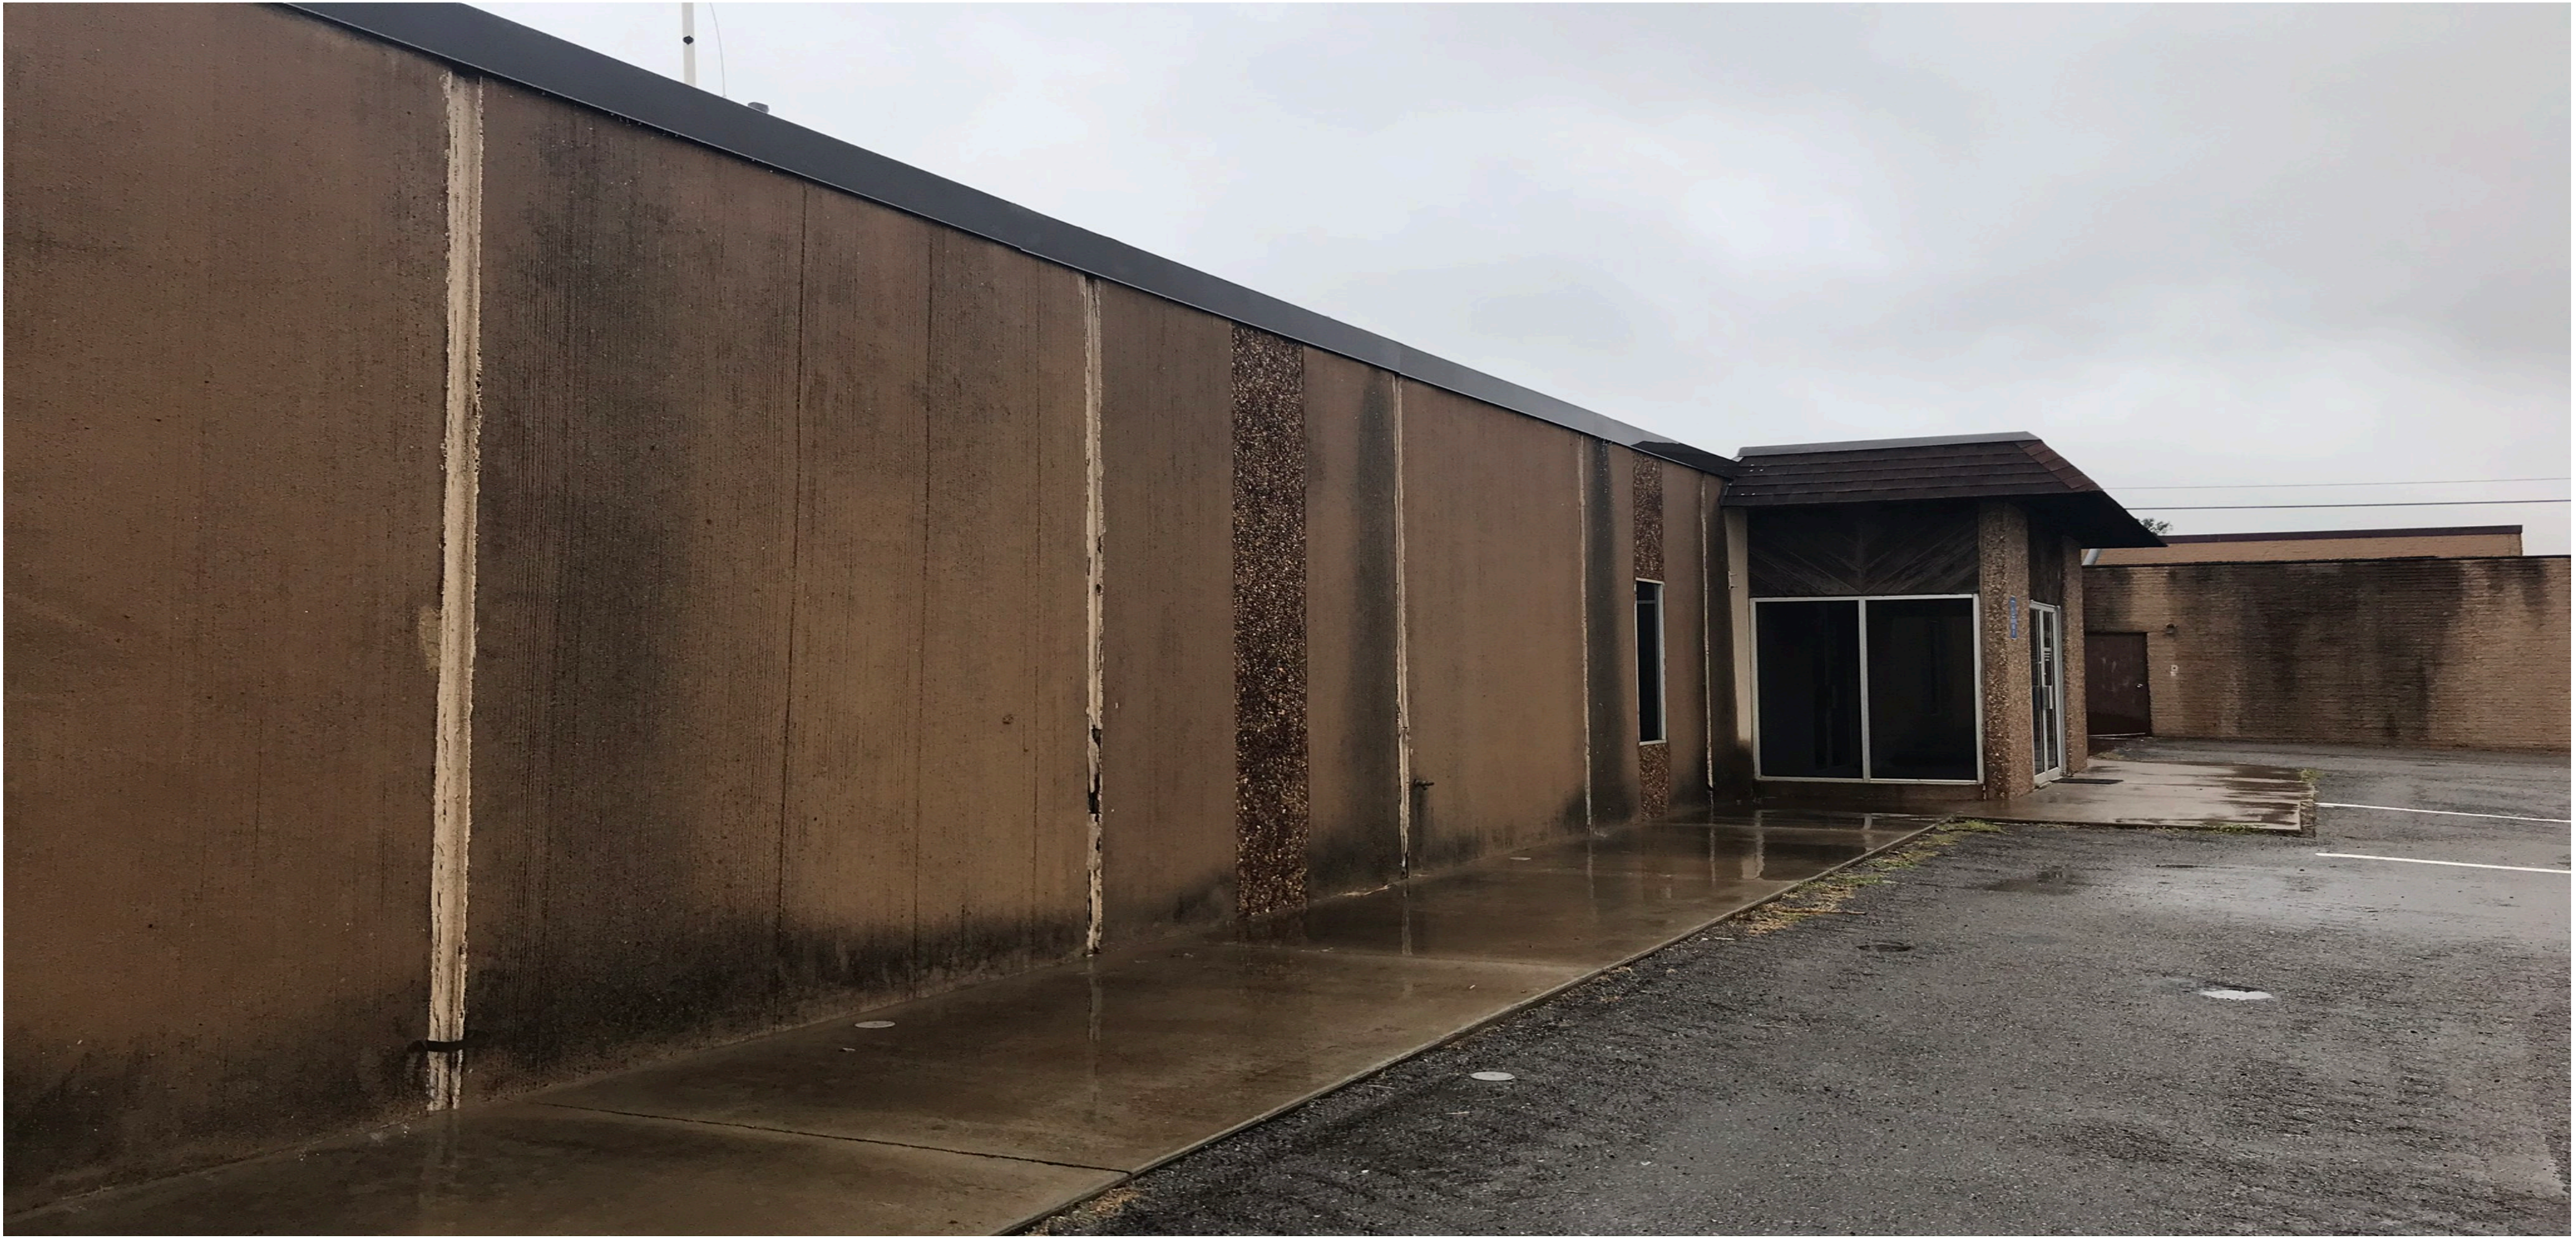
Police Building - ACM Wall Expansion Joint Texture/Barrier - round the building

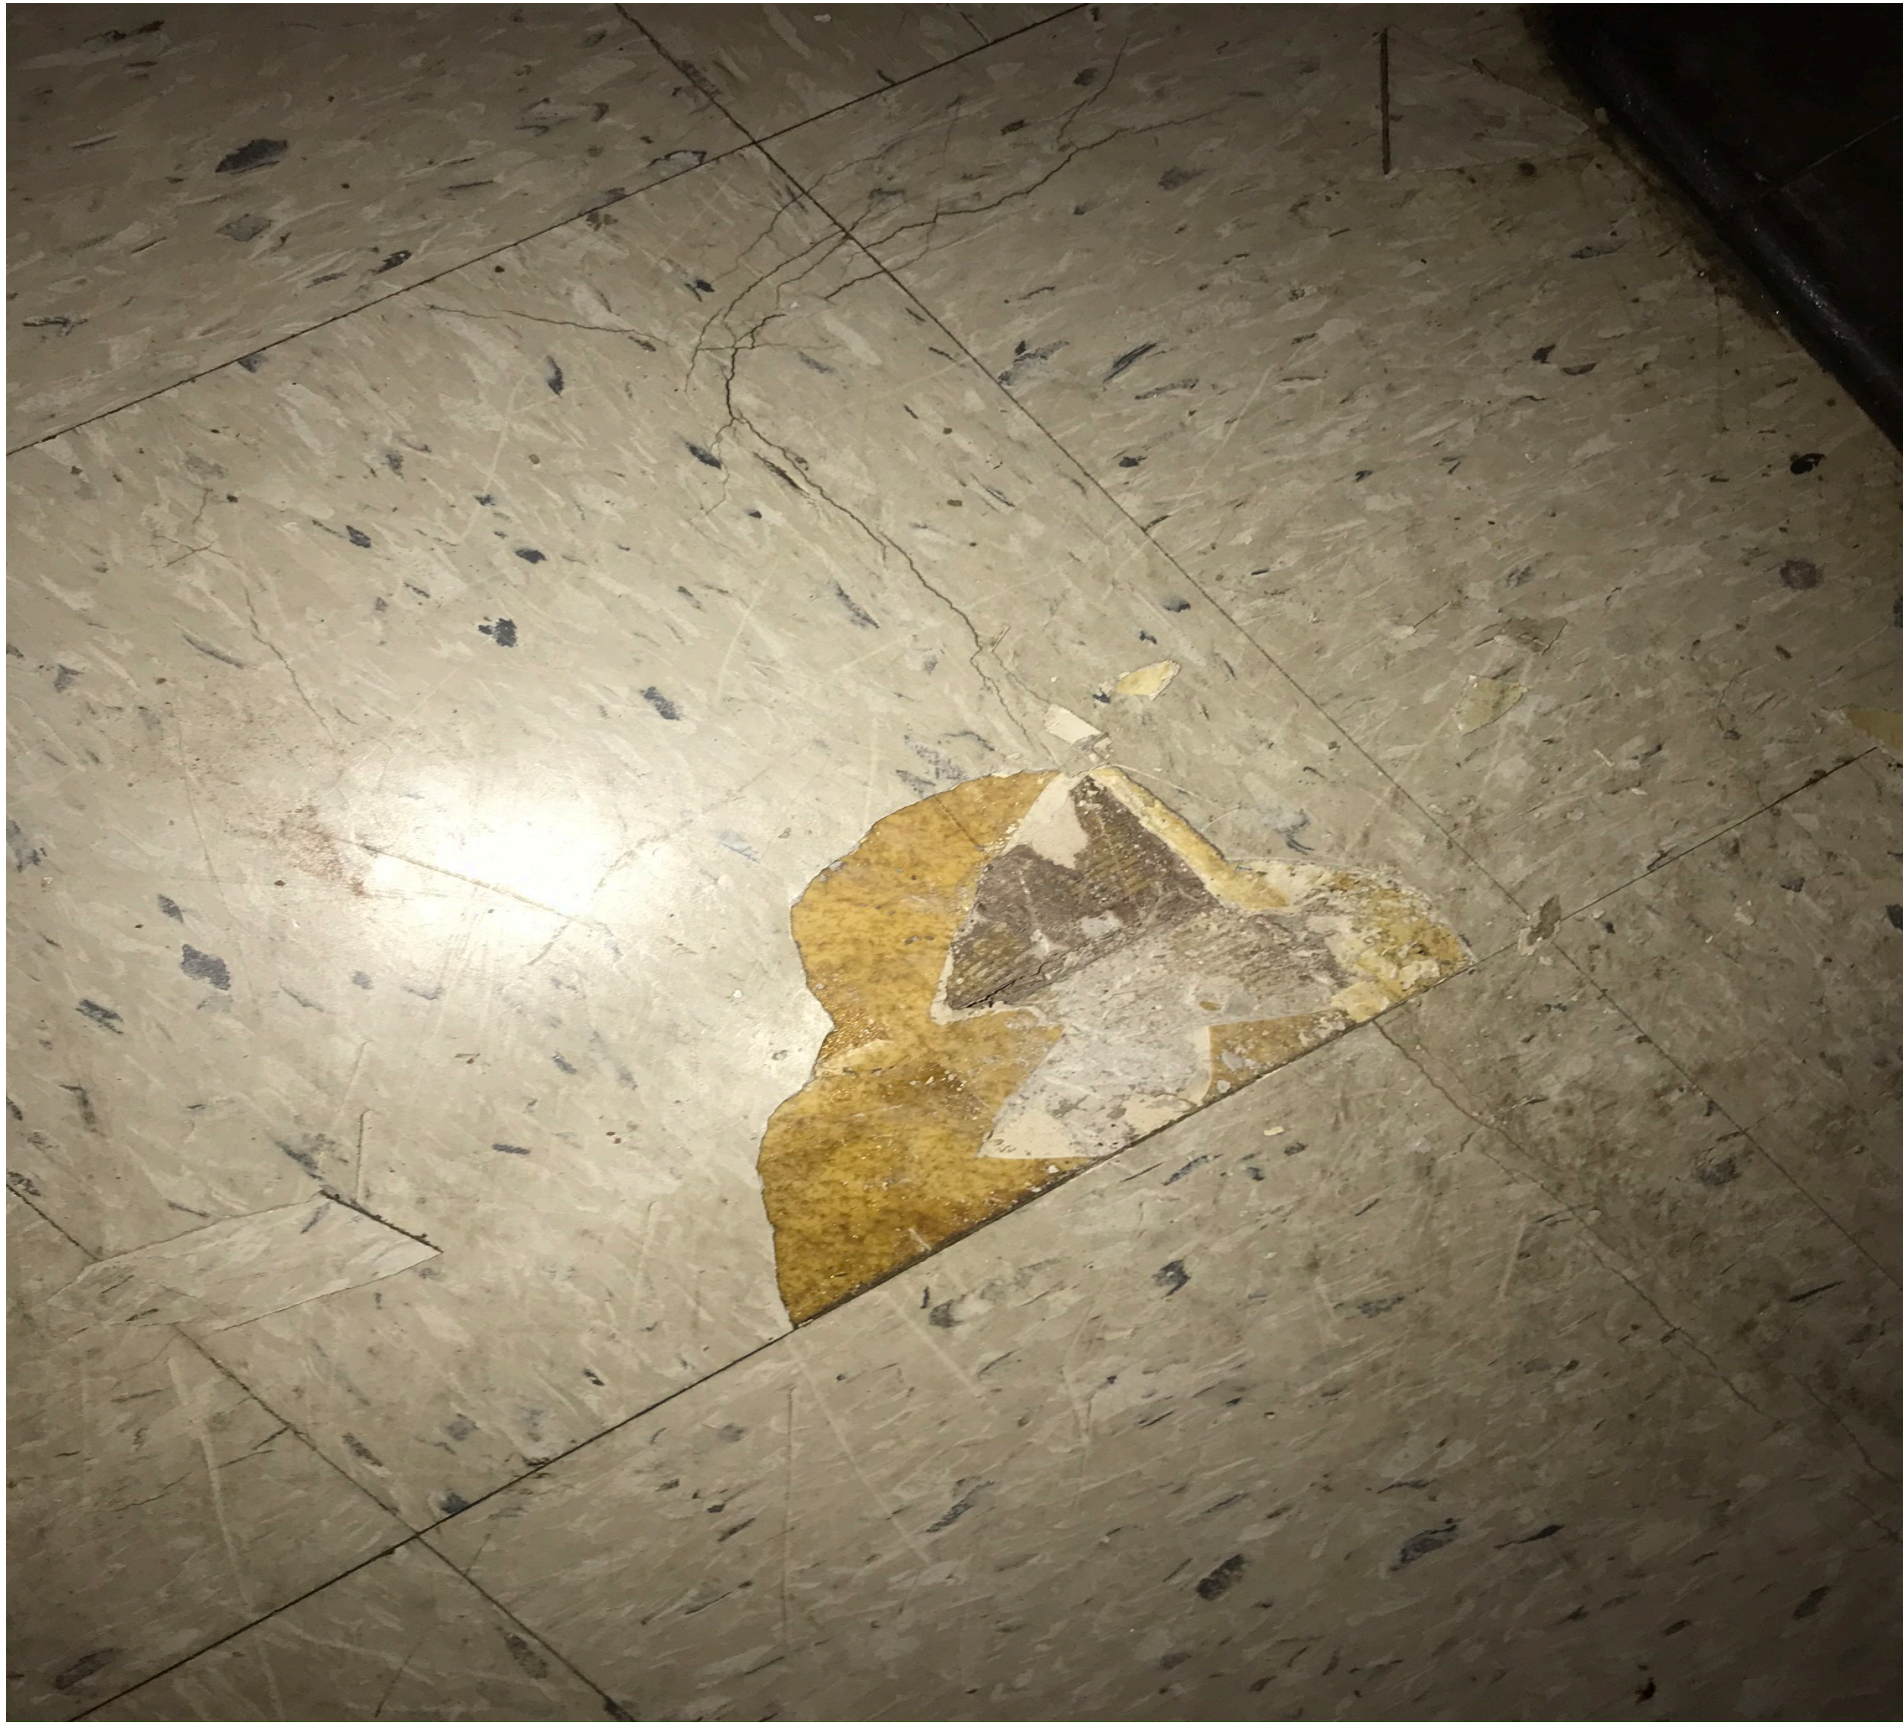
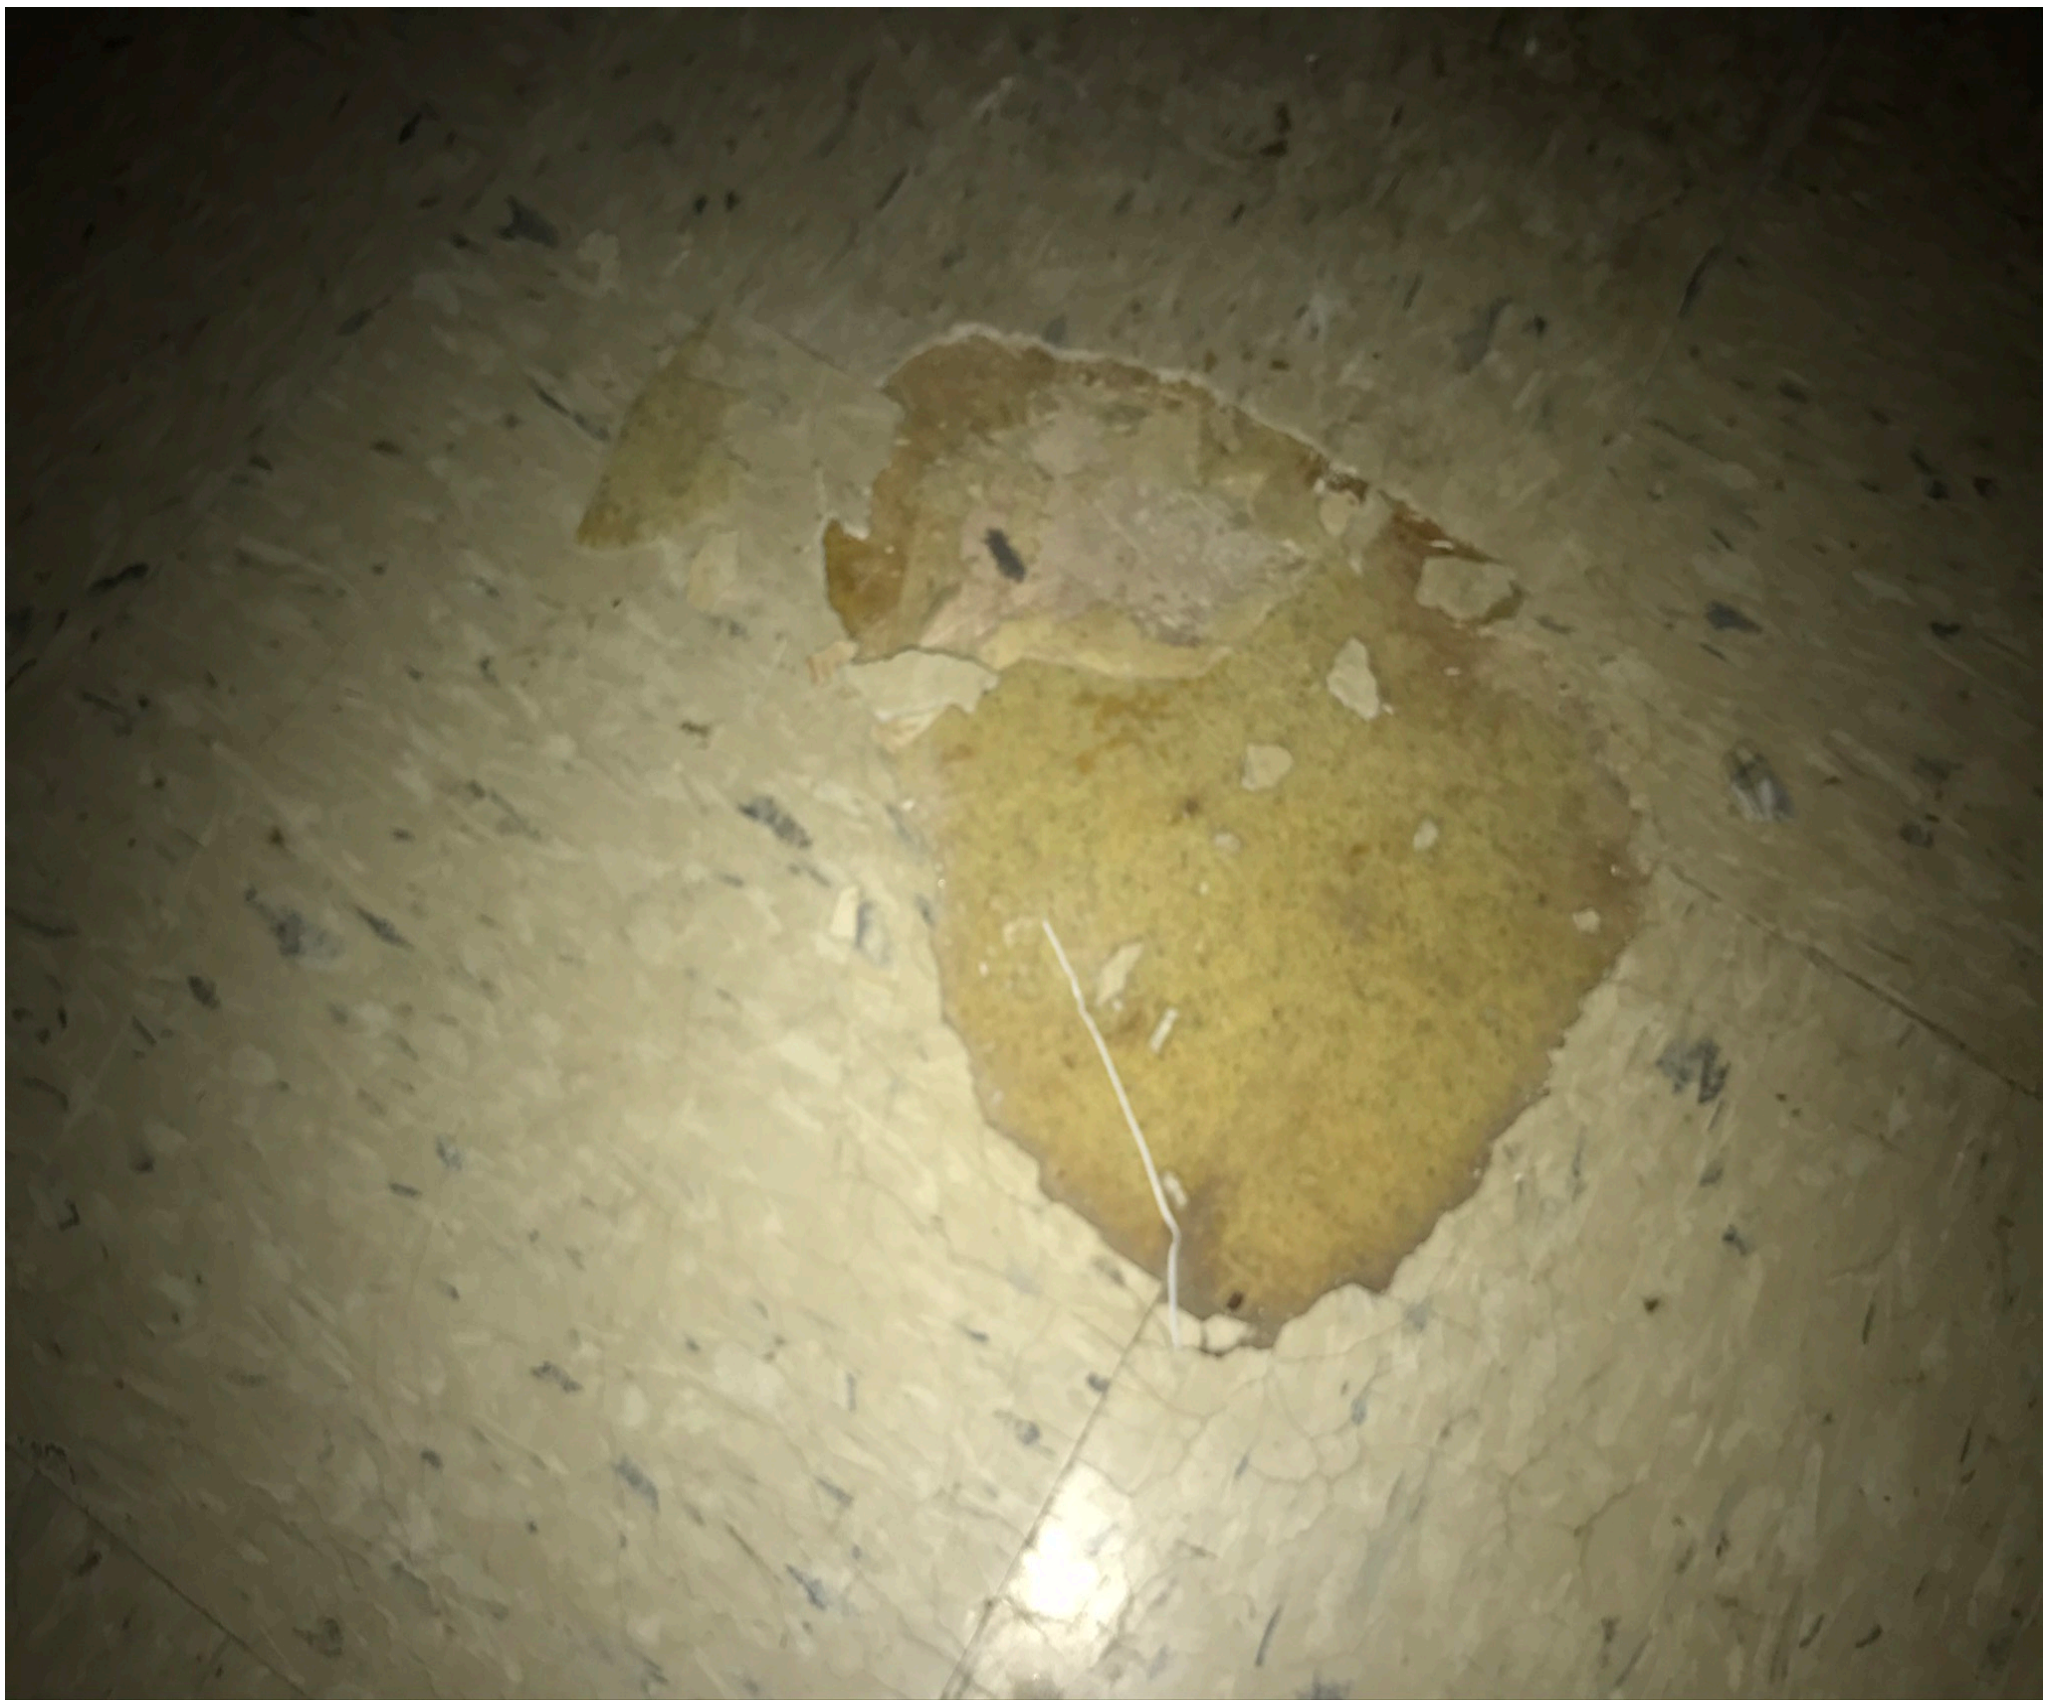
Room 1 & Room 123 Hallway - ACM sheet flooring beneath the floor tiles in all rooms/hallway throughout the nursing home (Building 1-3)
