# Former Thomas Hospital Building 7

Thomas, Oklahoma

## Final Remediation Report

### Asbestos Remediation Details

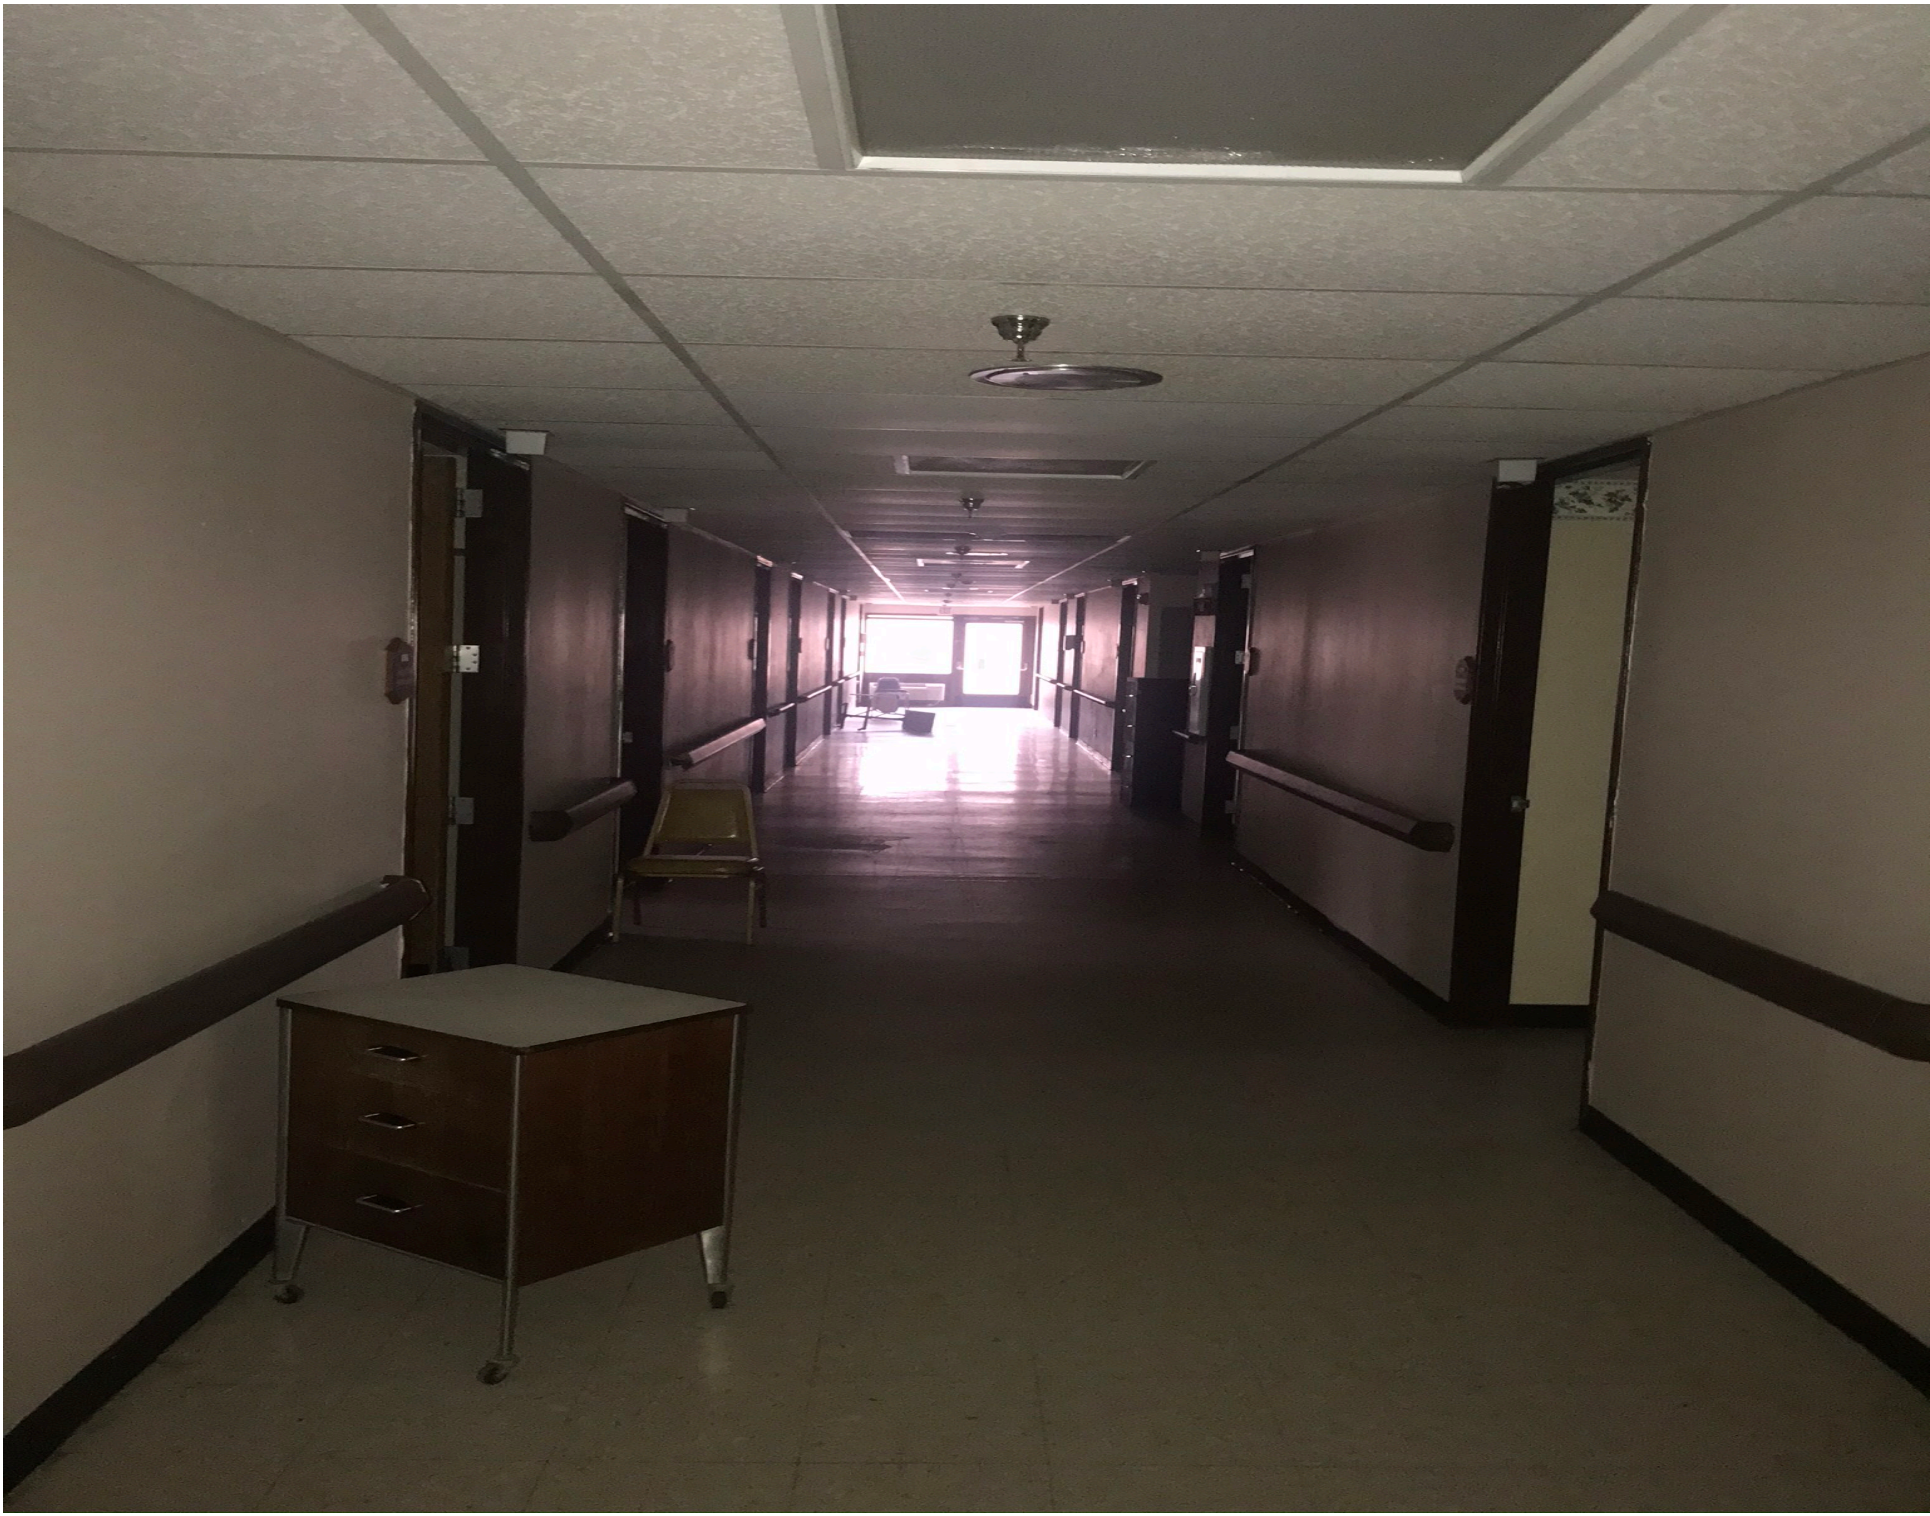
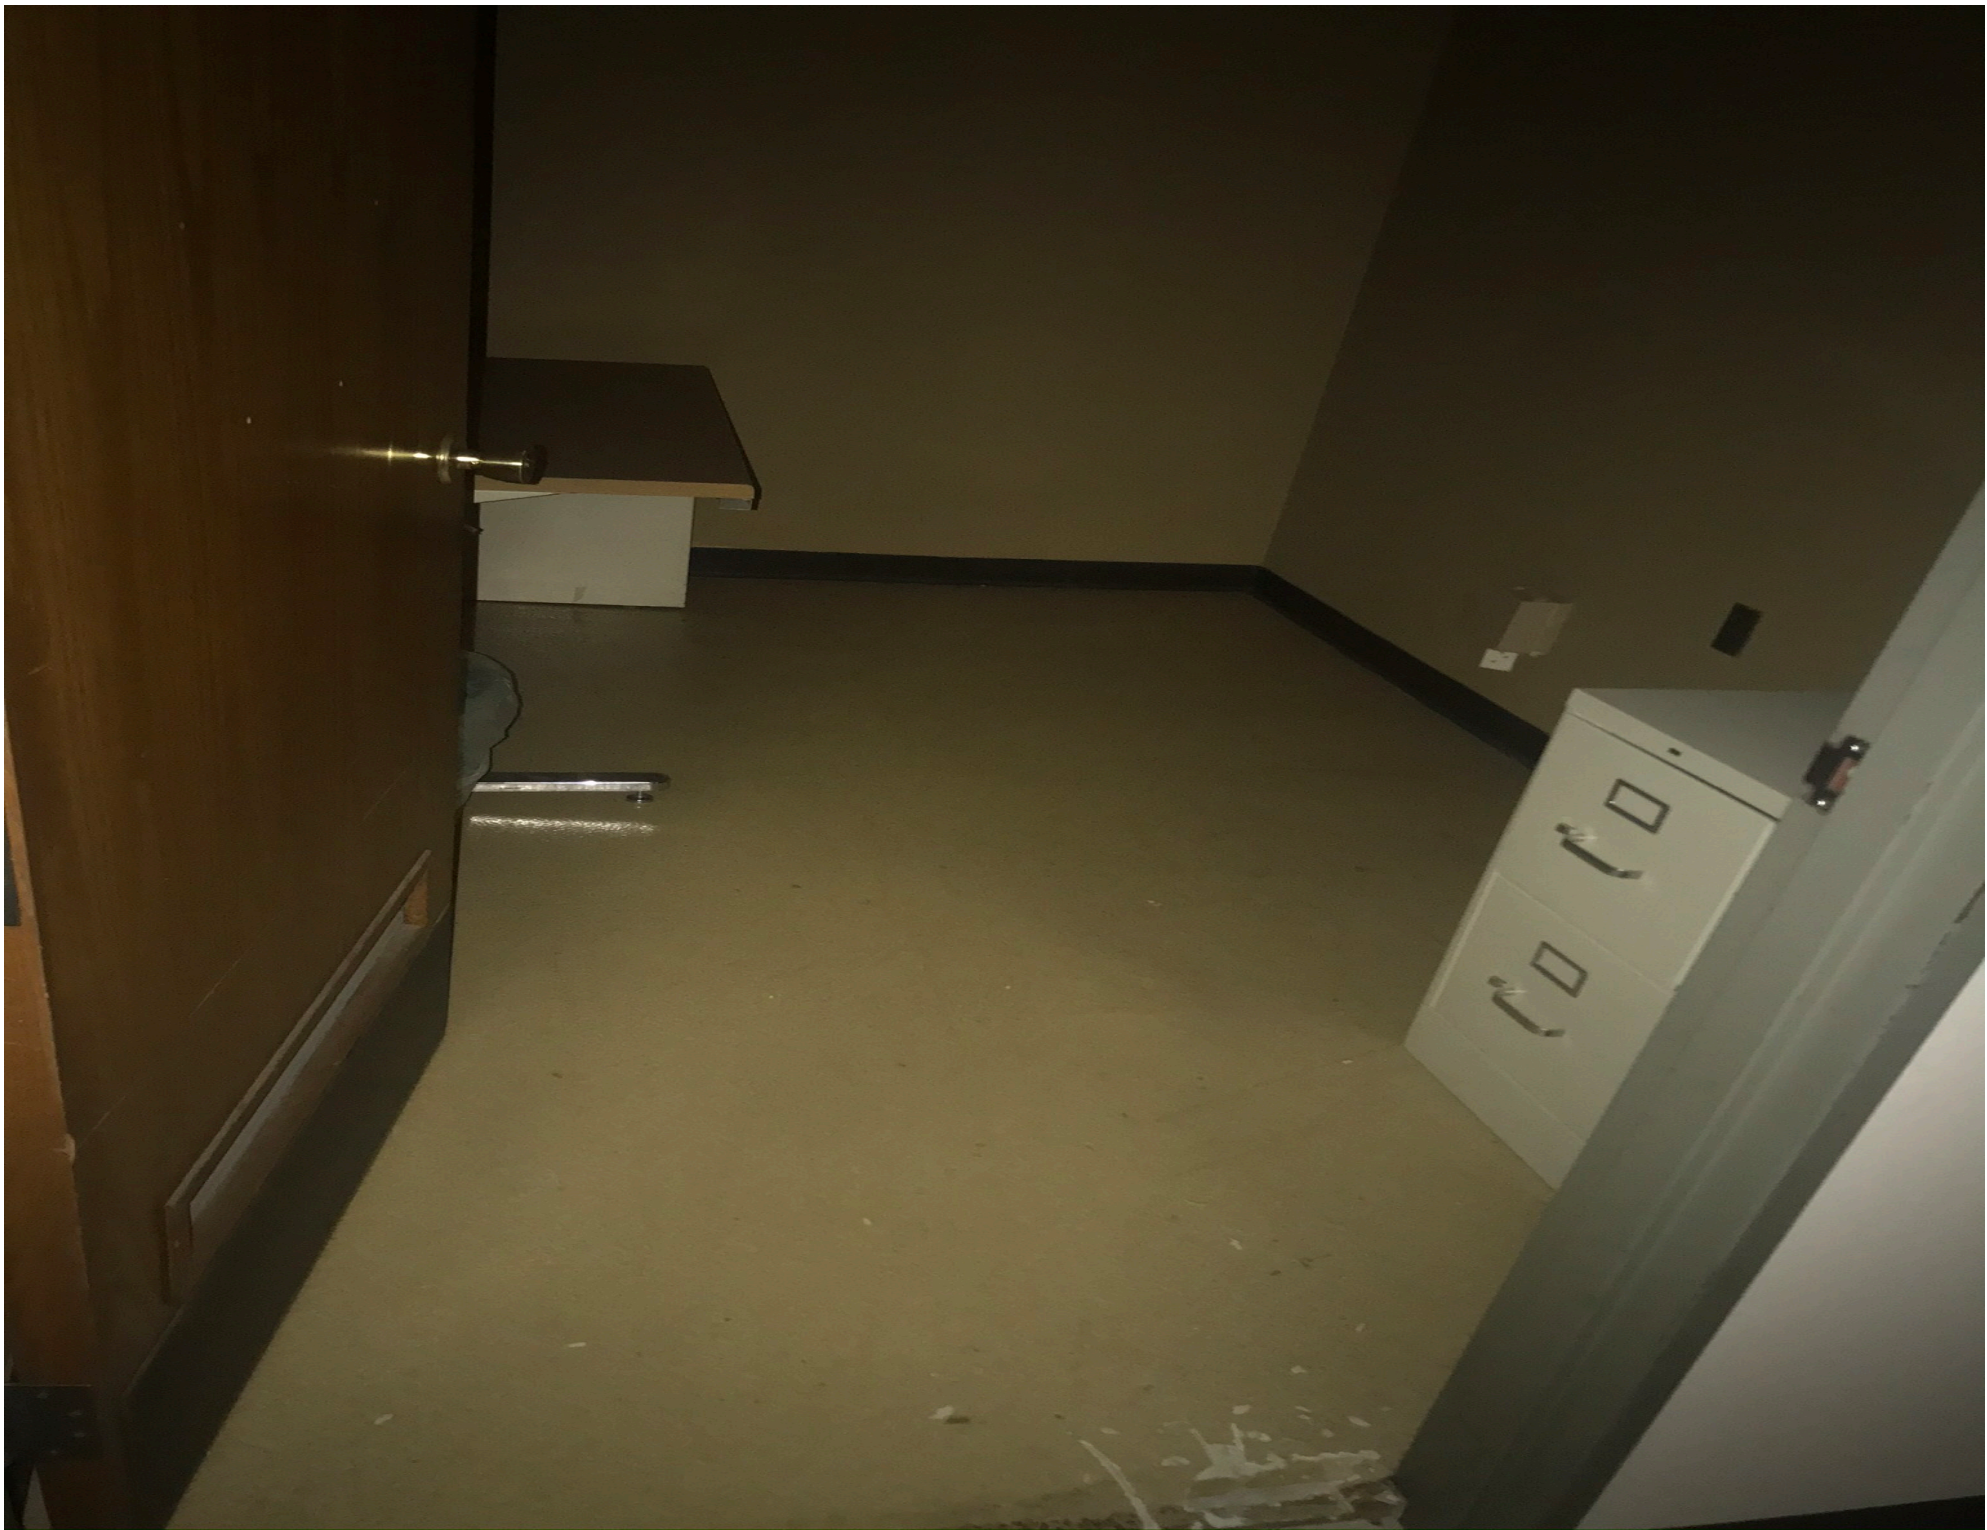
- Bldg 1 Hallway (Nursing Home) - ACM sheet flooring beneath floor tiles throughout bldg. 1-3  
- ACM - Texture & Joint Compounds of the wall systems throughout the bldg 1-3

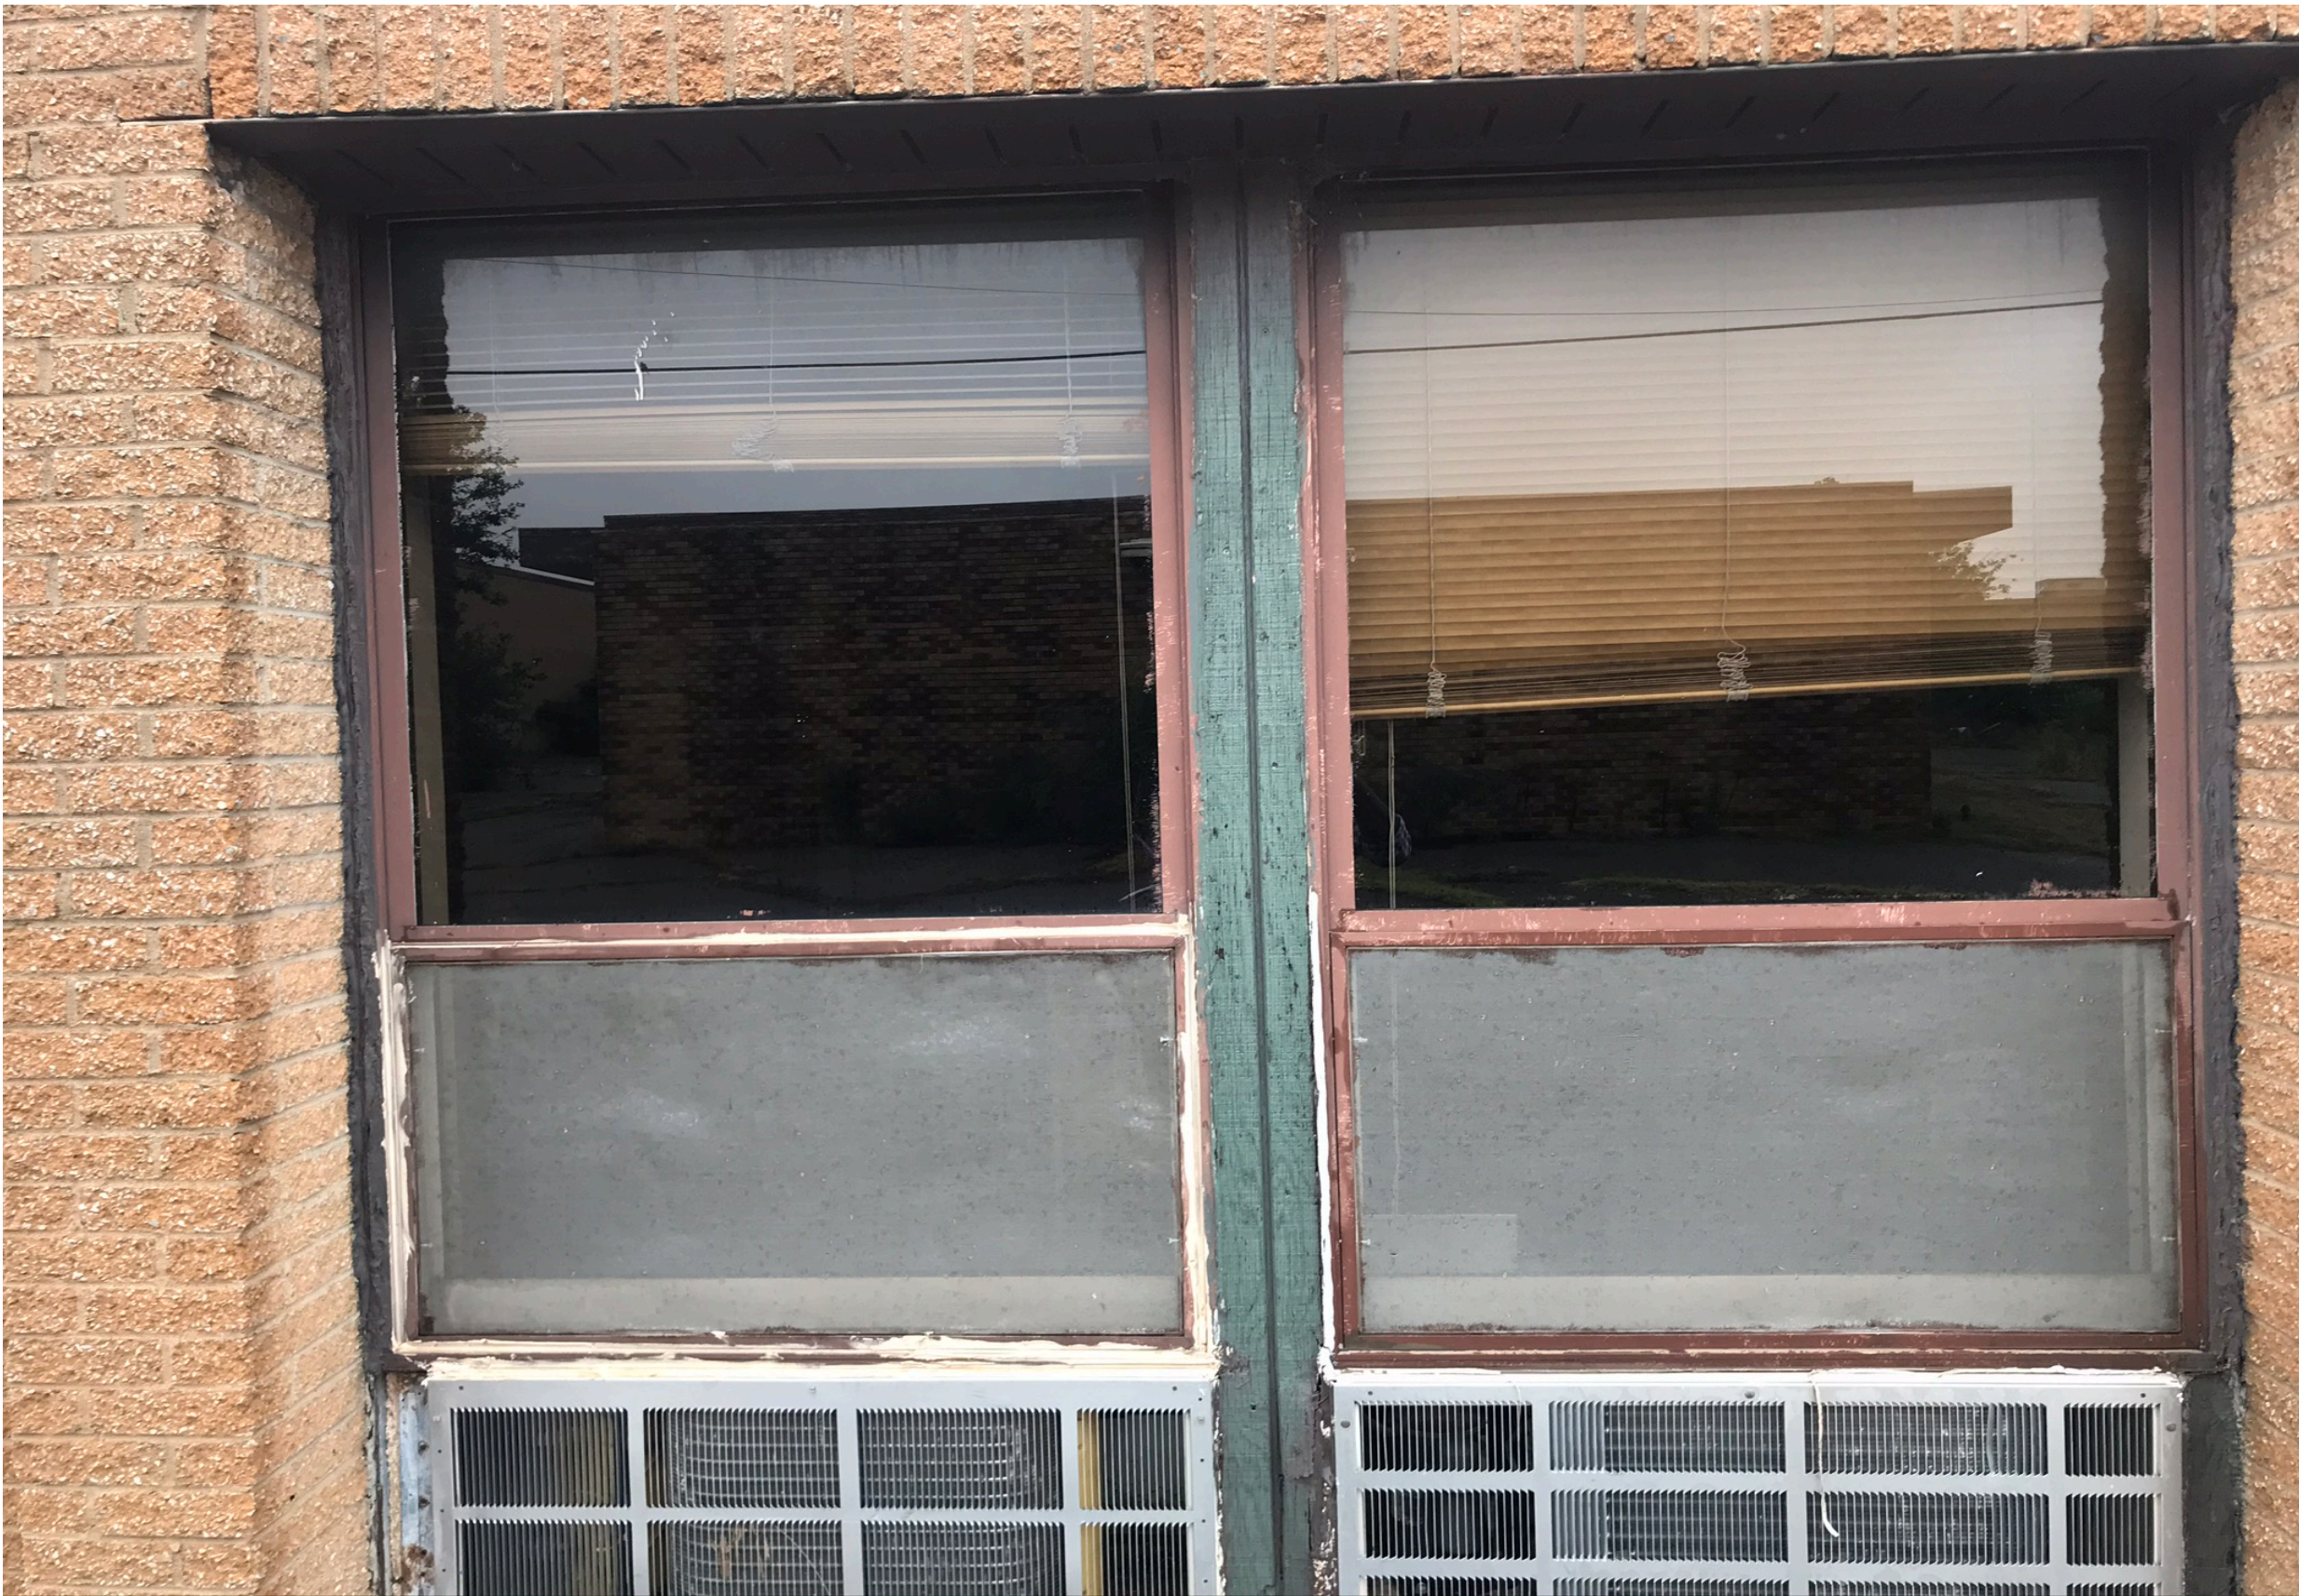
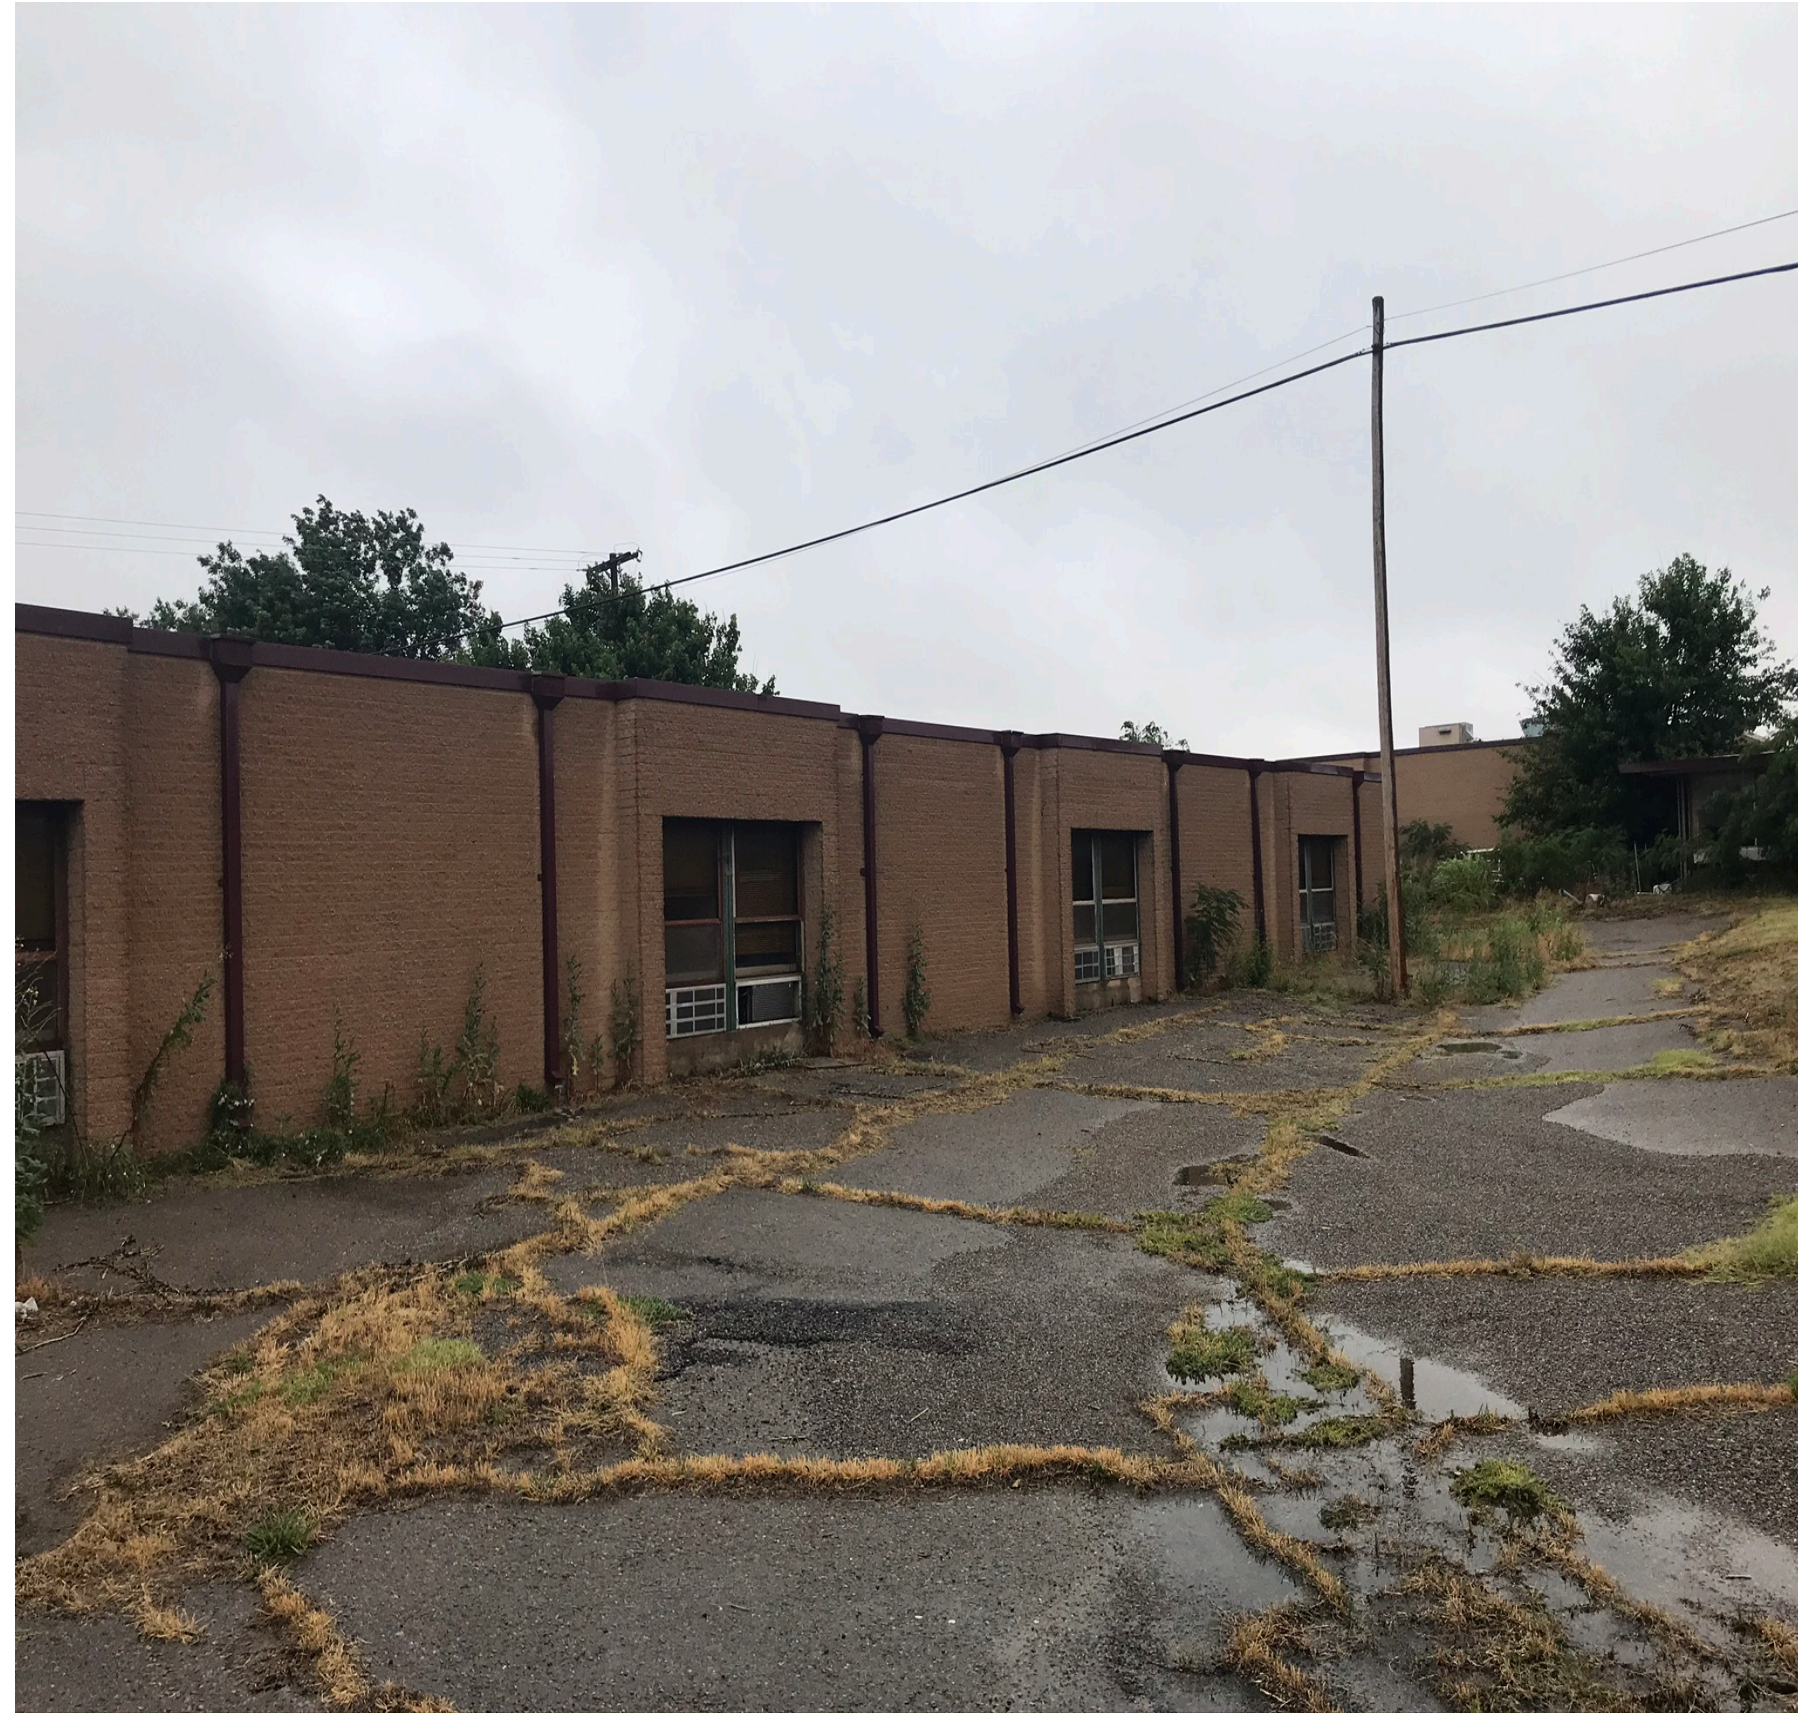
Bldg. 1-3 (Nursing Home) - ACM - window caulking throughout the building

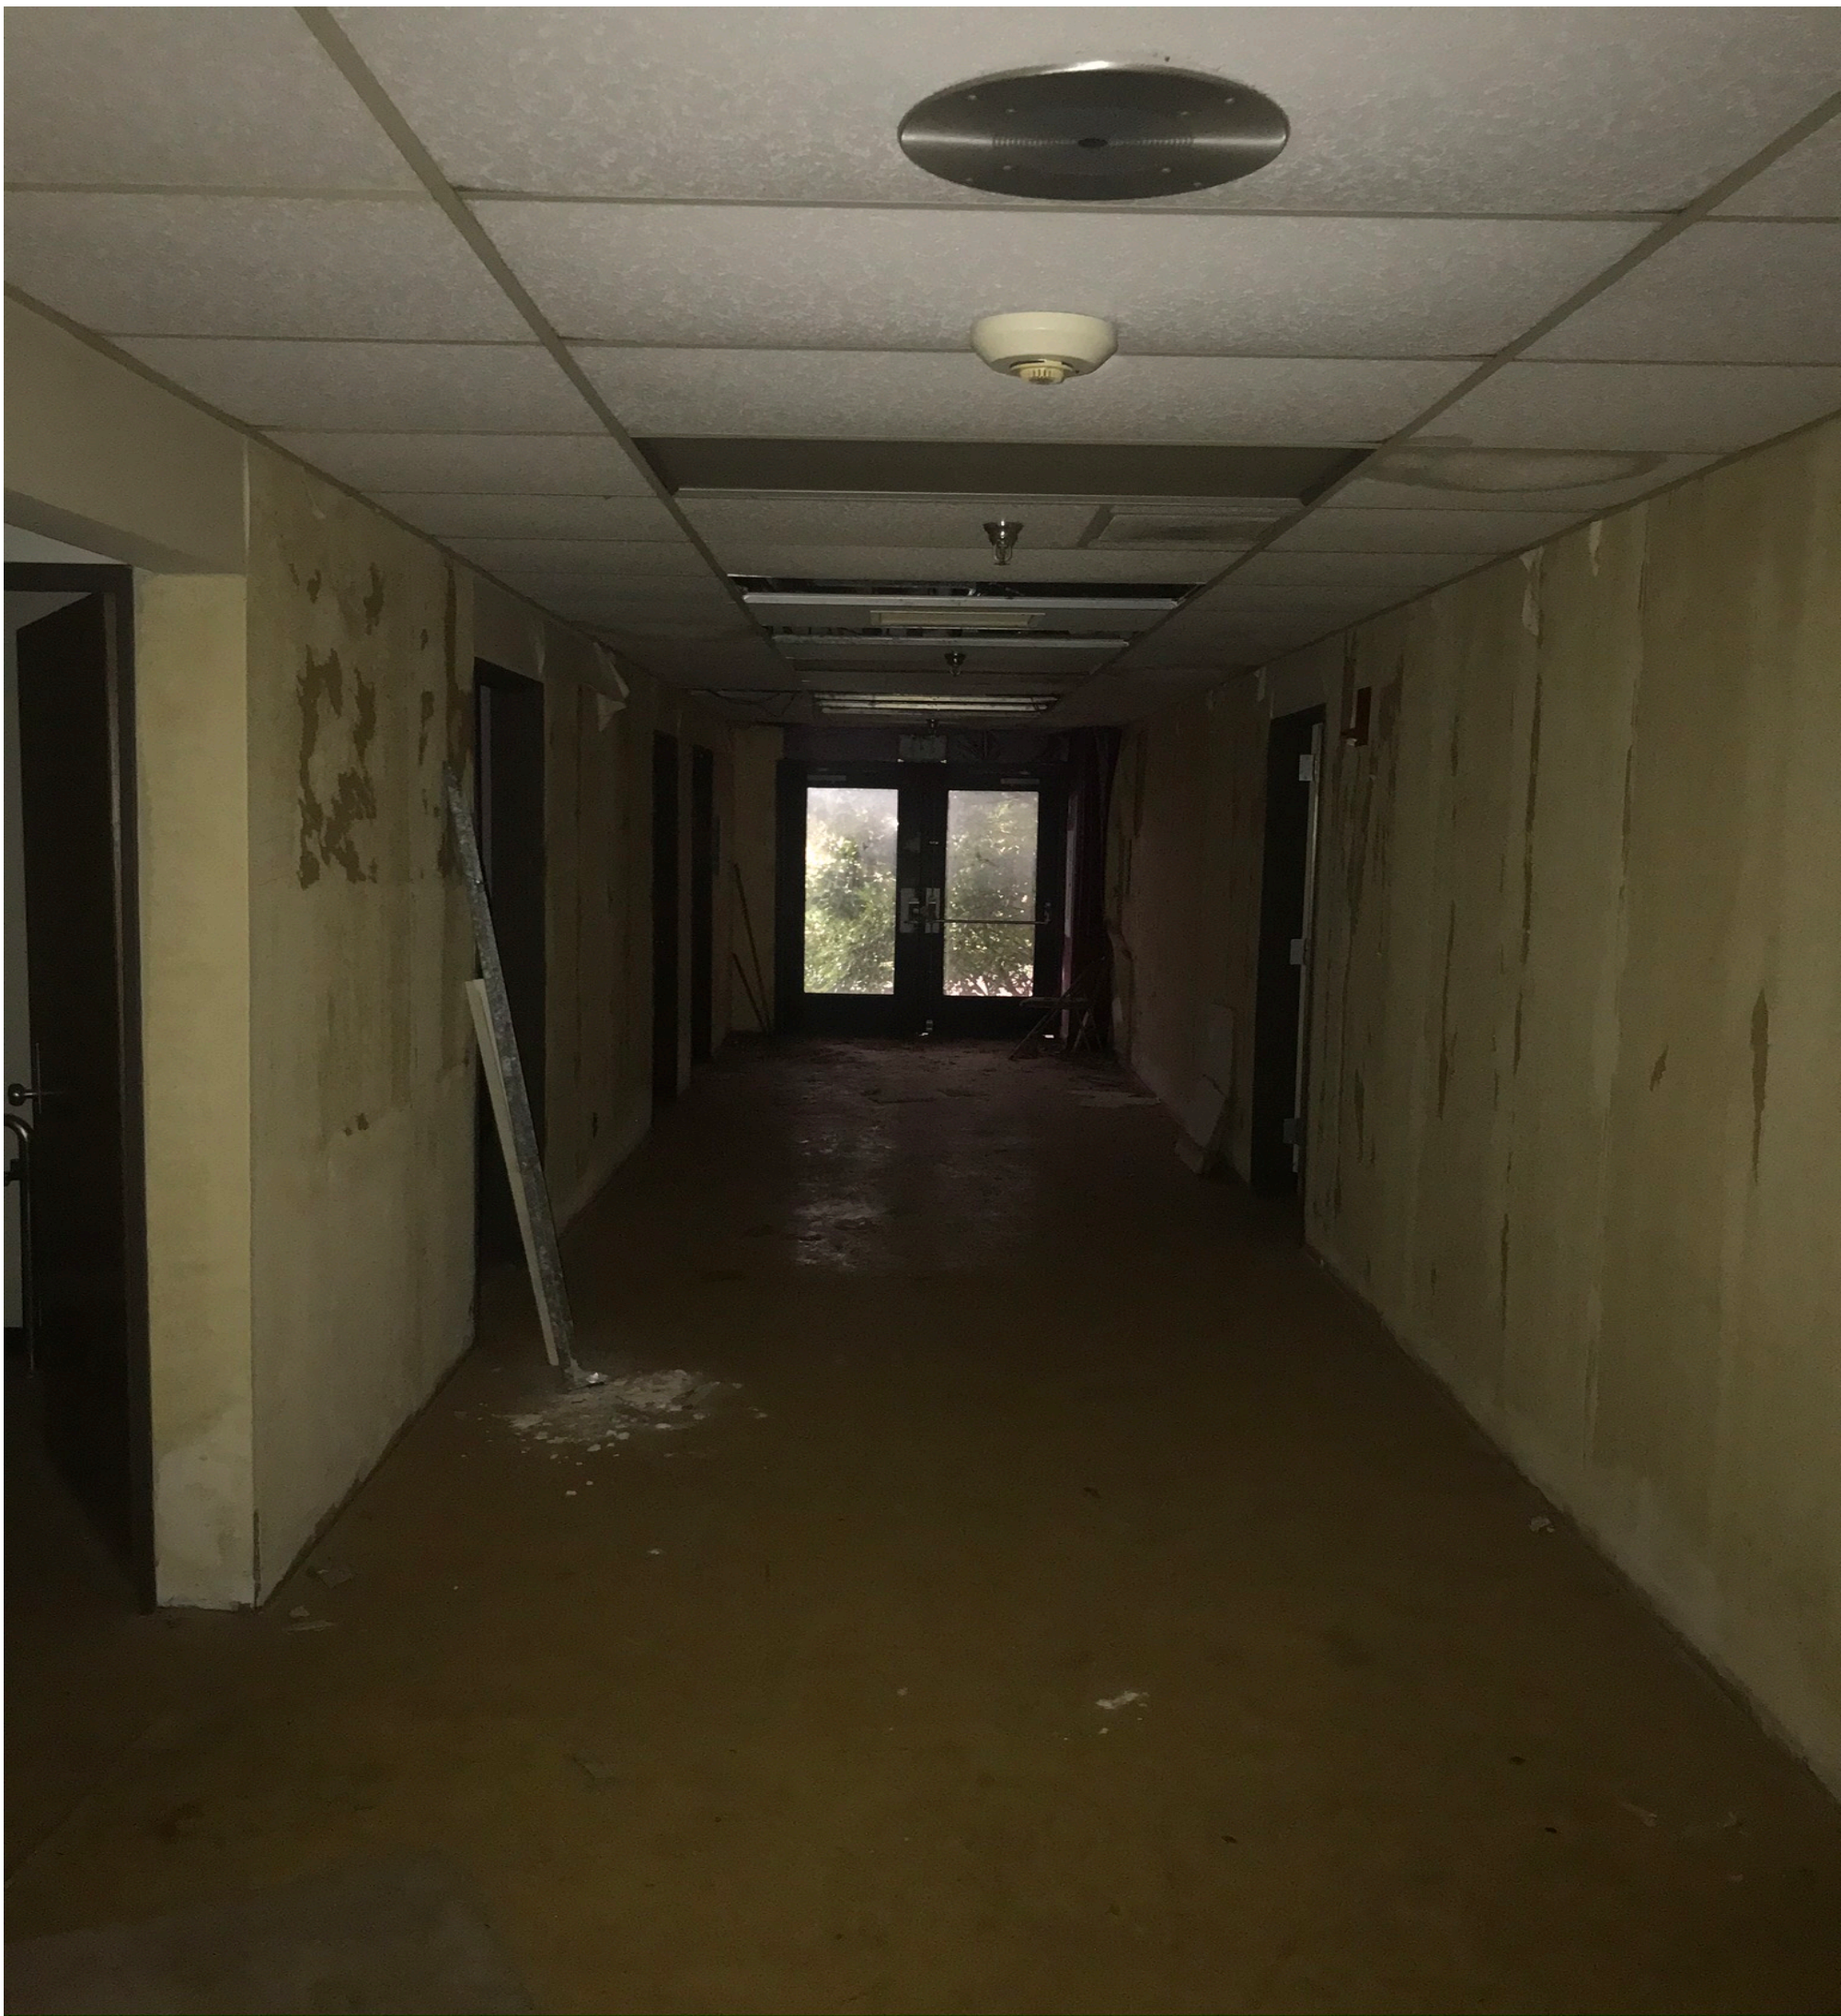
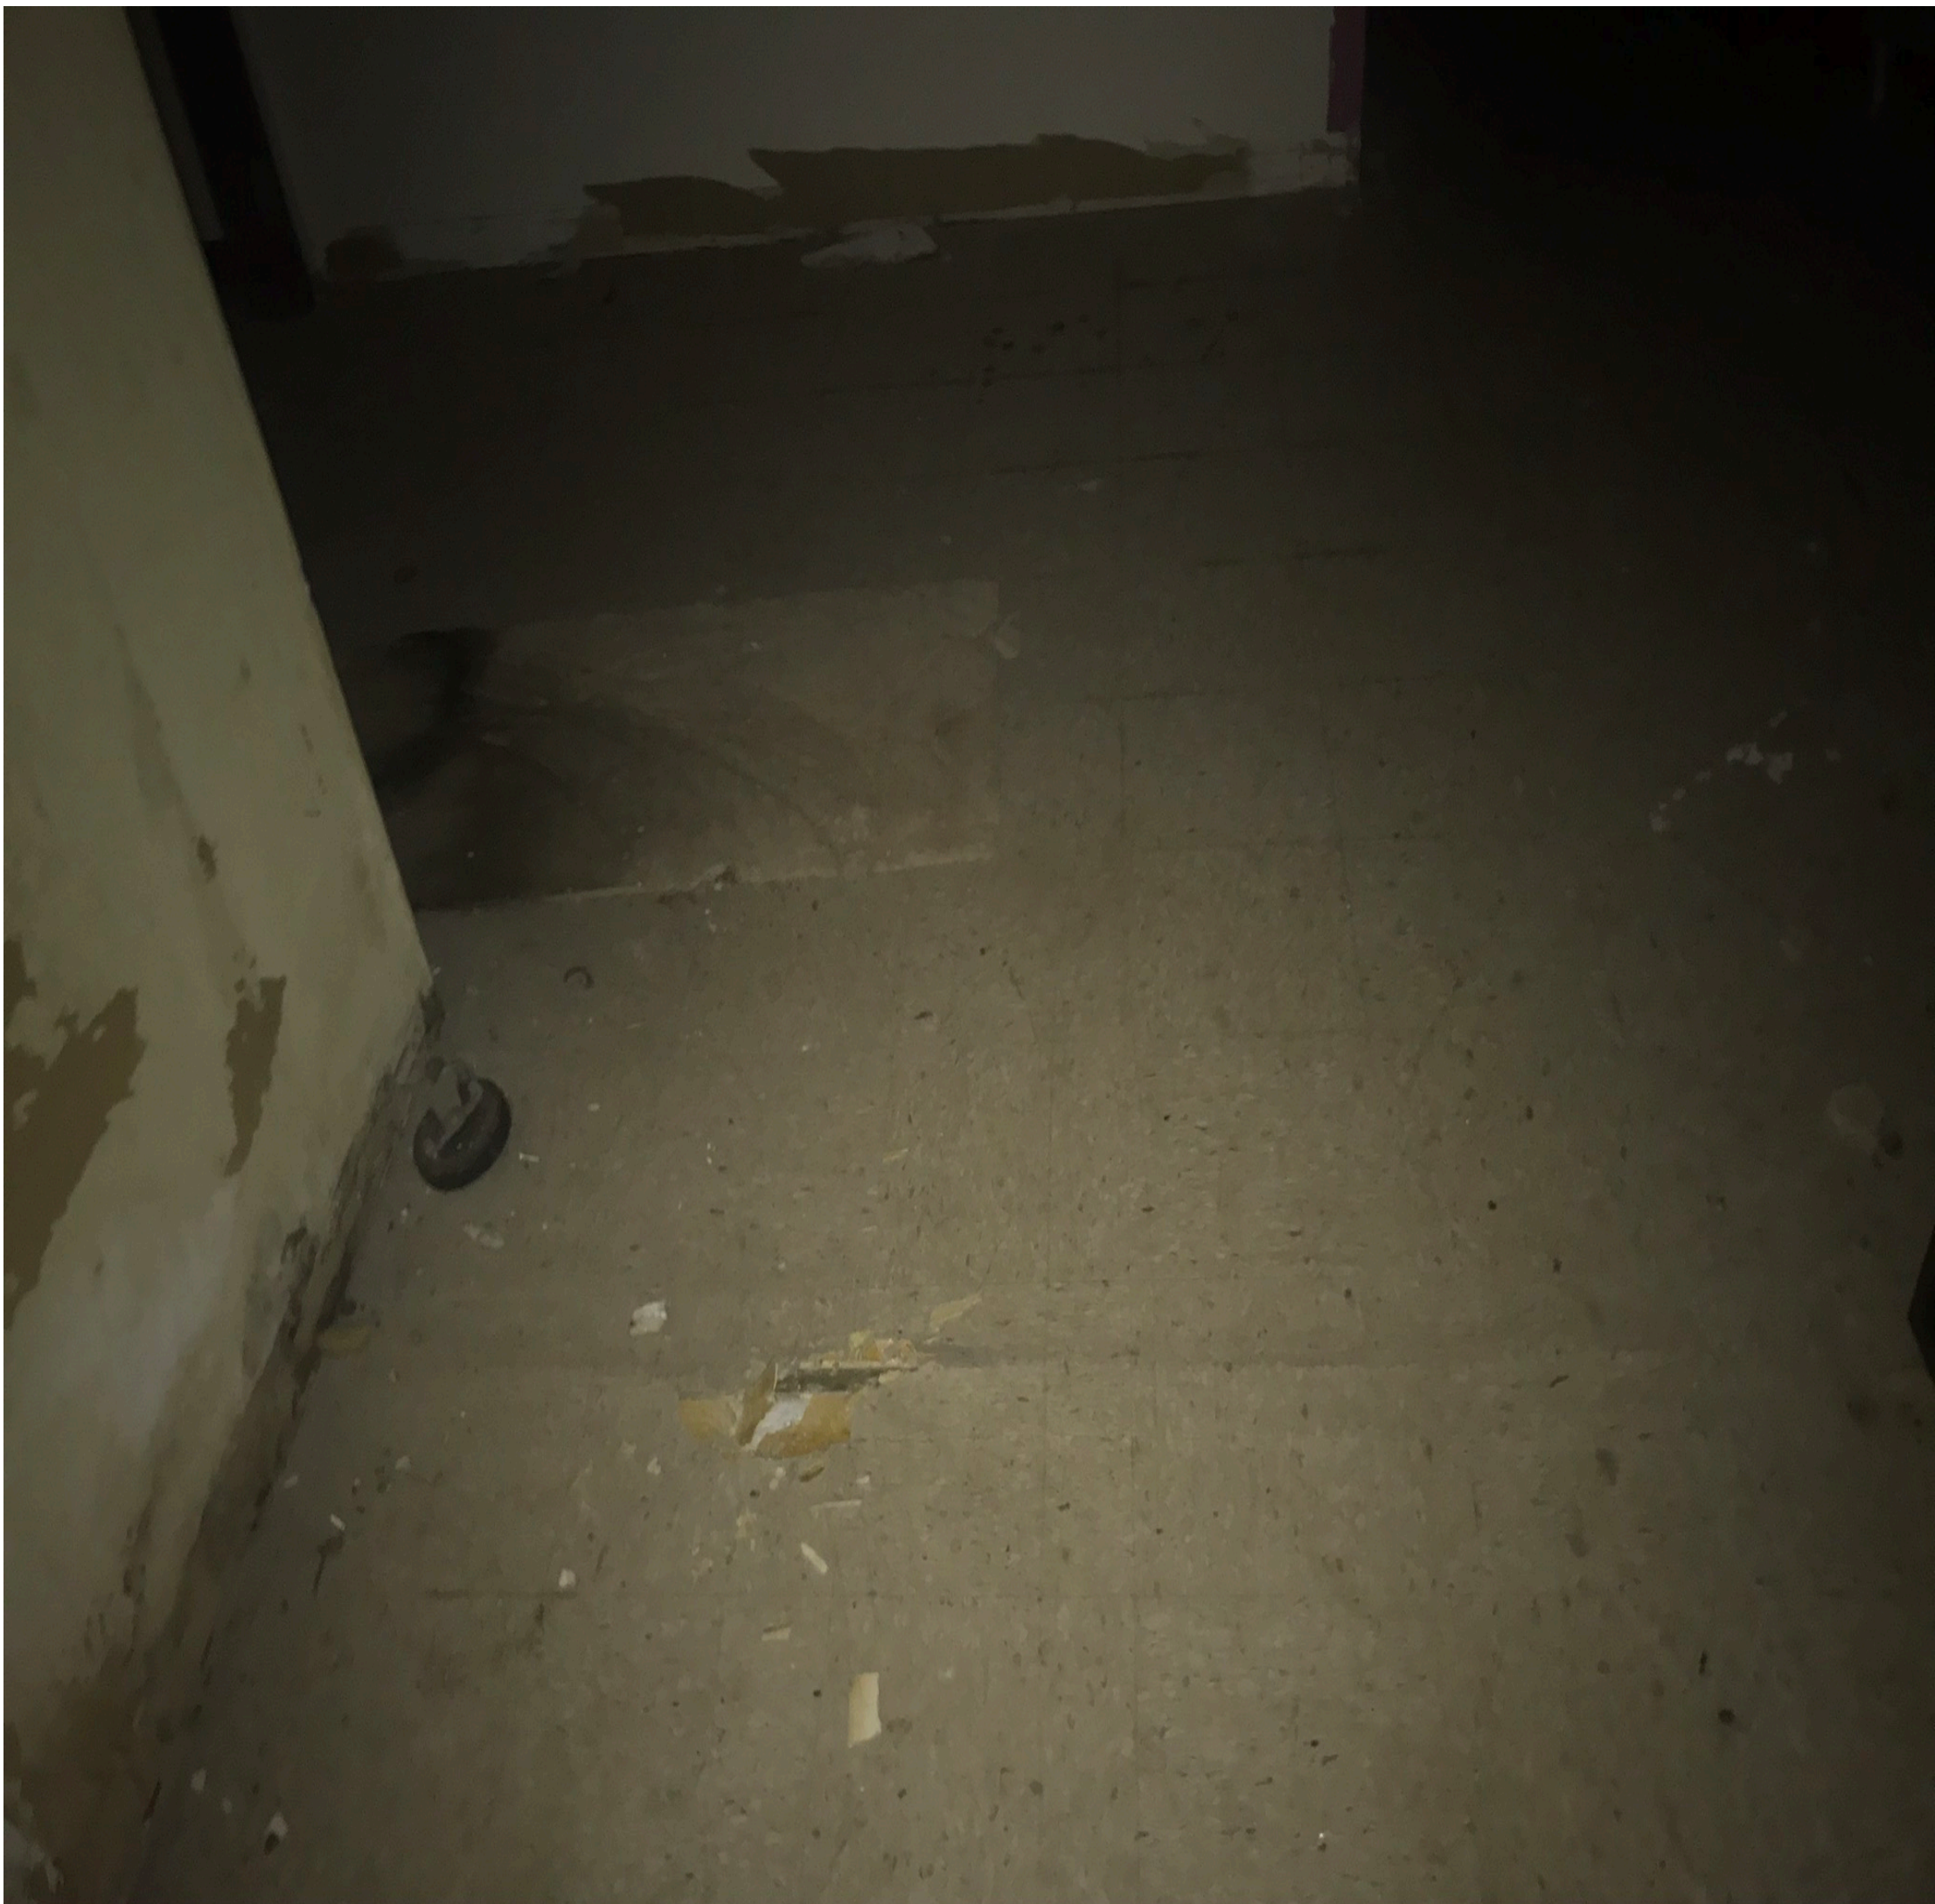
Bldg. 7 Room 20 Hallway - west: ACM - Sheet flooring & texture/joint compound wall systems

Bldg. 7 Room 34 Hallway - ACM: Sheet flooring beneath floor tiles throughout bldg. 7
