# Former Thomas Hospital Building 7

Thomas, Oklahoma

## Final Remediation Report

### Asbestos Remediation Details

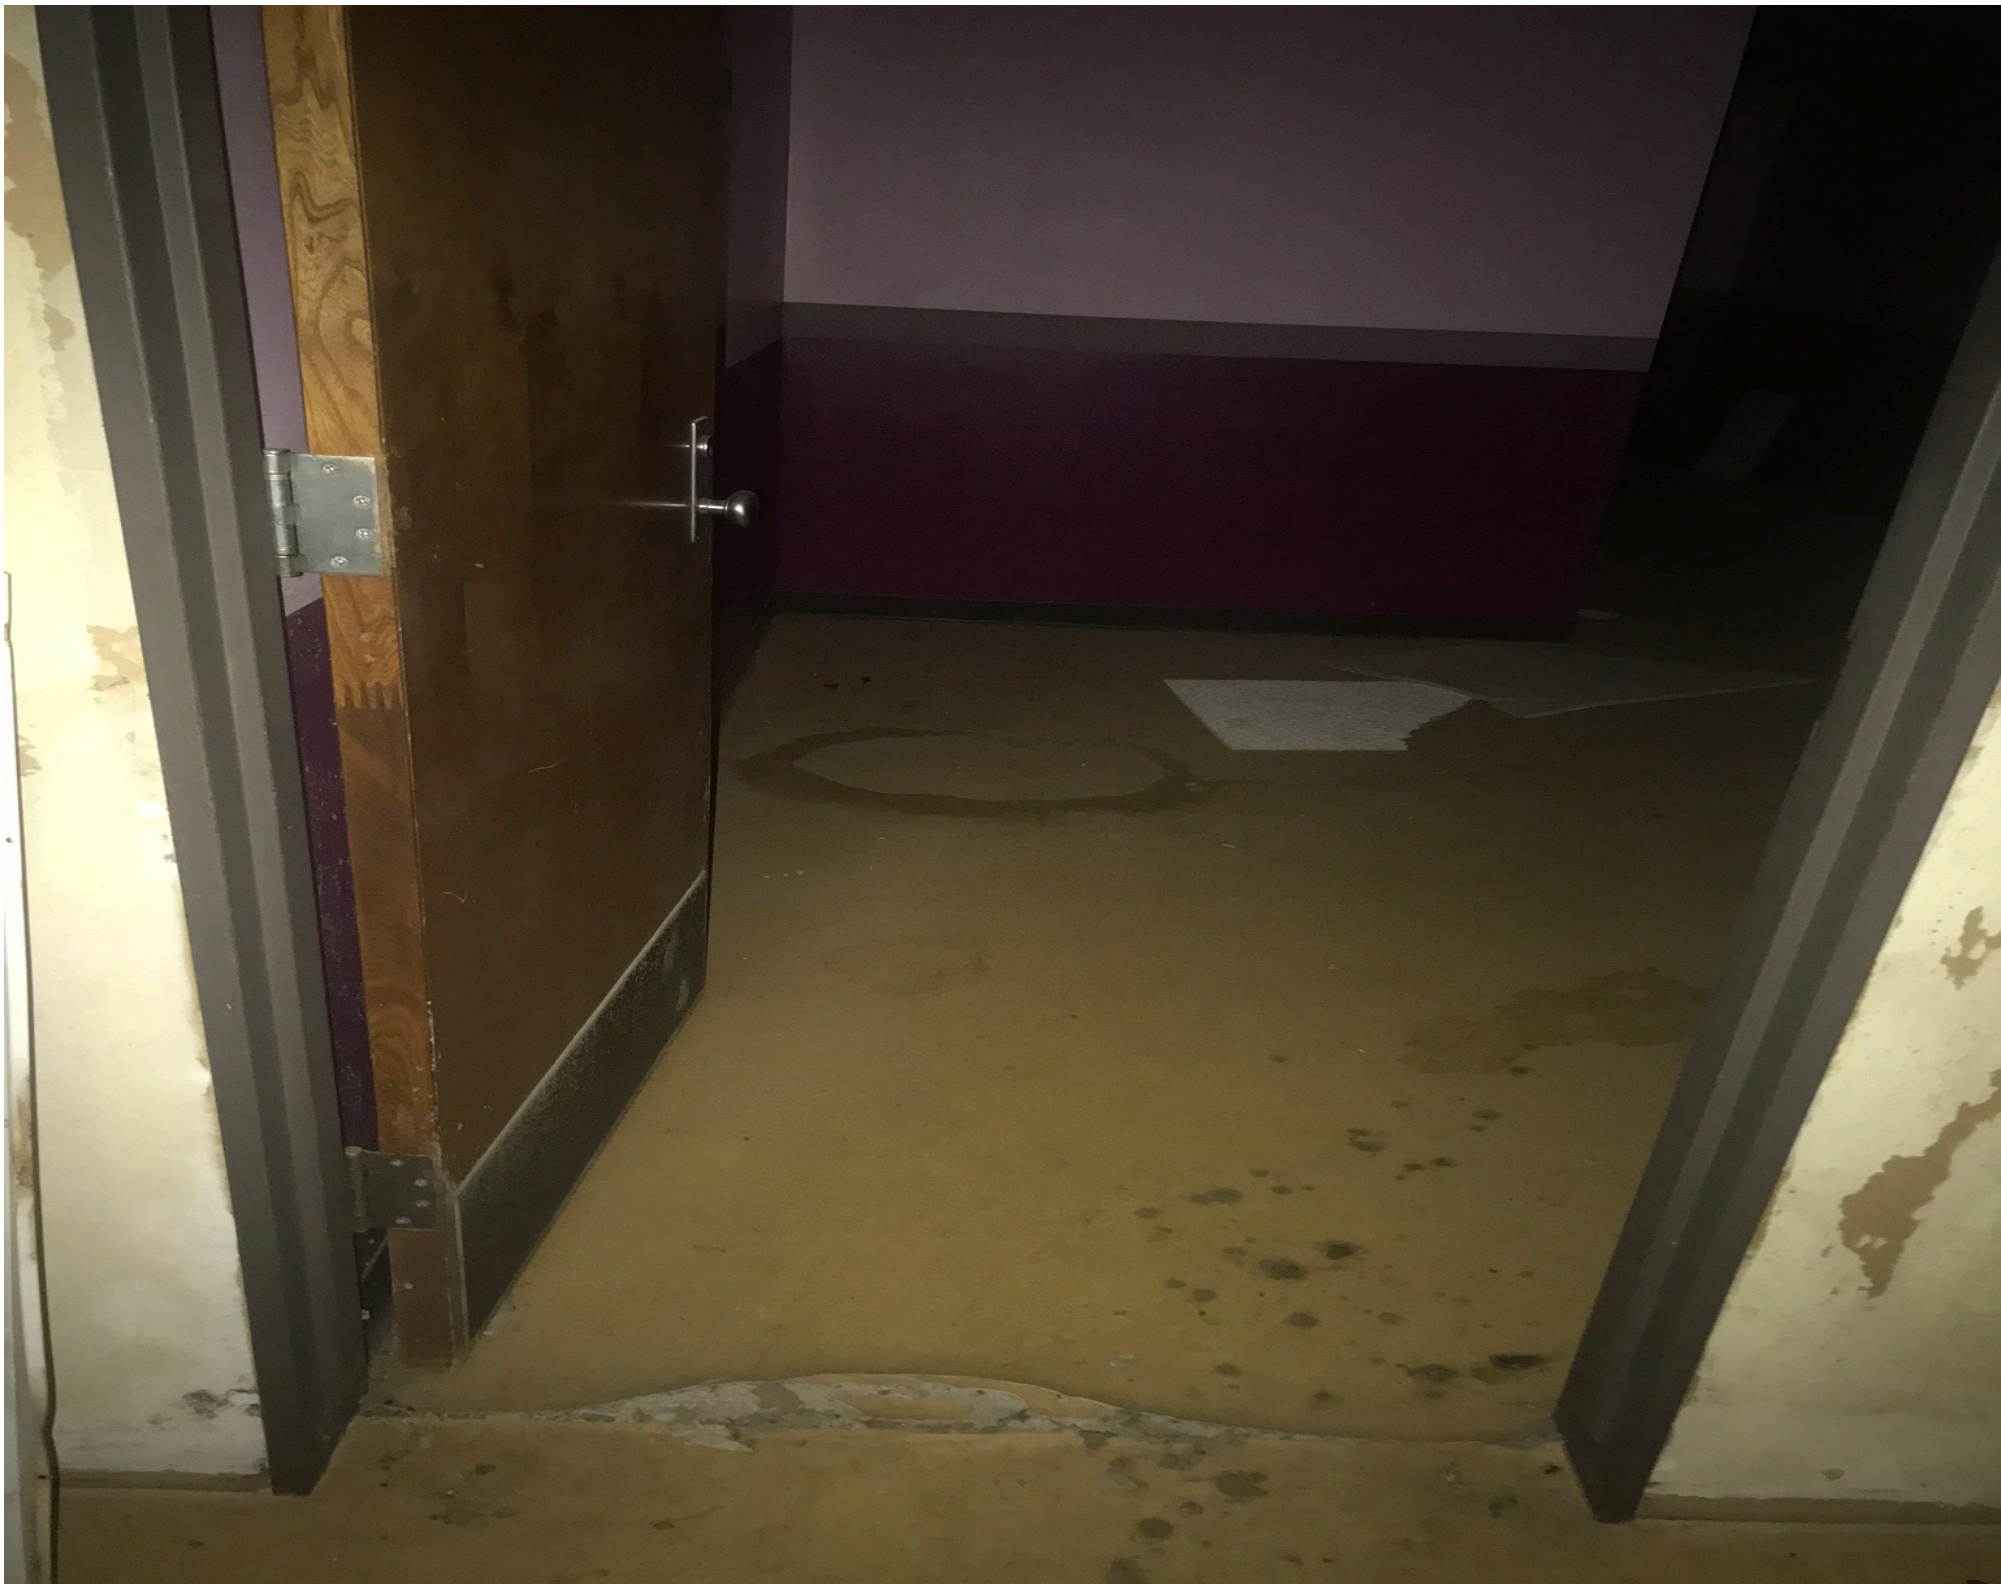
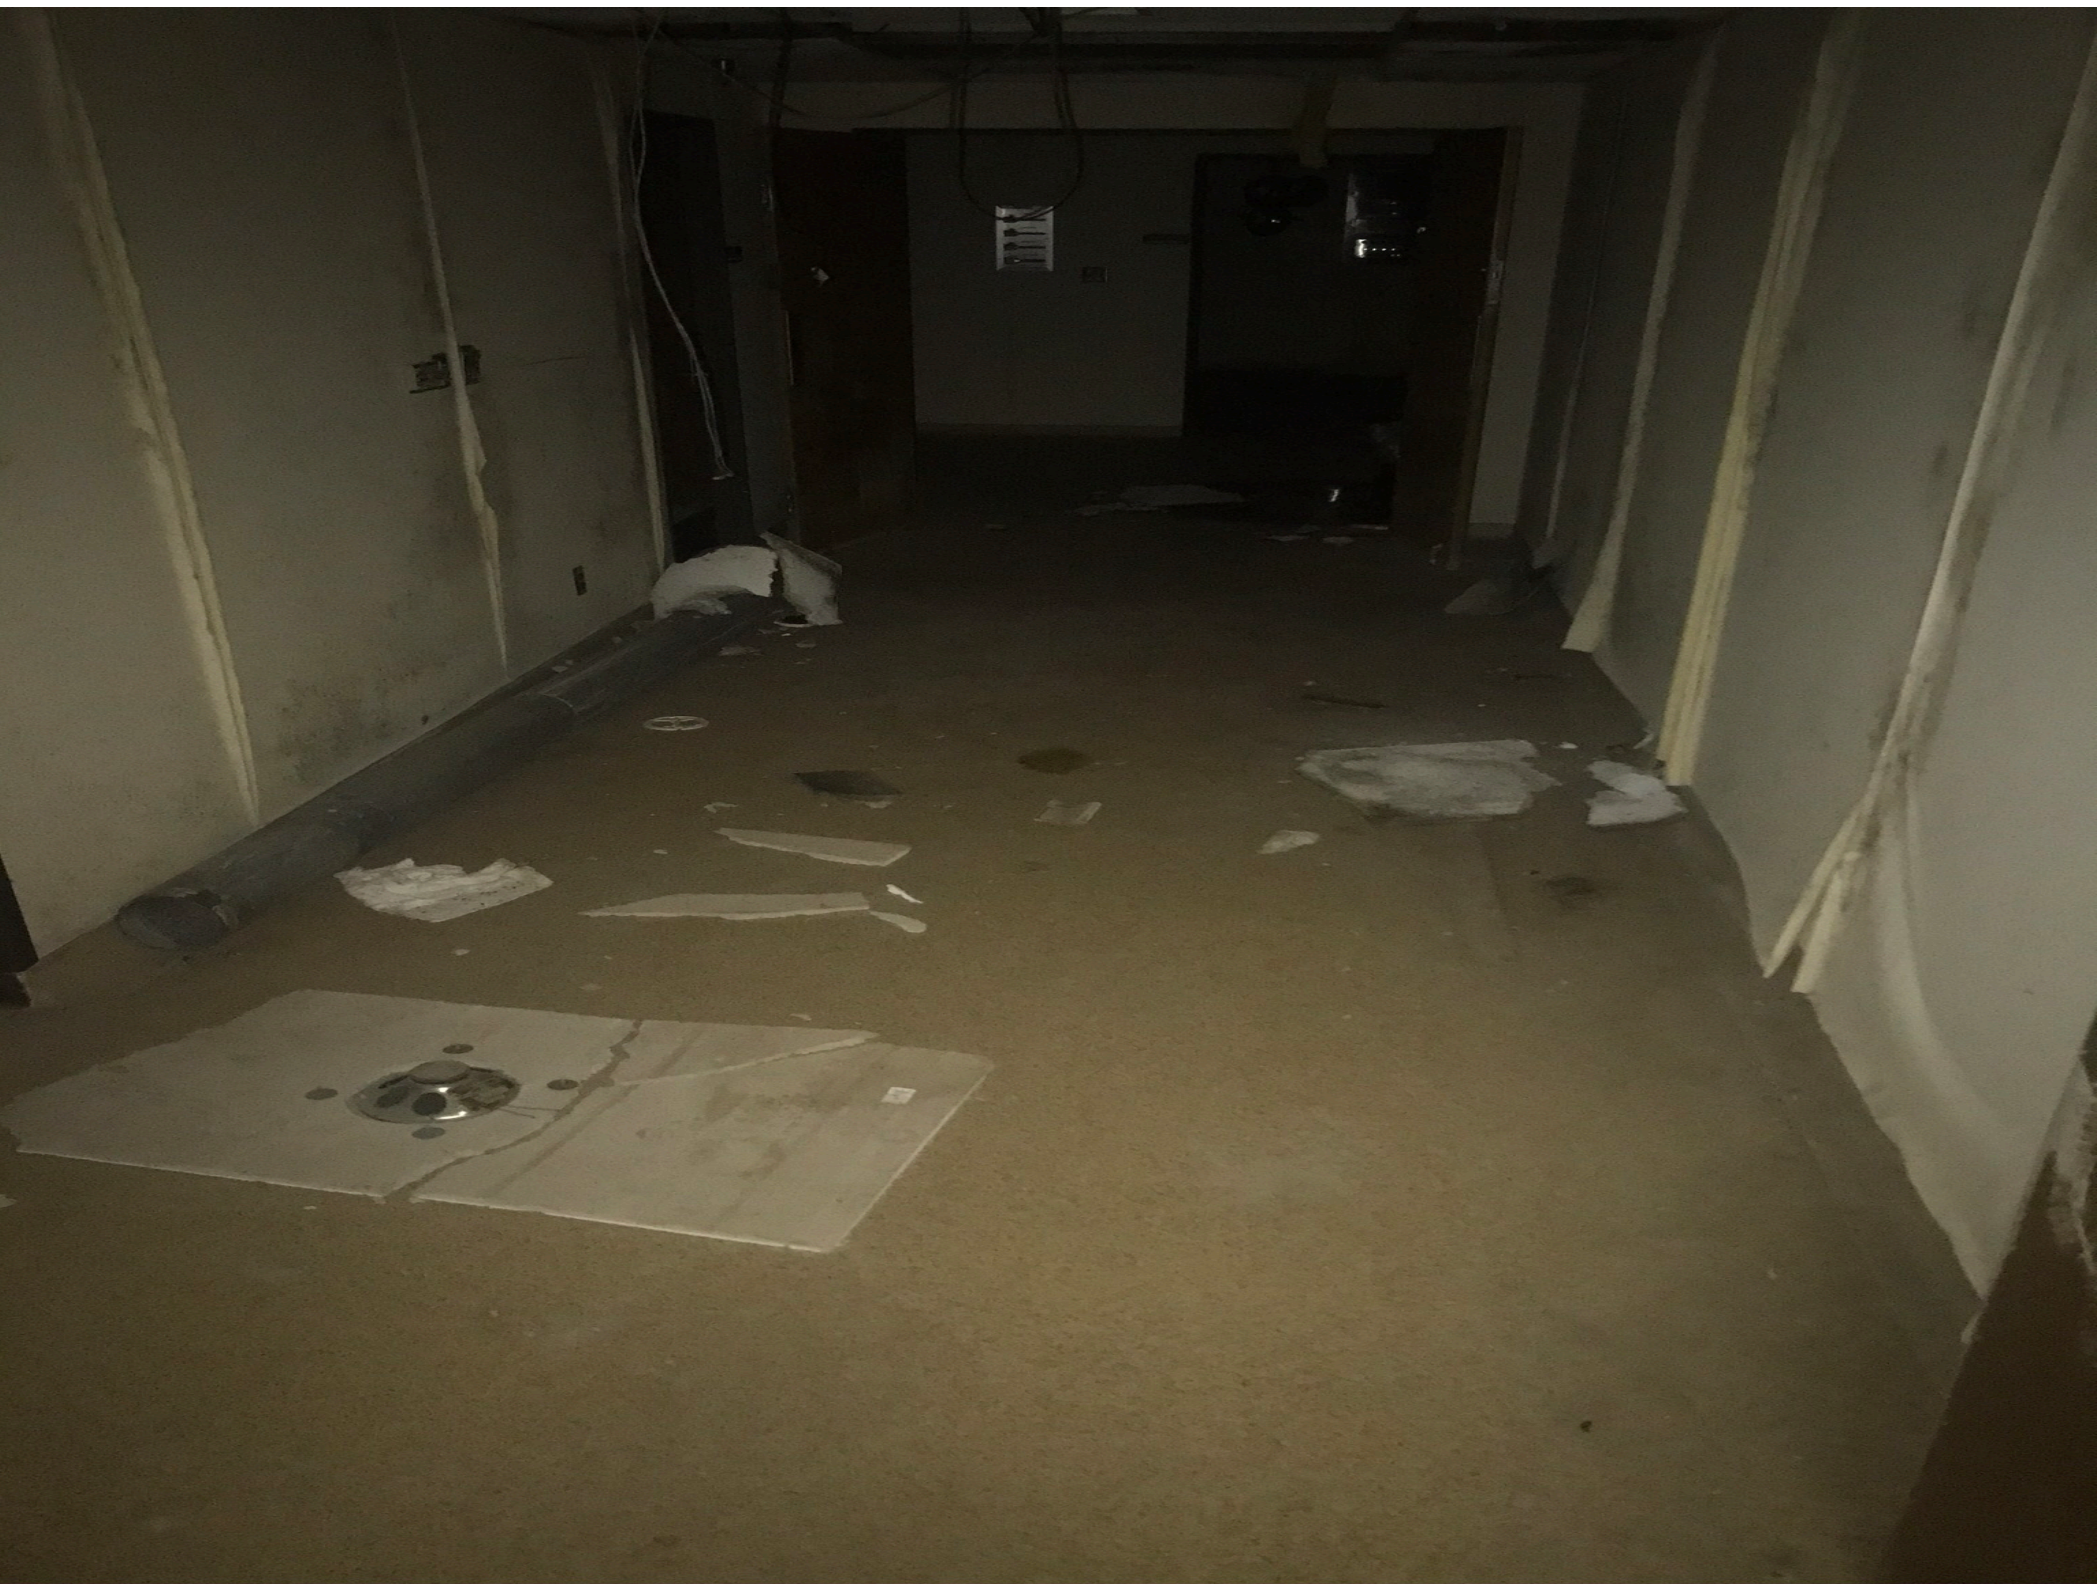
Bldg. 7 Room 20 - sheet floor/wall system

Bldg. 7 Room 20 Hallway - east: Wall system/sheet flooring

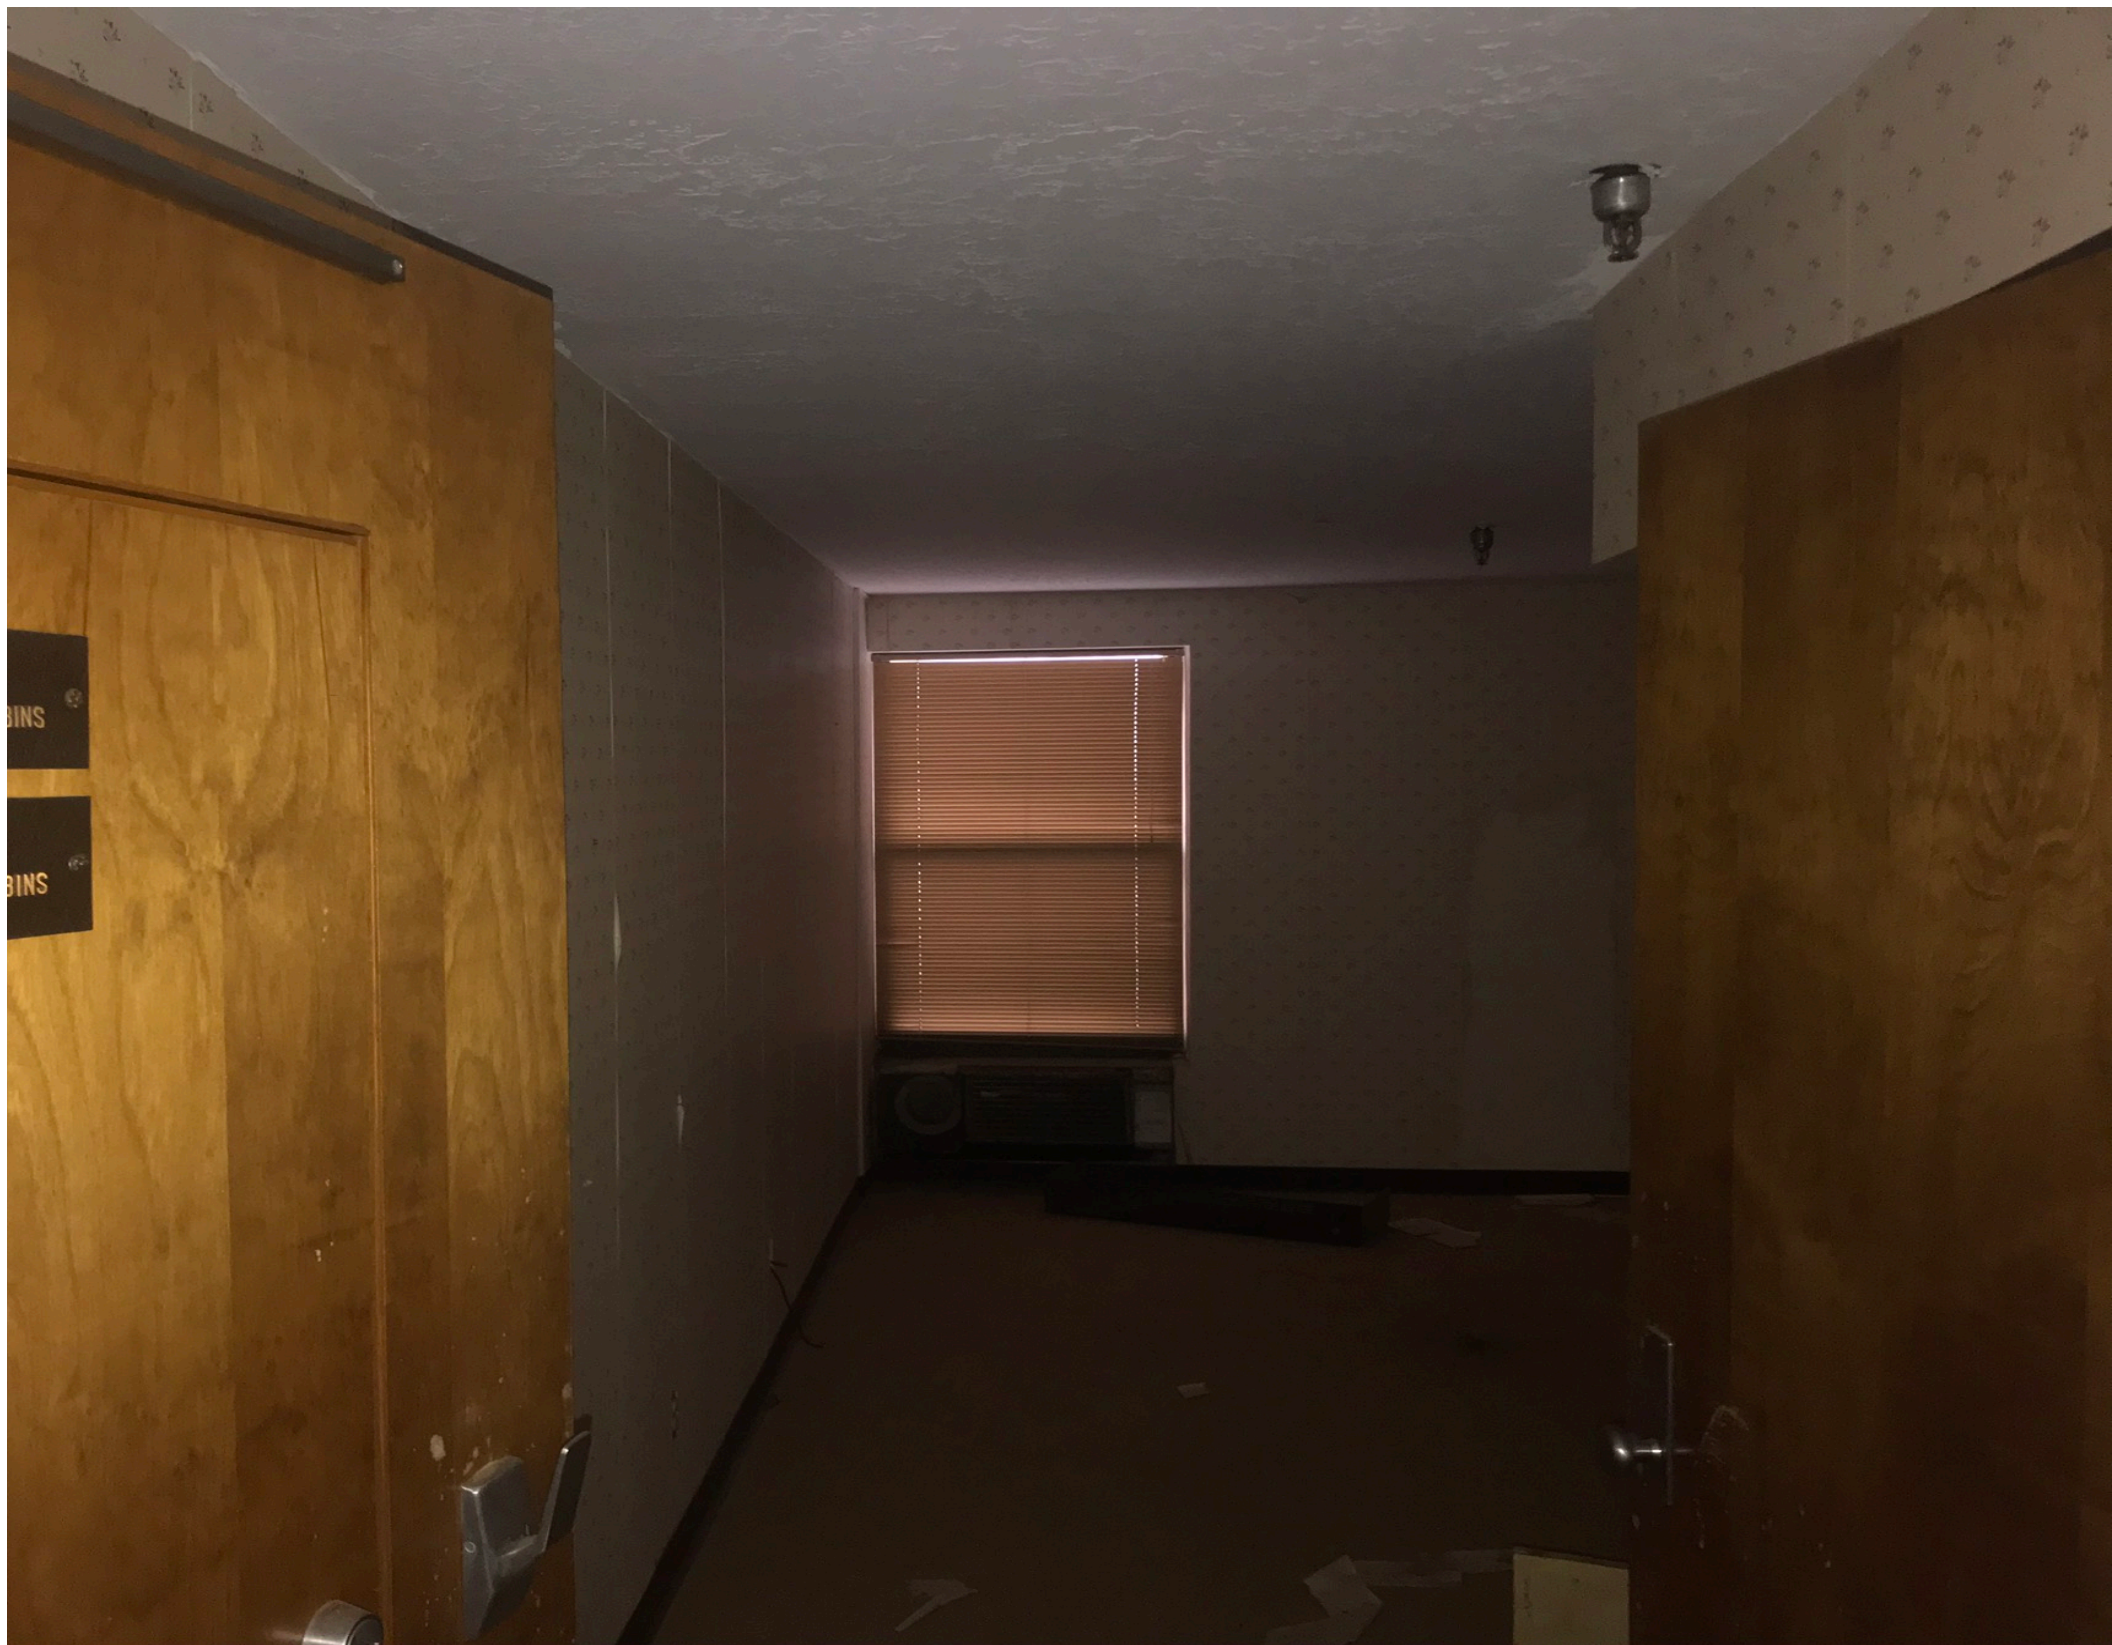
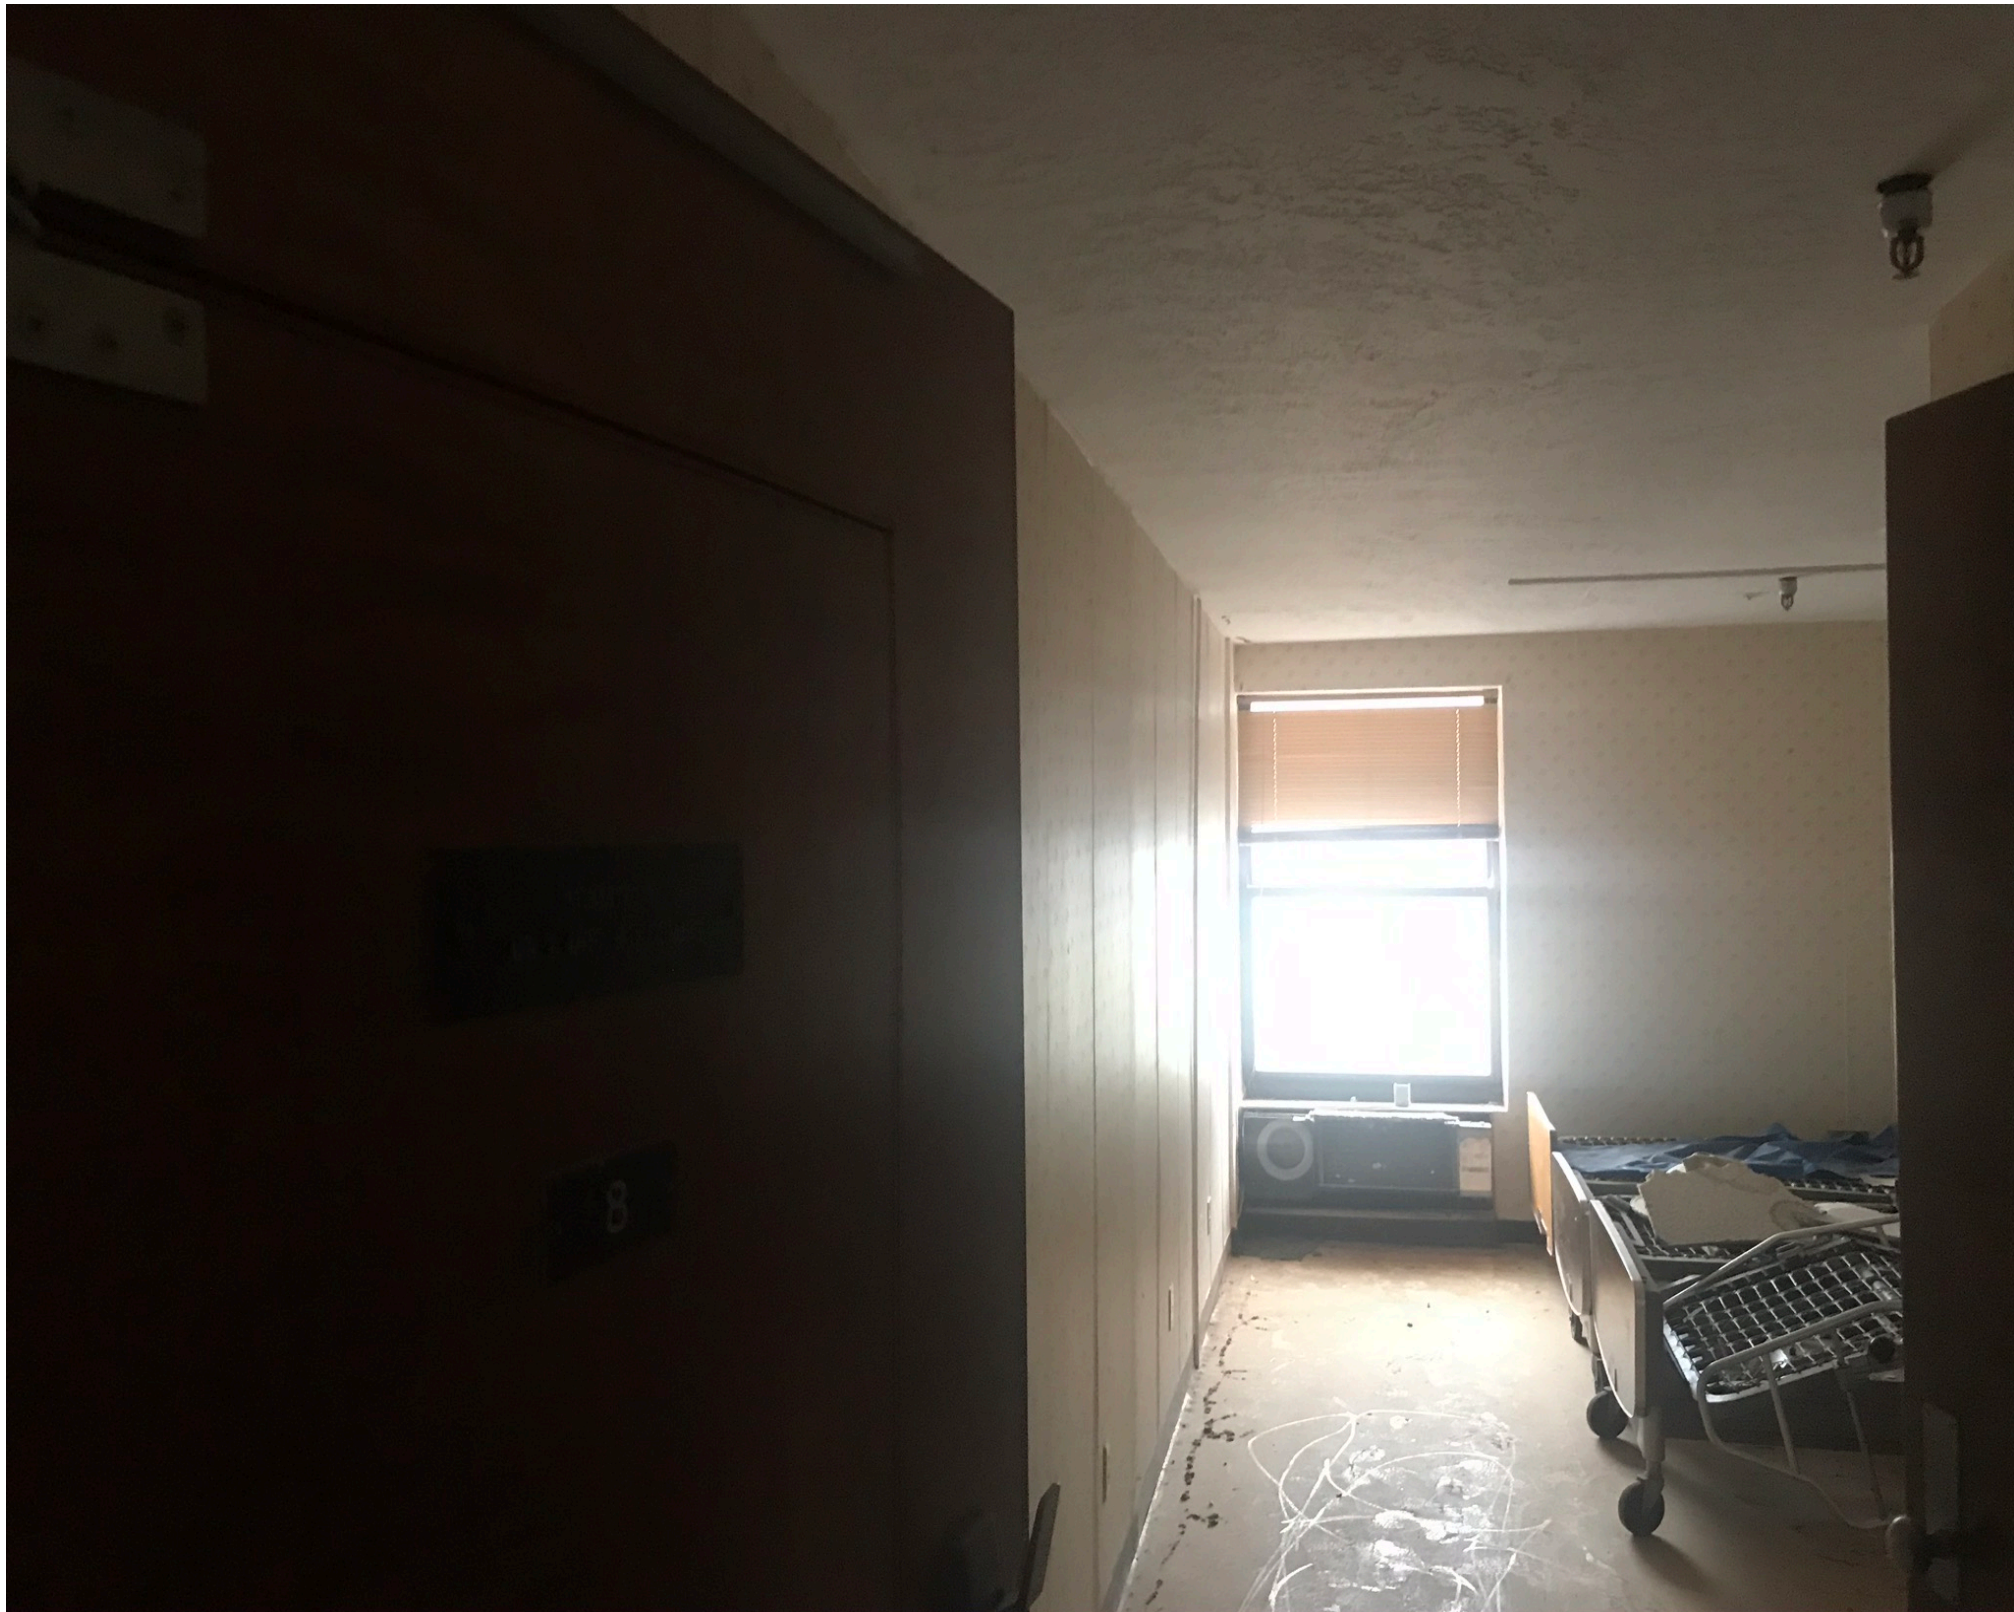
Bldg. 7 Room 6&8 - ACM - Walls/ceiling/sheet flooring

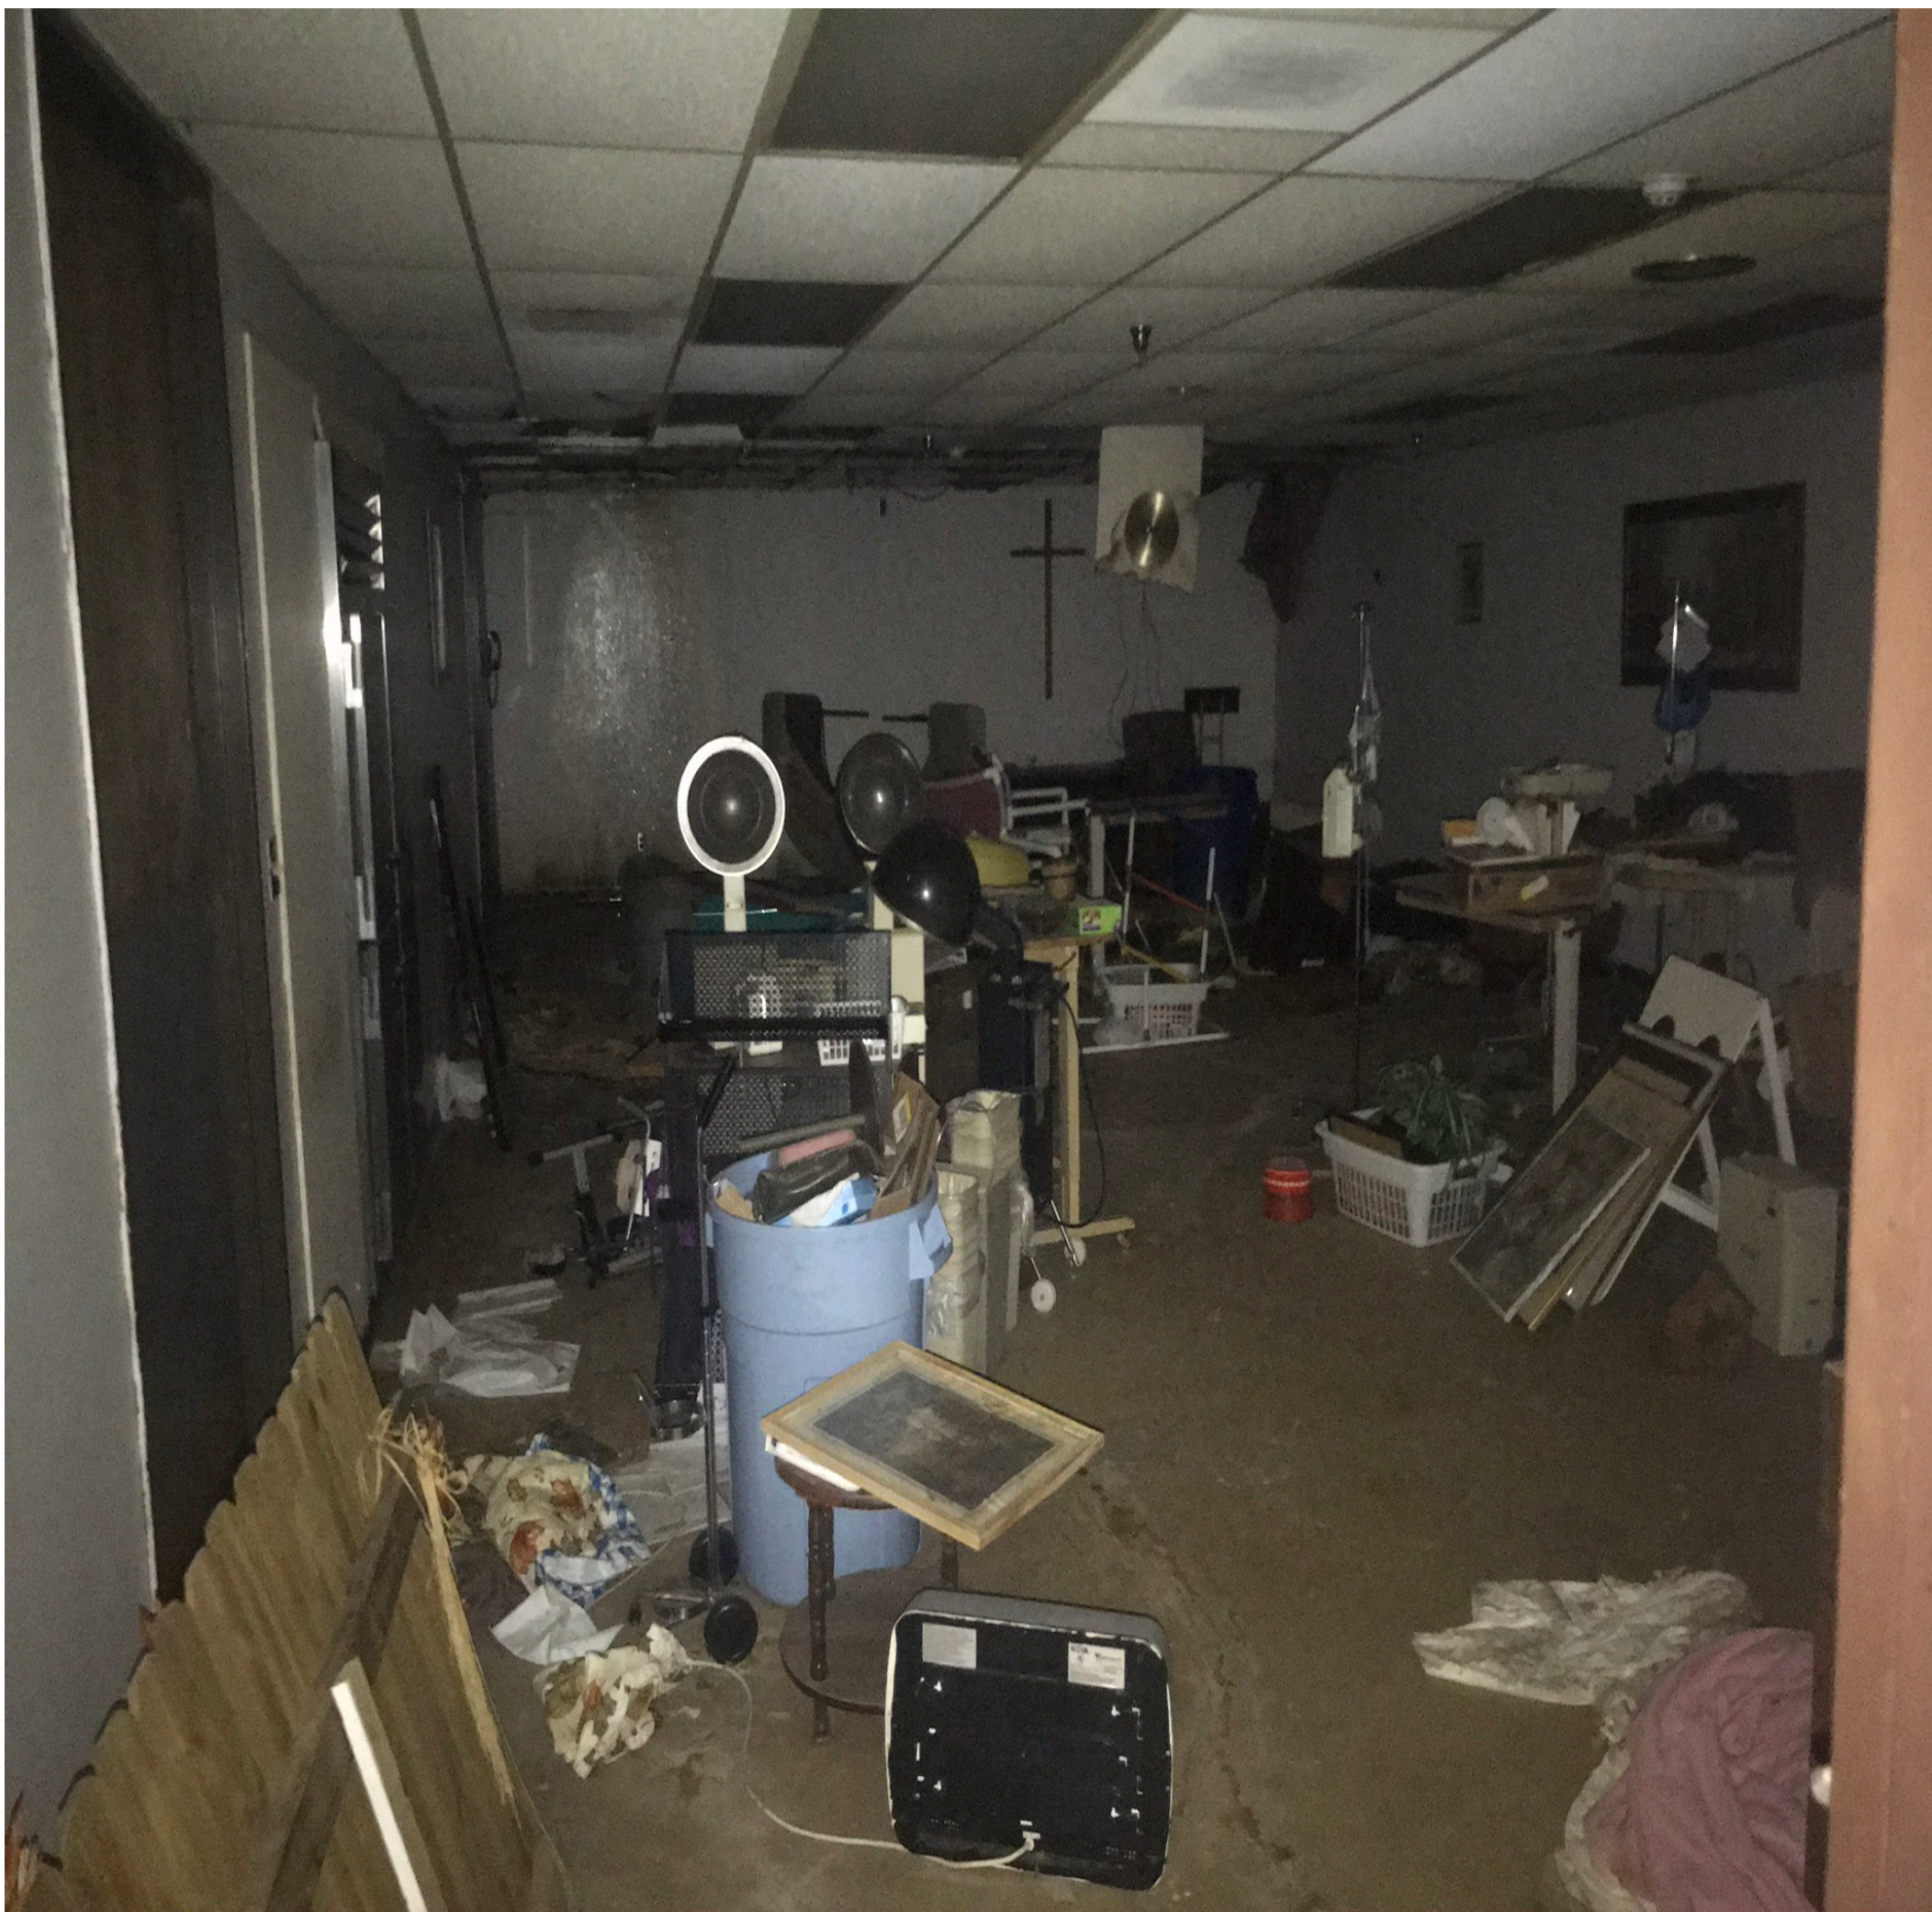
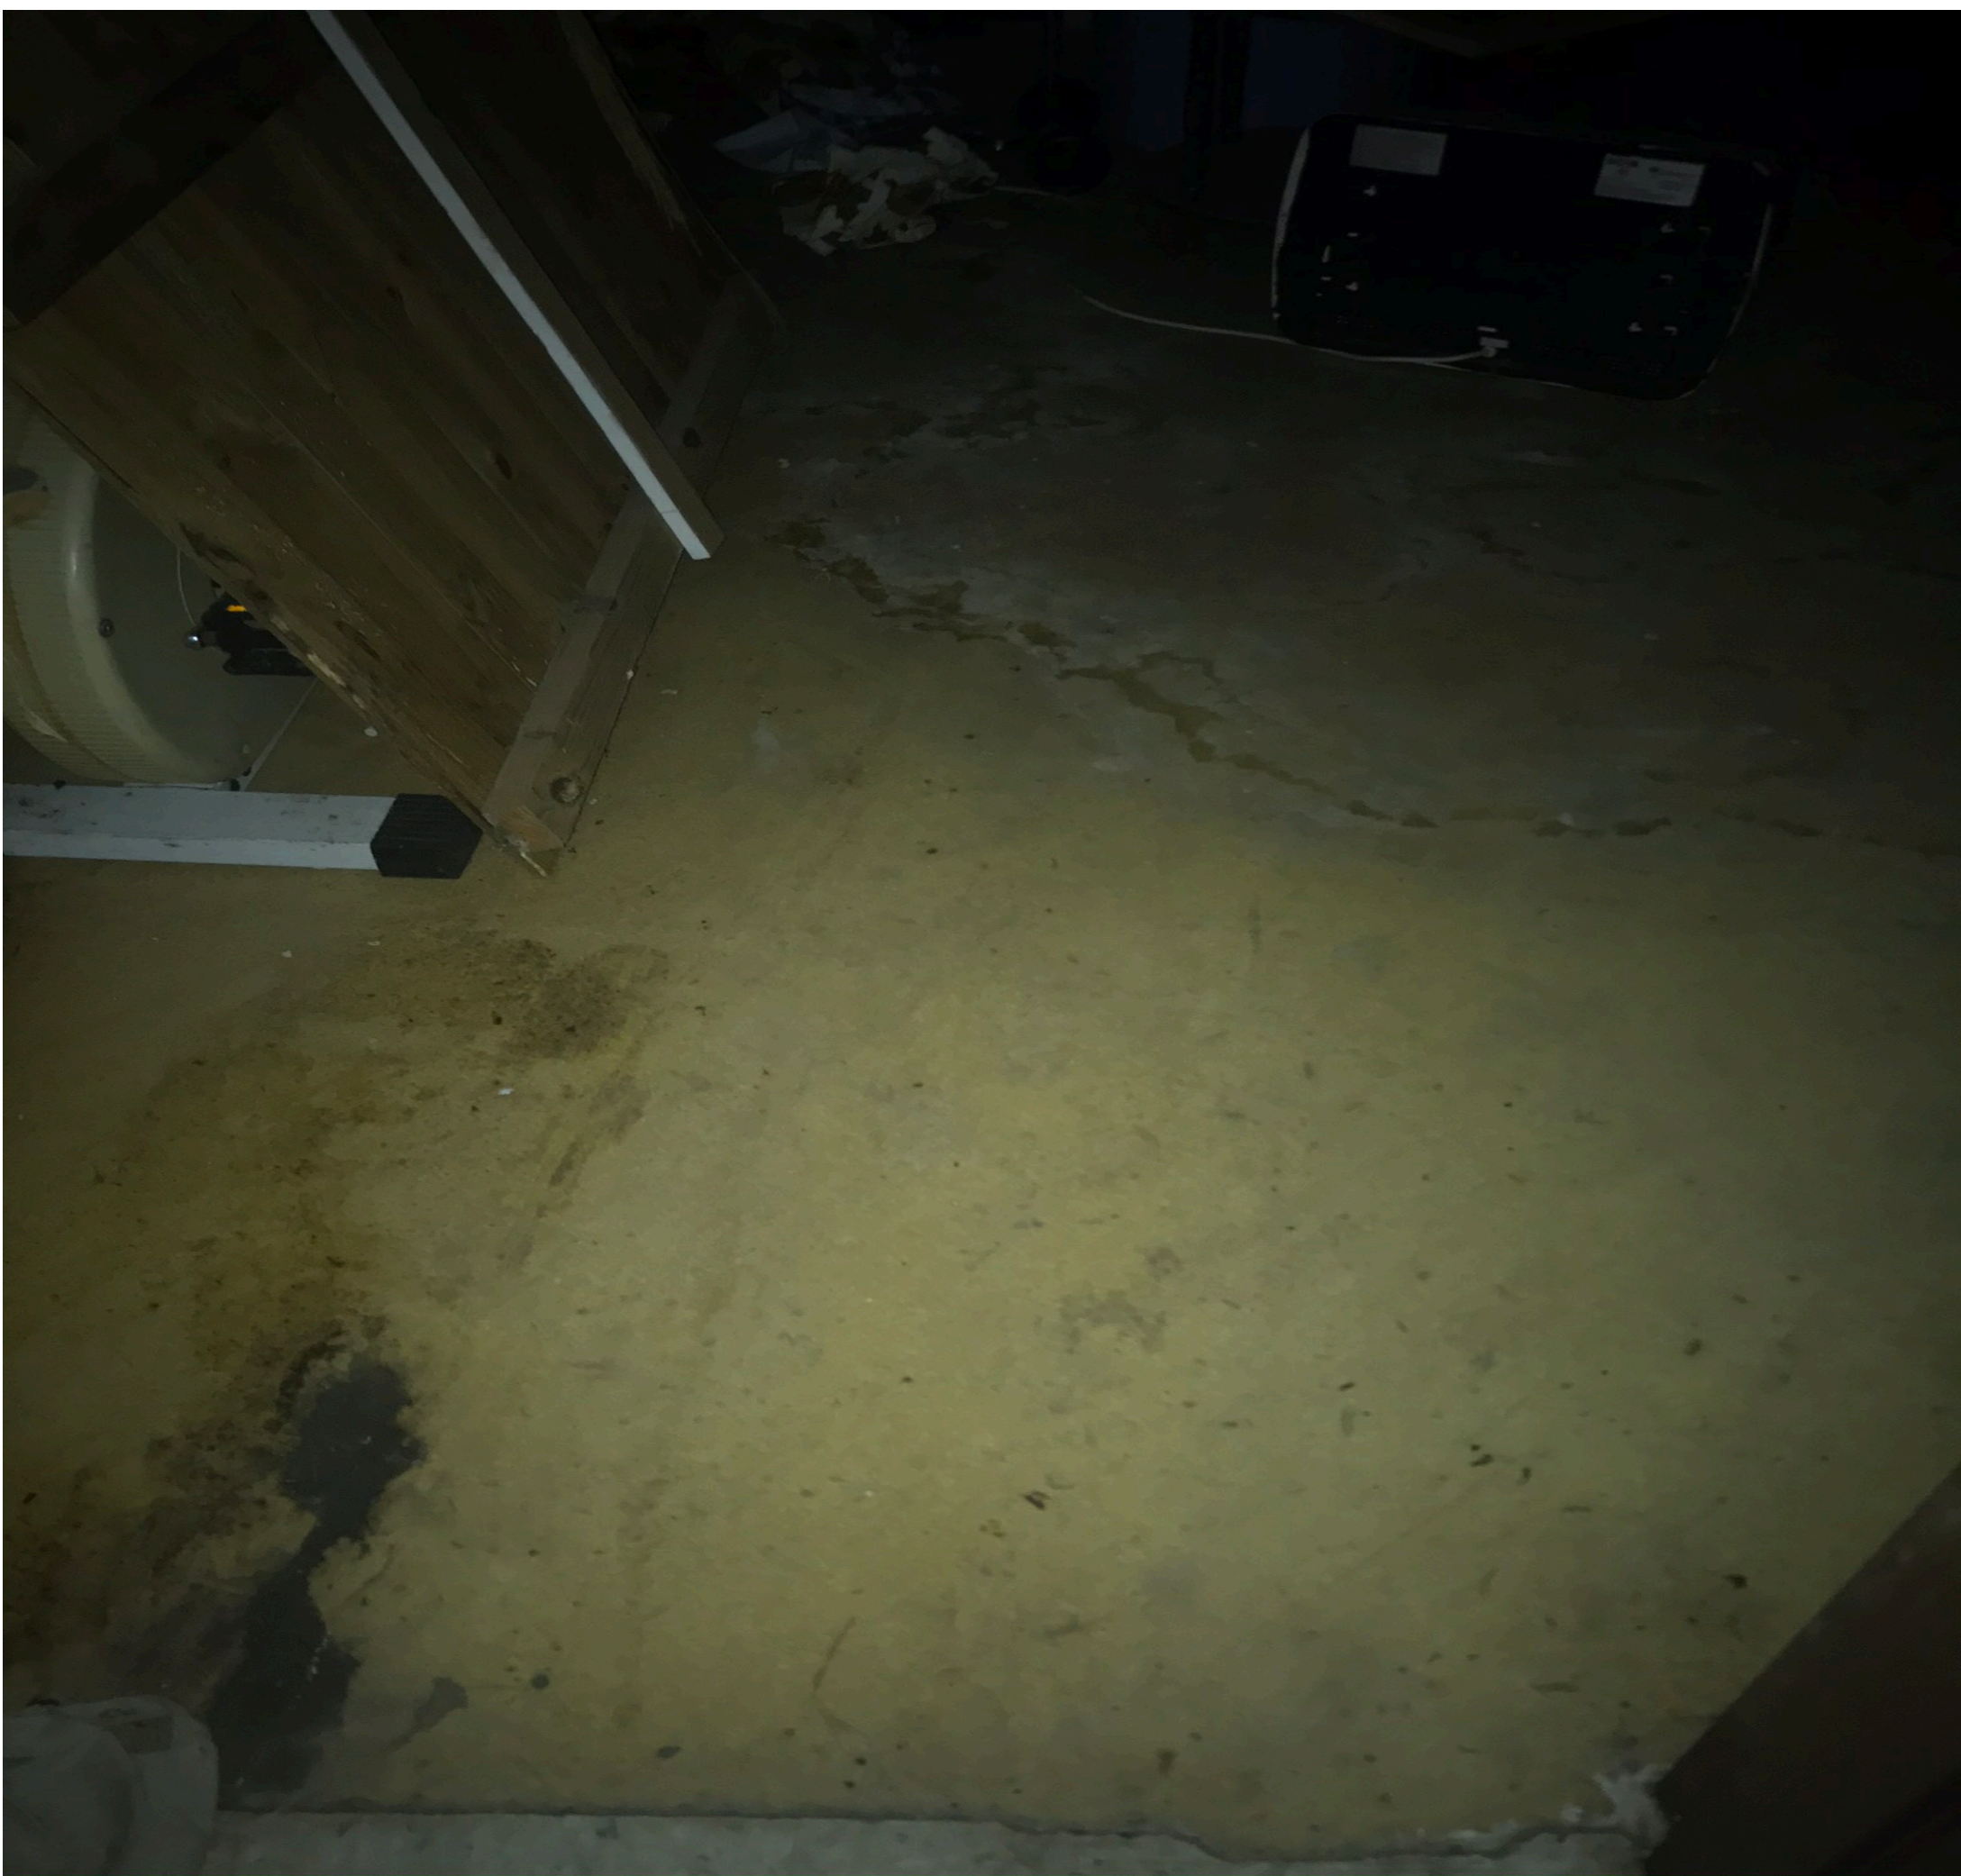
West Wing (Bldg. 4) Room 2 - Sheet flooring beneath (also beneath the floor tiles throughout bldg. 4)

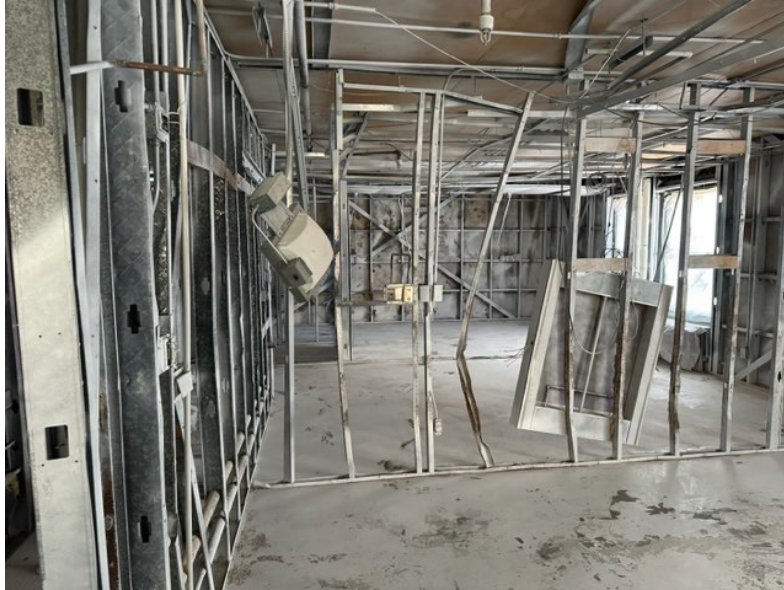
**PHOTO # 1** – View of NW area after abatement and lockdown.

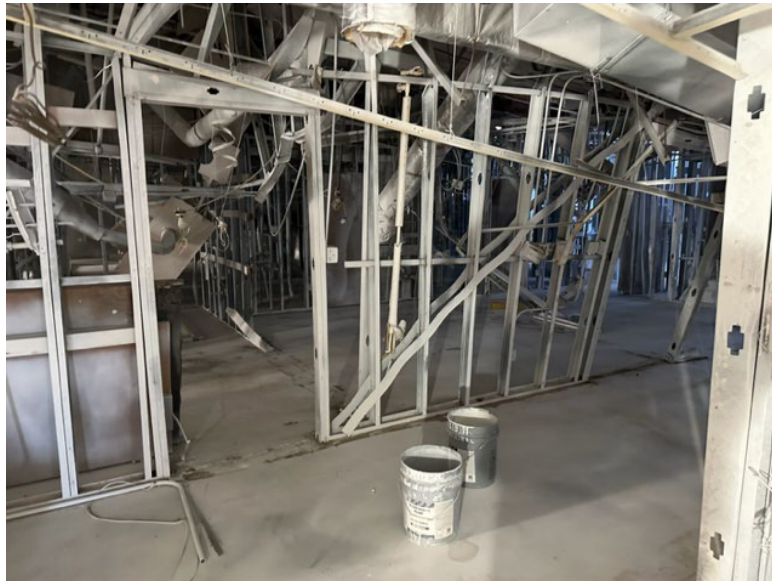
**PHOTO # 2** – View of SW area after abatement and lockdown.

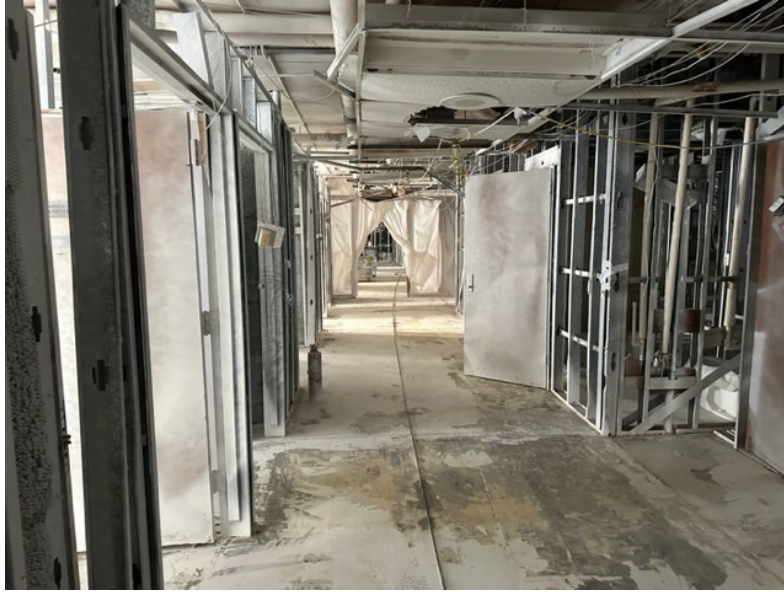
**PHOTO # 3** – View of NE area after abatement and lockdown.

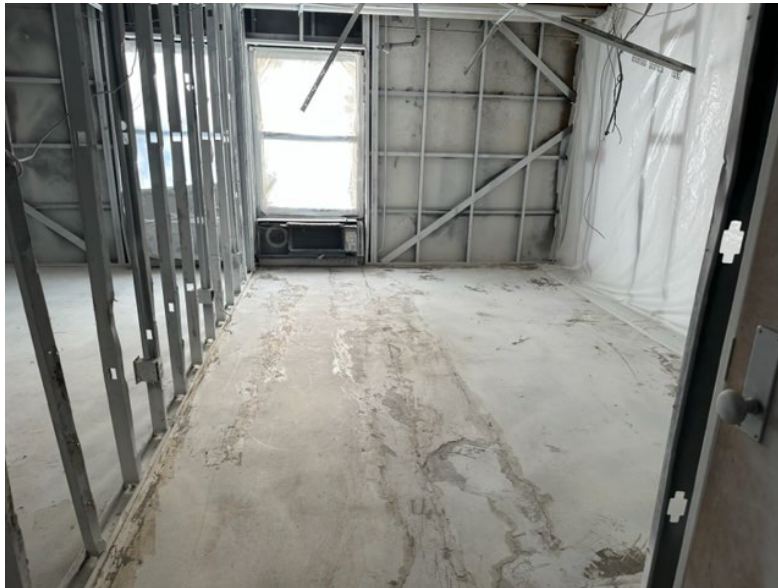
**PHOTO # 4** – View of SE area after abatement and lockdown.

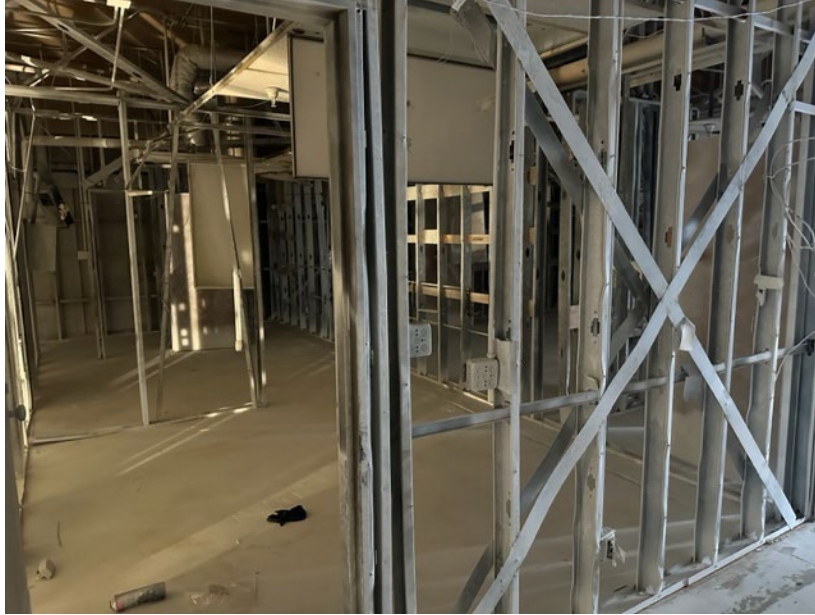
**PHOTO # 5** – View of Cental area after abatement and lockdown.
