Bridge Assessment Report
Interstate 40 over Arkansas River
NBI No. 17051, Location No. 6822 0000X
Muskogee and Sequoyah Counties
(Rehabilitation of Span Nos. 1, 2 and 3
and West Approach Slab)

April 29, 2022

BRIDGE ASSESSMENT REPORT **(Rehabilitation of Span Nos. 1, 2 and 3 and West Approach Slab)**

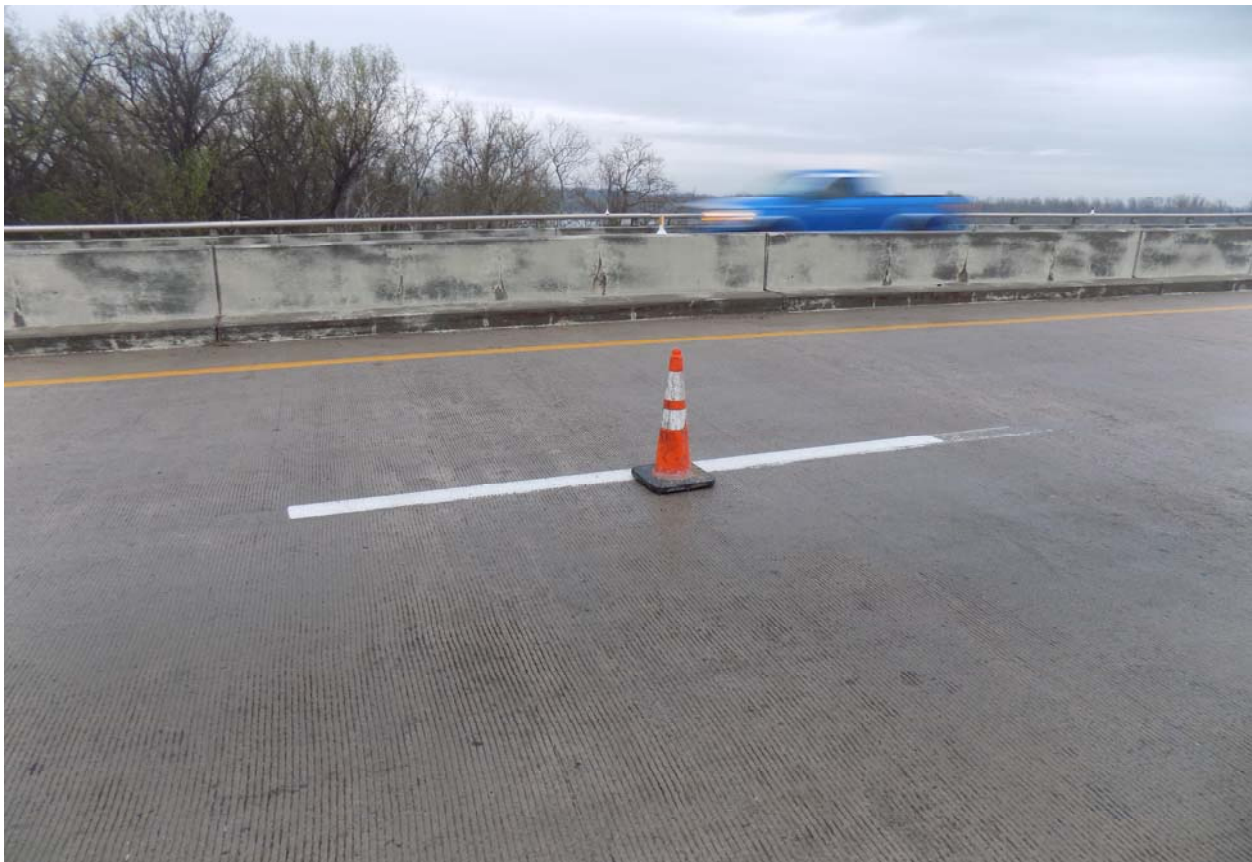
Existing Condition: The existing deck slab has a total width of 68'-6" and a thickness of 8". The soffit of the deck slab between the beams was constructed with stay-in-place steel deck forms and is not visible; however, the soffits of the deck slab overhangs are in good condition with no significant deterioration or efflorescence. The top surface of the deck slab contains abrasion and some small patches, potholes and impending potholes. The most significant problem with the deck slab is the presence of extensive map cracking. The cracks are small but numerous and prevalent throughout the deck slab in Span Nos. 1, 2 and 3.

Eastbound Deck Slab and Median Barrier

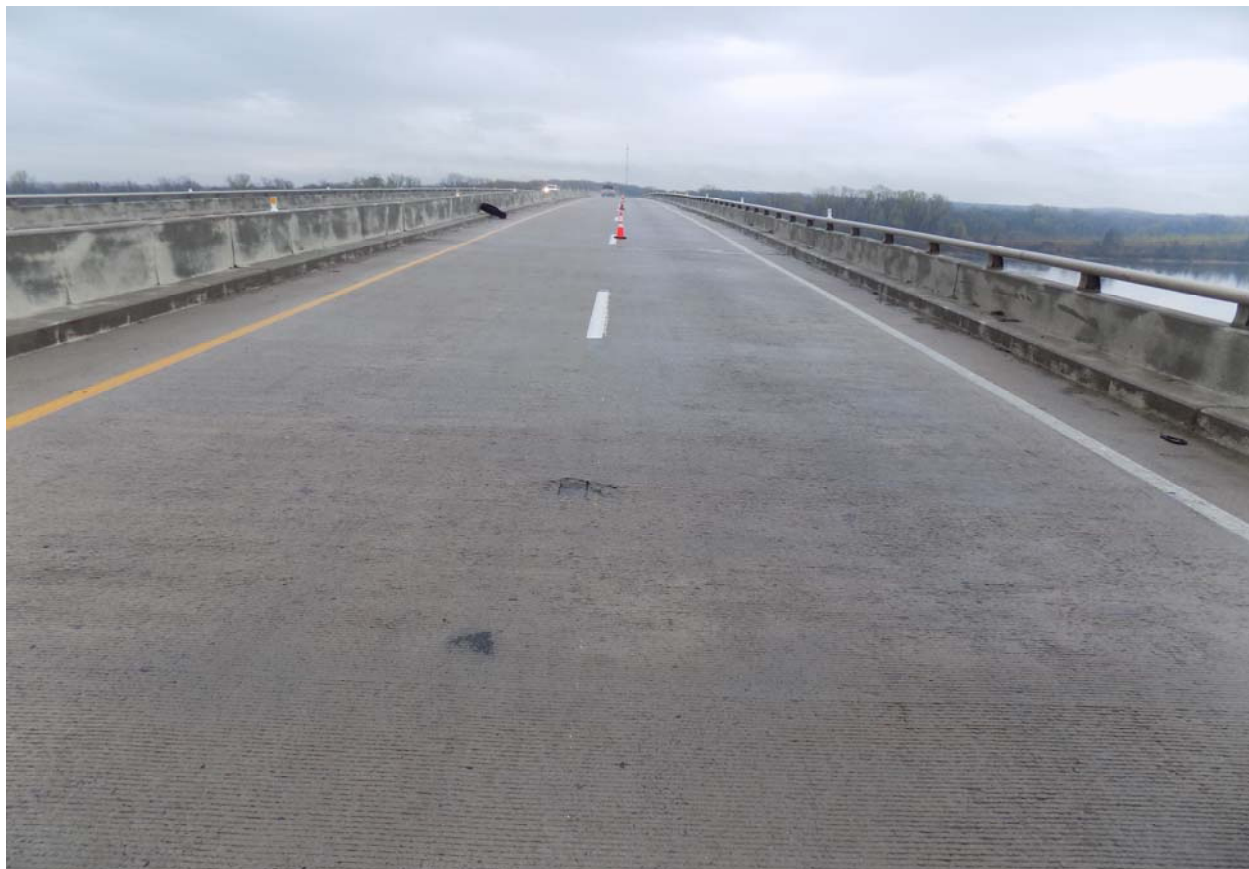
The parapets on the deck slab consists of vertical face parapets with metal hand railing supported on approximately 8" tall curbs. The median barrier at the centerline of the bridge consists of an 11" wide vertical wall supported on a 4' wide by 8" tall curb. The parapets and median barrier are of an obsolete design and are in fair condition but do contain numerous vertical cracks. Additionally, the concrete surface finish has worn off in most areas resulting in significant discoloration of the concrete. The metal handrailing on the parapets are in good condition with little to no corrosion.

Eastbound Deck Slab, Median Barrier and Parapet

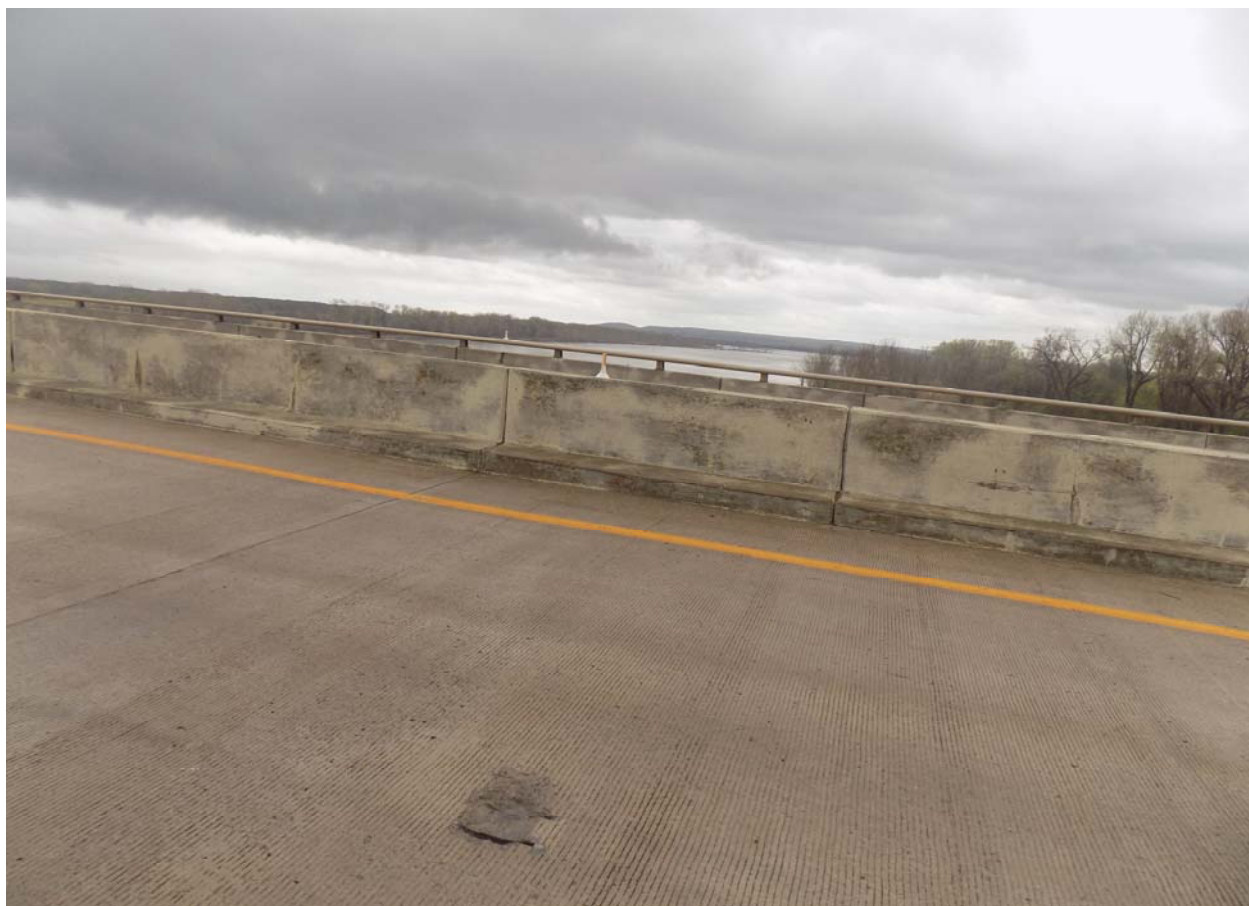
Westbound Deck Slab and Median Barrier

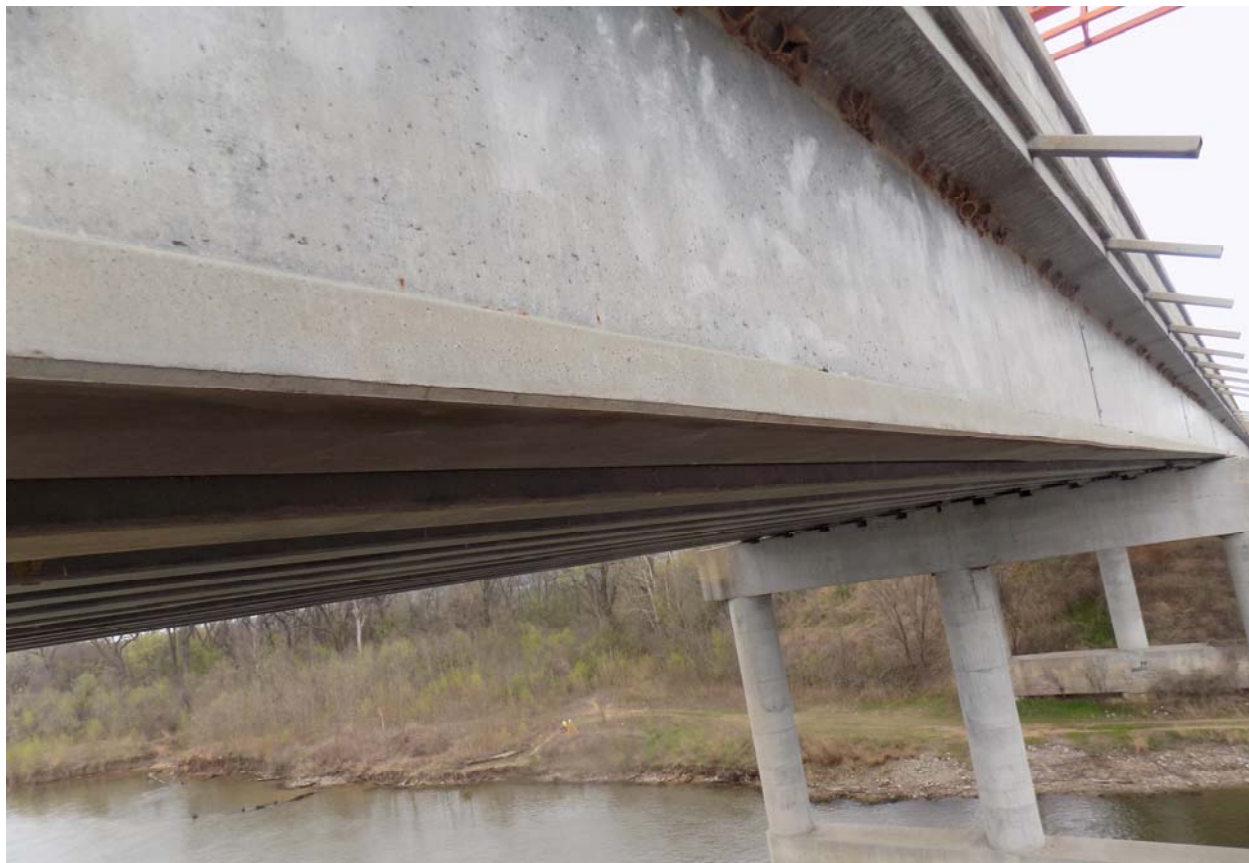
Soffit of Eastbound Deck Slab

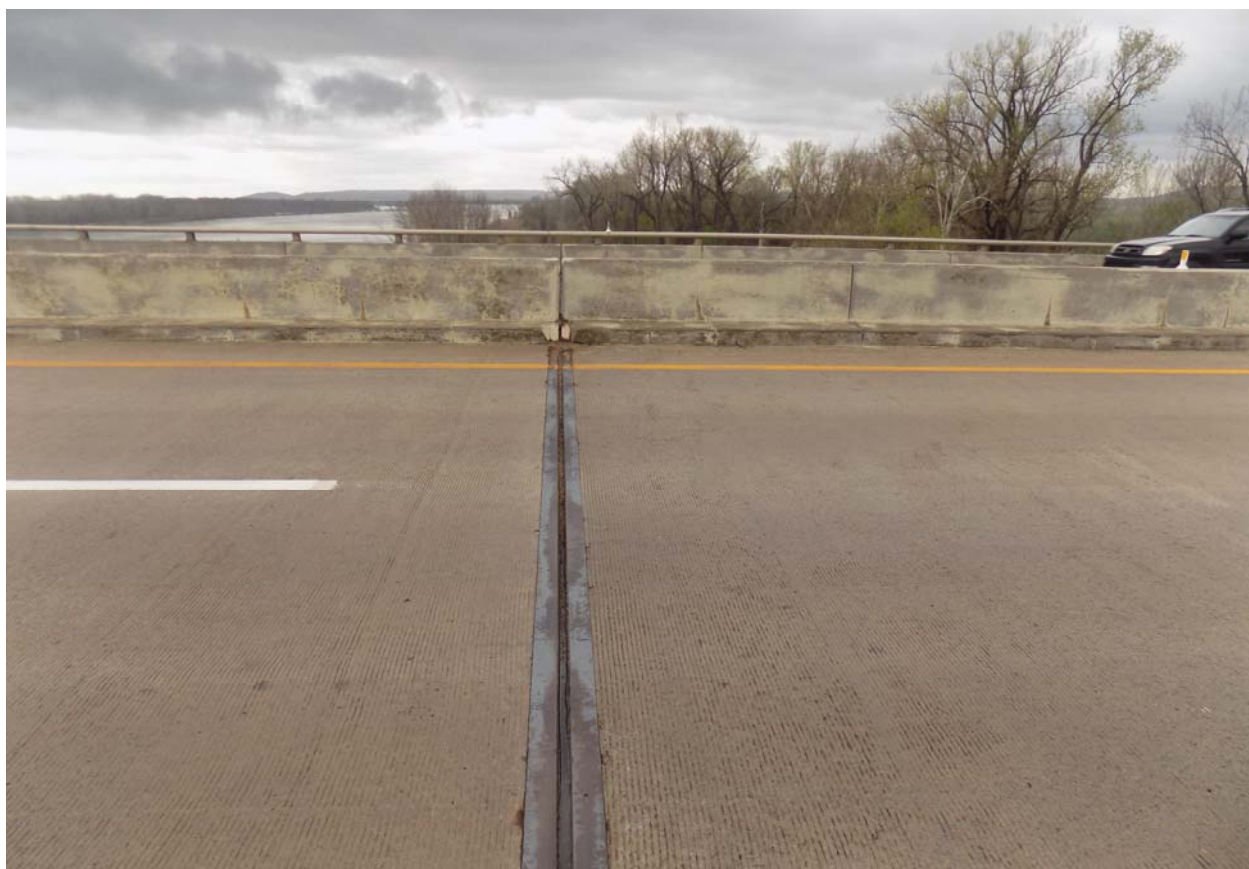
A sealed expansion joint exists in the deck slab at Pier No. 1. A modular expansion joint exists in the deck slab at Pier No. 3. Construction joints exist in the deck slab between the approach slab and deck slab and at Pier No. 2. The joint between the approach slab and deck slab is a sawed and sealed joint. The sealed and modular expansion joints are in fair condition with some corrosion and loss of coating on the steel parts. The neoprene diaphragms at the joints appear

Sealed Expansion Joint in Deck Slab

At the expansion joints, remove up to 4' of the deck slab on each side of the joints; subsequently, remove and replace the sealed and modular expansion joints to the level of the overlay. Maintain the construction joints between the approach slab and the deck slab and in the deck slab at Pier No. 2. by placing the overlay concrete in two separate pours on each side of the construction joints. Seal the construction joint at Pier No. 2 with sealer resin.

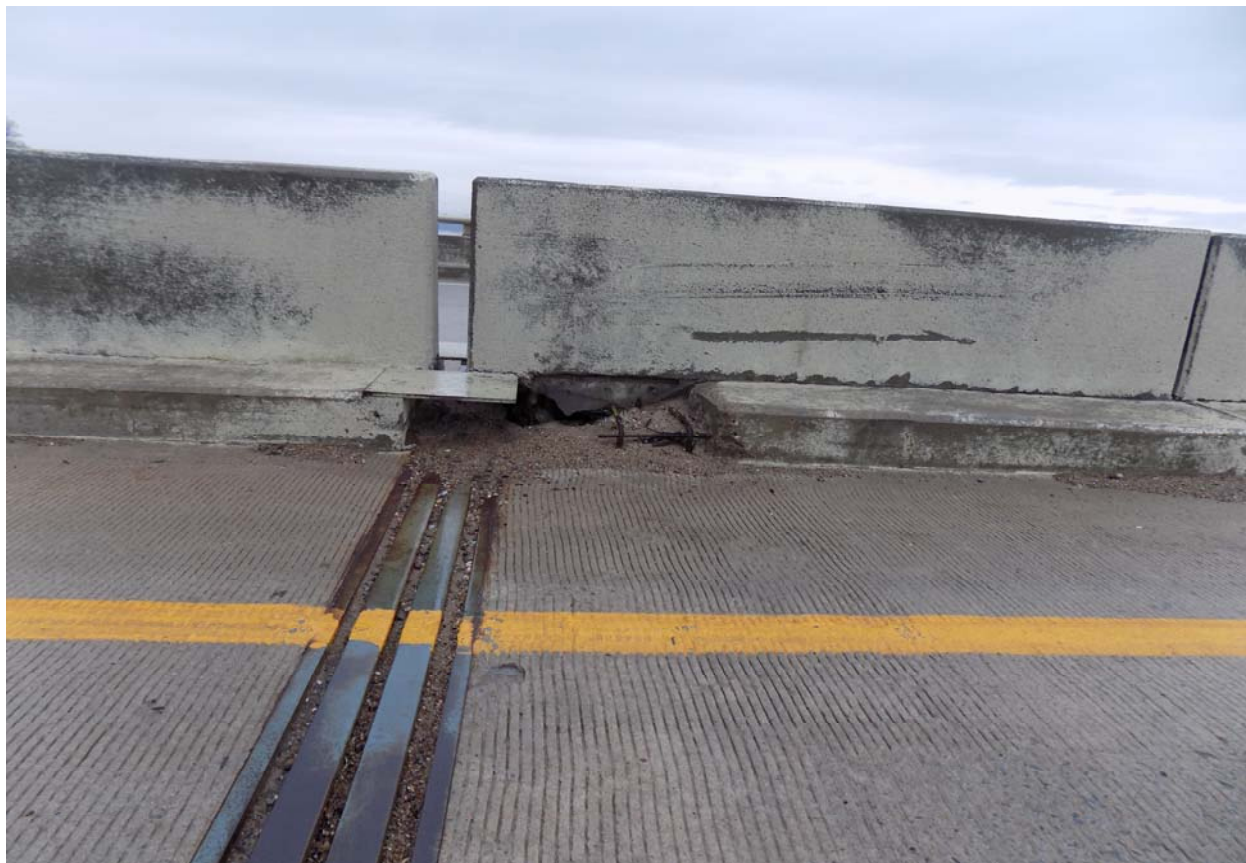
Modular Expansion Joint in Deck Slab

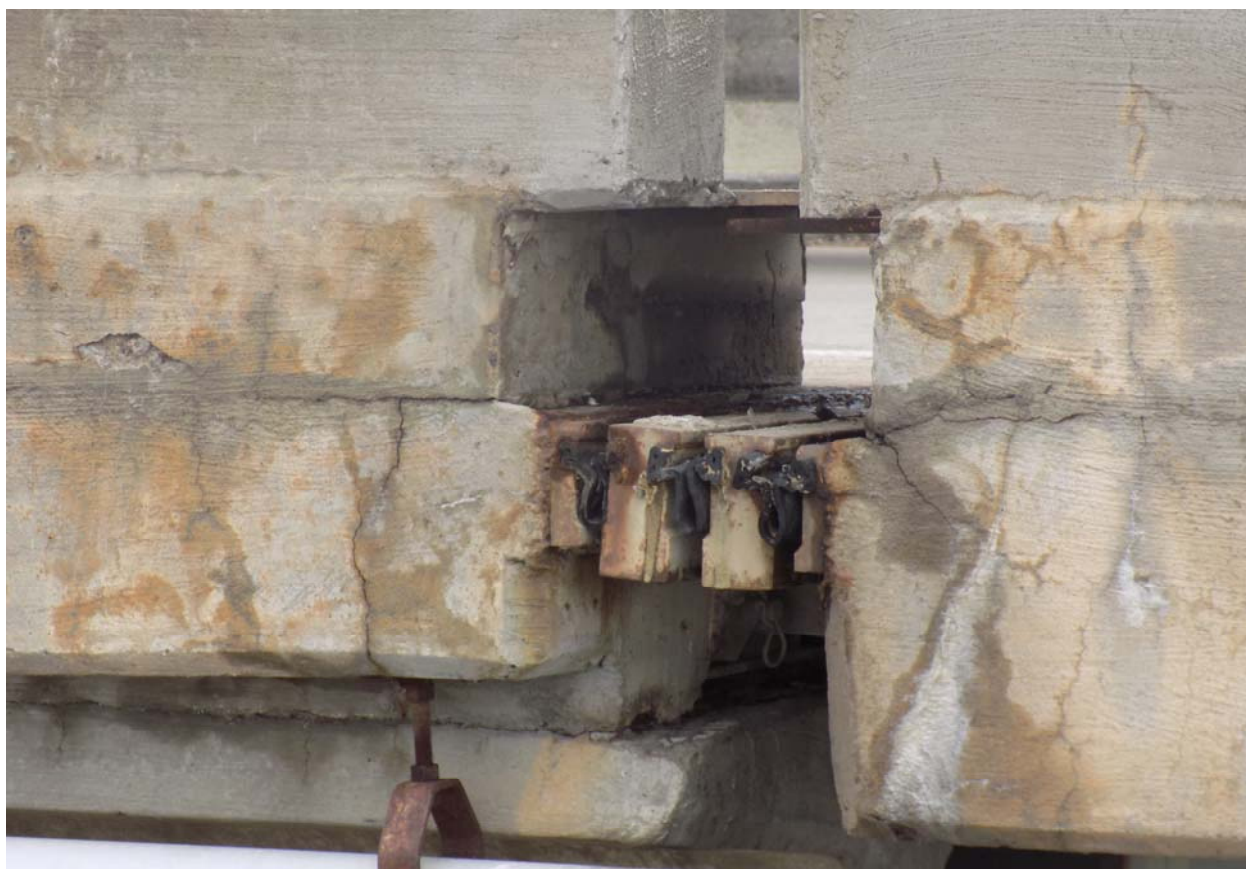
to be functioning with some tearing and seepage; however, the joints contain significant debris. The fascia concrete in the deck slab at the ends of the modular expansion joint is in poor condition with cracking and impending spalls.

Deck Slab Fascia at Modular Expansion Joint

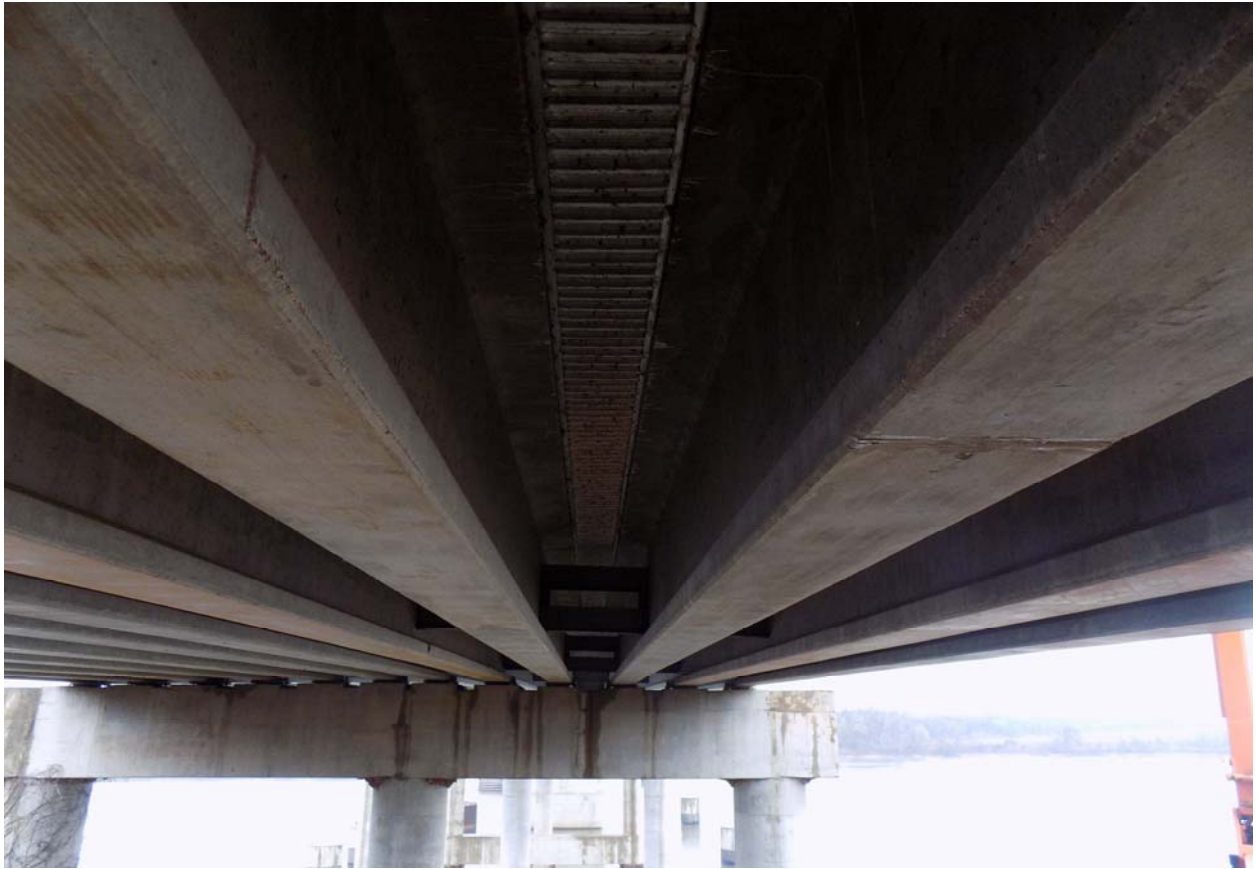
Existing Condition: The existing p.c. beams consist of 72” Bulb Tee beams extending along twelve (12) beam lines. The end and intermediate diaphragms consist of double steel channels bolted to the p.c. beams with angle gussets. The diaphragms are spaced at third points along the beams. The p.c. beams and diaphragms are mostly in good condition. Two (2) of the p.c. beams in the north exterior beam line contain some spalling with exposed prestressing strands on the end face of the p.c. beams. These occur over Pier Nos. 2 and 3. The diaphragms are in good condition; however, several of the bolted connections between the angle gussets and the p.c. beams have loose or missing bolts.

P.C Beams (Typical)

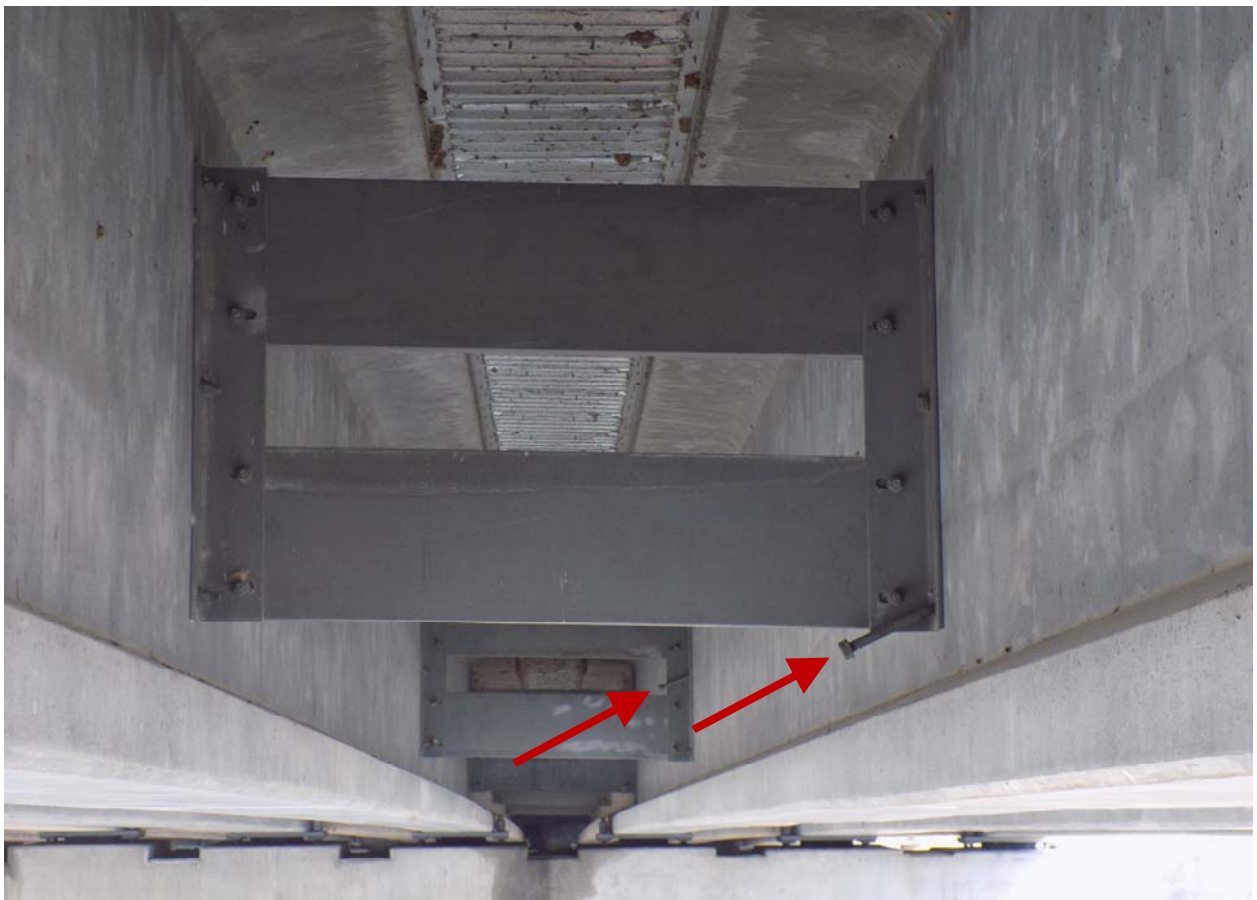
Structural Steel Diaphragms and Angle Gussets (Typical)

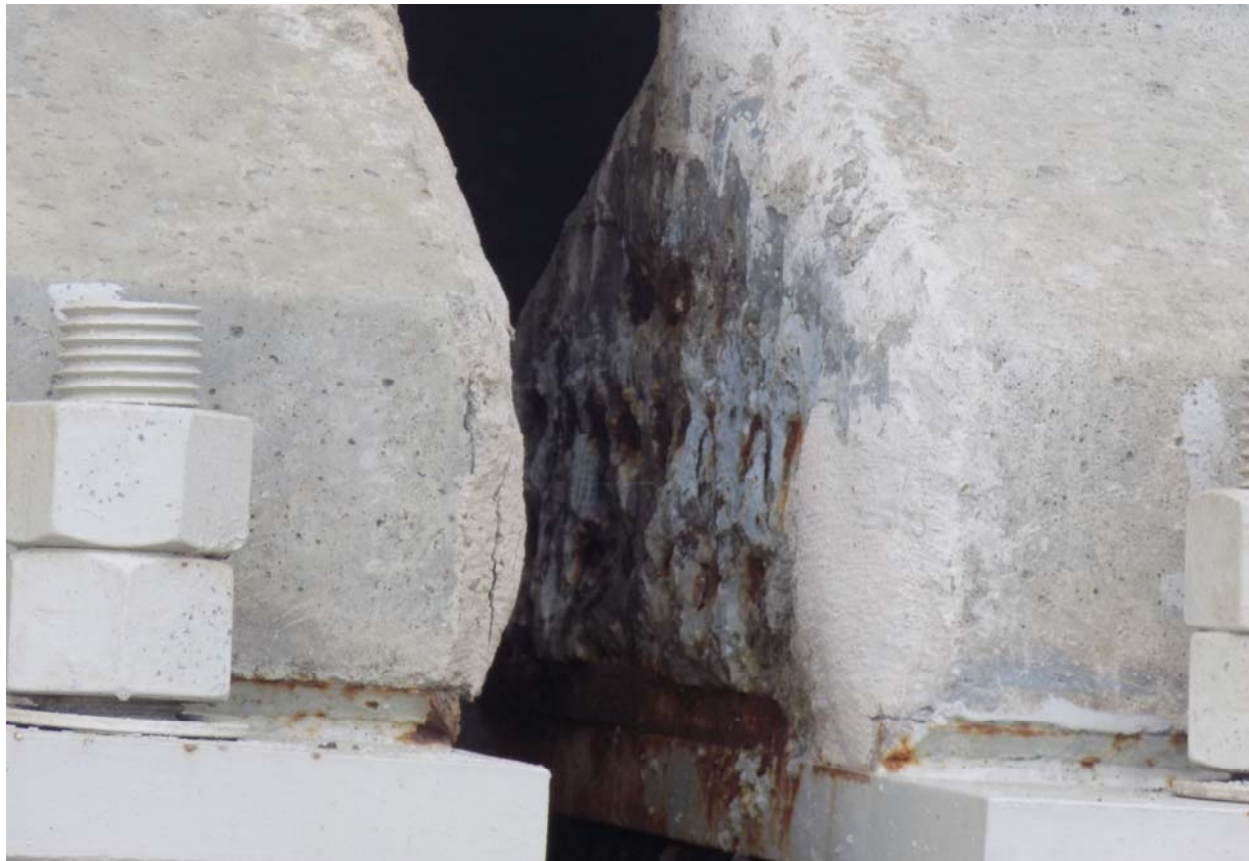
North Exterior P.C. Beam End at Pier No. 2

Repair the two (2) p.c. beam ends that currently contain spalling and exposed prestressing strands. Remove all loose and unsound concrete from beam ends and patch with pneumatically placed mortar. Subsequently, apply an elastomeric coating to the repaired beam ends. Add two additional beam lines of 72” Bulb Tee p.c. beams to accommodate widening of the bridge superstructure. Add missing bolts, retighten loose bolts with thread lock compound on the steel diaphragm angle gusset connections to the p.c. beams. Add additional steel double channel diaphragms with angle gussets between the new and existing p.c. beams.

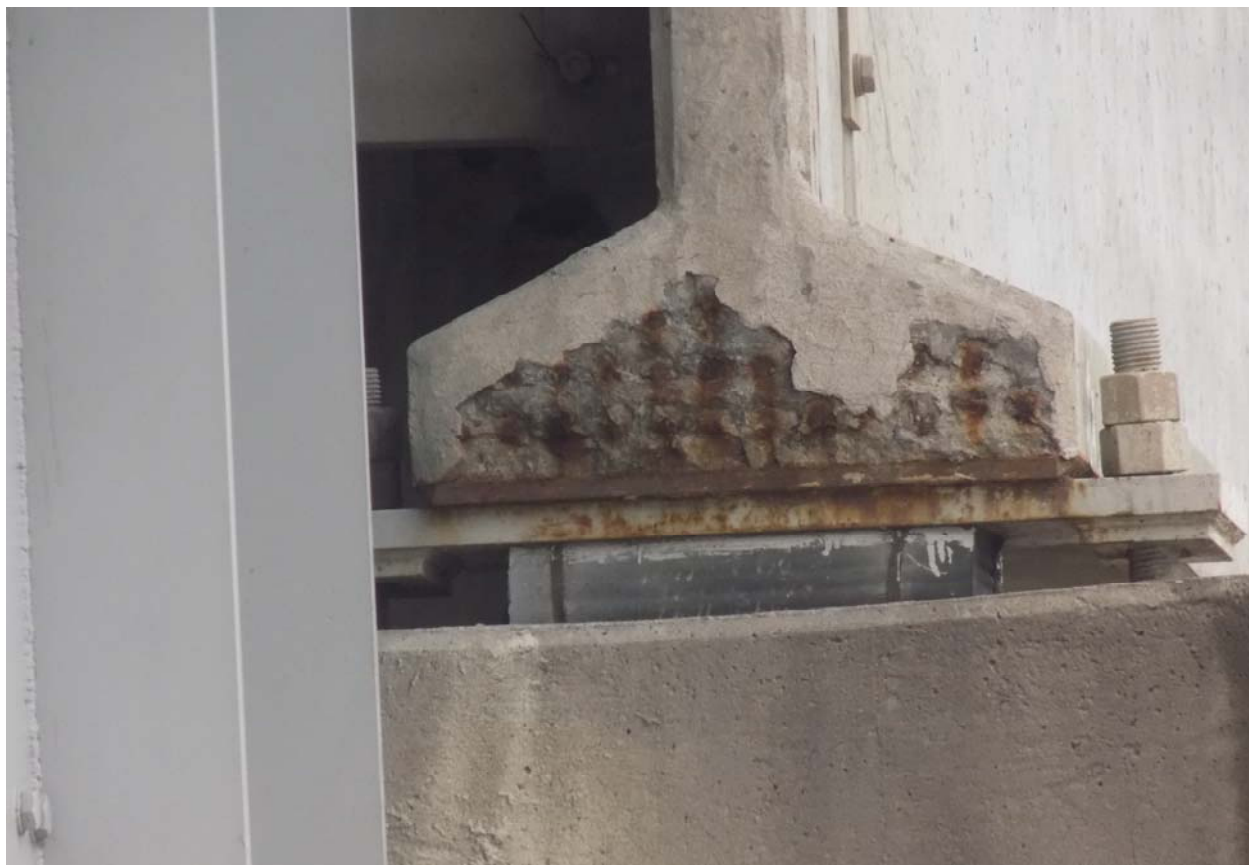
North Exterior P.C. Beam End at Pier No. 3

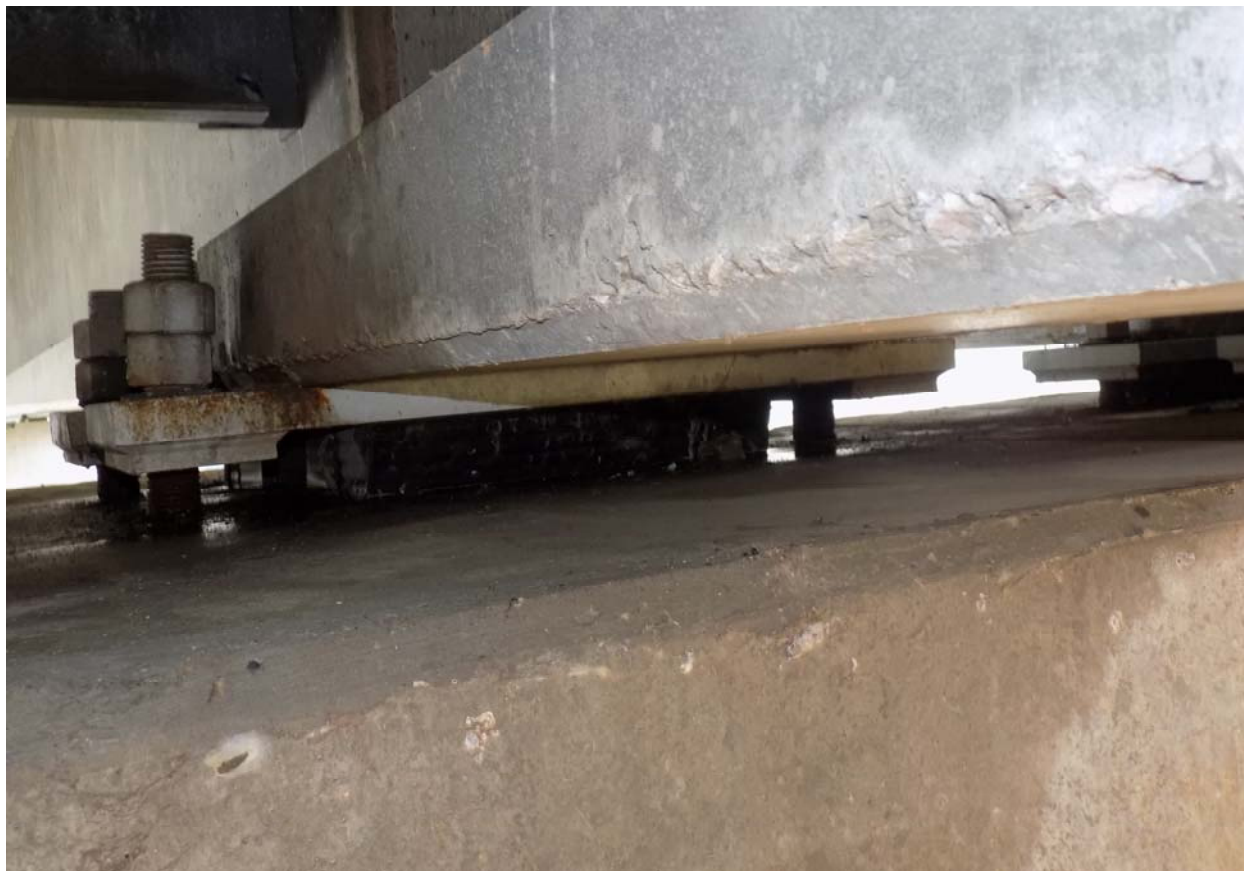
Existing Condition: The existing bearings assemblies consist of steel reinforced elastomeric pads with painted weathering steel beveled anchor plates, contact plates and anchor bolt assemblies. The bearing pads are in good condition with little deterioration or bulging. The steel parts of the bearing assemblies are in good condition but have some moderate paint coating failure and rust staining. Most of the staining is at the joint between the anchor plates and p.c. beam sole plates.

Painted Weathering Steel Bearing Assembly

Leave all existing bearing assemblies in-place. Clean and paint all steel parts of the existing bearing assemblies. Since the existing p.c. beams will be removed in Alternate No. 2, the existing beveled anchor plates will need to be separated from the sole plates in the existing p.c. beams for Alternate No. 2. Any weld material remaining on the anchor plates after removal of the p.c. beams should be ground flush prior to painting the anchor plates.

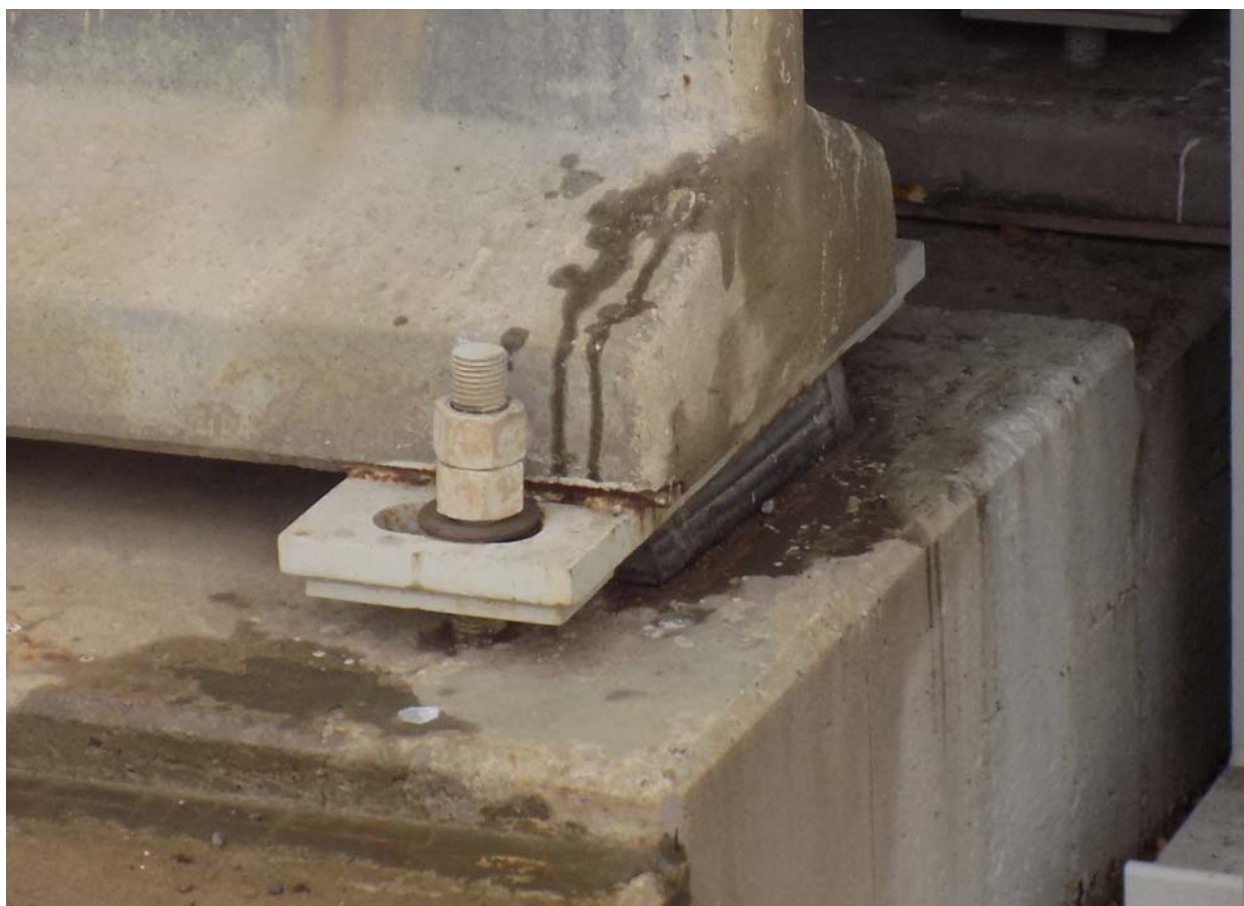
Painted Weathering Steel Bearing Assembly at Exterior P.C. Beam

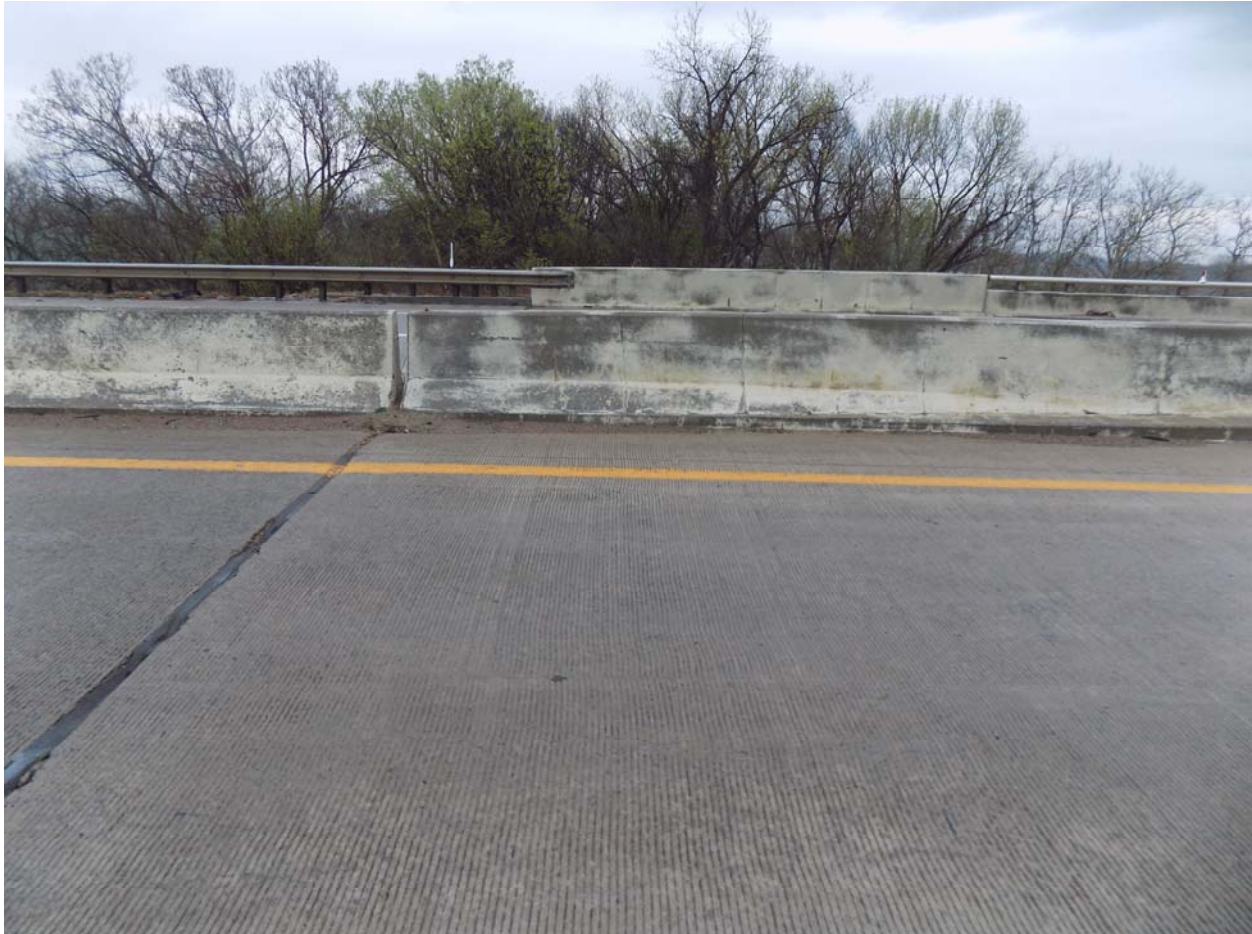
Existing Condition: The west approach slab has a length of 30'-0" a width of 81'-0" and a thickness of 13". The existing parapets on the approach slab are not located at the edges of the approach slab. They located approximately 6' from the edges of the approach slab thereby confining the current bridge clear roadway to 30'-0" on each side of the median barrier. The top surface of the approach slab contains abrasion and some minor potholes and impending potholes. The most significant problem with the approach slab is the presence of extensive map cracking. The cracks are small but numerous and prevalent throughout the approach slab. A sawed and sealed construction joint exists between the approach slab and deck slab.

West Approach Slab on Eastbound Side of Bridge

Remove the existing parapets, median barrier and curbs supporting those elements on the approach slab at the edges and centerline of the bridge. Scarify (cold mill) and conduct hydrodemolition of the existing approach slab surface to remove approximately 1" of the surface concrete. Apply a concrete overlay of no less than 2" above the original approach slab surface elevation across the full width of the approach slab.

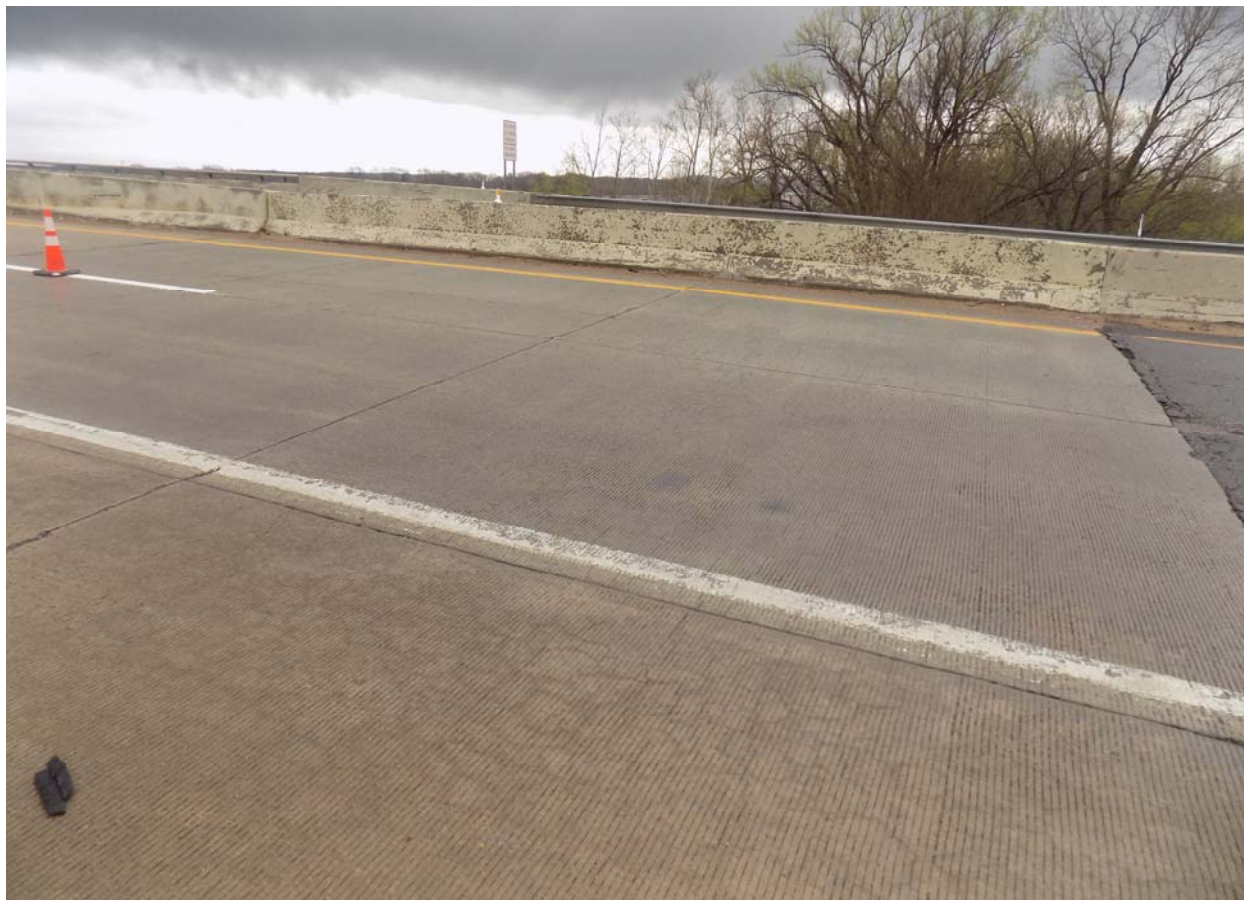
The parapets on the approach slab consist of vertical wall parapets supported on approximately 8" tall curbs. The median barrier on the approach slab consists of an 11" wide vertical wall supported on a 4' wide by 8" tall curb at the begin bridge. This section transitions to the ODOT standard 42" median barrier at the begin approach slab. The parapets and median barrier are of an obsolete design and are in fair condition but do contain numerous vertical cracks. Additionally, the concrete surface finish has worn off in most areas resulting in significant discoloration of the concrete. The south parapet on the approach slab contains impact damage as well.

West Approach Slab on Westbound Side of Bridge

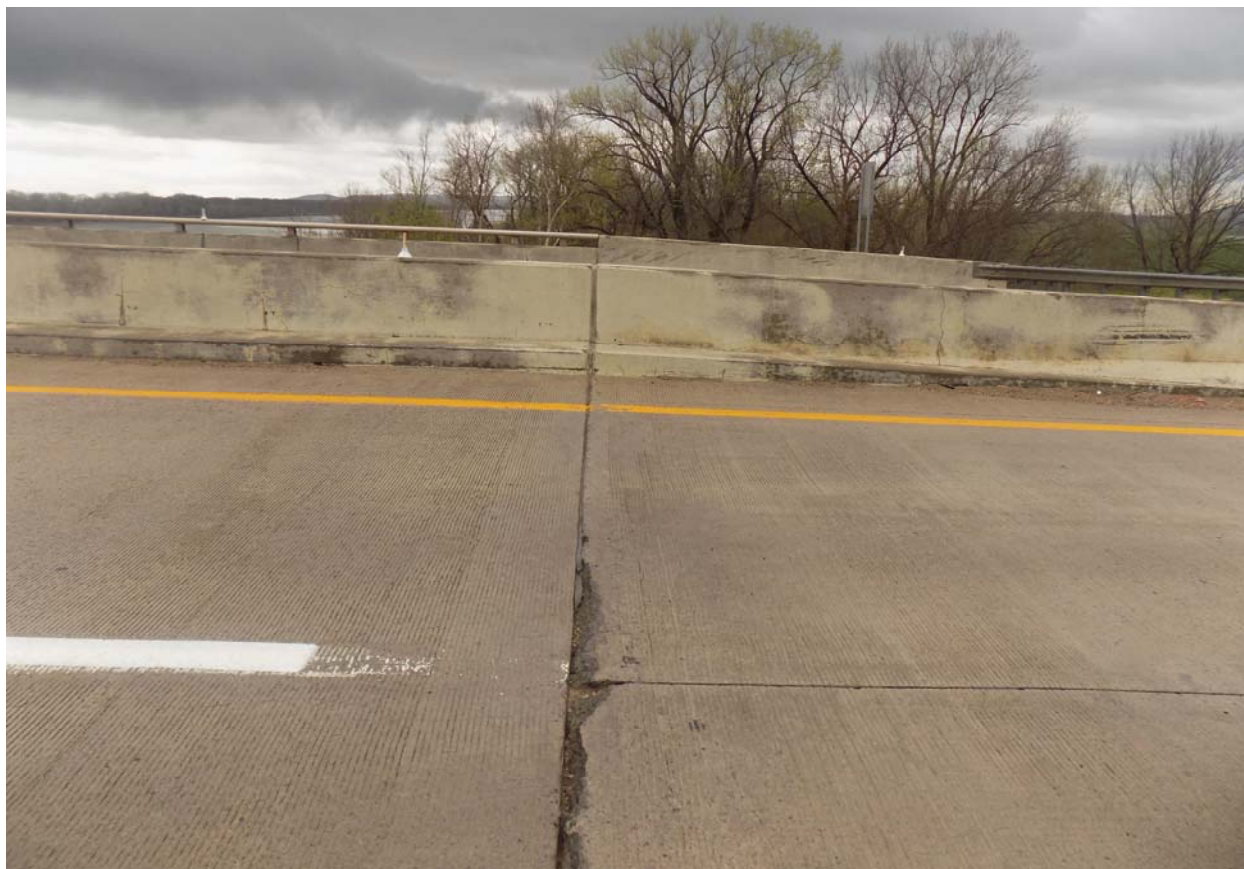
Construction Joint between Deck Slab Approach Slab

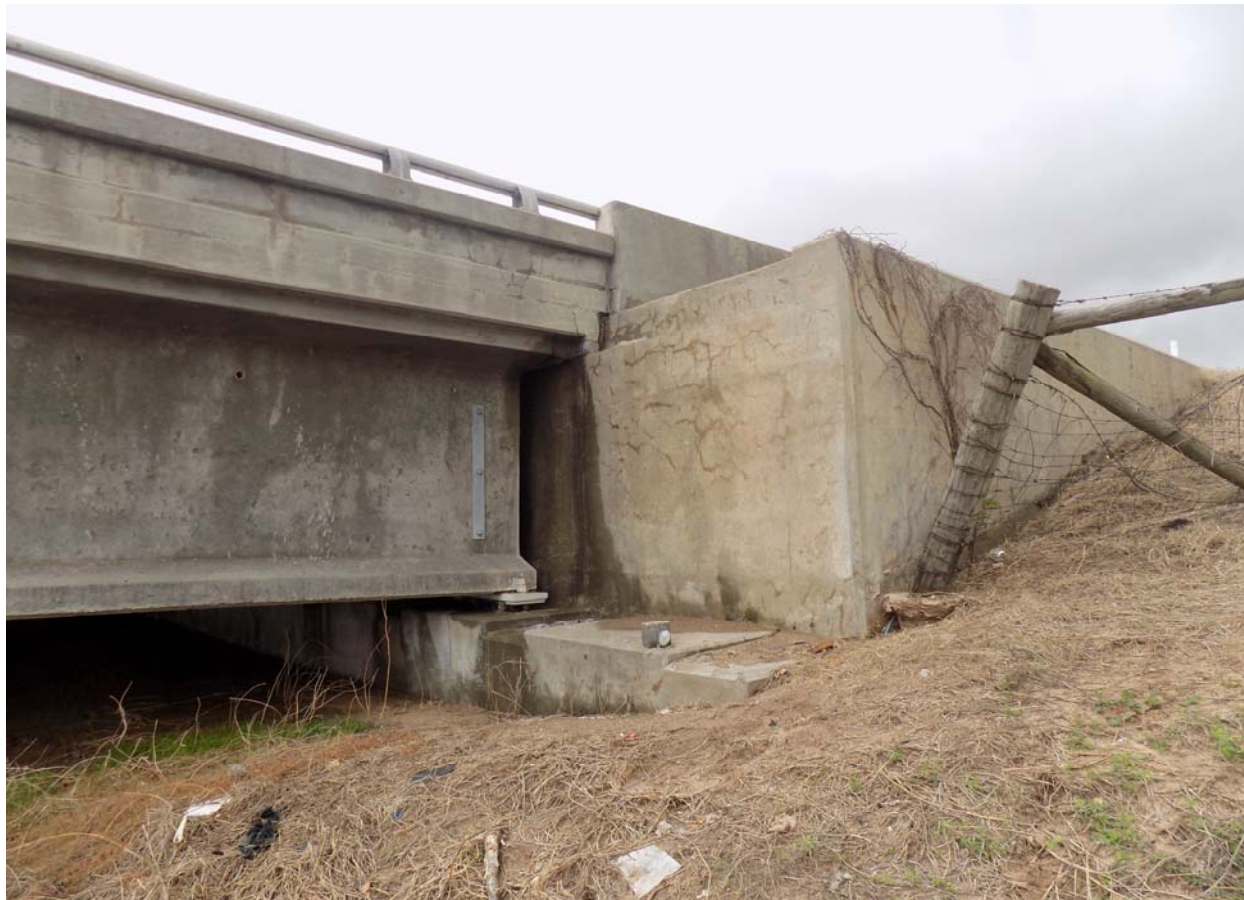
Existing Condition: The bridge seats and back walls of Abutment No. 1 are in fair to good condition but contain some abrasion, cracks and minor spalls throughout. Map cracking exists on the backwall at the exposed ends of the abutment. The pedestals are in good condition. The abutment wings are in fair condition with no significant spalling but some map cracking. A portion of the abutment from the original bridge was not removed with the construction of the existing abutment in 2002 and remains in front of the existing bridge seat.

North End of Abutment No. 1

Remove all unsound concrete from the bridge seat, backwall and wings of Abutment No. 1. Pneumatically place mortar to repair the areas of unsound concrete that is removed. Place the mortar back to the original lines and surfaces of the abutment. Apply corrosion inhibitor to the repaired areas. After making the pneumatically placed mortar repairs, make epoxy crack repairs to any cracks remaining in the abutment concrete. Apply an elastomeric coating (Cim 1000) to the top of the abutment bridge seat and pedestals.

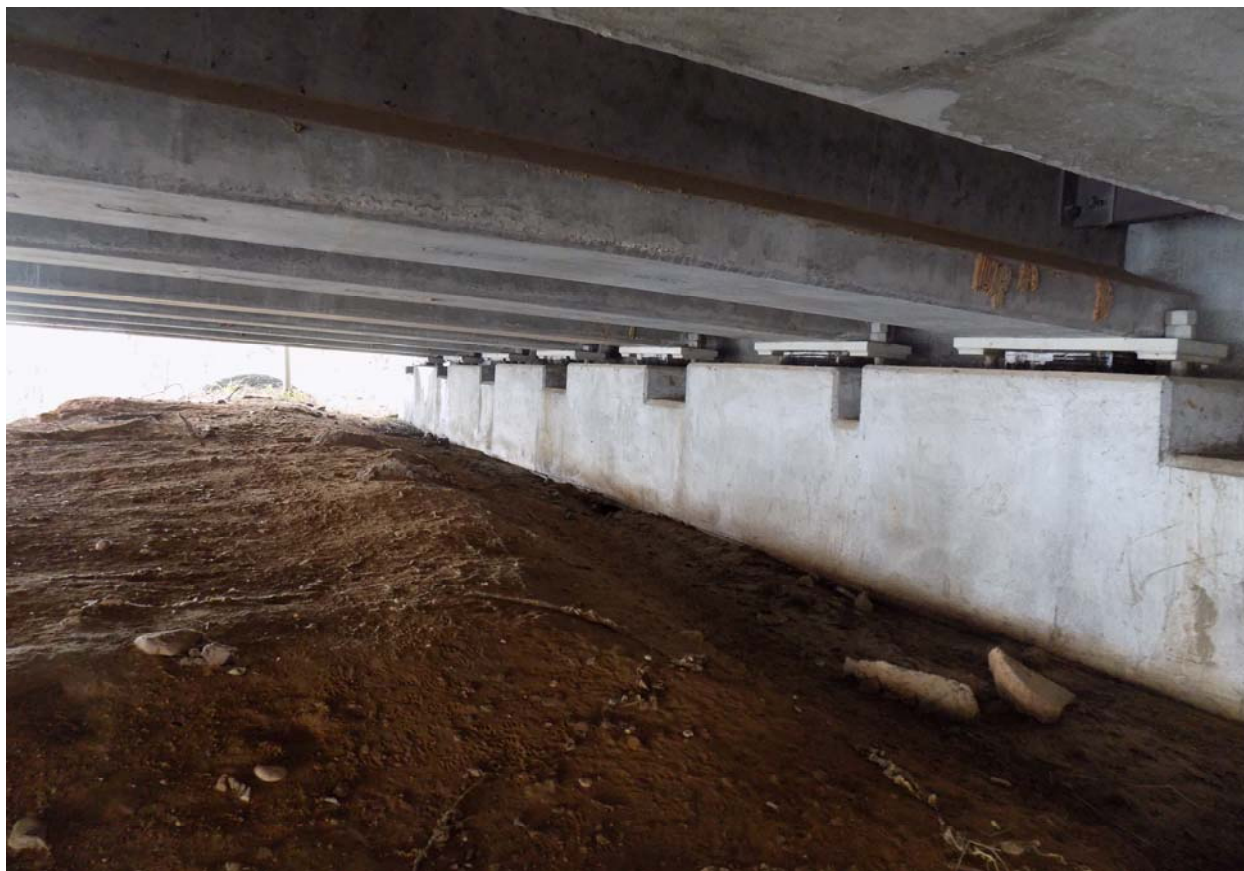
Bridge Seat of Abutment No. 1
