Bridge Assessment Report
Interstate 40 over Arkansas River
NBI No. 17051, Location No. 6822 0000X
Muskogee and Sequoyah Counties
(Rehabilitation of Span Nos. 1, 2 and 3
and West Approach Slab)

April 29, 2022

BRIDGE ASSESSMENT REPORT **(Rehabilitation of Span Nos. 1, 2 and 3 and West Approach Slab)**

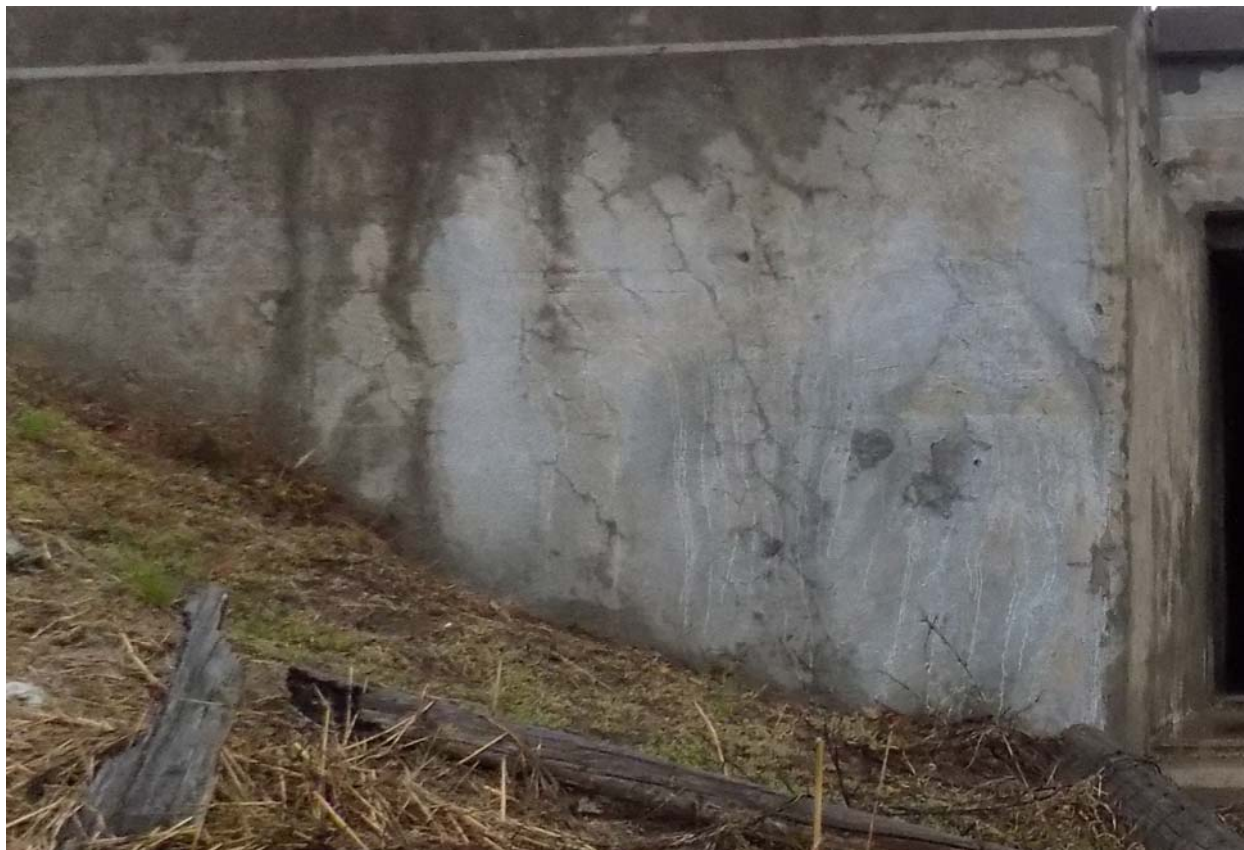
South Wing of Abutment No. 1

Remove all unsound concrete from the bridge seat, backwall and wings of Abutment No. 1. Pneumatically place mortar to repair the areas of unsound concrete that is removed. Place the mortar back to the original lines and surfaces of the abutment. Apply corrosion inhibitor to the repaired areas. After making the pneumatically placed mortar repairs, make epoxy crack repairs to any cracks remaining in the abutment concrete. Apply an elastomeric coating (Cim 1000) to the top of the abutment bridge seat and pedestals.

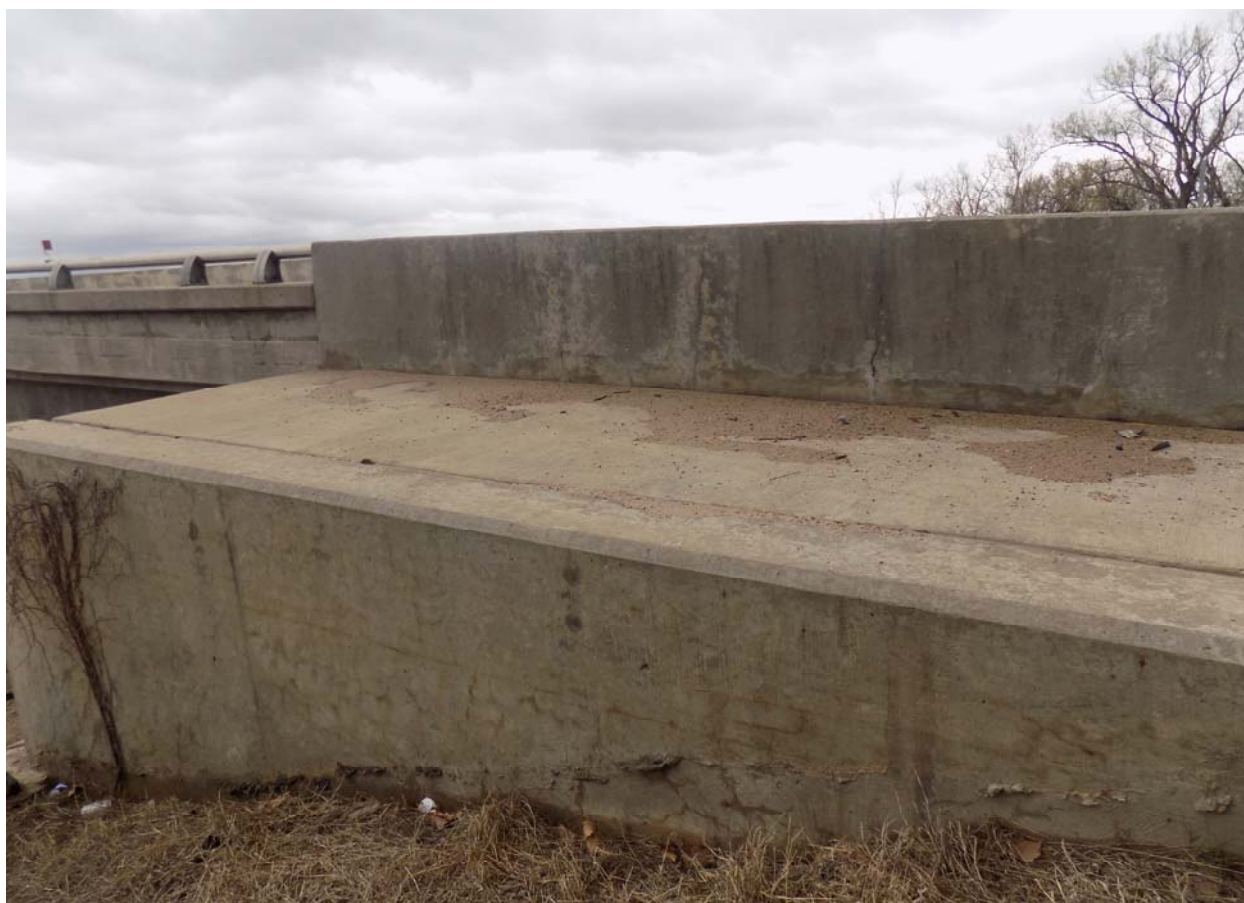
North Wing of Abutment No. 1

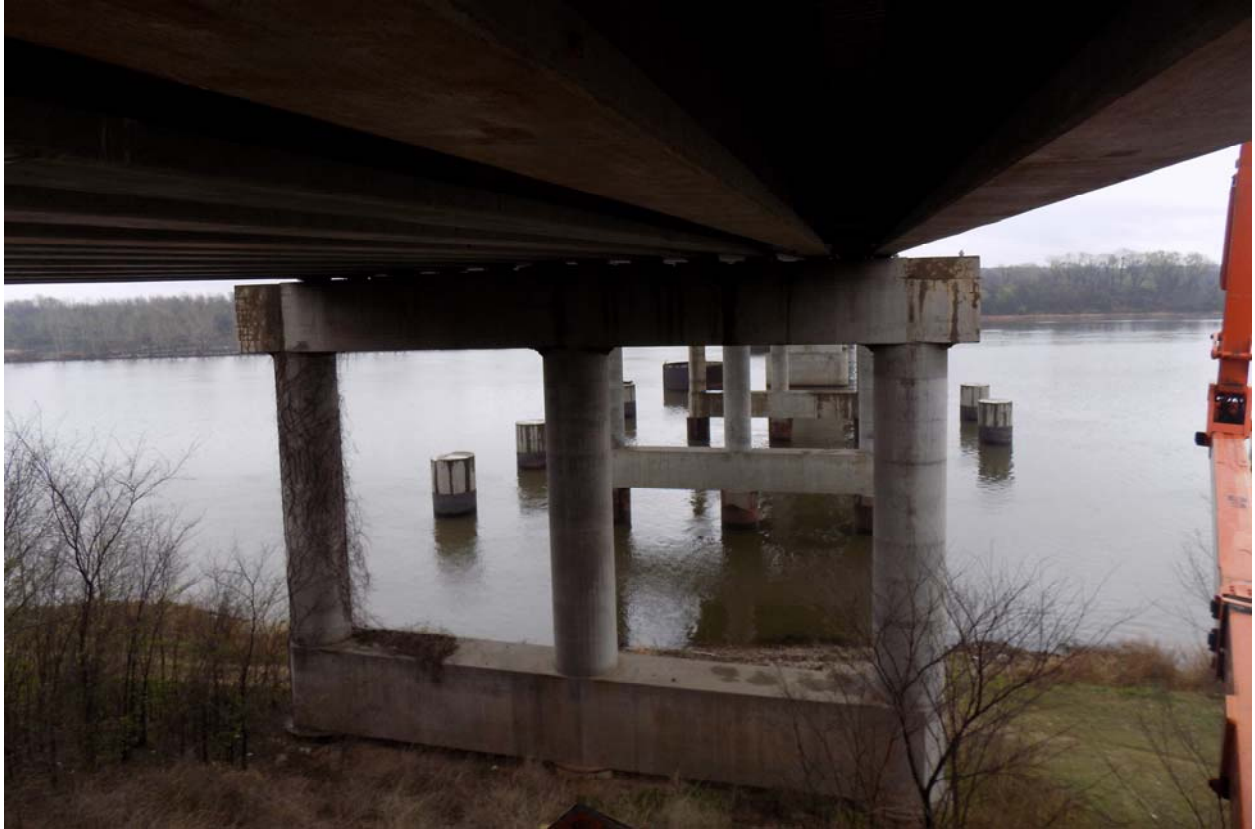
Existing Condition: The existing piers consist of 7' wide x 8' deep pier caps supported on three 7' diameter columns. The pier caps at Pier No. 3 are stepped to allow support p.c. beams on one side of the pier and steel girders on the opposite side of the pier. All piers are founded on 9' diameter drilled shafts. 7' wide by 10' deep web walls extend between the columns at the base of the columns at all piers. The existing pier caps are in fair condition but do contain some large cracks and impending spalls. The ends of pier caps that extend beyond the superstructure contain the most significant deterioration. There is some efflorescence in the cracks on the pier cap overhangs. The pier columns and web walls are in fair condition but do contain some cracks including map cracking and impending spalls.

West Side of Pier No. 1

Remove all unsound concrete from the pier cap, columns and web walls of Pier Nos. 1, 2 and 3. Where the removals of the pier concrete are less than 2 inches deep, pneumatically place mortar to repair the areas of removed unsound concrete. Place the mortar back to the original lines and surfaces of the piers. Where the removals of the pier concrete are deeper than 2", cast Class AA Concrete to repair the areas of removed unsound concrete. Place the Class AA Concrete back to the original lines and surfaces of the piers. The Class AA Concrete should be specified to have a maximum coarse aggregate size of $\frac{3}{4}$ inches. Apply corrosion inhibitor to the repaired areas. After making the pneumatically placed mortar and Class AA Concrete repairs, make epoxy crack repairs to any cracks remaining in the pier concrete. Apply an elastomeric coating (Cim 1000) to the top of the pier caps and pedestals.

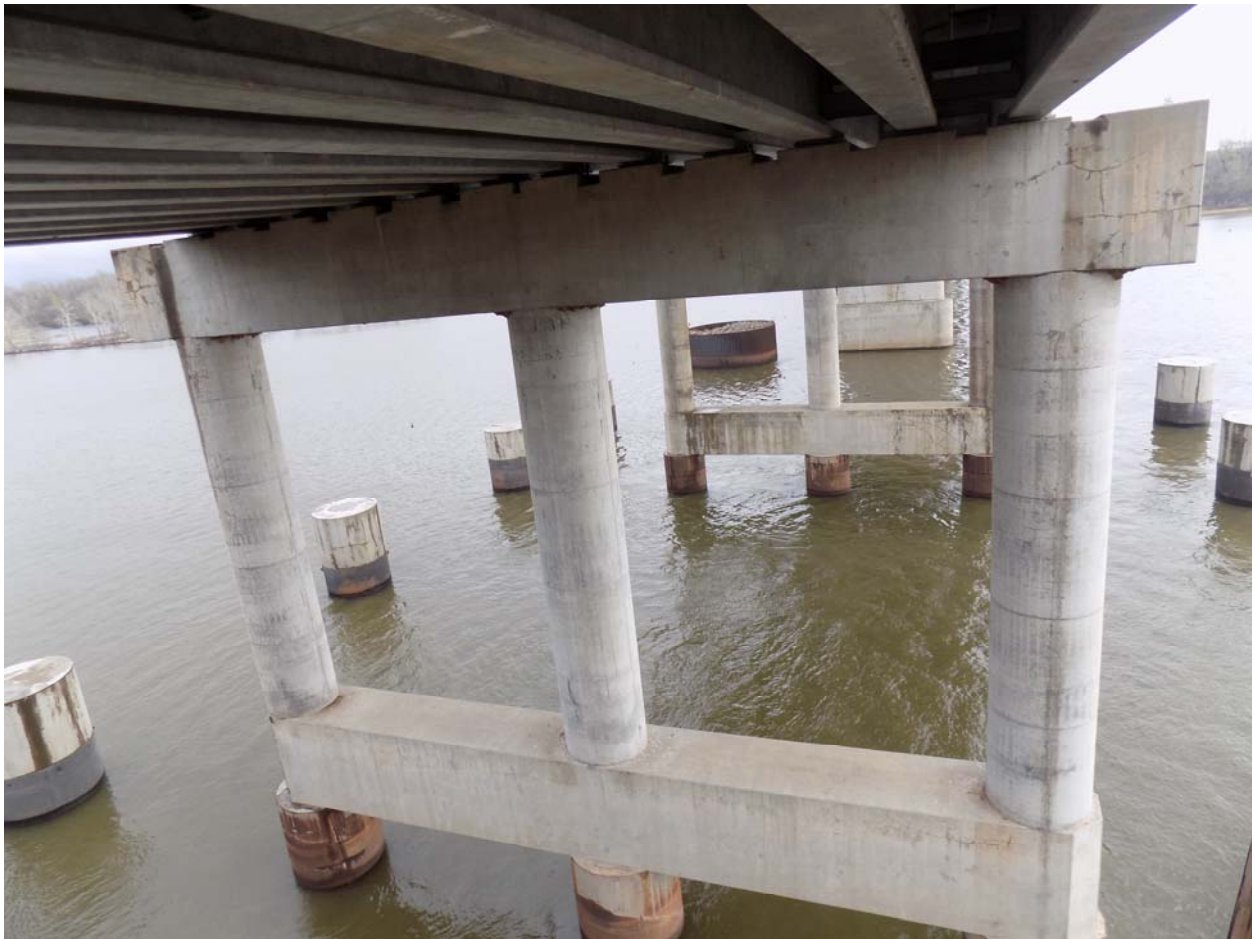
West Side of Pier No. 2

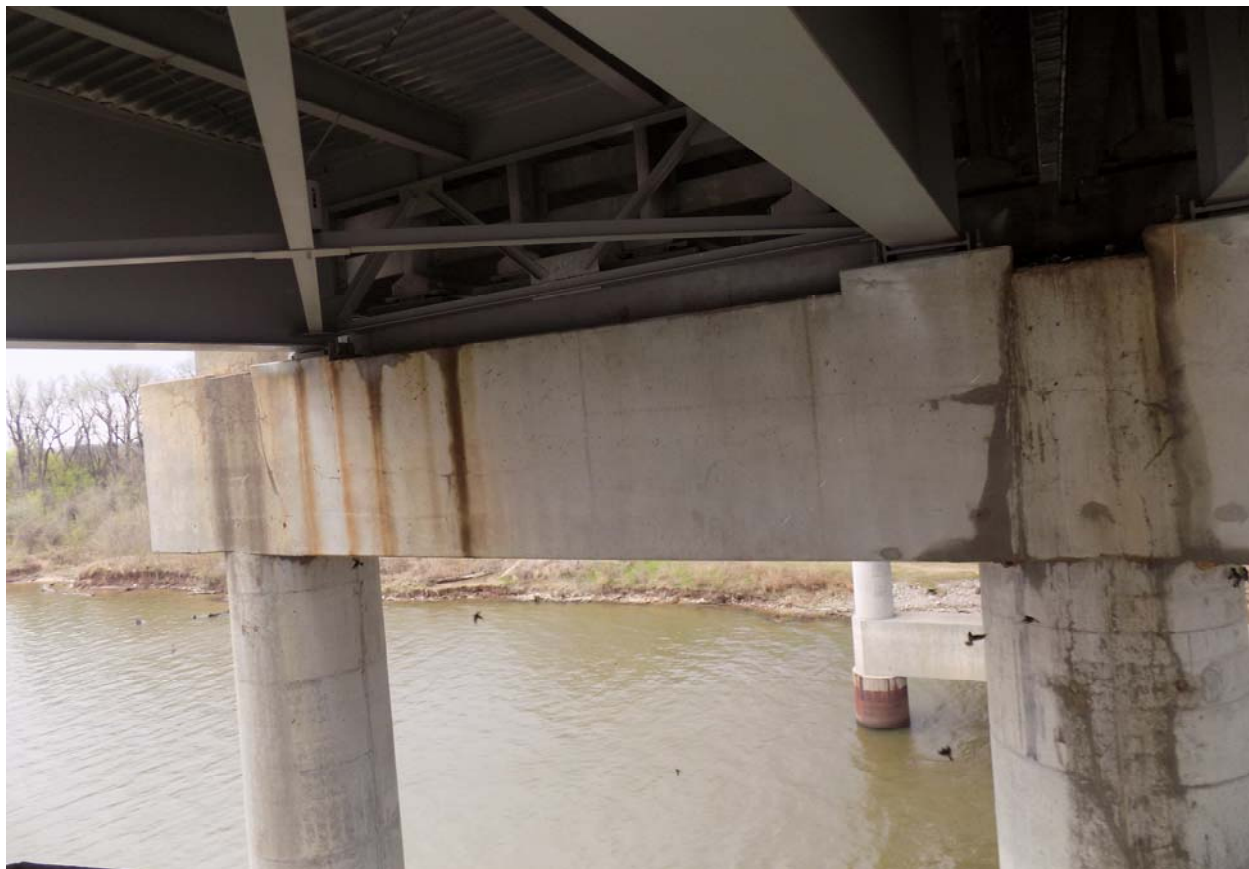
East Side of Pier No. 3

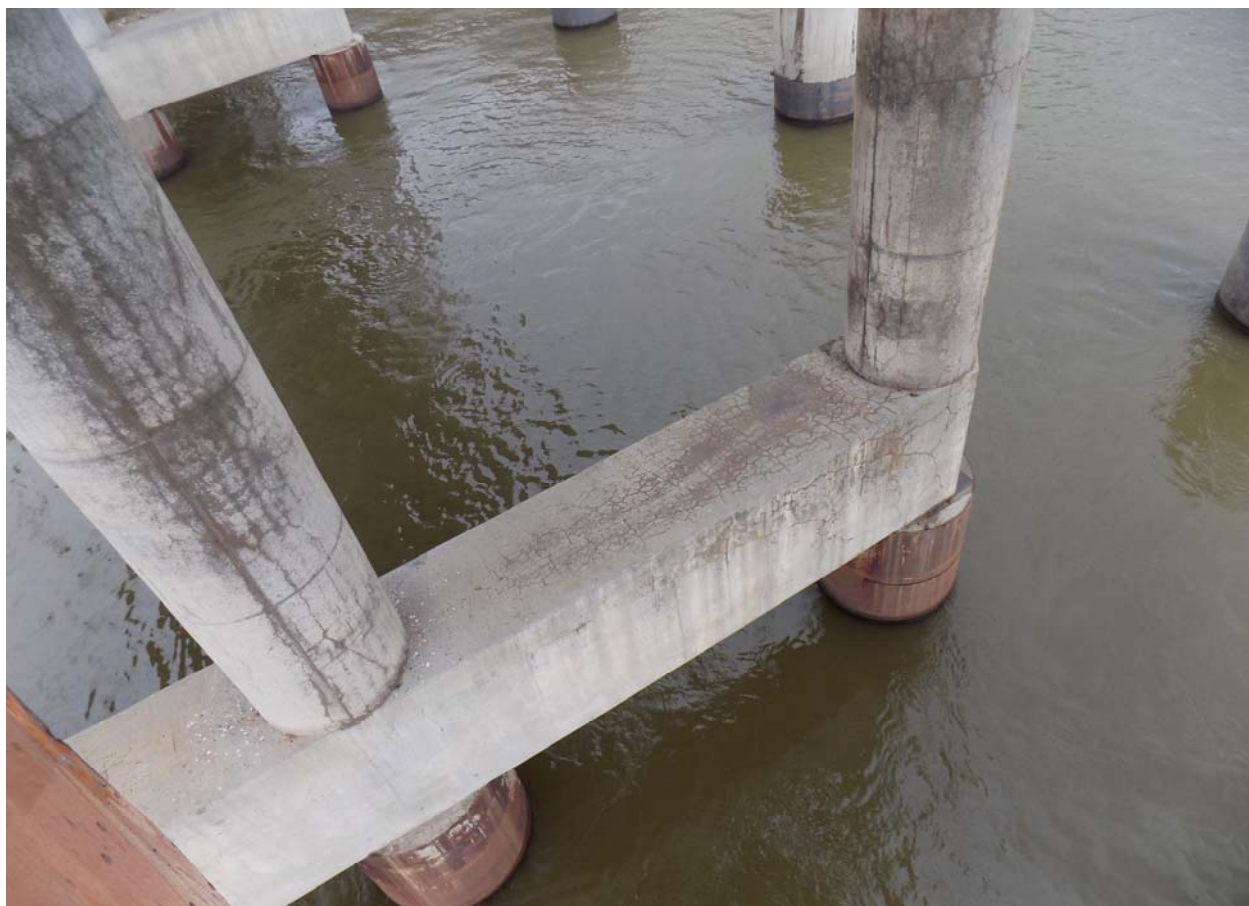
Web Wall at Pier No. 3

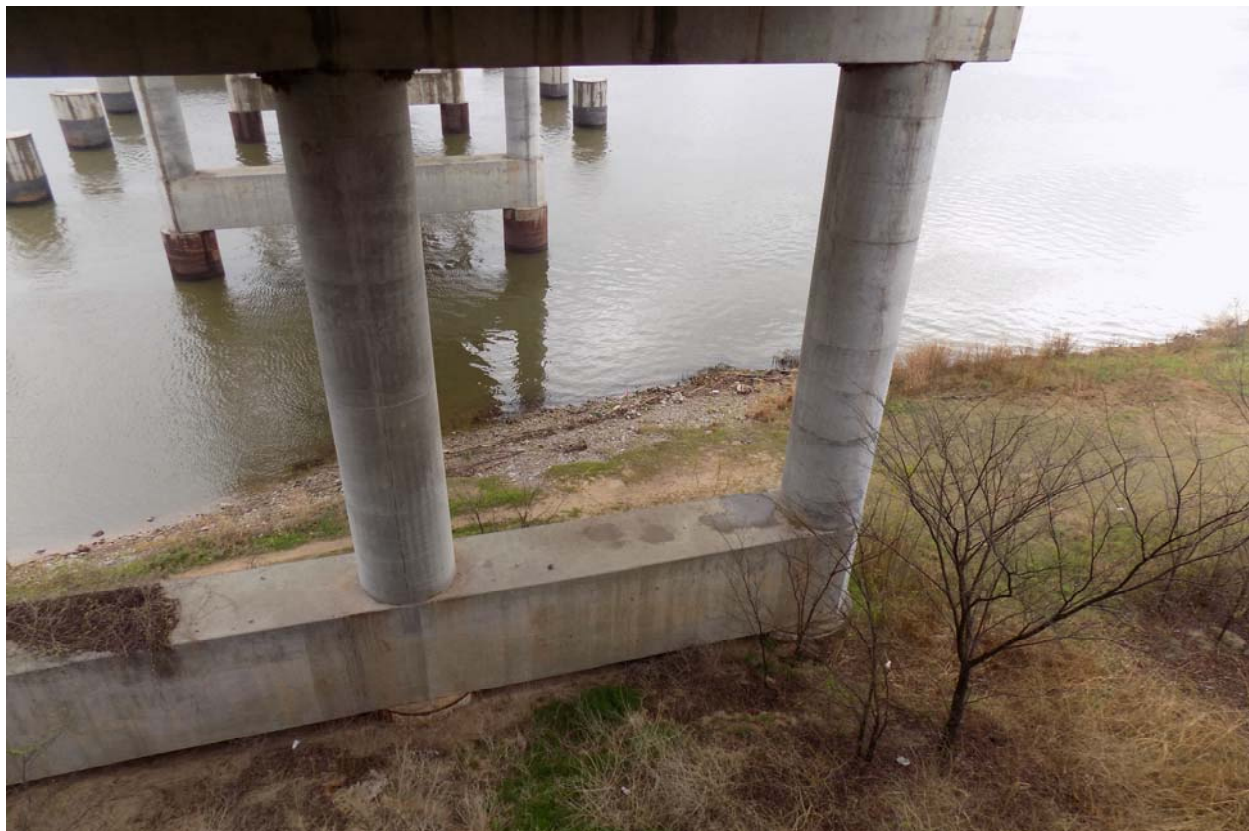
Web Wall at Pier No. 1

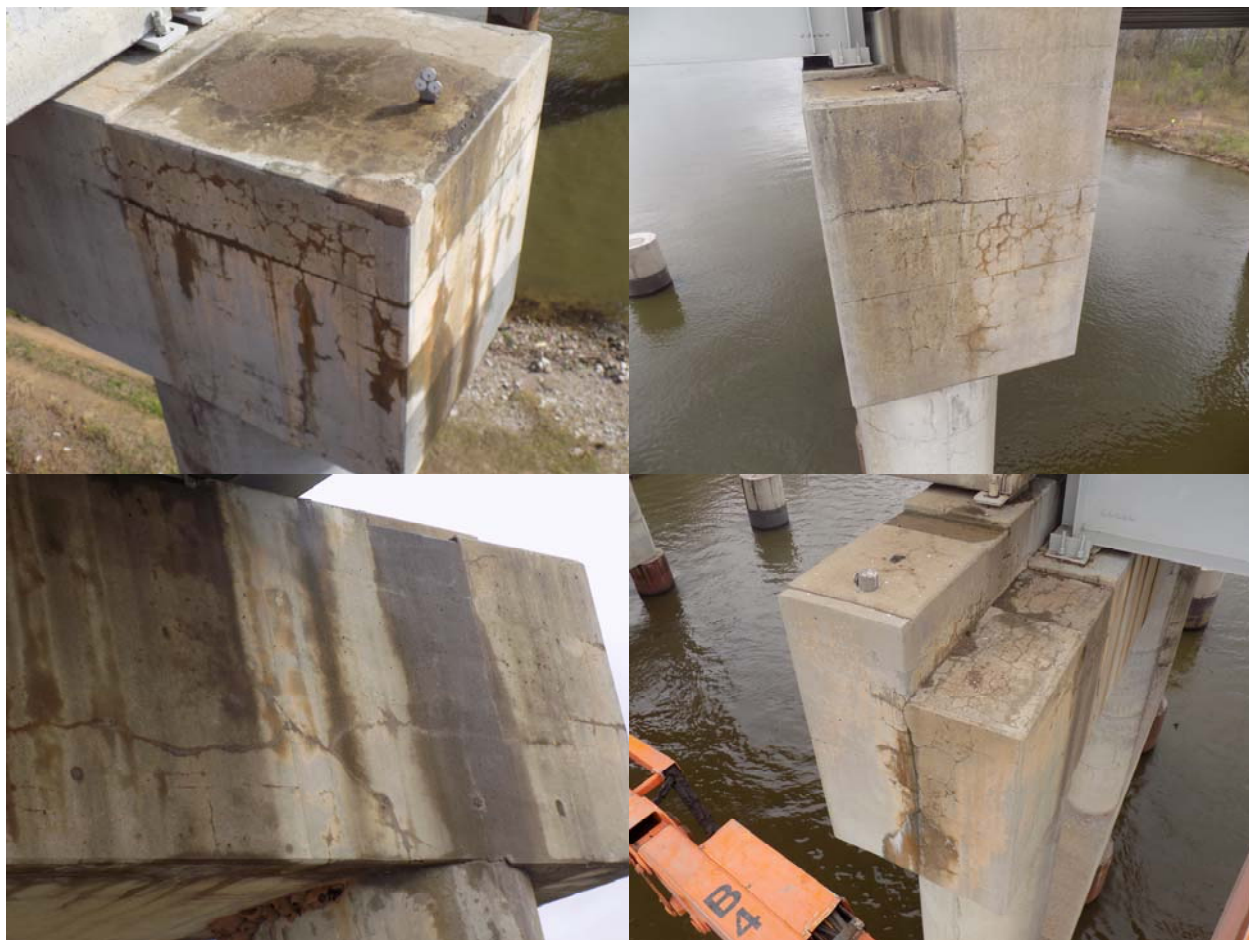
Pier Cap Overhangs
