Other Special Bridge Inspection Report

NBI Bridge No.: 17051

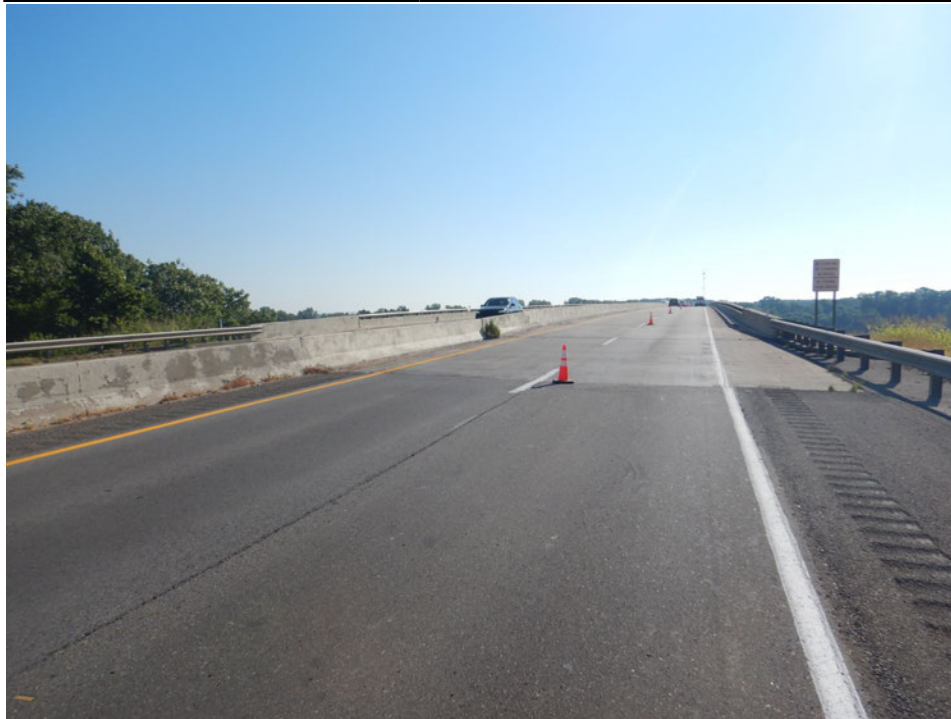
Photograph 1 - Looking east at the bridge end view.

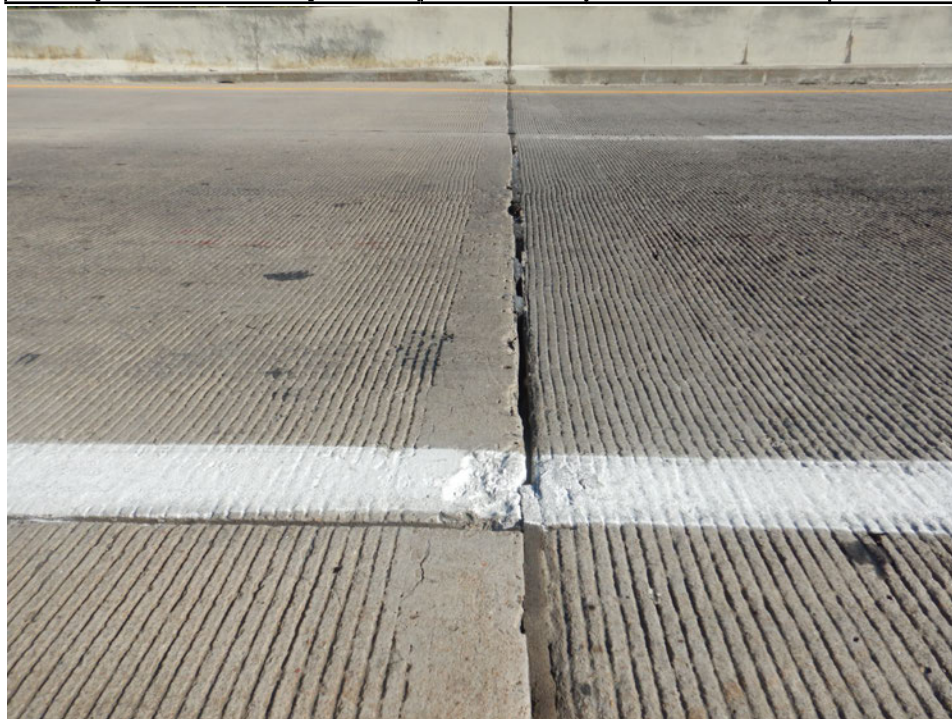
Photograph 4 - Looking north at the west abutment pourable joint. Note: 10 feet of joint seal is missing.

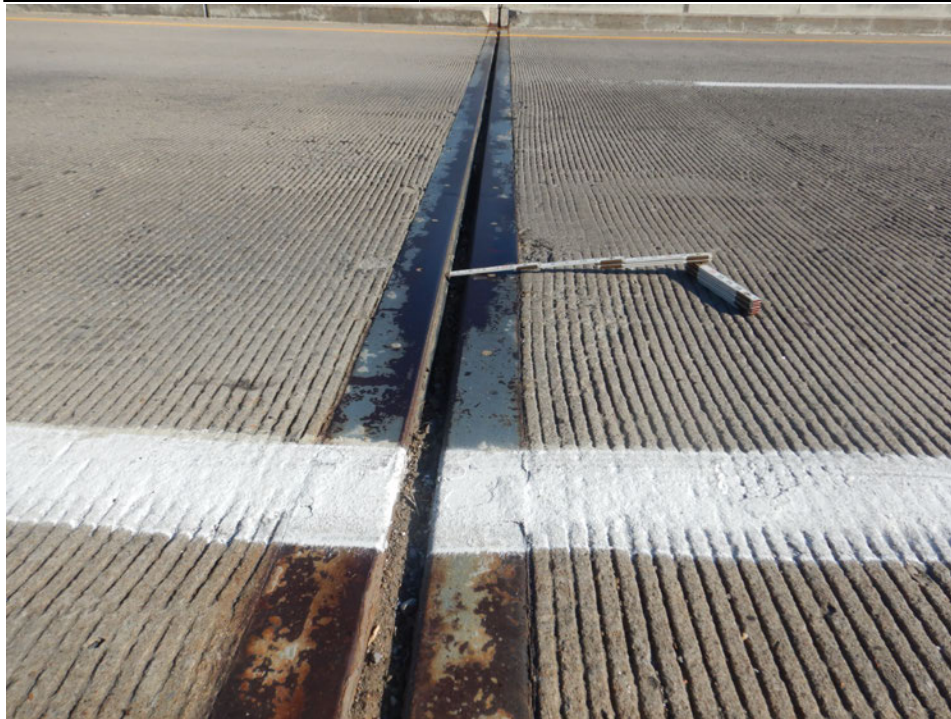
Photograph 5 - Looking north at the pier 1 expansion joint. Note: joint is filled with soil and open 1 1/2 inches.

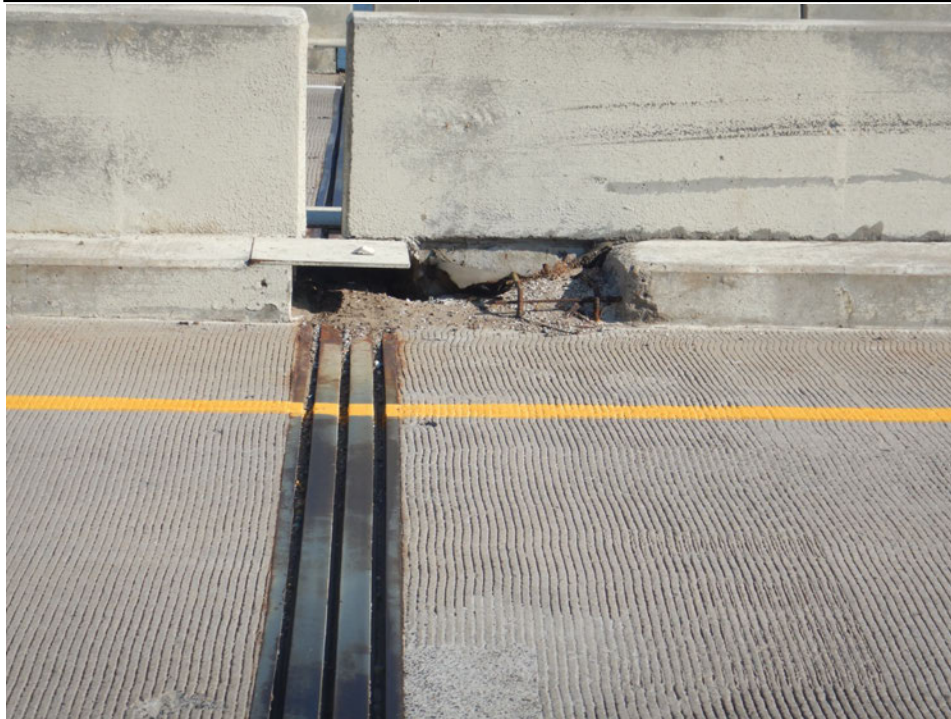
Photograph 6 - Looking north at the median curb at pier 3. Note: end 2 feet of curb is spalled with exposed reinforcement.

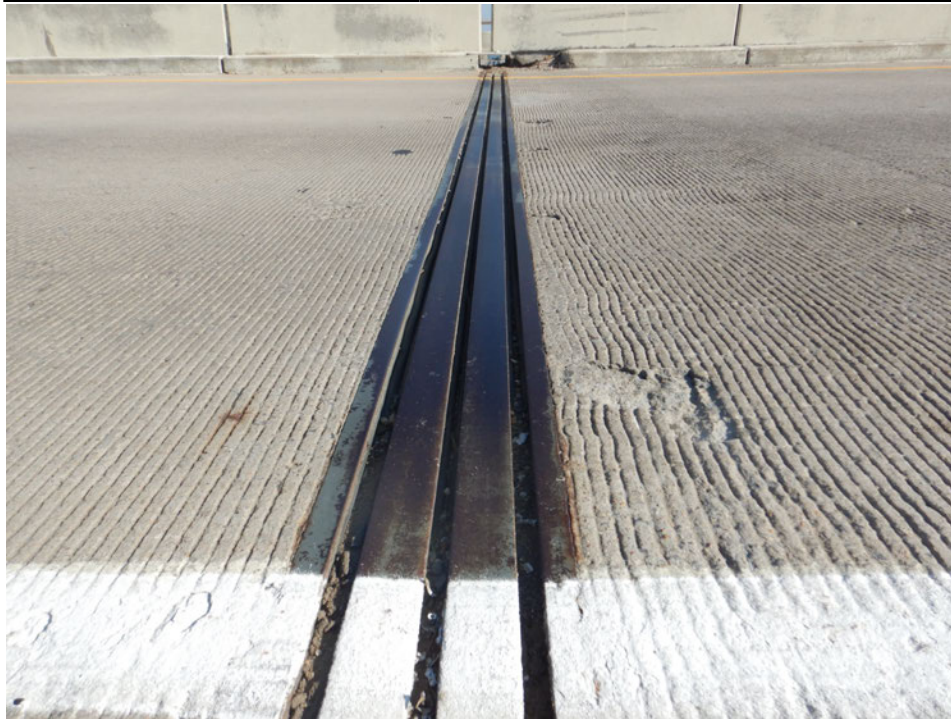
Photograph 7 - Looking north at the pier 3 modular joint. Note: west transverse bar is lifted 1/4-inch.

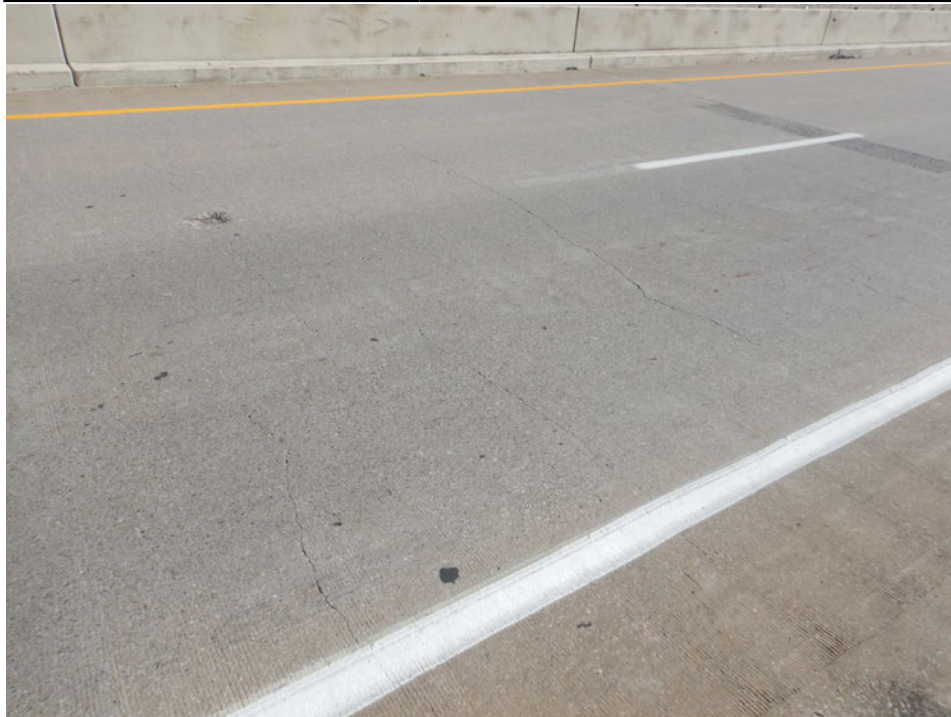
Photograph 8 - Looking northeast at the span 5 wearing surface. Note: transverse cracking spaced approximately 4 feet apart.

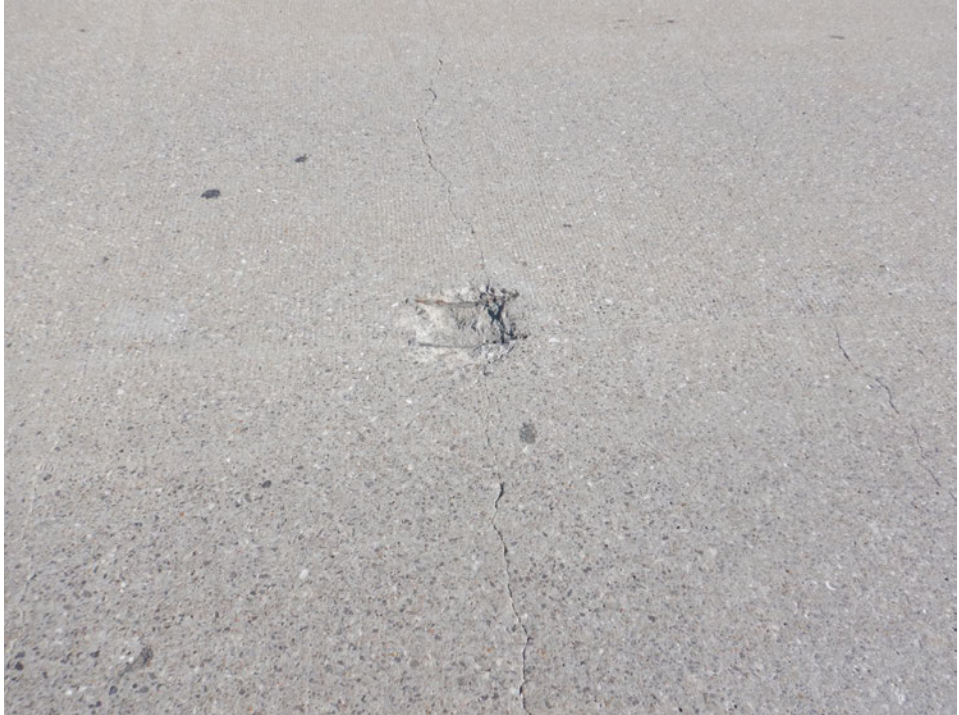
Photograph 9 - Looking north at the eastbound lanes in span 5. Note: 8-inch-diameter spall in the lane centerline.

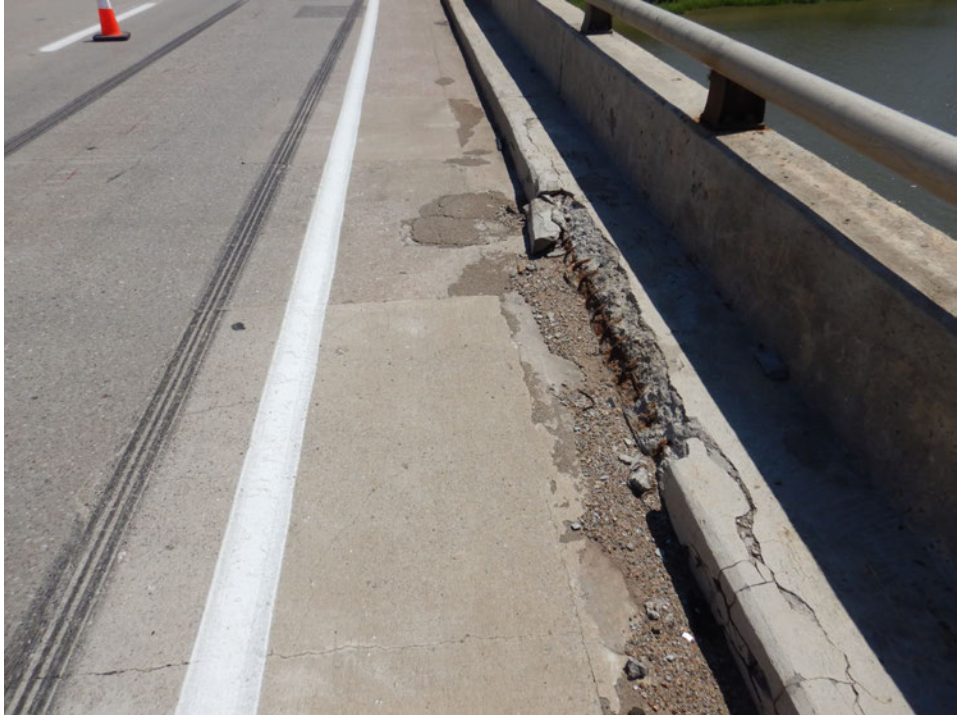
Photograph 10 - Looking east at the south curb of span 7 near pier 6. Note: two 6-foot-long spalls in the curb.

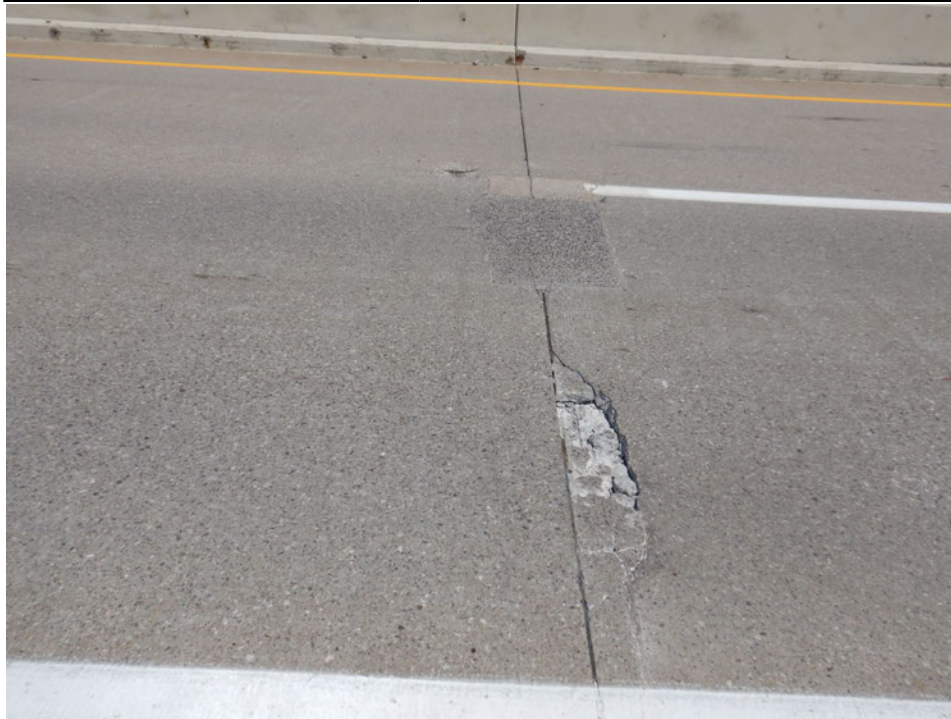
Photograph 11 - Looking north at the span 10 deck top at the deck control joint. Note: 1-foot-long x 2-foot-wide x 2 1/2-inch-deep spall in south wheel line of south eastbound lane.

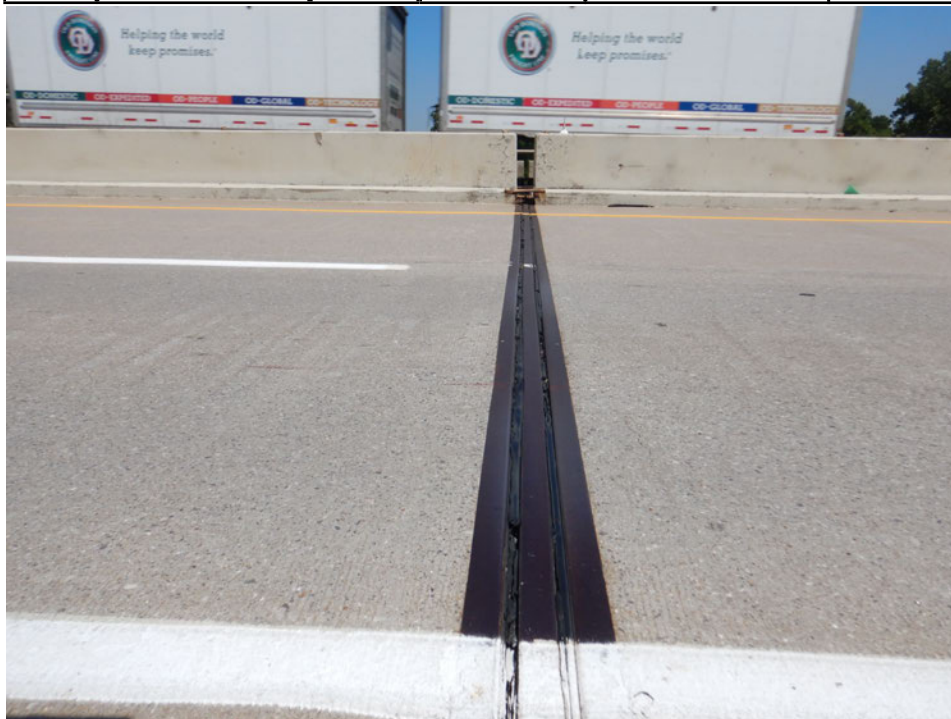
Photograph 12 - Looking north at the pier 10 joint. Note: joint open 3 3/4-inch at south curb. Joint seal torn for majority of joint.

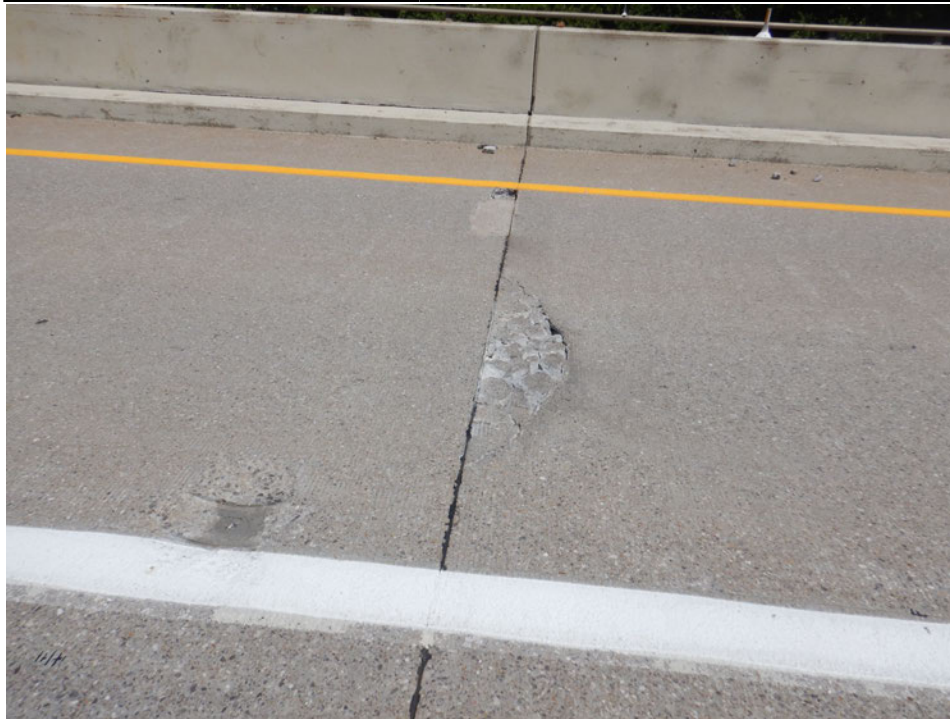
Photograph 13 - Looking north at the span 13 deck top at the deck control joint. Note: spall in the northern eastbound lane.

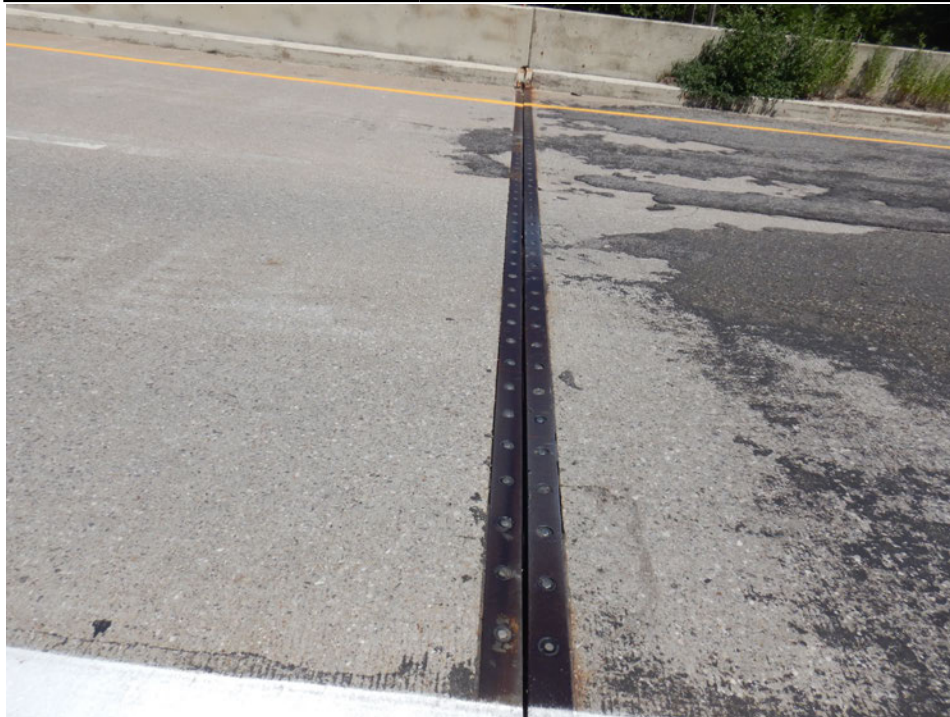
Photograph 14 - Looking north at the east abutment joint. Note: 1/2-inch vertical offset exists across the joint.

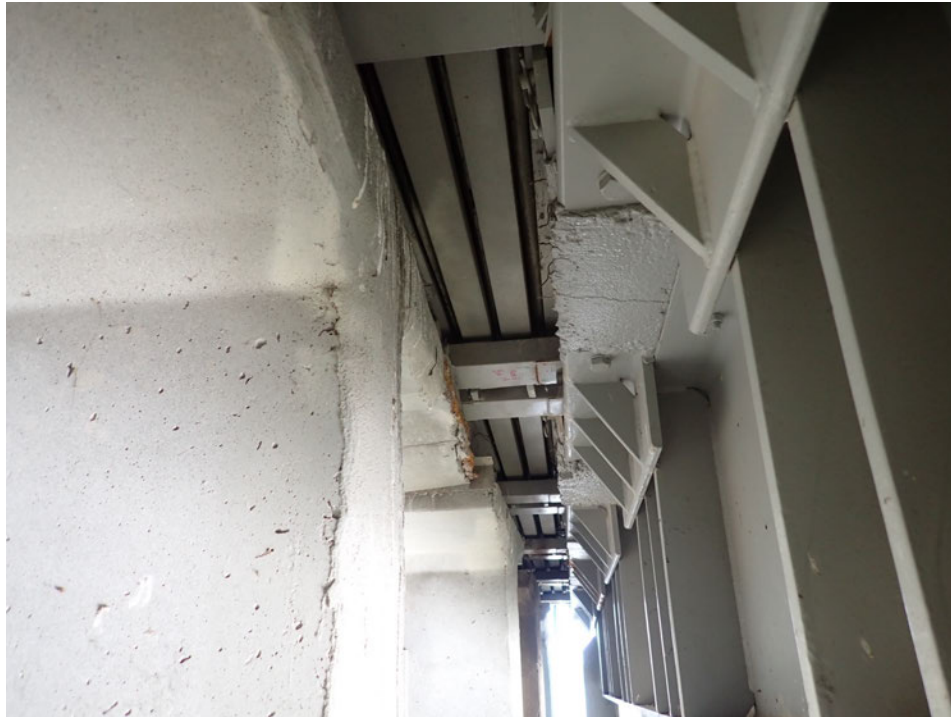
Photograph 15 - Looking north at the underside of the pier 3 joint. Note: typical condition of joint with no equidistant bars.

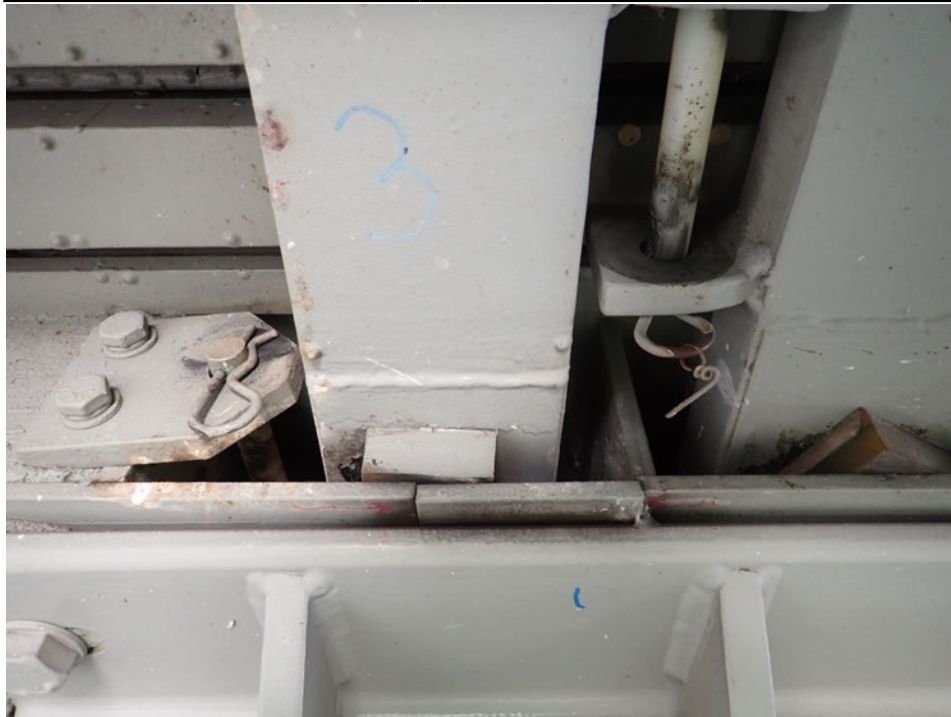
Photograph 16 - Looking east at support joint assembly 3 at the pier 3 modular joint. Note: both bottom plates of support boxes have fractured below the support bars.

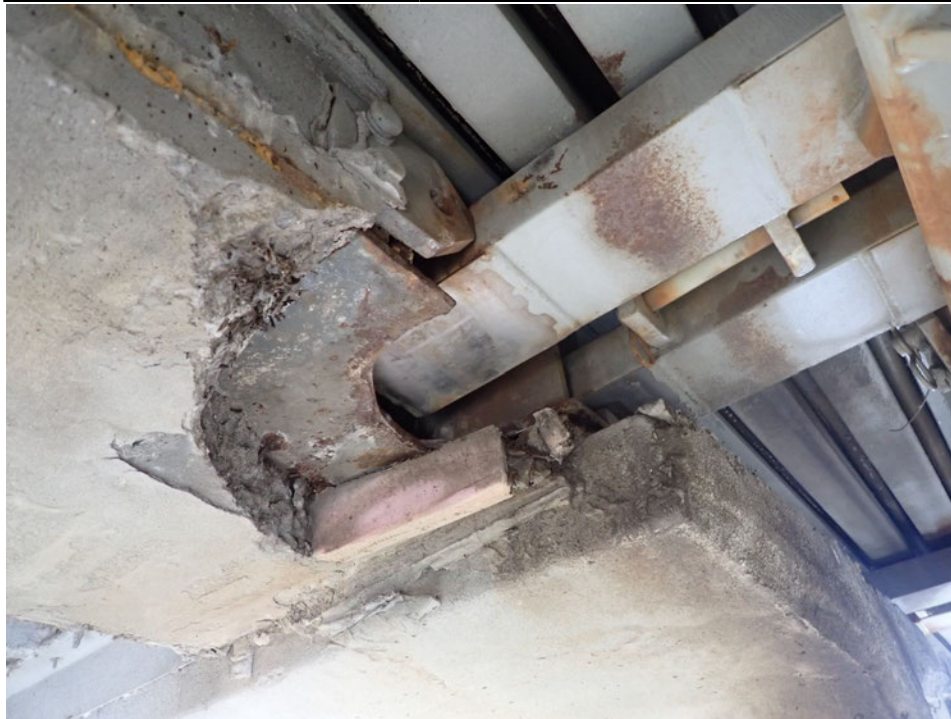
Photograph 17 - Looking northwest at support joint assembly 16 at the pier 3 modular joint. Note: west bottom plate of the support box and the 3-inch-thick unreinforced concrete pour below the support box have fractured and are no longer supporting the south support bar.

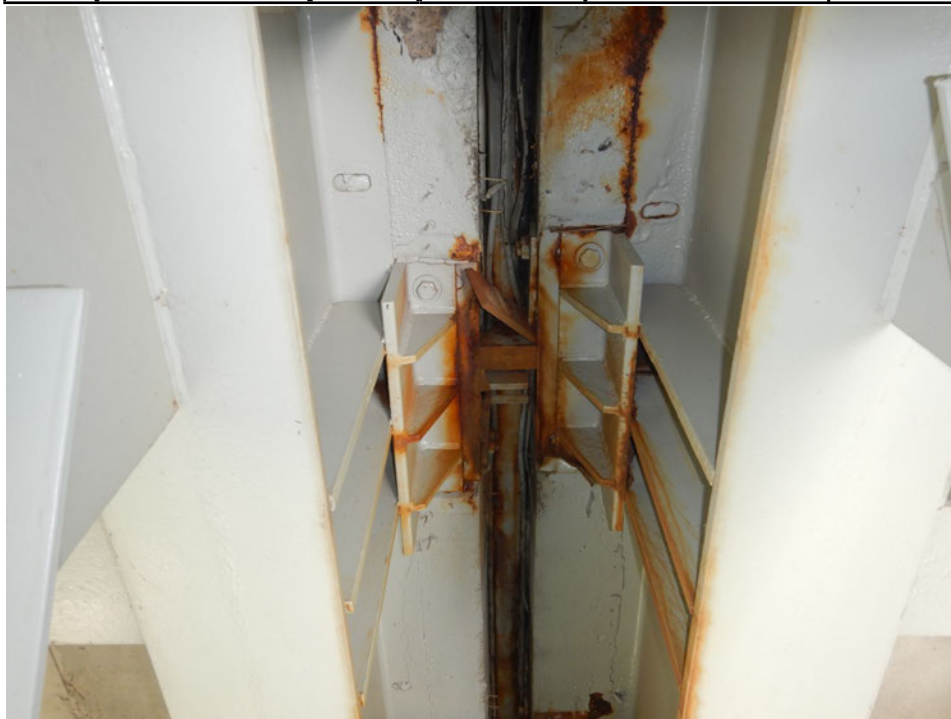
Photograph 18 - Looking north at support assembly 10 at the pier 6 modular joint. Note: no change to the one dislodged control bar.

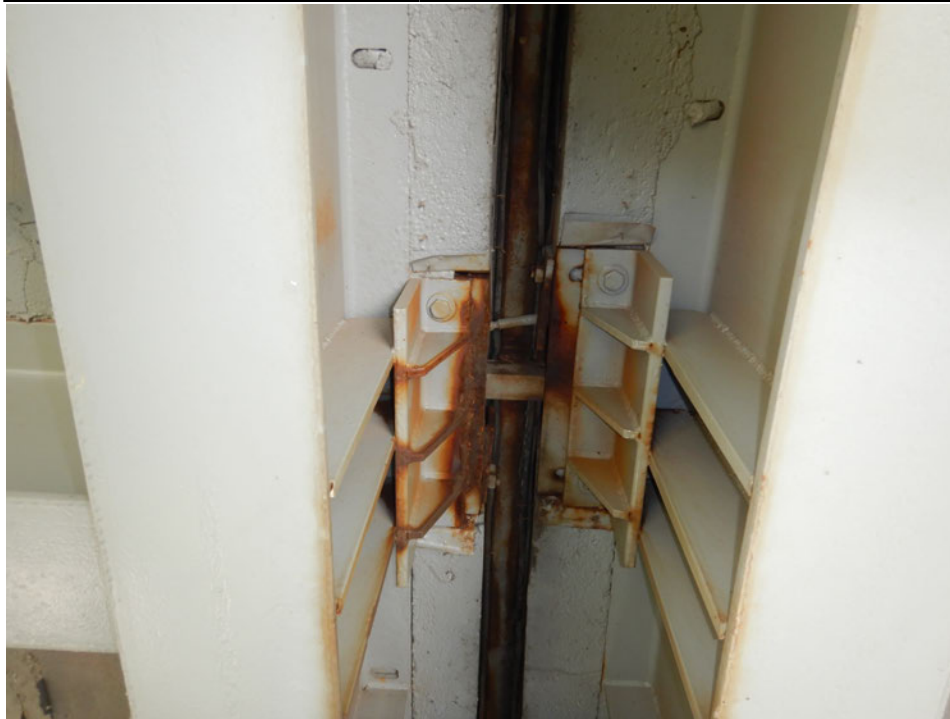
Photograph 19 - Looking north at support assembly 12 at the pier 6 modular joint. Note: no change to the missing control bars.

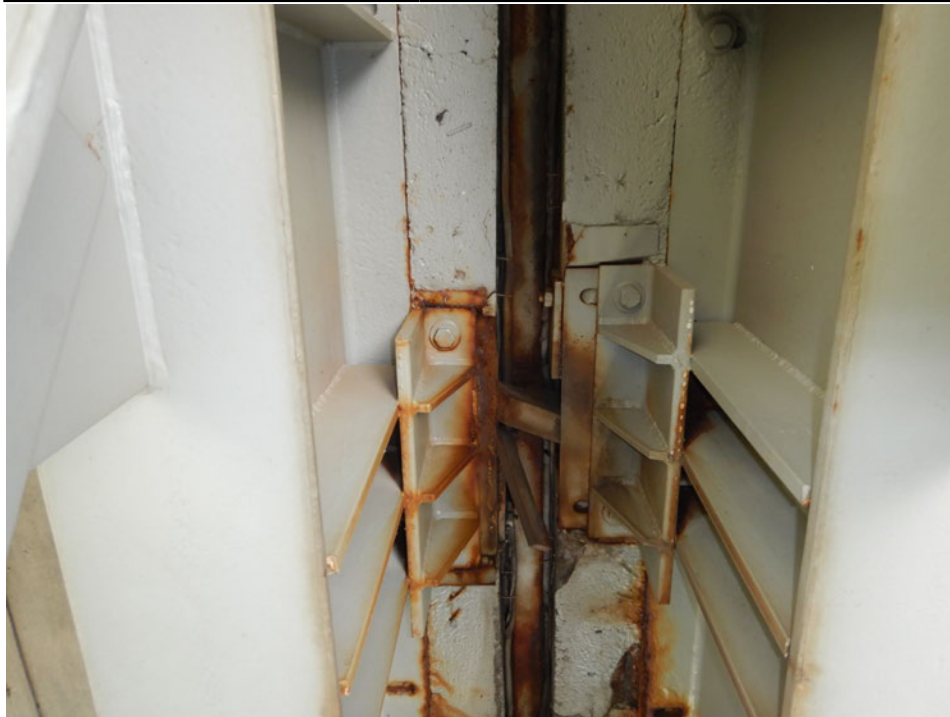
Photograph 20 - Looking north at support assembly 13 at the pier 6 modular joint. Note: one control bar is dislodged and one control bar is missing the transverse separation beam is bent and fractured.

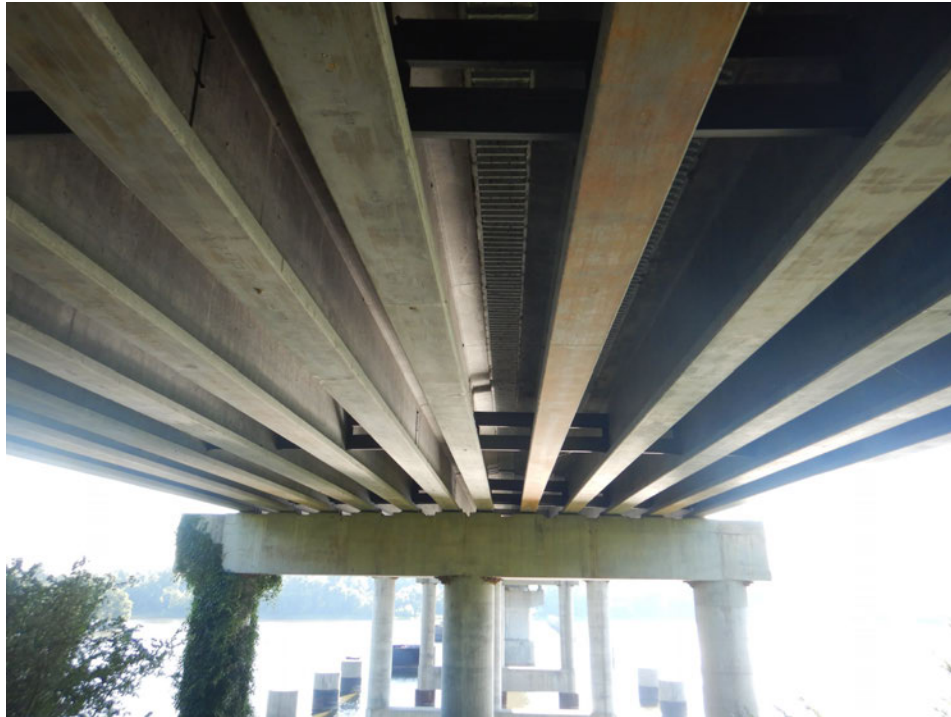
Photograph 21 - Looking east at the underside of span 1. Note: no significant deficiencies.

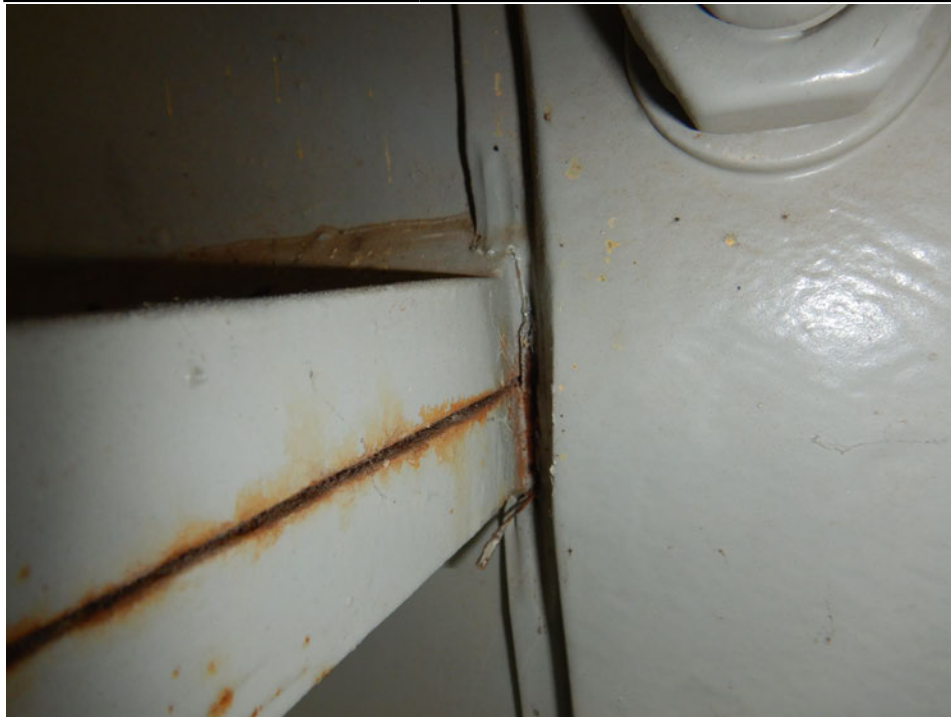
Photograph 22 - Looking south at girder 1, span 4 at end of horizontal splice near floor beam 5. Note: weld appears to be splintering. No crack observed.

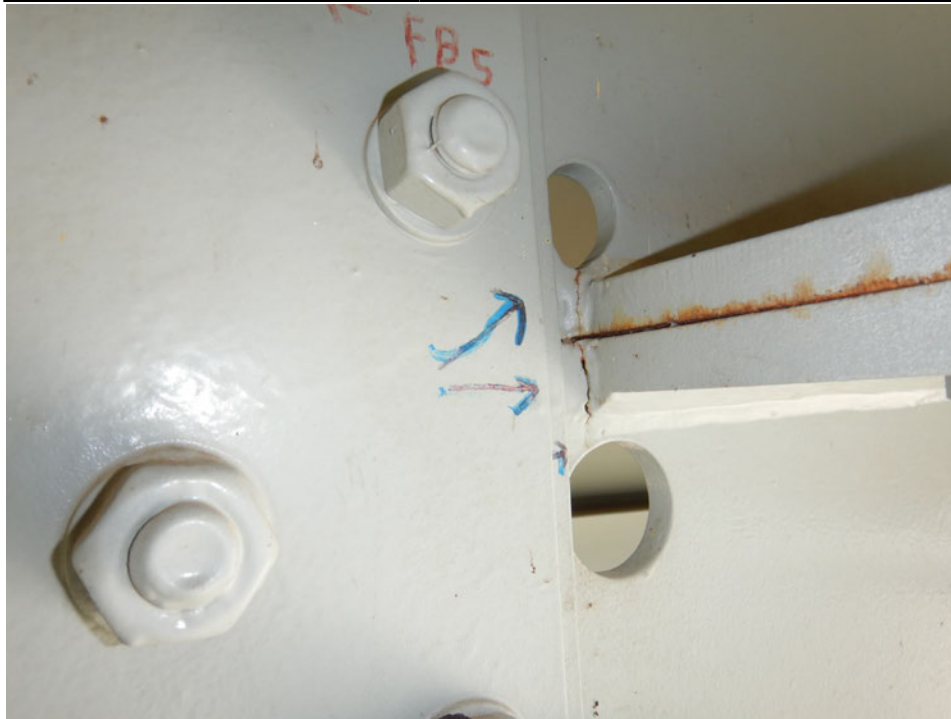
Photograph 23 - Looking northeast at girder 2, span 4 at end of horizontal splice near floor beam 5. Note: no change to crack at end of horizontal splice.

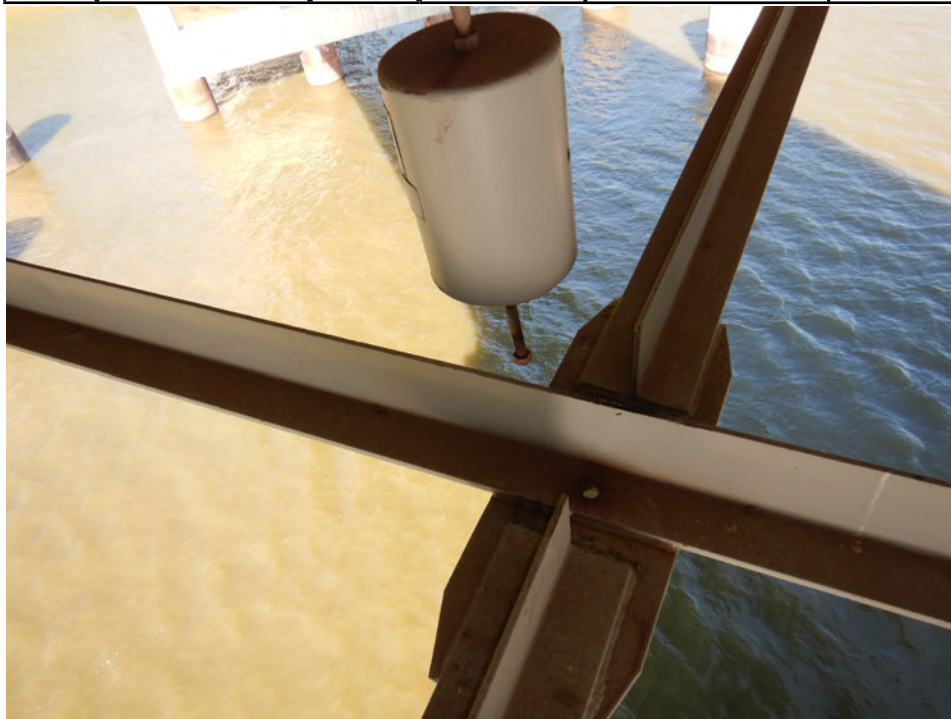
Photograph 24 - Looking northwest at lower lateral bracing dampener in span 4 between girders 1 and 2 and between floor beams 7 and 8. Note: dampener not connected to lower lateral bracing.

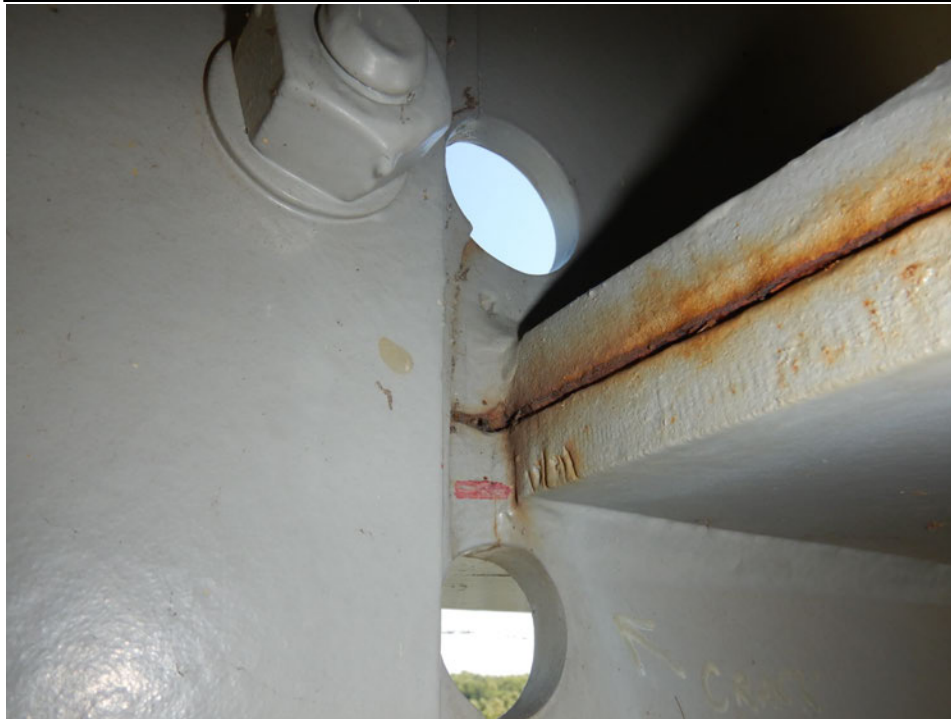
Photograph 25 - Looking north at girder 4, span 4 at end of horizontal splice near floor beam 5. Note: no change to crack in web of girder. Crack arrested by drilled holes.

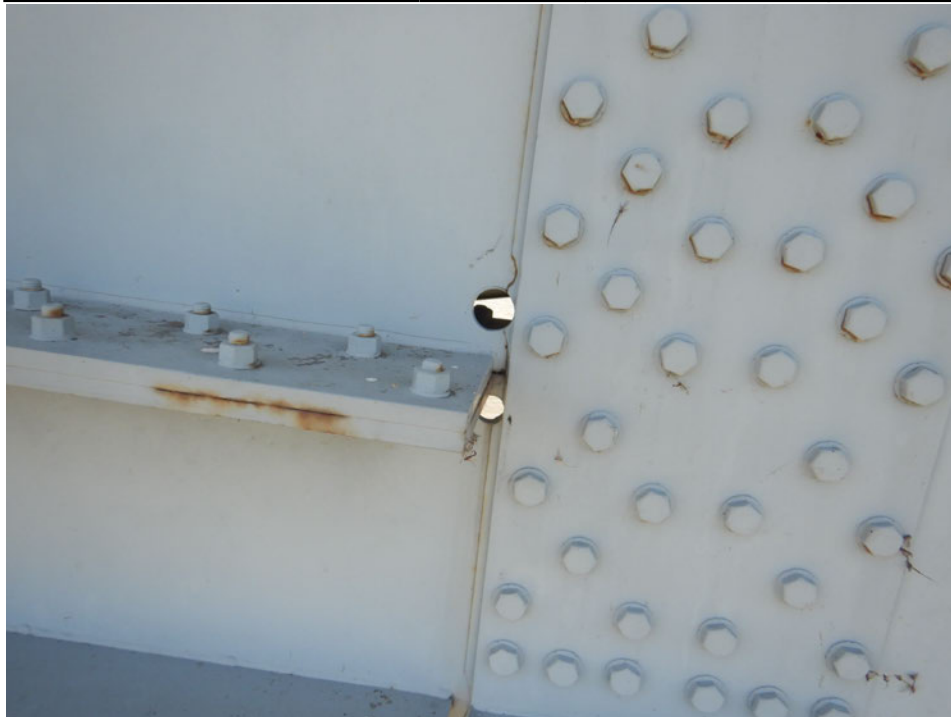
Photograph 26 - Looking south at end of the longitudinal stiffener for girder 4, span 4 near floor beam 5. Note: no change to crack in lower web arrested by drilled hole.

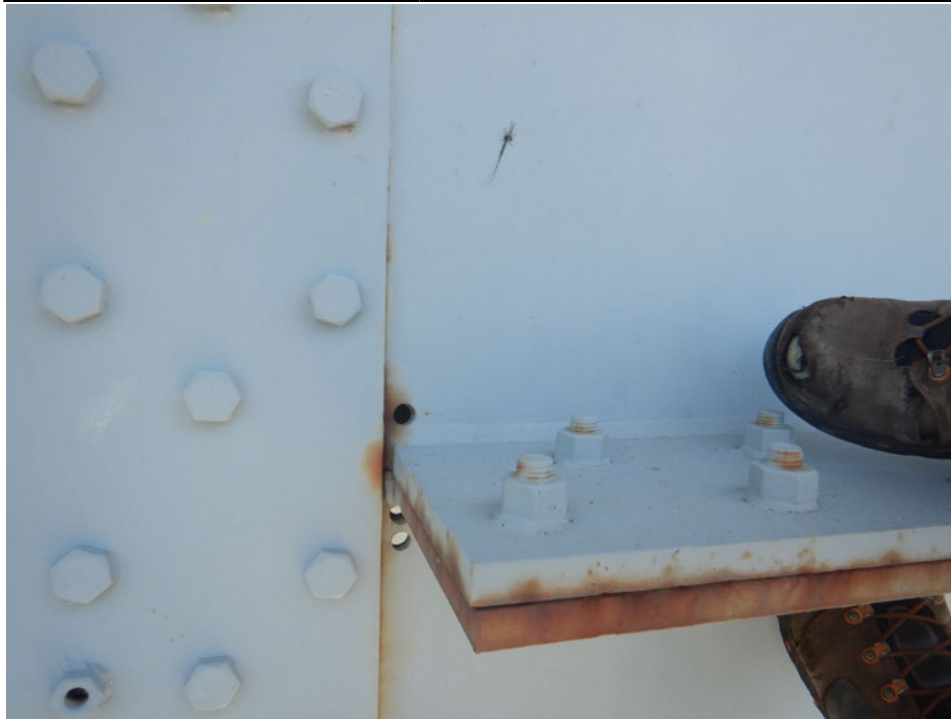
Photograph 27 - Looking north at the exterior face of girder 1, span 5 at floor beam 11. Note: upper web contains a 3/4-inch-long crack stopping short of the arrestor hole. Crack in bottom web is 1 1/4-inches-long and is arrested by two 1/2-inch-diameter drilled holes.

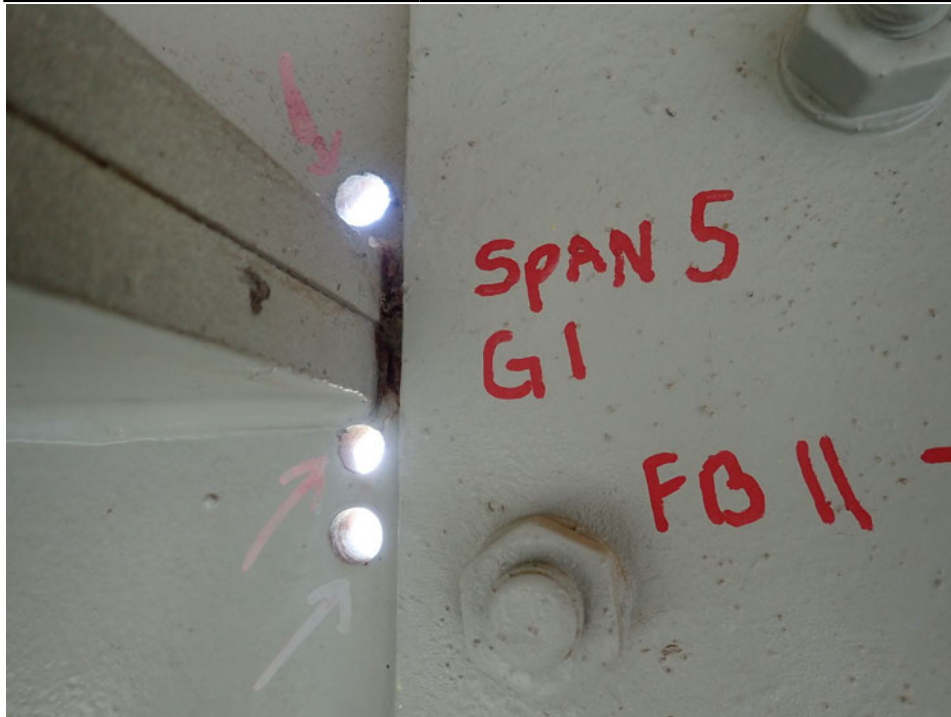
Photograph 28 - Looking south at the end of the longitudinal stiffener for girder 1, span 5 near floor beam 11. Note: no change to crack in upper web stopping short of the arrestor hole. No change to crack in lower web arrested by two 1/2-inch diameter drilled holes.

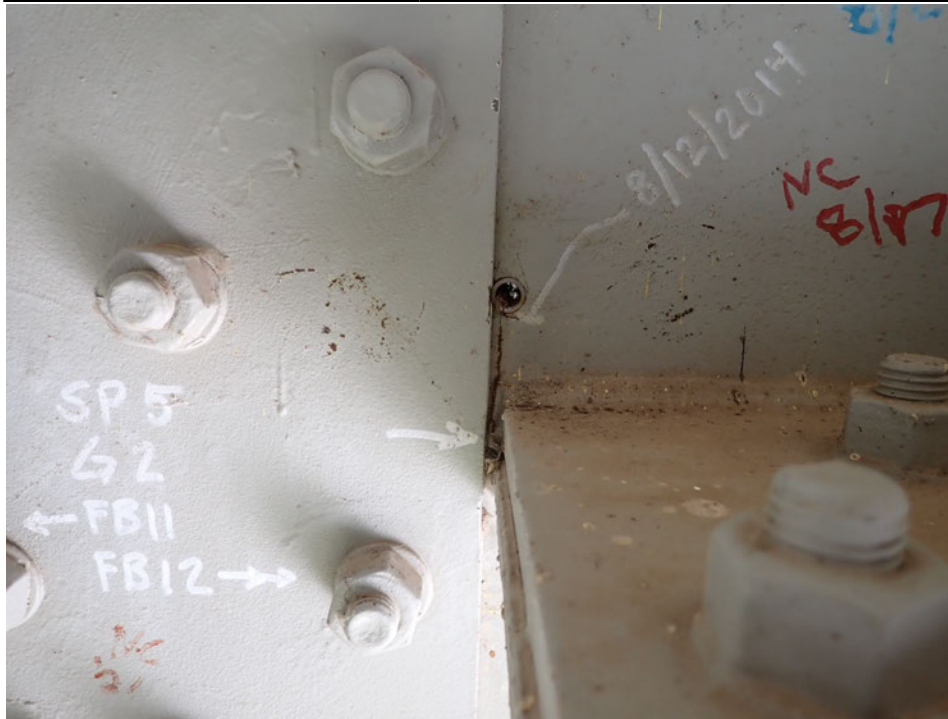
Photograph 29 - Looking north at girder 2, span 5 near floor beam 11. Note: no change to 2-inch-long crack retrofitted with crack arrested bushing in the upper web.

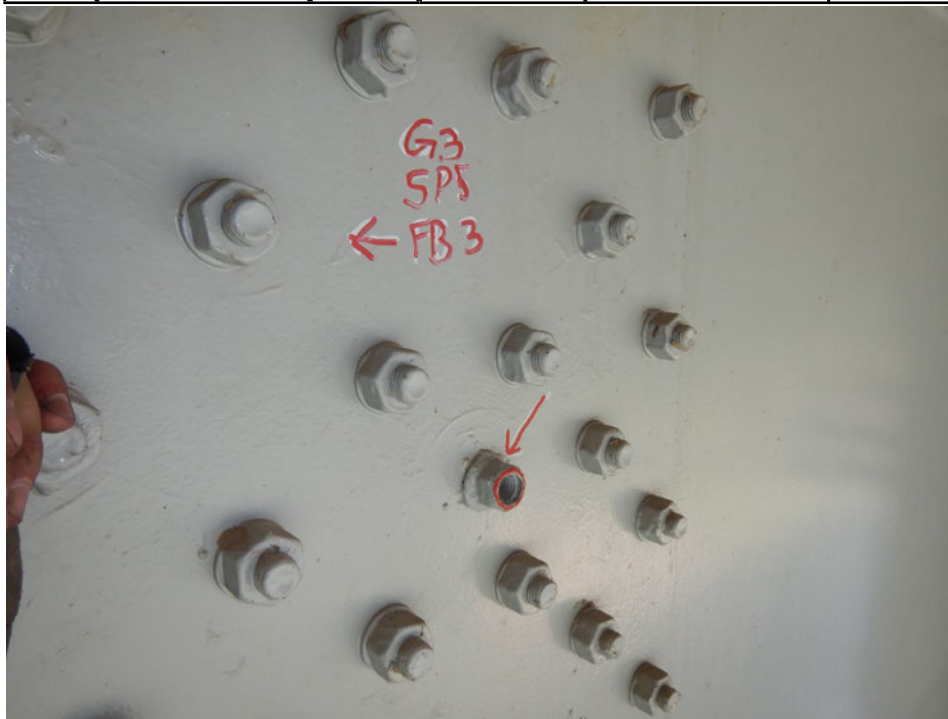
Photograph 30 - Looking south at girder 3, span 5 horizontal splice near floor beam 3. Note: missing bolt in the web of the girder.

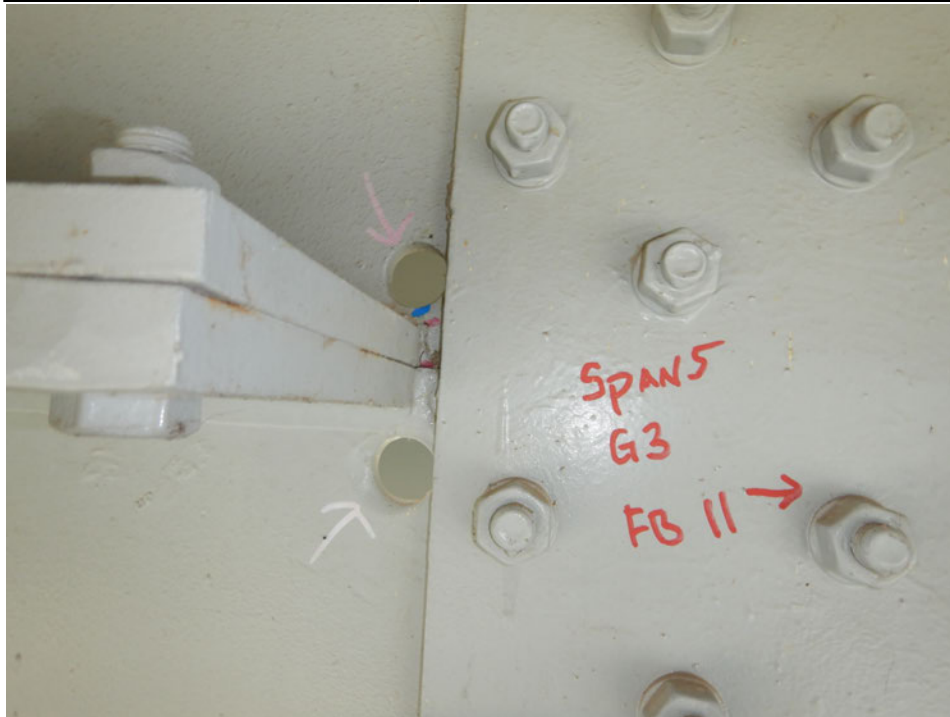
Photograph 31 - Looking south at the interior face of girder 3, span 5 near floor beam 11. Note: no change to crack at end of horizontal web splice, crack is still stopped short of arrest hole.

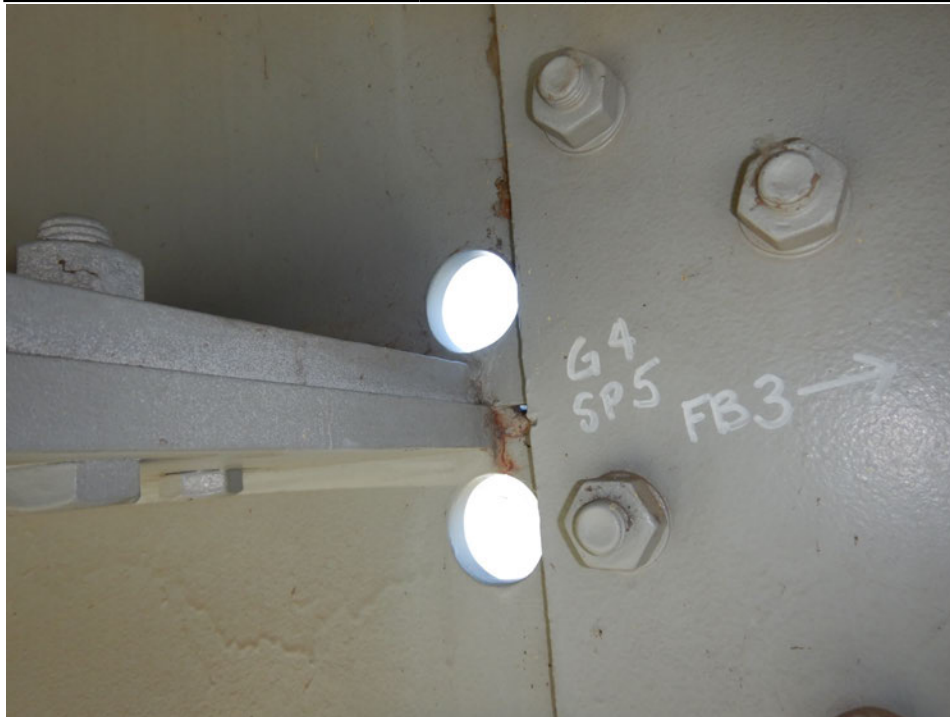
Photograph 32 - Looking north at girder 4, span 5 horizontal splice near floor beam 3. Note: crack present with arresting holes in pace. Crack has not jumped the arresting holes.

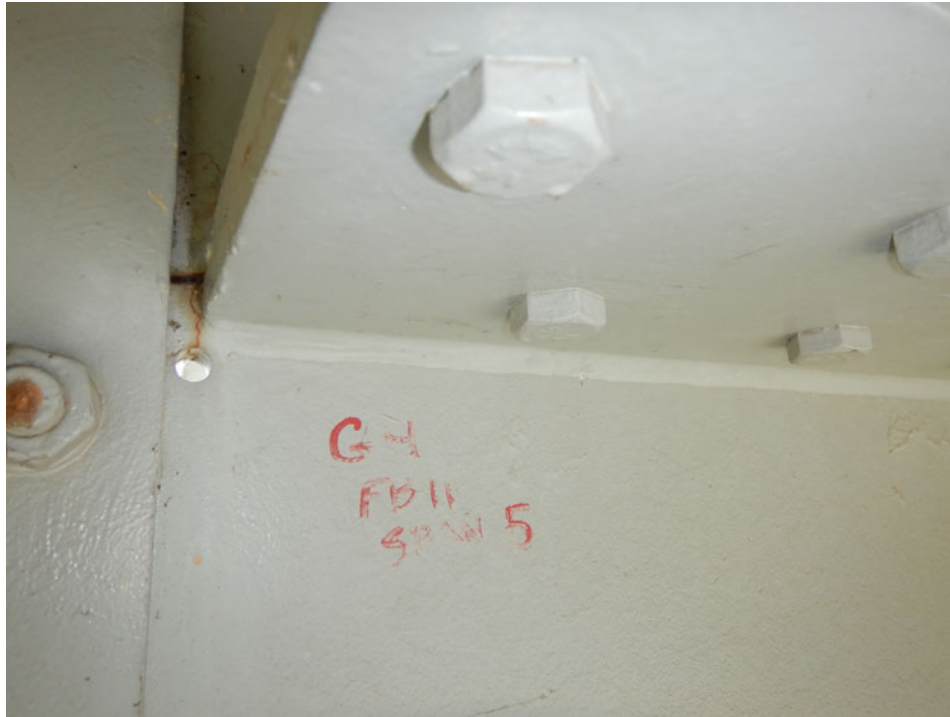
Photograph 33 - Looking north at the interior face of girder 4, span 5 near floor beam 11. Note: no change to crack with arrest hole at end of horizontal web splice.

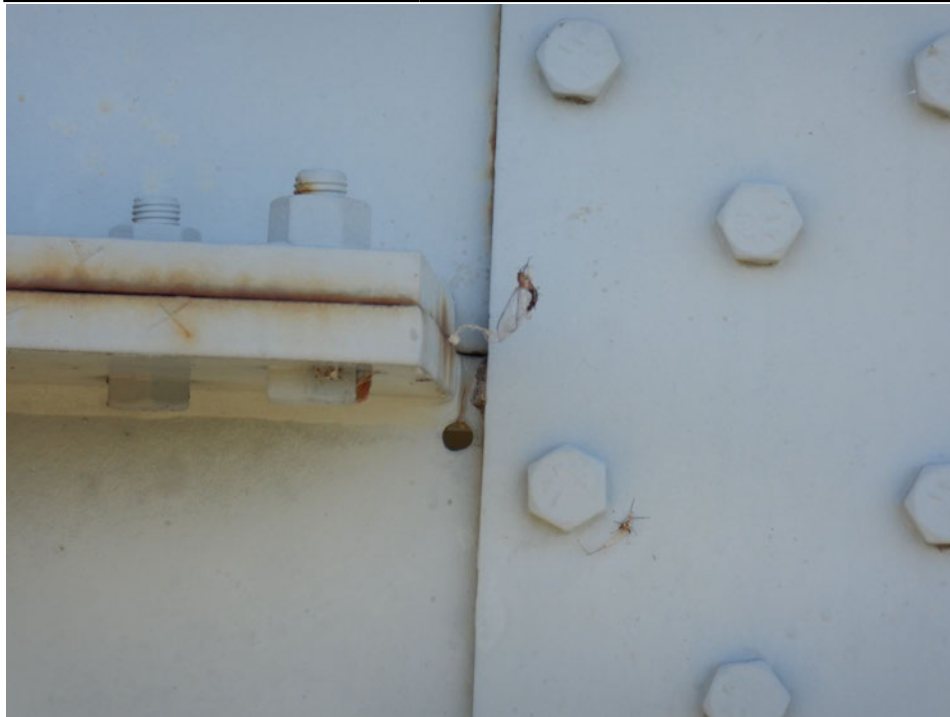
Photograph 34 - Looking south at end of the longitudinal stiffener for girder 4, span 5 near floor beam 11. Note: no change to crack in lower web arrested with a drilled hole.
