Other Special Bridge Inspection Report

NBI Bridge No.: 17051

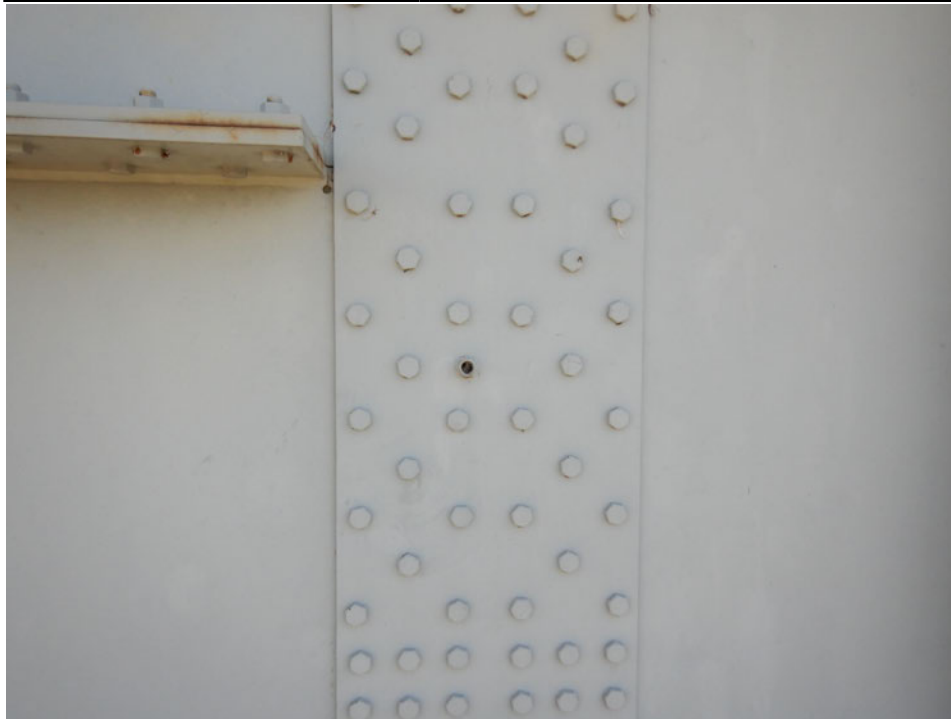
Photograph 35 - Looking south at the exterior face of the field splice for girder 4, span 5 near floor beam 11. Note: missing bolt in web splice.

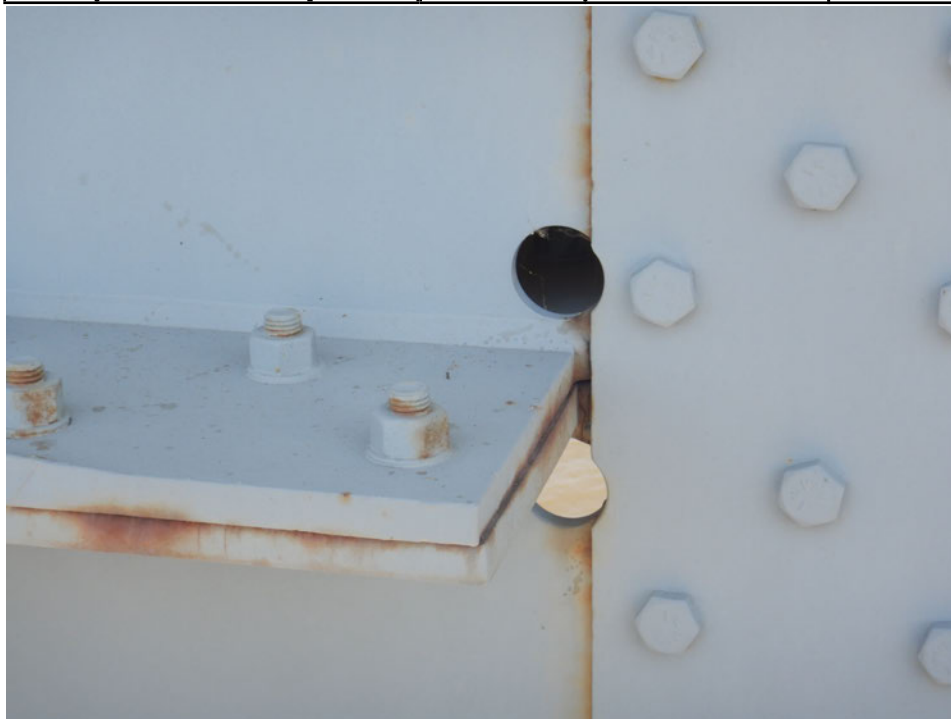
Photograph 36 - Looking north at the exterior face of girder 1, span 6 at floor beam 3. Note: two vertical cracks at the end of the longitudinal splice plates arrested in 2-inch-diameter holes.

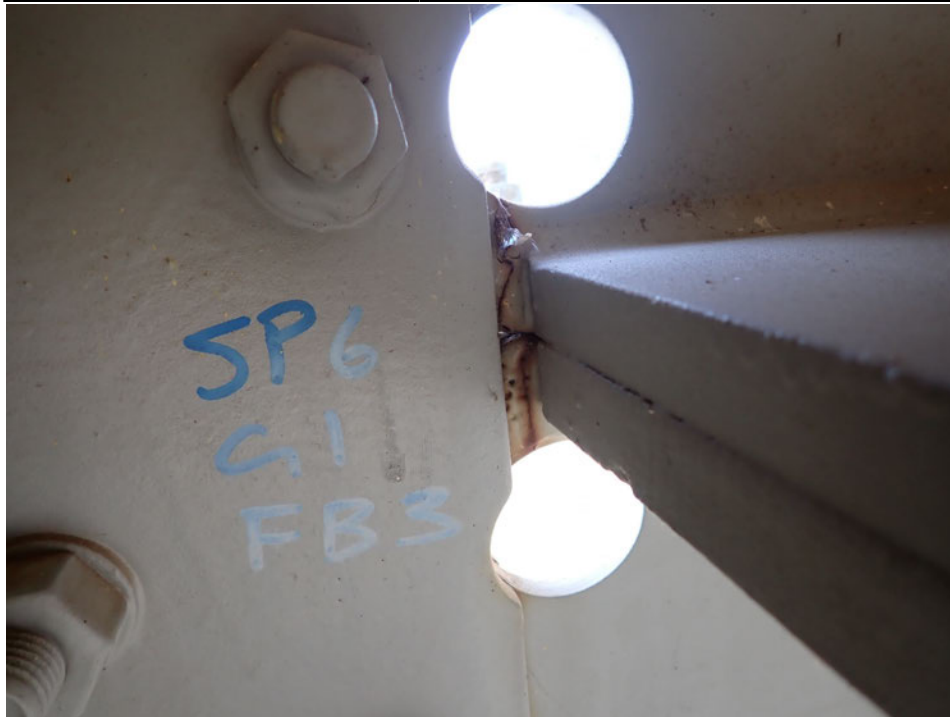
Photograph 37 - Looking south at the end of the longitudinal stiffener for girder 1, span 6 near floor beam 3. Note: no change to two cracks arrested by 2-inch-diameter arrestor holes.

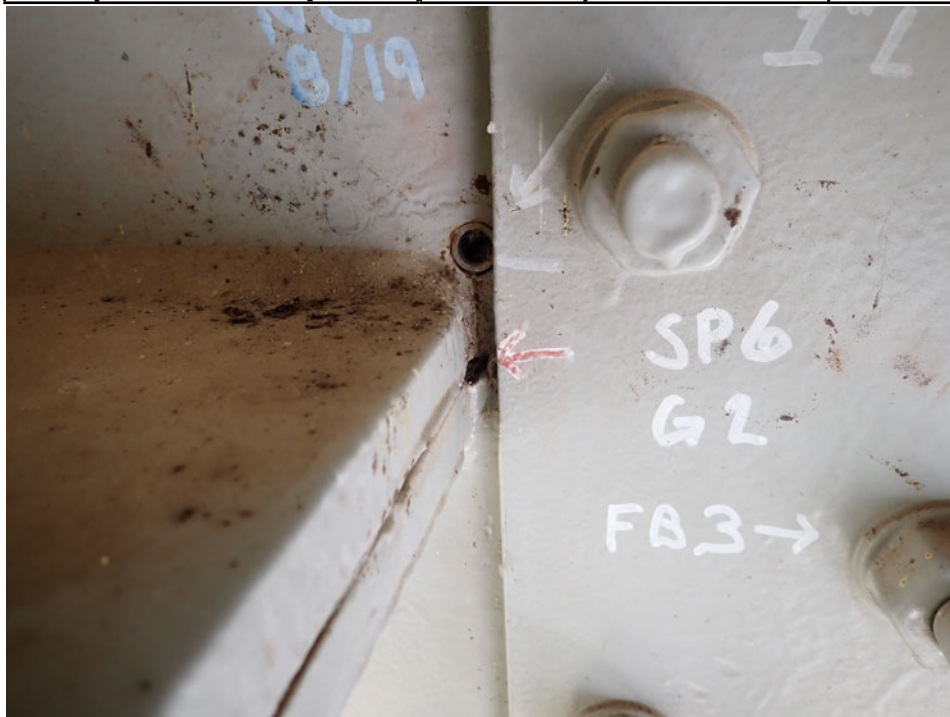
Photograph 38 - Looking north at end of the longitudinal stiffener of girder 2, span 6 near floor beam 3. Note: no change to crack in upper web retrofitted with a crack arrest bushing.

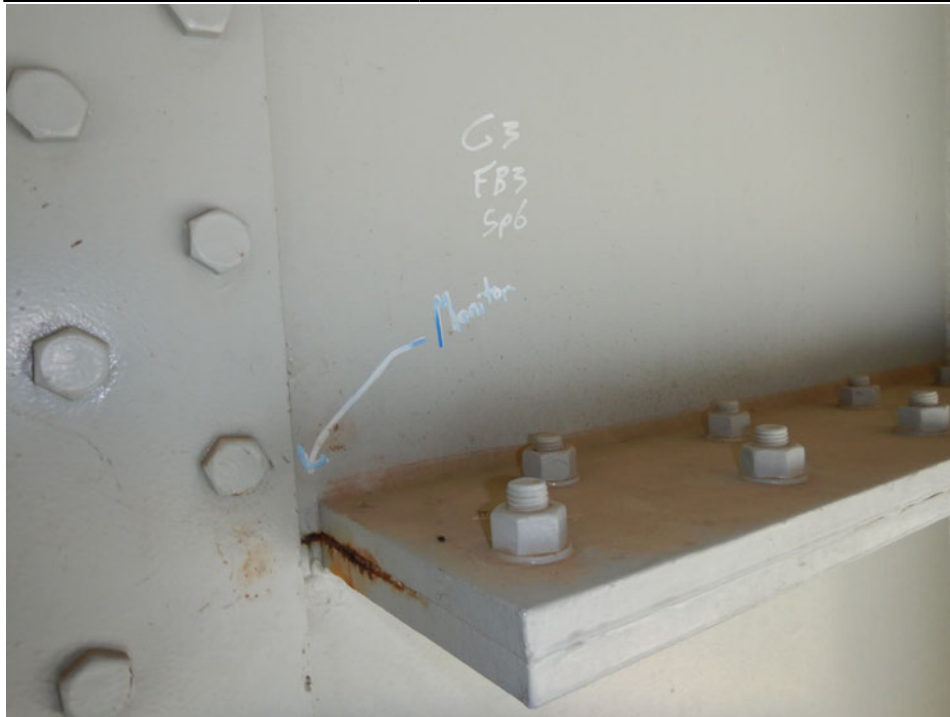
Photograph 39 - Looking south at the interior face of girder 3, span 6 near floor beam 3. Note: no change to paint crack at end of horizontal web splice.

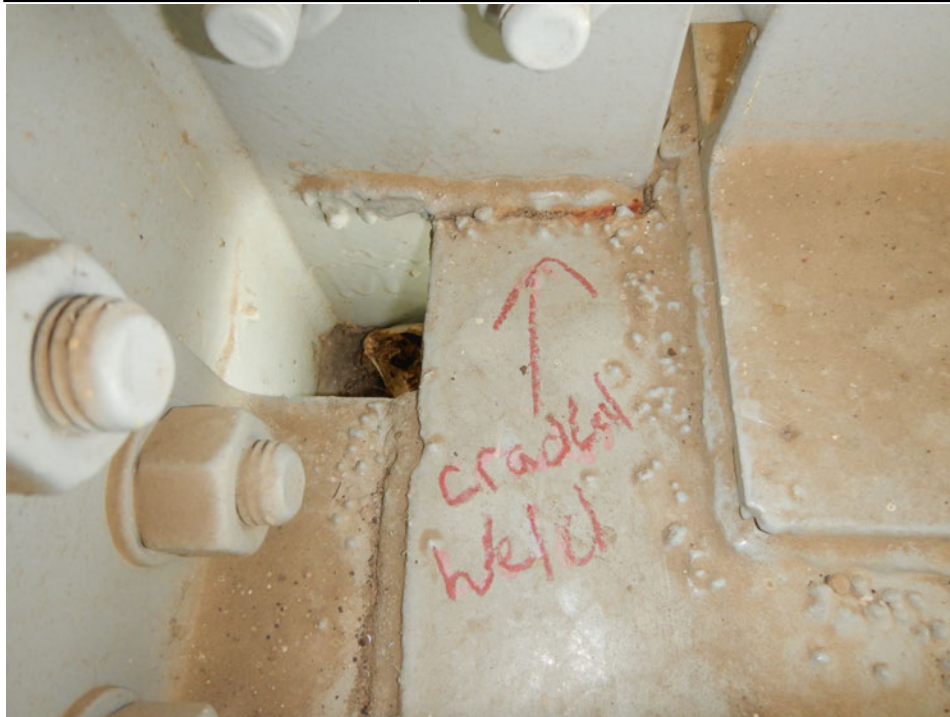
Photograph 40 - Looking west at the lower lateral bracing gusset plate connection to girder 3, span 6 at floor beam 5. Note: no change to crack along weld of the east face of the vertical stiffener to the lower lateral gusset plate.

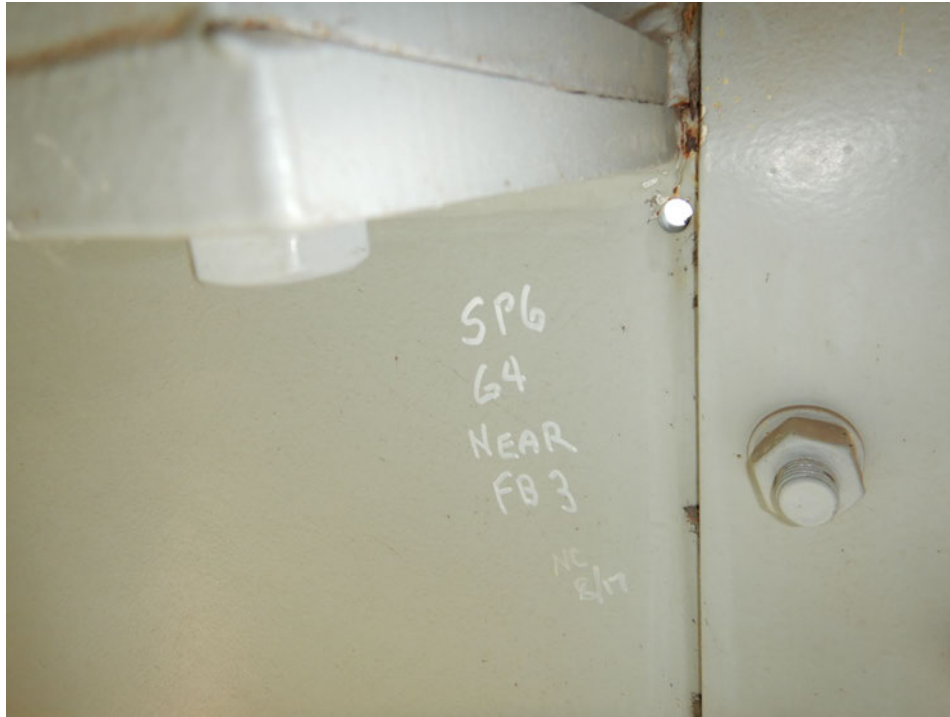
Photograph 41 - Looking north at the interior face of girder 4, span 6 near floor beam 3. Note: no change to crack with arrest hole at end of horizontal web splice.

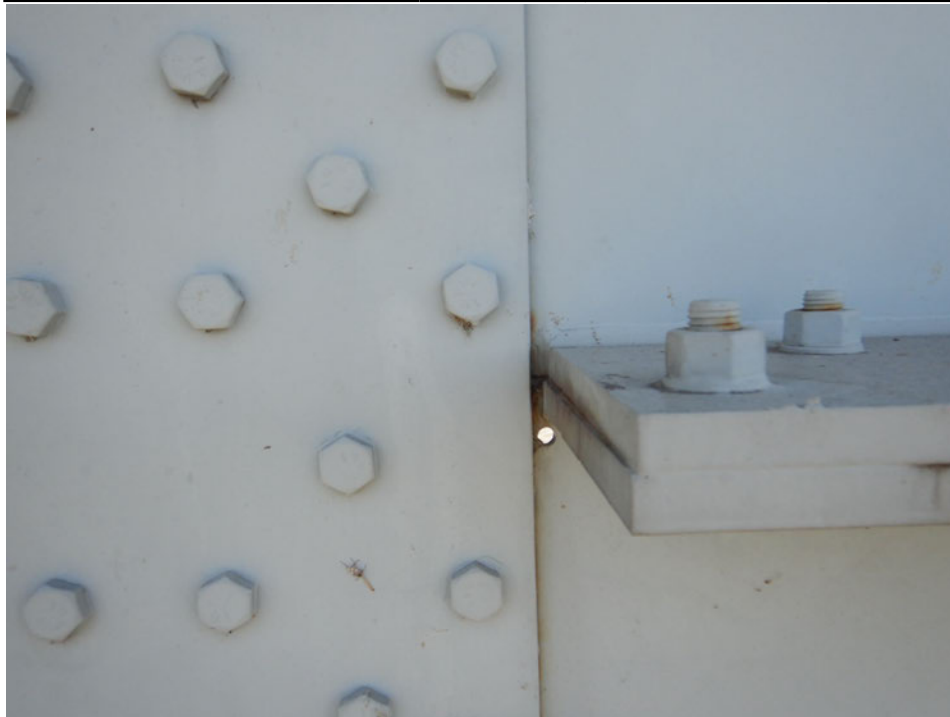
Photograph 42 - Looking south at the end of the longitudinal stiffener of girder 4, span 6 near floor beam 3. Note: 1 1/4-inch-long crack arrested in drilled holes.

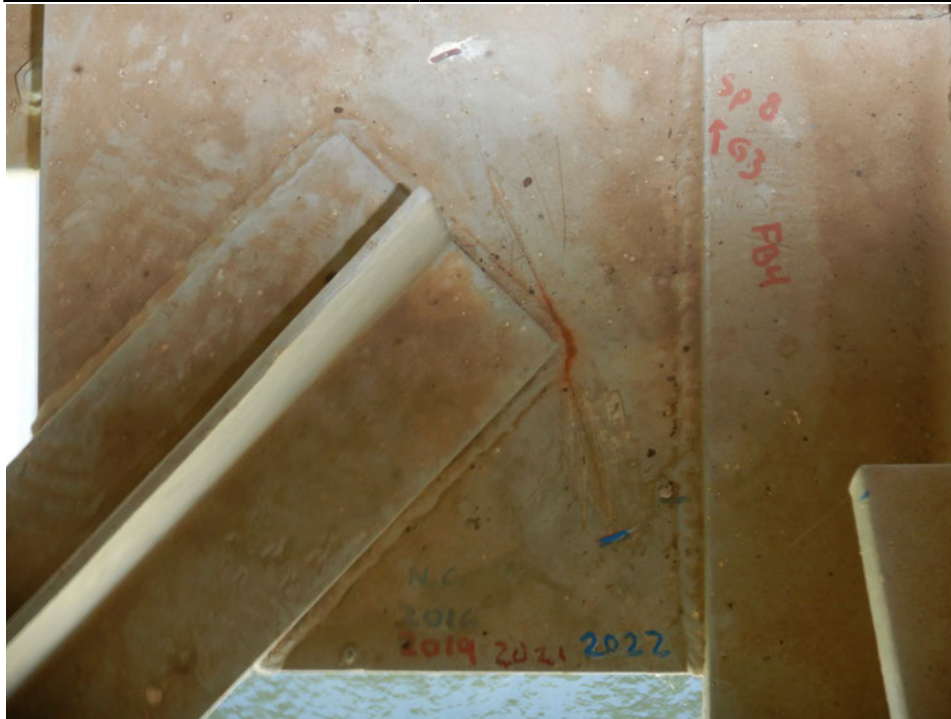
Photograph 43 - Looking south at the lower lateral bracing gusset plate for floor beam 4 at girder 3, span 8. Note: no change to cracks at lower lateral gusset plate connection to lateral bracing members.

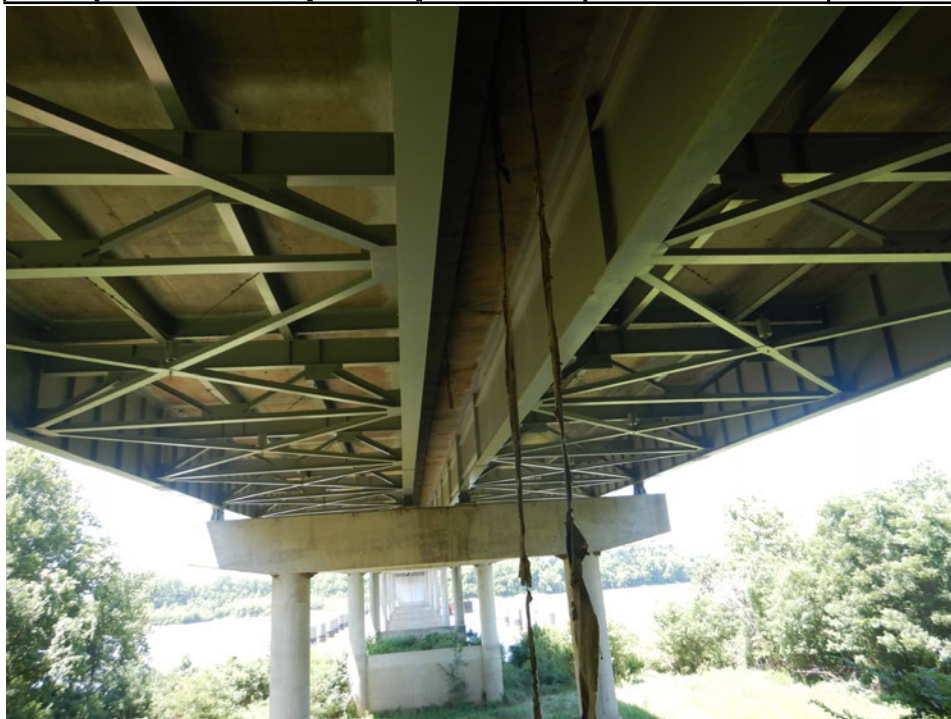
Photograph 44 - Looking west at the underside of framing in span 13. Note: no significant deficiencies.

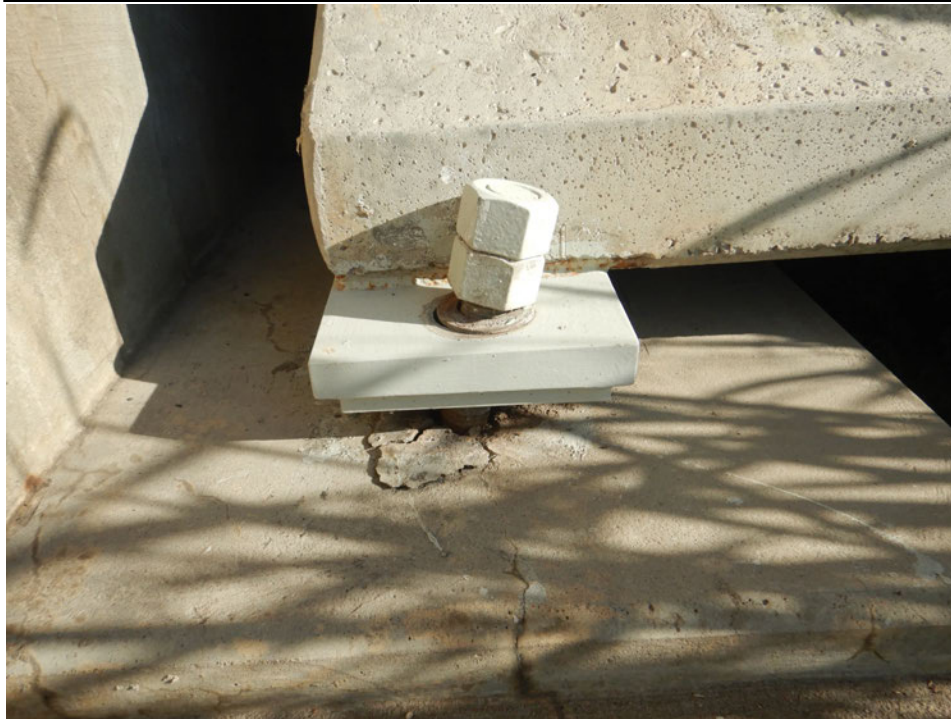
Photograph 45 - Looking north at beam 1 at the west abutment. Note: bent anchor bolt.

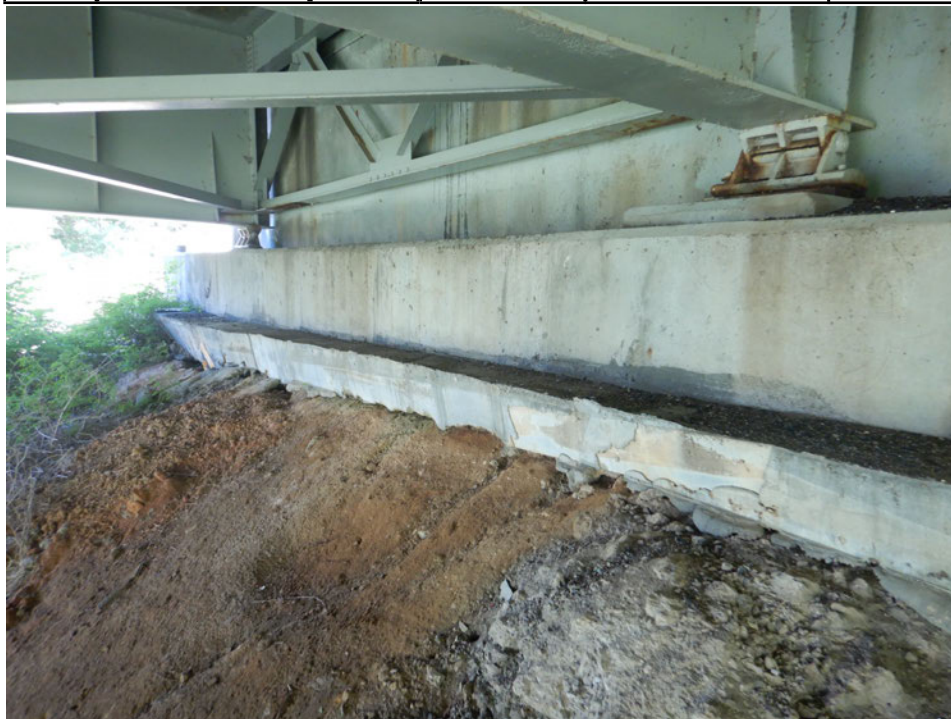
Photograph 52 - Looking northeast at the east abutment. Note: no significant deficiencies.

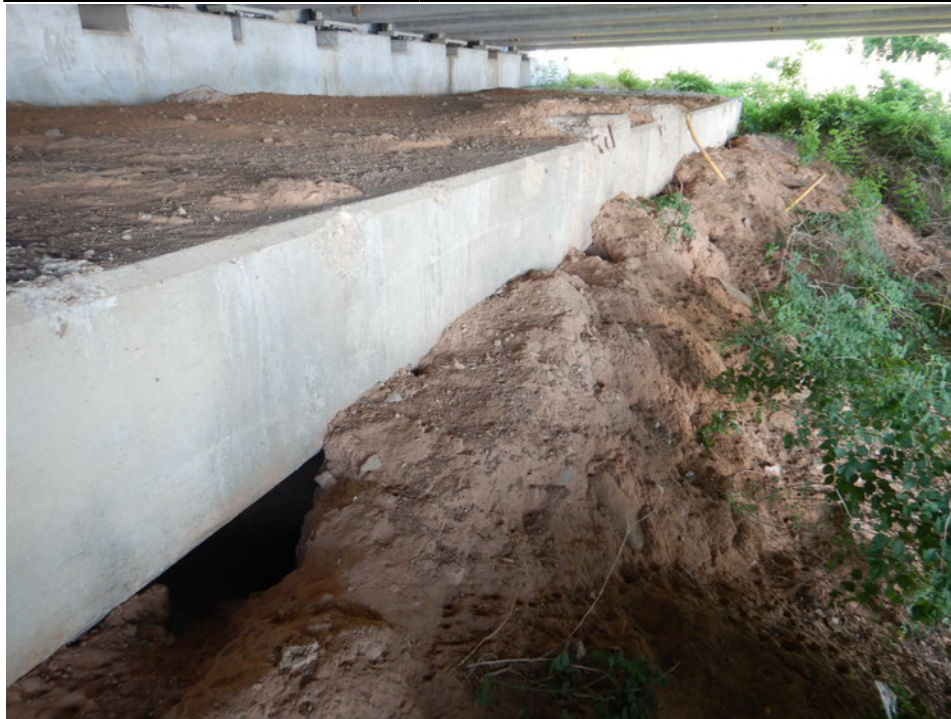
Photograph 53 - Looking north at the west abutment breastwall. Note: multiple erosion holes undermine the abutment up to 3 feet under beams 3, 5, and 7.

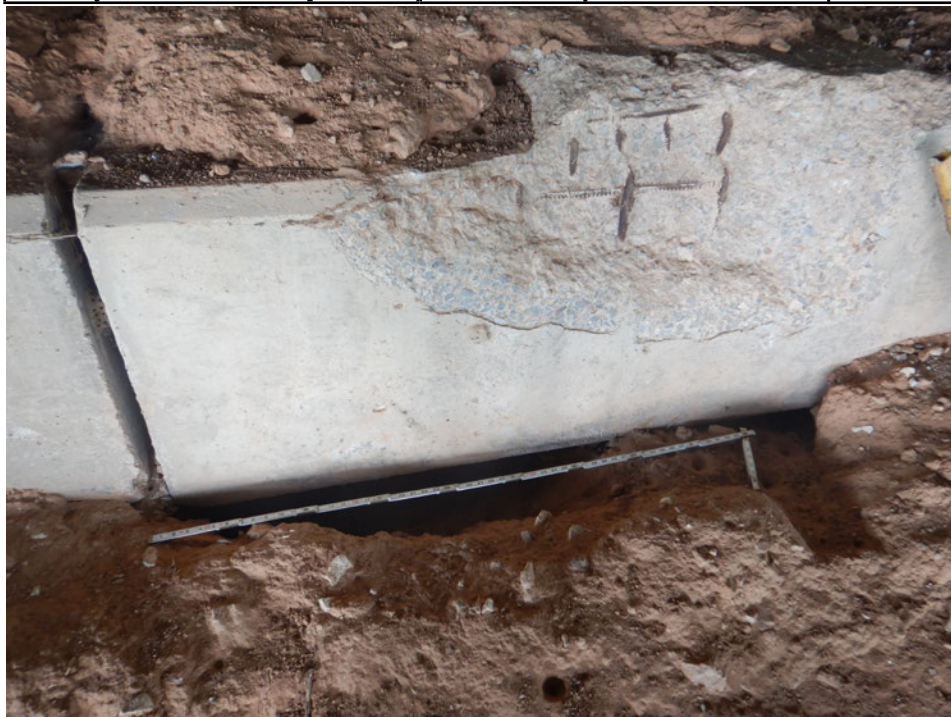
Photograph 56 - Looking west at the west abutment under beam 7. Note: 2-foot-deep erosion hole with 18 inches of penetration, and a 3-foot-wide x 2 1/2-foot-tall x 3/4-inch-deep spall with exposed reinforcement at the top corner of the breastwall.
