# DOLPHIN REMOVAL & REPLACEMENT STUDY

January 2019

The Tulsa Port of Catoosa wishes to remove and replace several failing or deteriorating mooring dolphins in the main channel. In the summer of 2014 the Port conducted an underwater inspection of 15 dolphins. The aerial in Figure 1 depicts all of the dolphins inspected with yellow numbers. The inspection report is in Appendix A and referred to as *Marcan Report*. All of the inspected Dolphins showed signs of deterioration, some requiring immediate repair or decommissioning. **The scope of this study is to investigate construction methods for removal and replacement of the dolphins, determine the most feasible construction methods and the associated opinion of probable cost and recommend project phasing.**

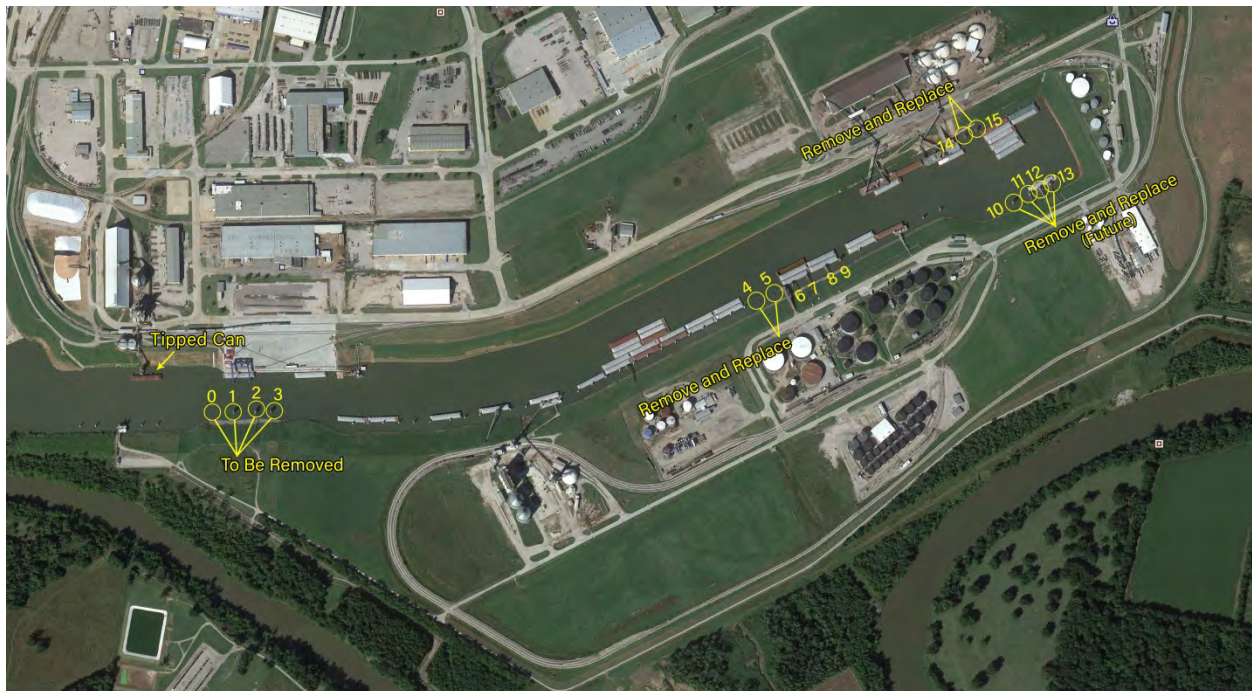
We began by reviewing the Marcan Report shown in Appendix A to determine the dolphins requiring the most immediate need of replacement. The aerial in Figure 1 depicts all of the dolphins inspected with yellow numbers. Two dolphins had clearly failed by the time of inspection and were not included in the 15 inspected. Dolphins 1, 2, and 3 have already been decommissioned due to disrepair. These are tower structures on concrete piers with a concrete platform and truss type construction tying them together. Because they are in an area of the channel that is narrow, causing a bottleneck to the barge traffic, they are to be removed but not replaced. A fourth dolphin, noted as “0”, in this area has been removed above the water and the materials drug to the bank. This Dolphin also needs to be removed down to the stream bed and the steel superstructure removed from the site.

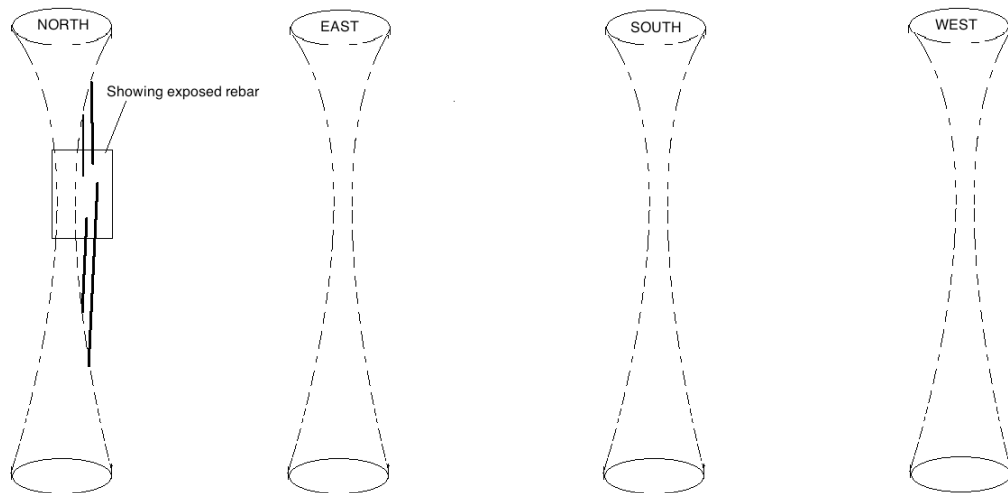
**North** side of pile one shows major deterioration, with a loss in circumference greater than 6" and consisted of heavy chiseling and softening of concrete. Pieces were falling off by touch. Pile formed an hourglass shape as noted in illustration and showing exposed rebar. This is a sign of structural failure.

**East** side of pile one shows major deterioration, with a loss in circumference greater than 6" and consisted of heavy chiseling and softening of concrete. Pieces were falling off by touch. Pile formed an hourglass shape as noted in illustration and showing exposed rebar. This is a sign of structural failure.

**West** side of pile one shows major deterioration, with a loss in circumference greater than 6" and consisted of heavy chiseling and softening of concrete. Pieces were falling off by touch. Pile formed an hourglass shape as noted in illustration and showing exposed rebar. This is a sign of structural failure.

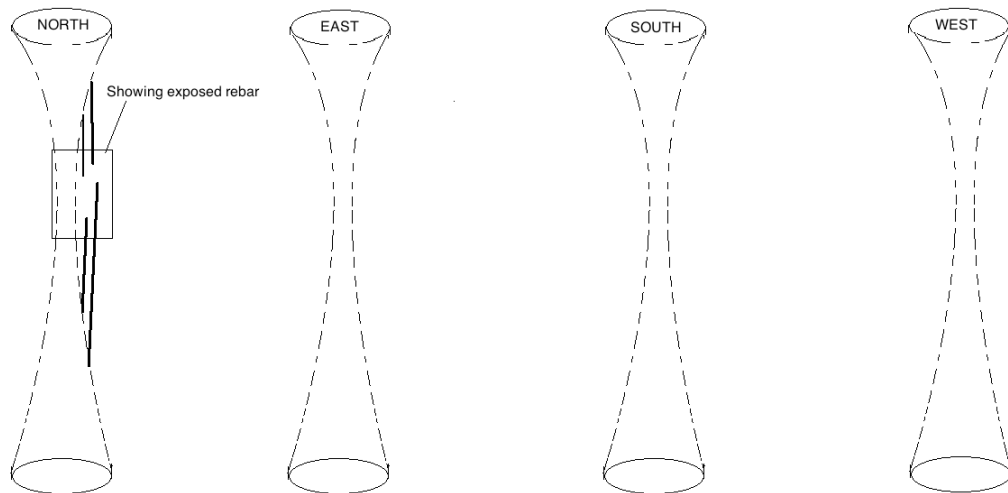
## MOORING STRUCTURE #1

**North** side of pile one shows major deterioration, with a loss in circumference greater than 6" and consisted of heavy chiseling and softening of concrete. Pieces were falling off by touch.

**West** side of pile one shows major deterioration, with a loss in circumference greater than 6" and consisted of heavy chiseling and softening of concrete. Pieces were falling off by touch. Pile formed an hourglass shape as noted in illustration and showing exposed rebar. This is a sign of structural failure.

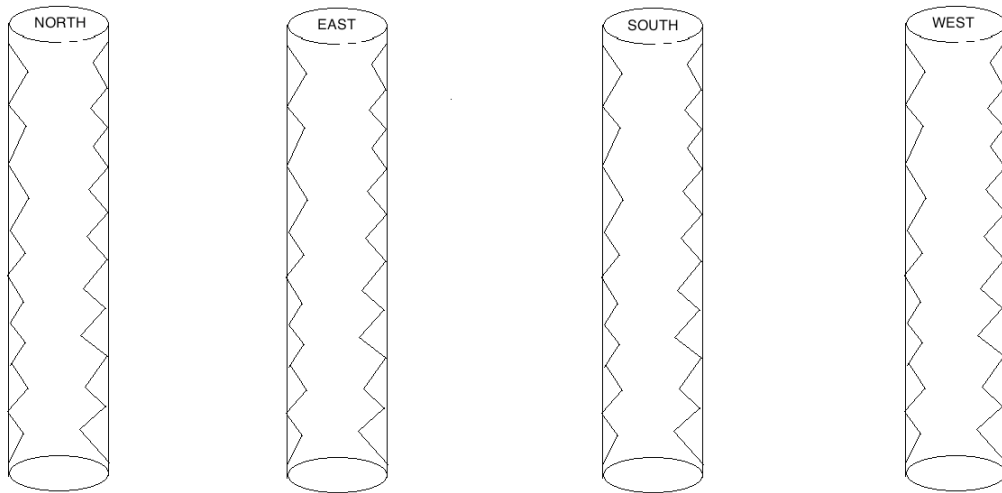
## MOORING STRUCTURE #2

**West** side of pile one shows major deterioration, with a loss in circumference greater than 6" and consisted of heavy chiseling and softening of concrete. Pieces were falling off by touch.

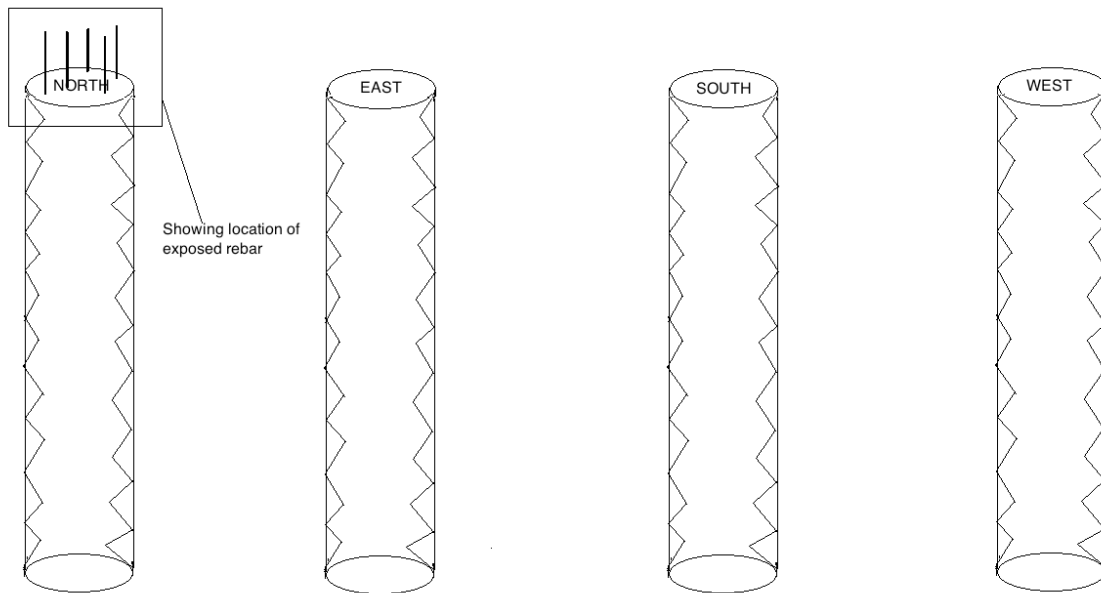
## MOORING STRUCTURE #2

**West** side of pile one shows major deterioration, with a loss in circumference greater than 6" and consisted of heavy chiseling and softening of concrete. Pieces were falling off by touch. 6" gap from top of pile to the bottom of the rectangular block, showing exposed broken off rebar. This is a sign of structural failure.

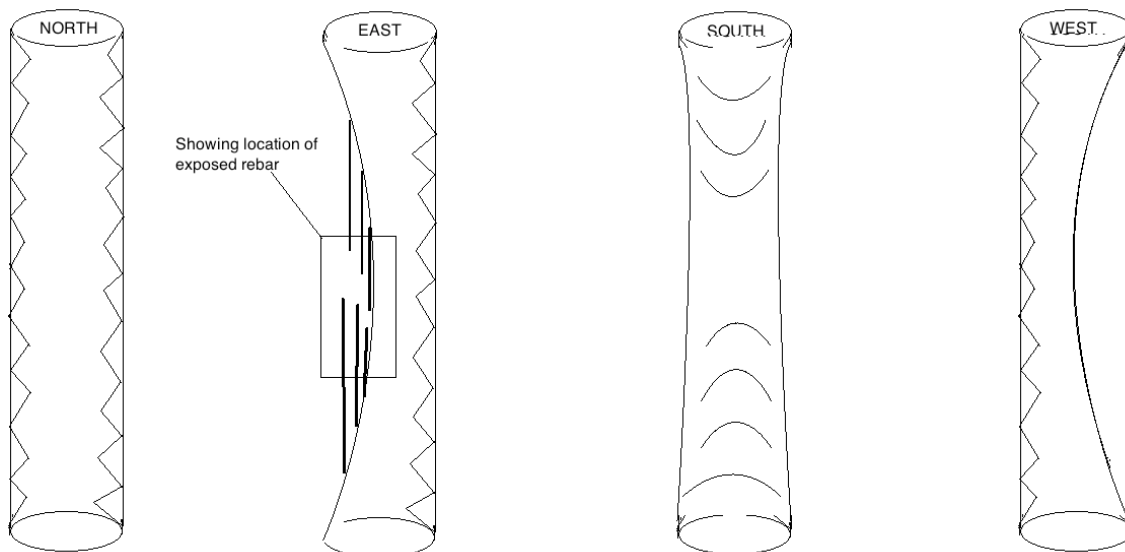
## MOORING STRUCTURE #2

**West** side of pile one shows major deterioration, with a loss in circumference greater than 6" and consisted of heavy chiseling and softening of concrete. Pieces were falling off by touch. Also, noted the backside of the pile was chiseled away from deterioration, leaving behind corroded rebar.

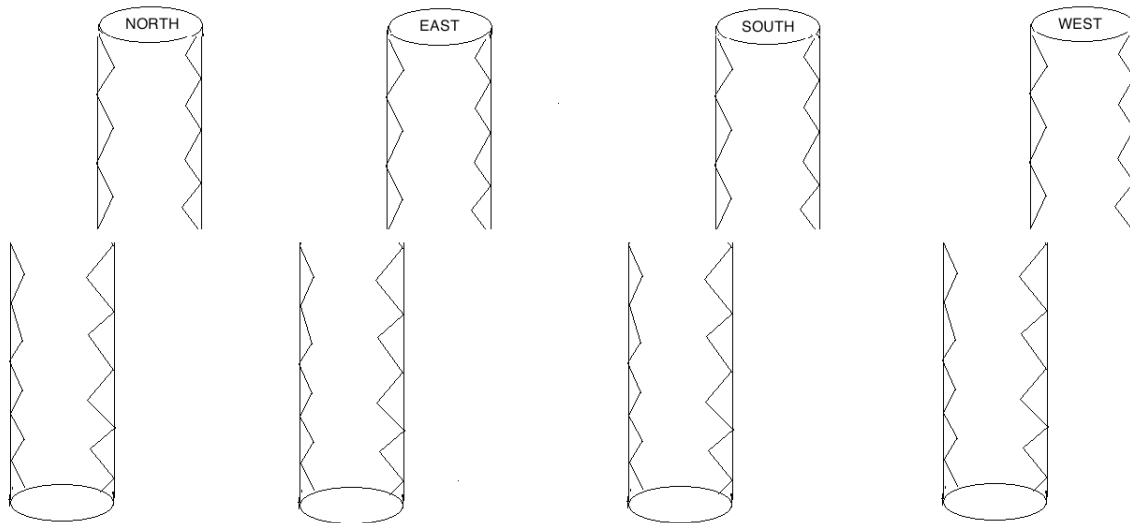
**West** side of pile one shows major deterioration, with a loss in circumference greater than 6" and consisted of heavy chiseling and softening of concrete. Pieces were falling off by touch. Also, noticed as illustrated below that pile 1 was broken in half all the way through and offset from its top half.

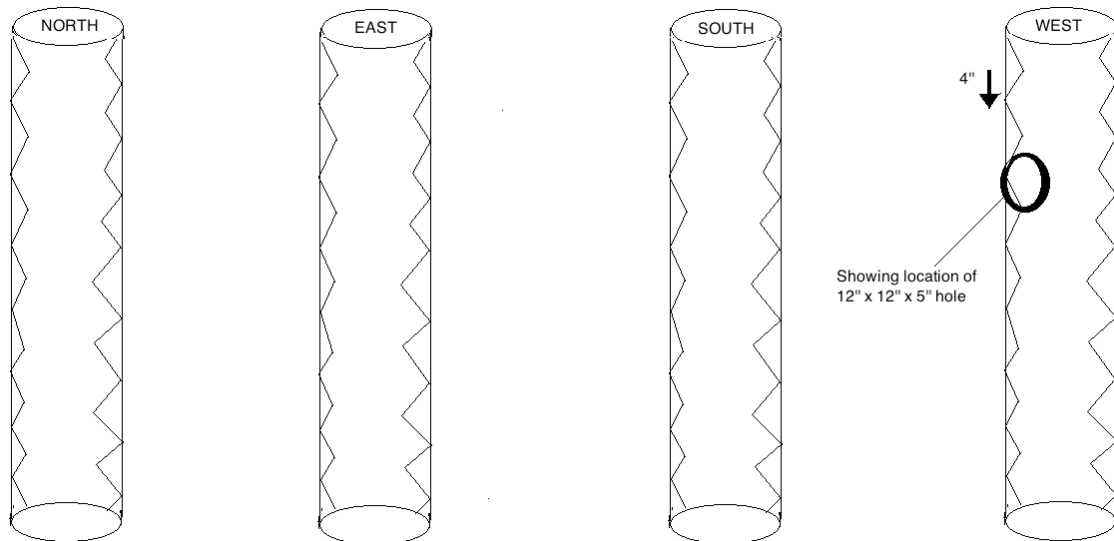
## MOORING STRUCTURE #5

**West** side of pile one shows major deterioration, with a loss in circumference greater than 6" and consisted of heavy chiseling and softening of concrete. Pieces were falling off by touch. Also, note in the illustration below, a 12" long by 12" wide by 5" deep hole. Located 4" down from the bottom of the rectangular block.

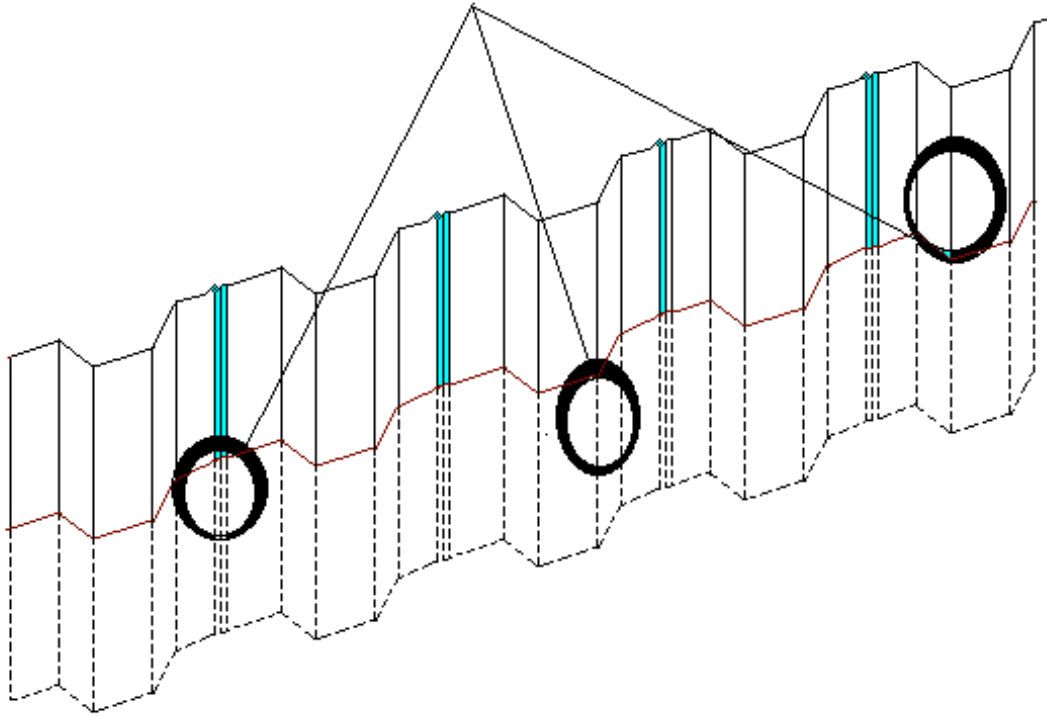
Showing random locations where sheet pile has eroded away.

After inspection the sheet pile, we located various spots where the sheet pile has eroded away, exposing concrete from the inside. An inspection was done on the exposed concrete exposed. Our findings were that the concrete seemed to be in decent condition, meaning it was not in soft form and stayed intact when gripped by hand.

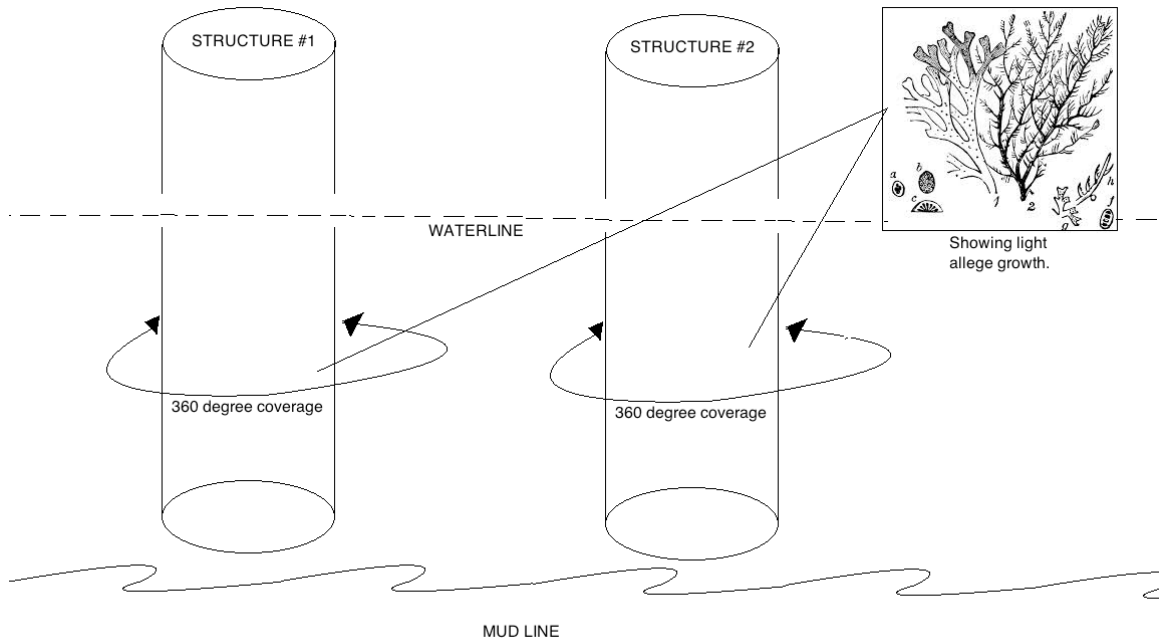
## 200 TON CRANE FRONT STRUCTURES

After completing the investigative dive on the two front structures of the 200-ton crane, we have noted that our findings only show light marine growth encompassing the cylindrical structures. There were no signs of damage or break in structural integrity.
