Bridge Data

Bridge Number (B.ID.01):	054470000000000	Agency Bridge ID:	05447
Bridge Name (B.ID.02):	4610 1166 X	Local ID:	10-1166
Feature Intersected:	CREEK	Bridge Nickname:	S.H. 9 OVER CREEK
Past Bridge ID (B.ID.03):		Facility Carried:	S.H. 9
Bridge notes:	Utility attached across the south side.

2024 Routine Inspection

NBI #	Structure #	County	Facility Carried	Feature Intersected	Date
05447	4610 1166 X	McIntosh	S.H. 9	Creek	10/23/2024

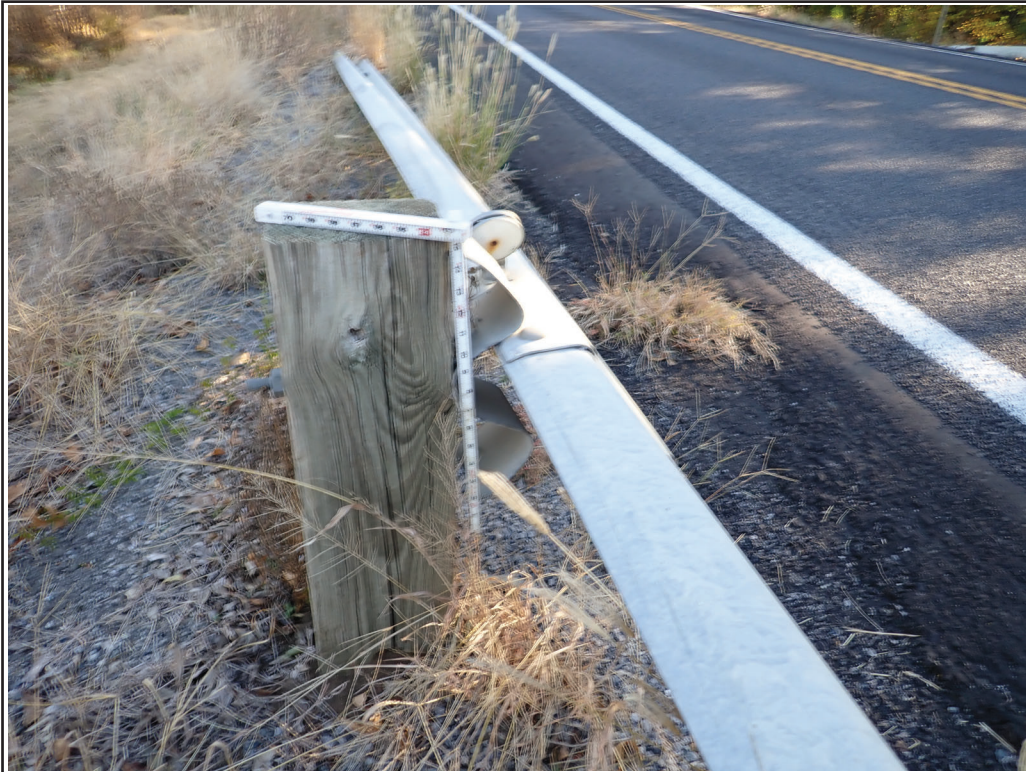
Photo 5 - Northeast approach guardrail; detached from posts

Agency Inspection Notes: PX - End of northeast approach guardrail is detached from posts. Reattach guardrail.
PX - Remove timber debris accumulation.
 FX - Monitor cracking with efflorescence buildup and spalling.
 FX - Monitor cracking at southeast wingwall interface.

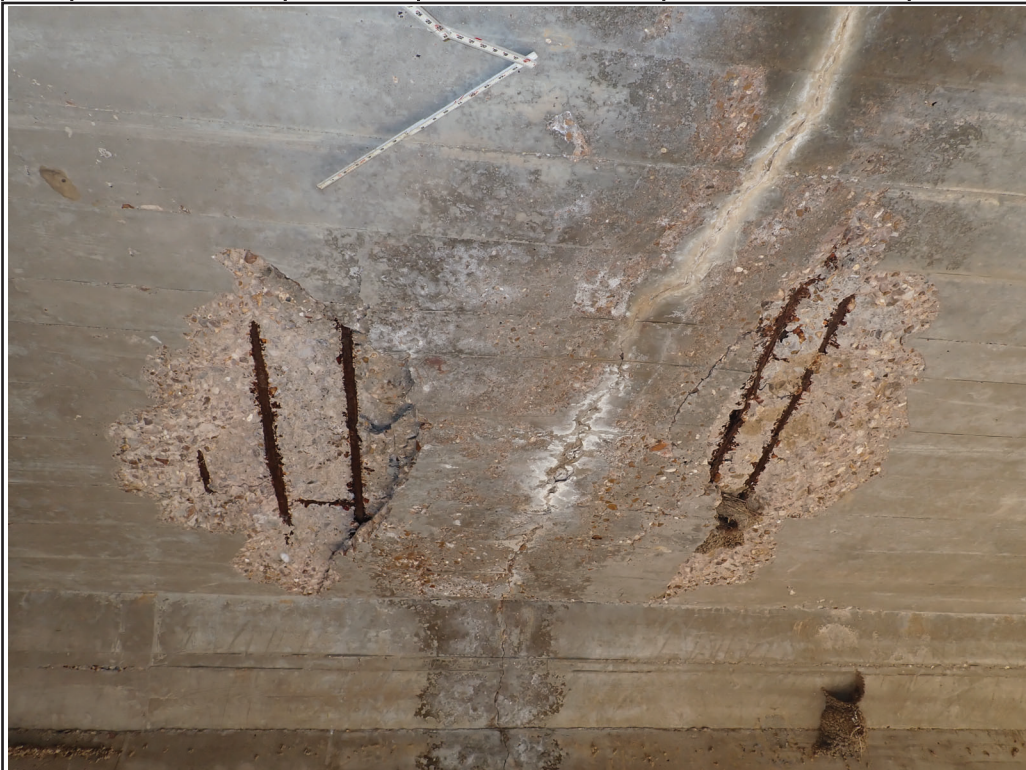
Elem /	Element Name	Total	Unit	State 1	State 2	State 3	State 4
241	Re Conc Culvert	185	ft	0	0	185	0
	FX - Cells 1, 2, and 4, the top slabs near midspan have multiple spalls up to 32-in L x 66-in W x 3-in D with exposed reinforcing with section loss. FX - Cells 2, 3, 4 and the south half of Cell 5 have hairline longitudinal and diagonal cracking with efflorescence buildup extending into the stem walls. FX - Cell 4, north end has spalling up to 24-in L x 84-in W x 3-in D with exposed corroded reinforcing with up to 90% section loss. FX - Cell 5, east wall, near the southeast wingwall connection, crack up to 3/4-in wide. Cell 1, west wall, south end, full height vertical crack up to 1/4-in wide. Cell 3, top slab, near midspan, impending spall up to 2-ft L x 3-ft W. Cell 5, east wall, north end, full height vertical crack up to 1/4-in wide. Cell floors have abrasion with exposed and missing aggregate throughout. Cell ceilings have areas of poor consolidation up to 3-ft L x full width with exposed reinforcing. Cell ceilings typically have hairline longitudinal cracks with efflorescence in the ceiling. Interior walls have vertical cracks up to 1/16-in wide. Interior walls, at the north end, typically have spalls up to 24-in H x 12-in W x 2-in D with exposed reinforcing due to debris impact.

Photo 6 - Cell 4, top slab, near midspan; spalls up to 32-in L x 66-in W x 3-in D with exposed reinforcing

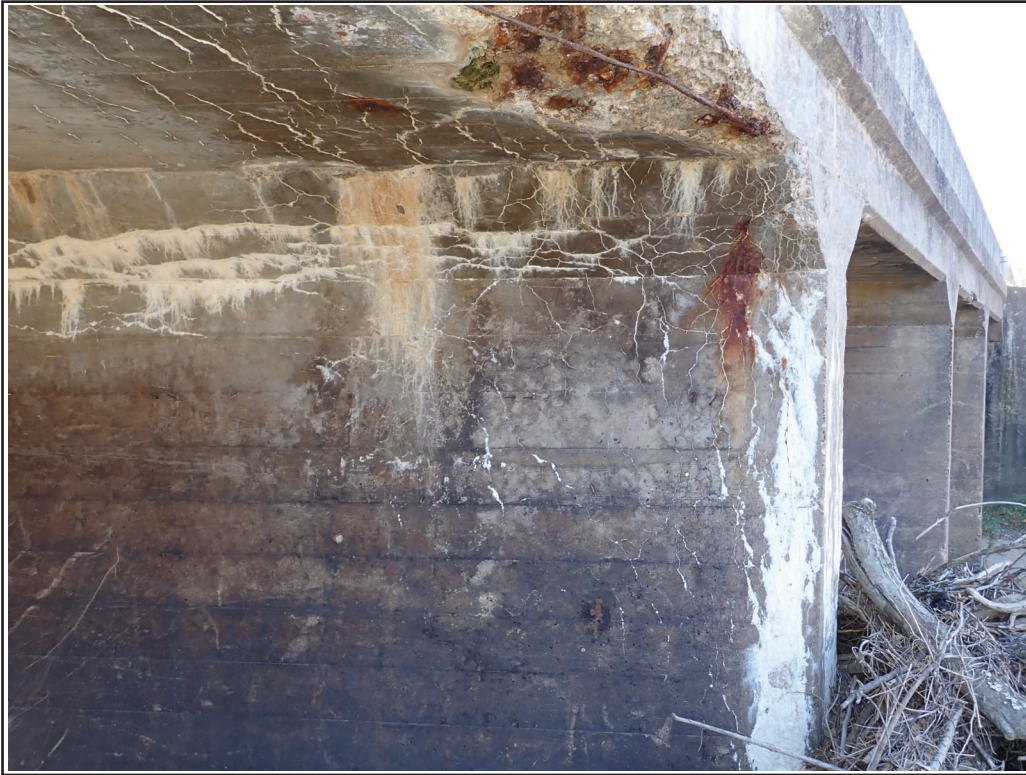
Photo 7 - Cell 4, west wall; hairline diagonal and longitudinal cracking with efflorescence buildup

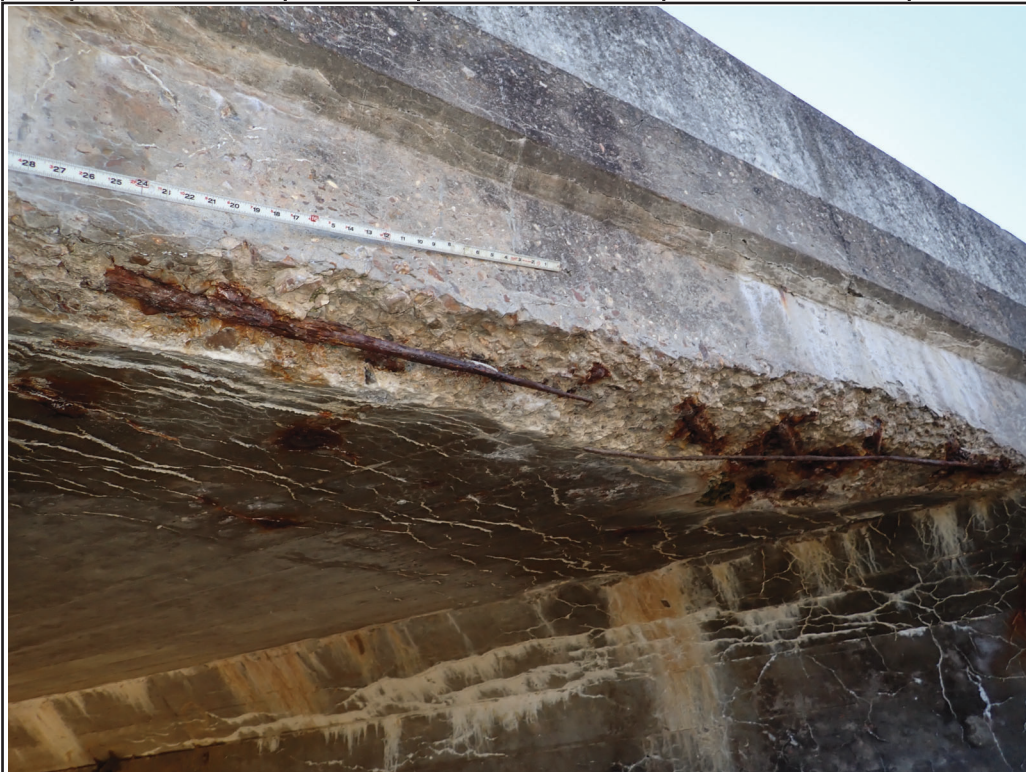
Photo 8 - Cell 4, north end; spall 24-in L x 84-in W x 3-in D exposed corroded reinforcing

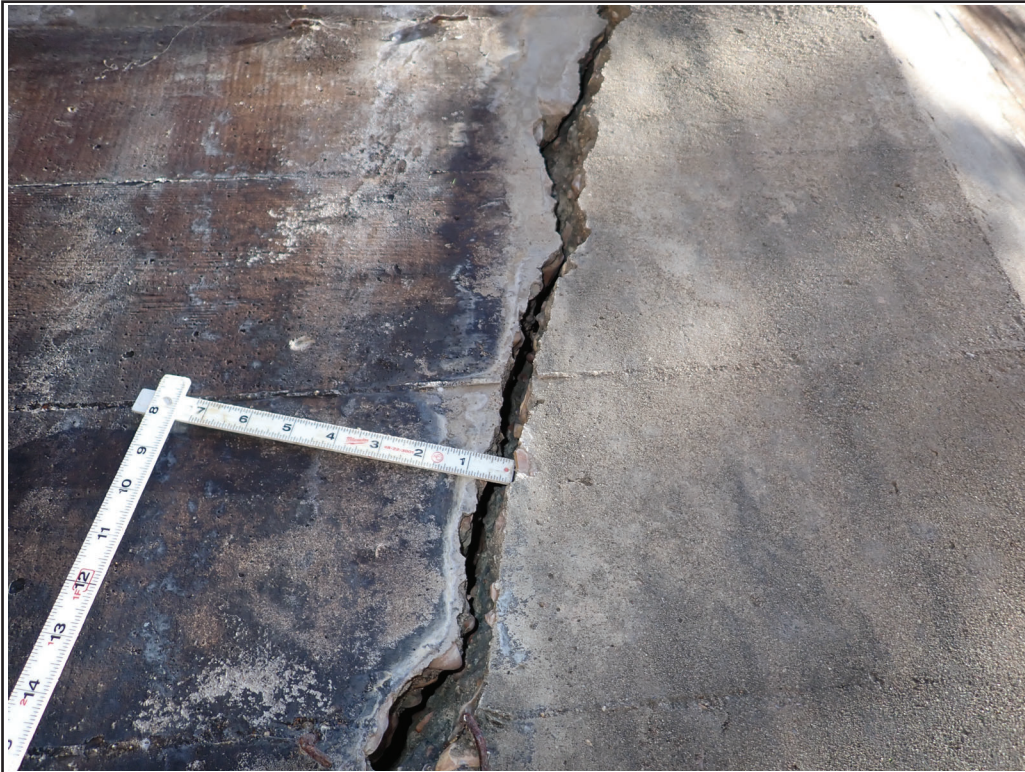
Photo 9 - Cell 5, east wall, near southeast wingwall connection; crack up to 3/4-in wide

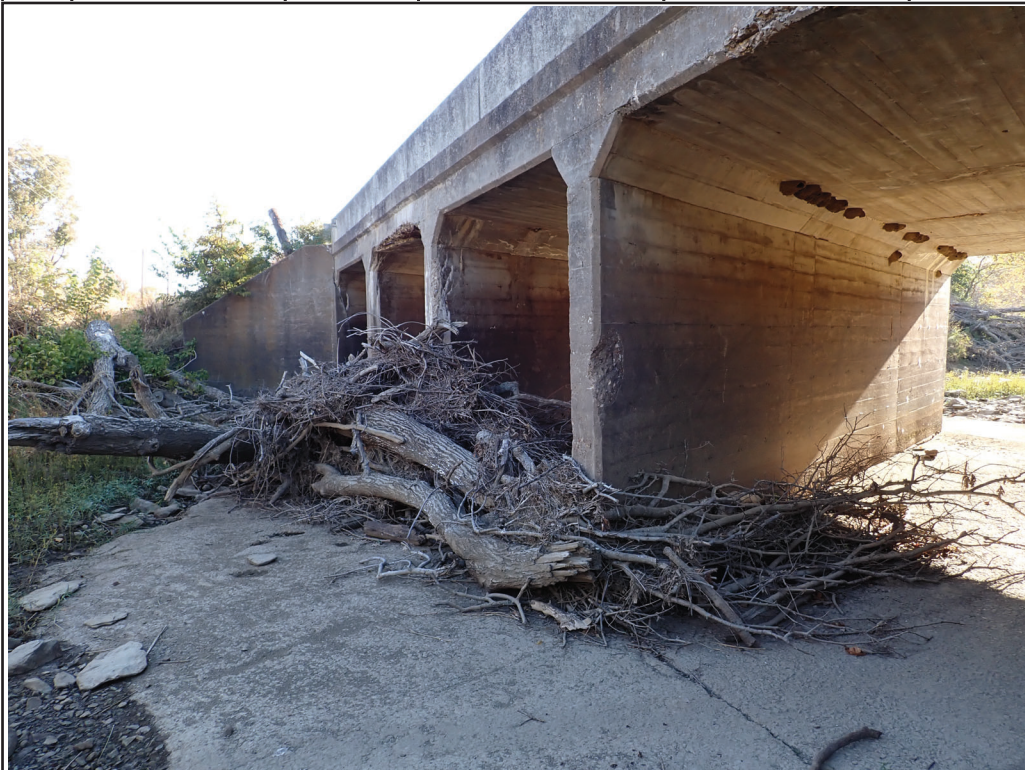
331	Re Conc Bridge Railing	129	ft	129	0	0	0
	Hairline vertical cracks throughout.						
870	Concrete Wingwall	4	each	3	1	0	0
	FX - Southeast wingwall is rotated 1/2-in towards the channel. Southwest wingwall, asphalt countermeasure behind the wingwall have settled creating voids up to 20-in deep.						
965	Debris SF	1	each	0	0	1	0
	PX - The upstream end has timber debris accumulation up to 3-ft high.

Photo 10 - Upstream end; timber debris accumulation up to 3-ft high
