Bridge Data

Bridge Number (B.ID.01):	05448000000000	Agency Bridge ID:	05448
Bridge Name (B.ID.02):	4610 1187 X	Local ID:	10-1187
Feature Intersected:	WALLACE CREEK	Bridge Nickname:	S.H. 9 OVER WALLACE CREEK
Past Bridge ID (B.ID.03):		Facility Carried:	S.H. 9
Bridge notes:

2024 Routine Inspection

NBI #	Structure #	County	Facility Carried	Feature Intersected	Date
05448	4610 1187 X	McIntosh	S.H. 9	Wallace Creek	10/23/2024

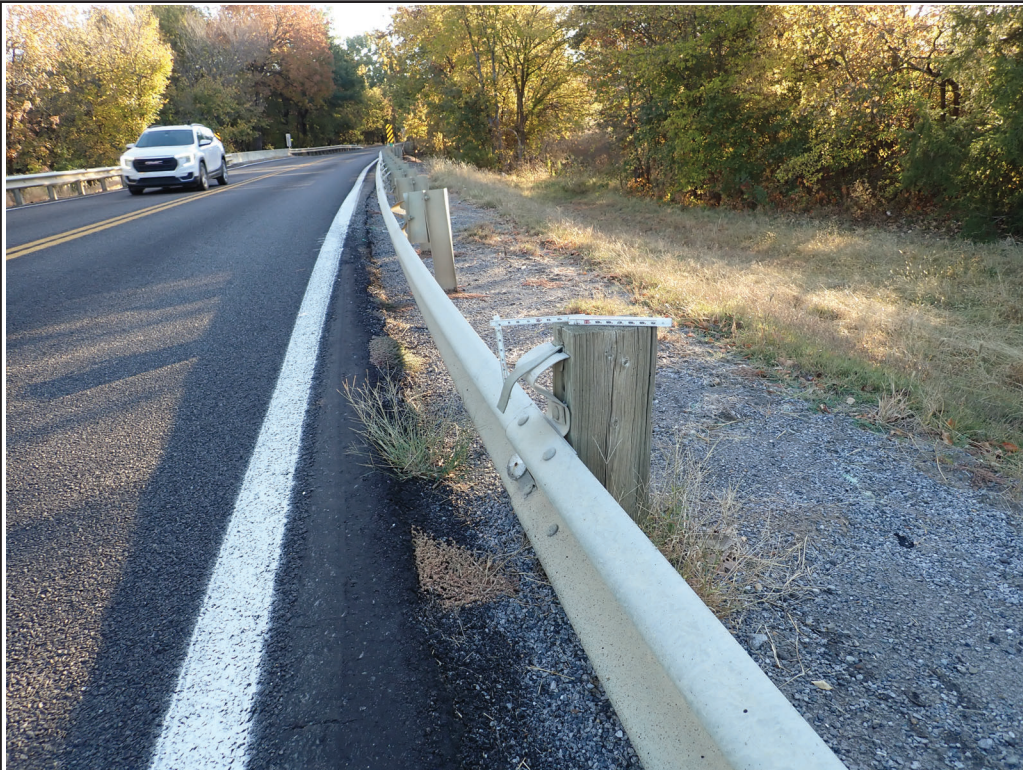
Photo 5 - Southwest approach guardrail; detached from the posts

PX - West approach guardrails and the northeast approach guardrail are detached from the posts.
 Reattach guardrails.
 PX - Remove cattle fence.
 FX - Monitor soffit deterioration.

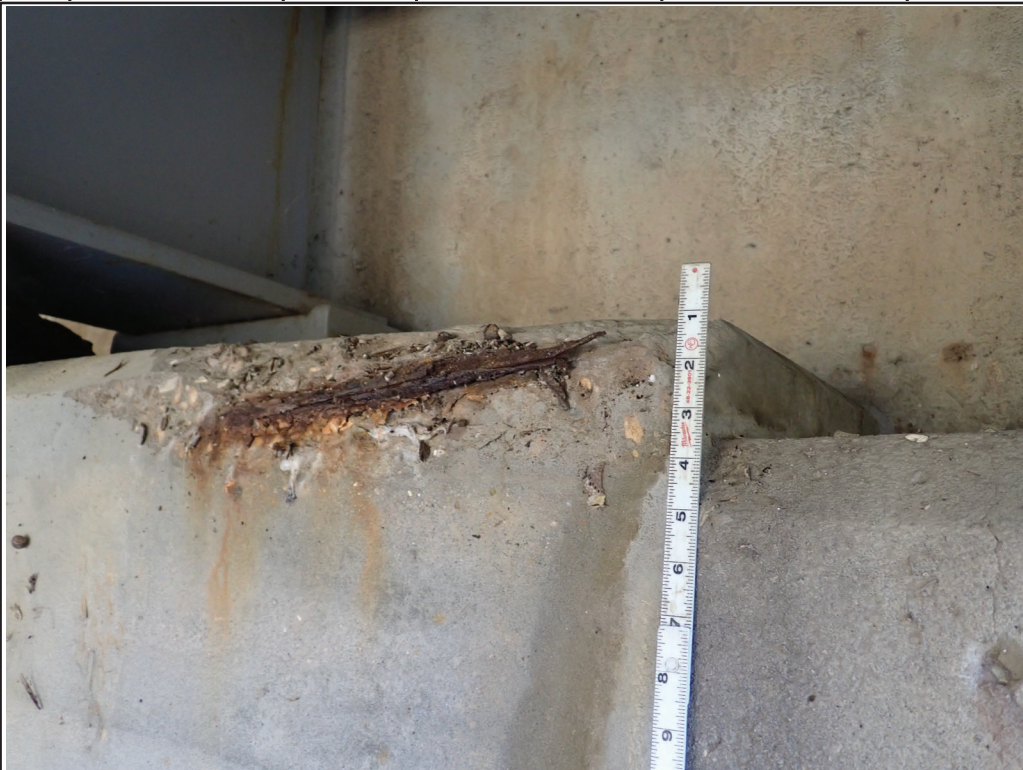
Photo 6 - East abutment, at Beam 2; spall 4-in H x 18-in L x 1 1/2-in D with exposed reinforcing

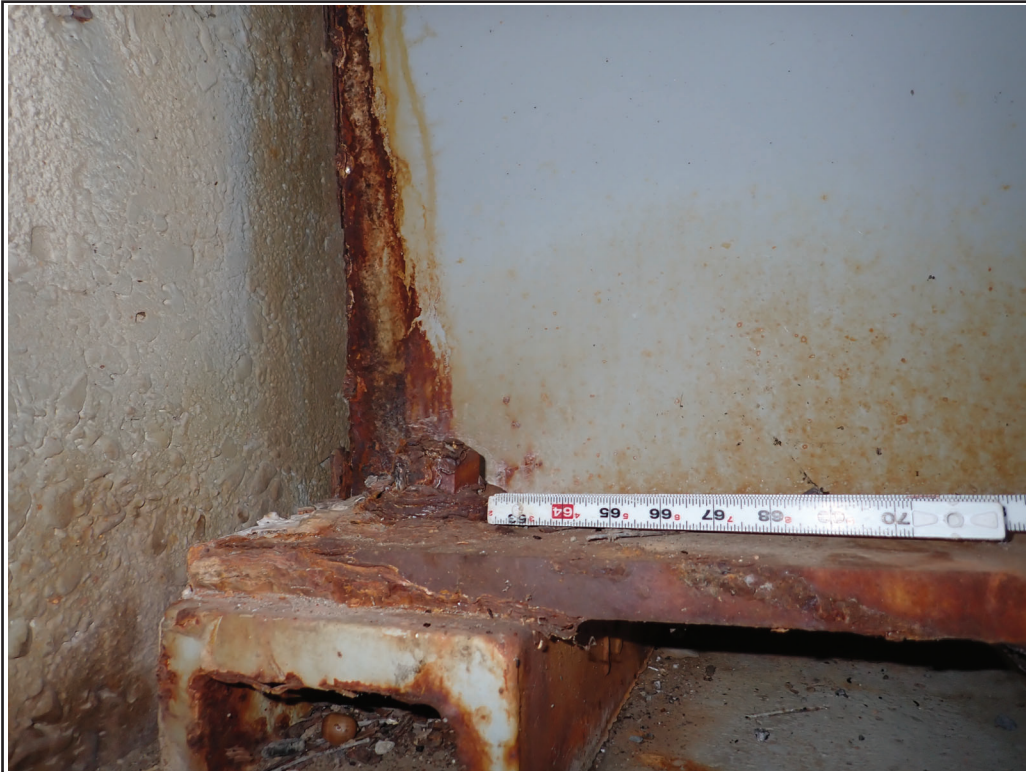
304	Open Expansion Joint	52	ft	52	0	0	0
	Covered with asphalt.						
311	Moveable Bearing	6	each	0	4	2	0
	Moveable bearings have surface corrosion with laminar corrosion forming on the exterior bearings.						
313	Fixed Bearing	6	each	0	4	2	0
	Fixed bearings have surface corrosion with laminar corrosion forming on the exterior bearings.						
321	Re Conc Approach Slab	2	sq.ft	2	0	0	0
	Covered with asphalt.						
331	Re Conc Bridge Railing	124	ft	0	0	124	0
	Debris has accumulated throughout the length of the curbs and is covering the previously noted heavy deterioration.						
968	Erosion SF	1	each	1	0	0	0

Photo 7 - East abutment, Bearing 6; laminar corrosion

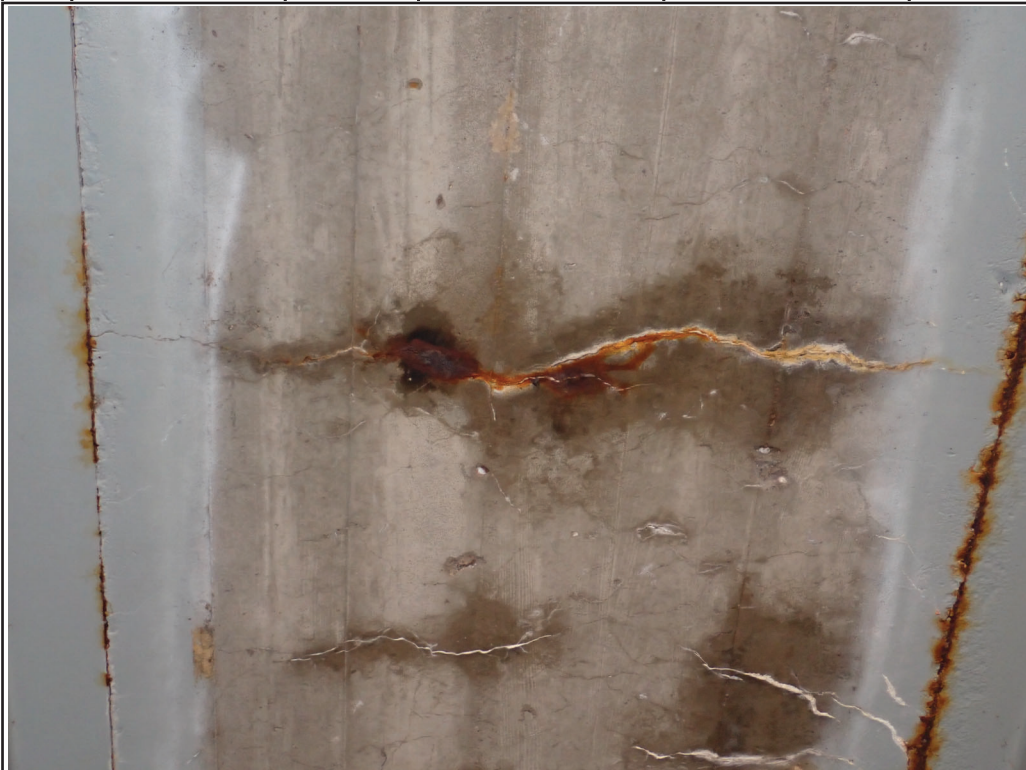
Photo 8 - Soffit, Bay 1; transverse cracking up to 1/32-in wide with efflorescence and corrosion staining

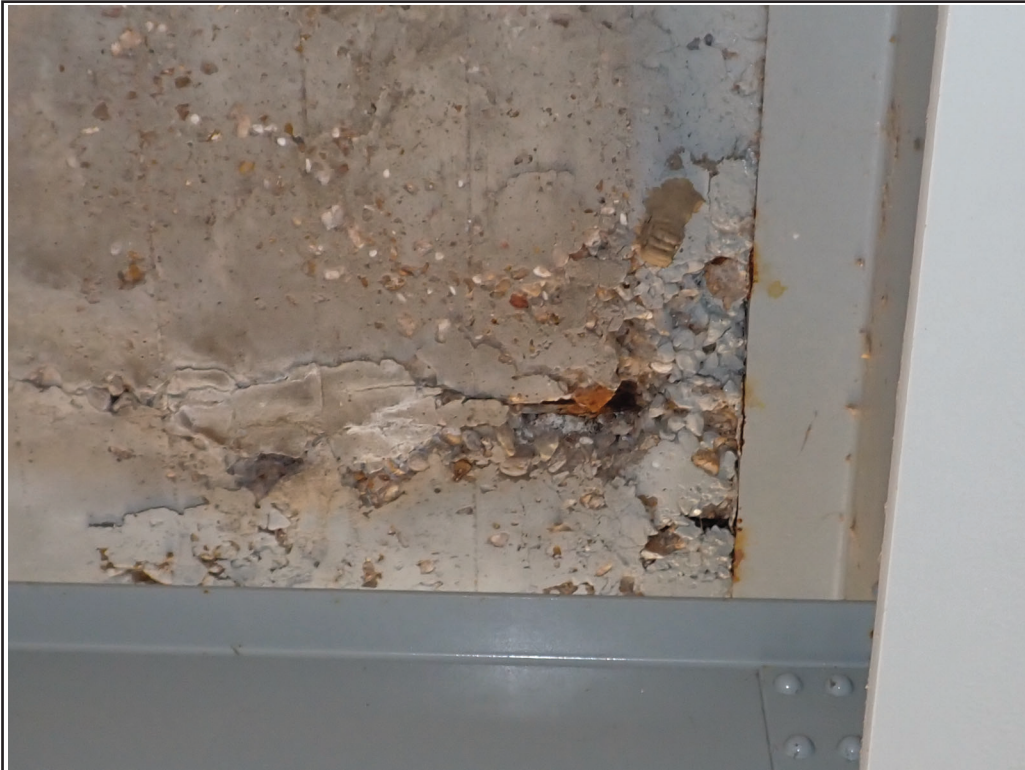
Photo 9 - Soffit, Bay 2; area of poor consolidation 24-in L x 30-in W x 3-in D with exposed reinforcing

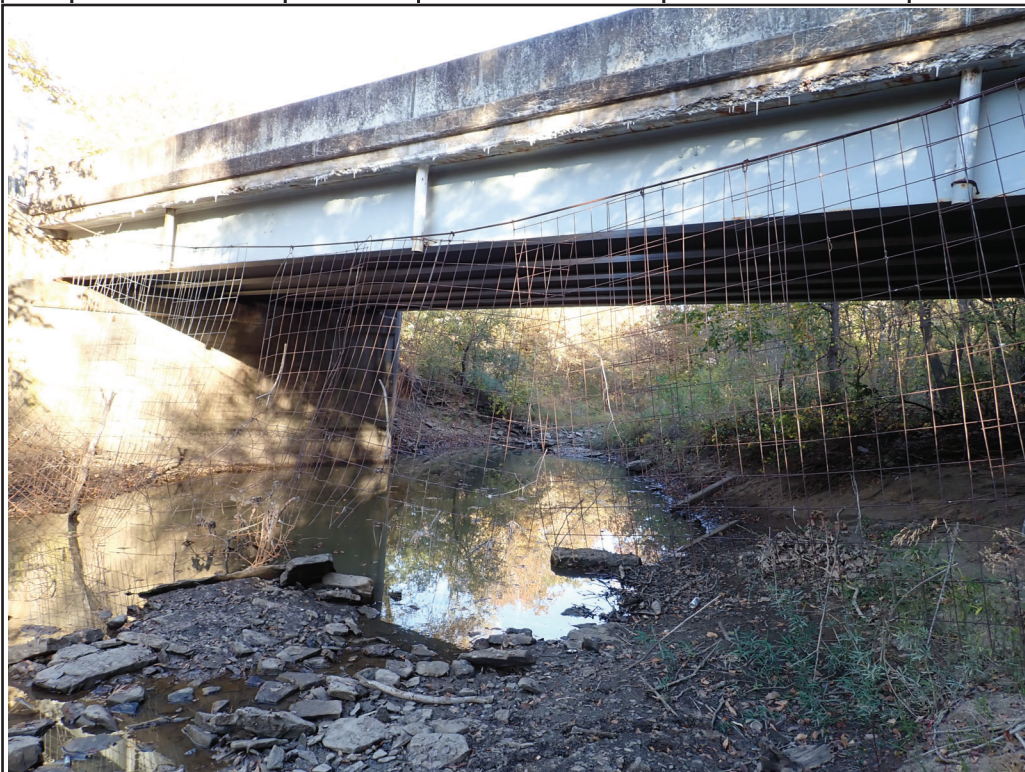
870	Concrete Wingwall	4 each	3	1	0	0
The northwest wingwall has abrasion with exposed but secure aggregate at the waterline.						
865	St.Open Gird End(5Ft	60 ft	16	40	4	0
All beam ends have surface corrosion and exterior beam ends have laminar corrosion at the bearings. Beam flanges and lower webs have painted over pitting up to 1/8-in deep throughout.						
859	Soffit	1 each	0	0	1	0
FX - Interior bays have numerous transverse cracks up to 1/32-in wide with efflorescence buildup and corrosion staining. There are also areas of poor consolidation and spalling up to 24-in L x 30-in W x 3-in D with exposed reinforcing. FX - Both overhangs are deteriorating with cracking up to 1/32-in wide and spalls up to full length x 12-in W x 3-in D with exposed corroded reinforcing and heavy efflorescence buildup.						
965	Debris SF	1 each	0	0	1	0
PX - A cattle fence has been installed on the south side of the structure that may restrict channel flow.

Photo 10 - South channel; cattle fence installed
