**OKLAHOMA**  
Corporation Commission

# OGCD UPDATE

MUSKOGEE CIVIC  
CENTER  
MARCH 25, 2026

# OGCD - FORM 1085 INCIDENT REPORT

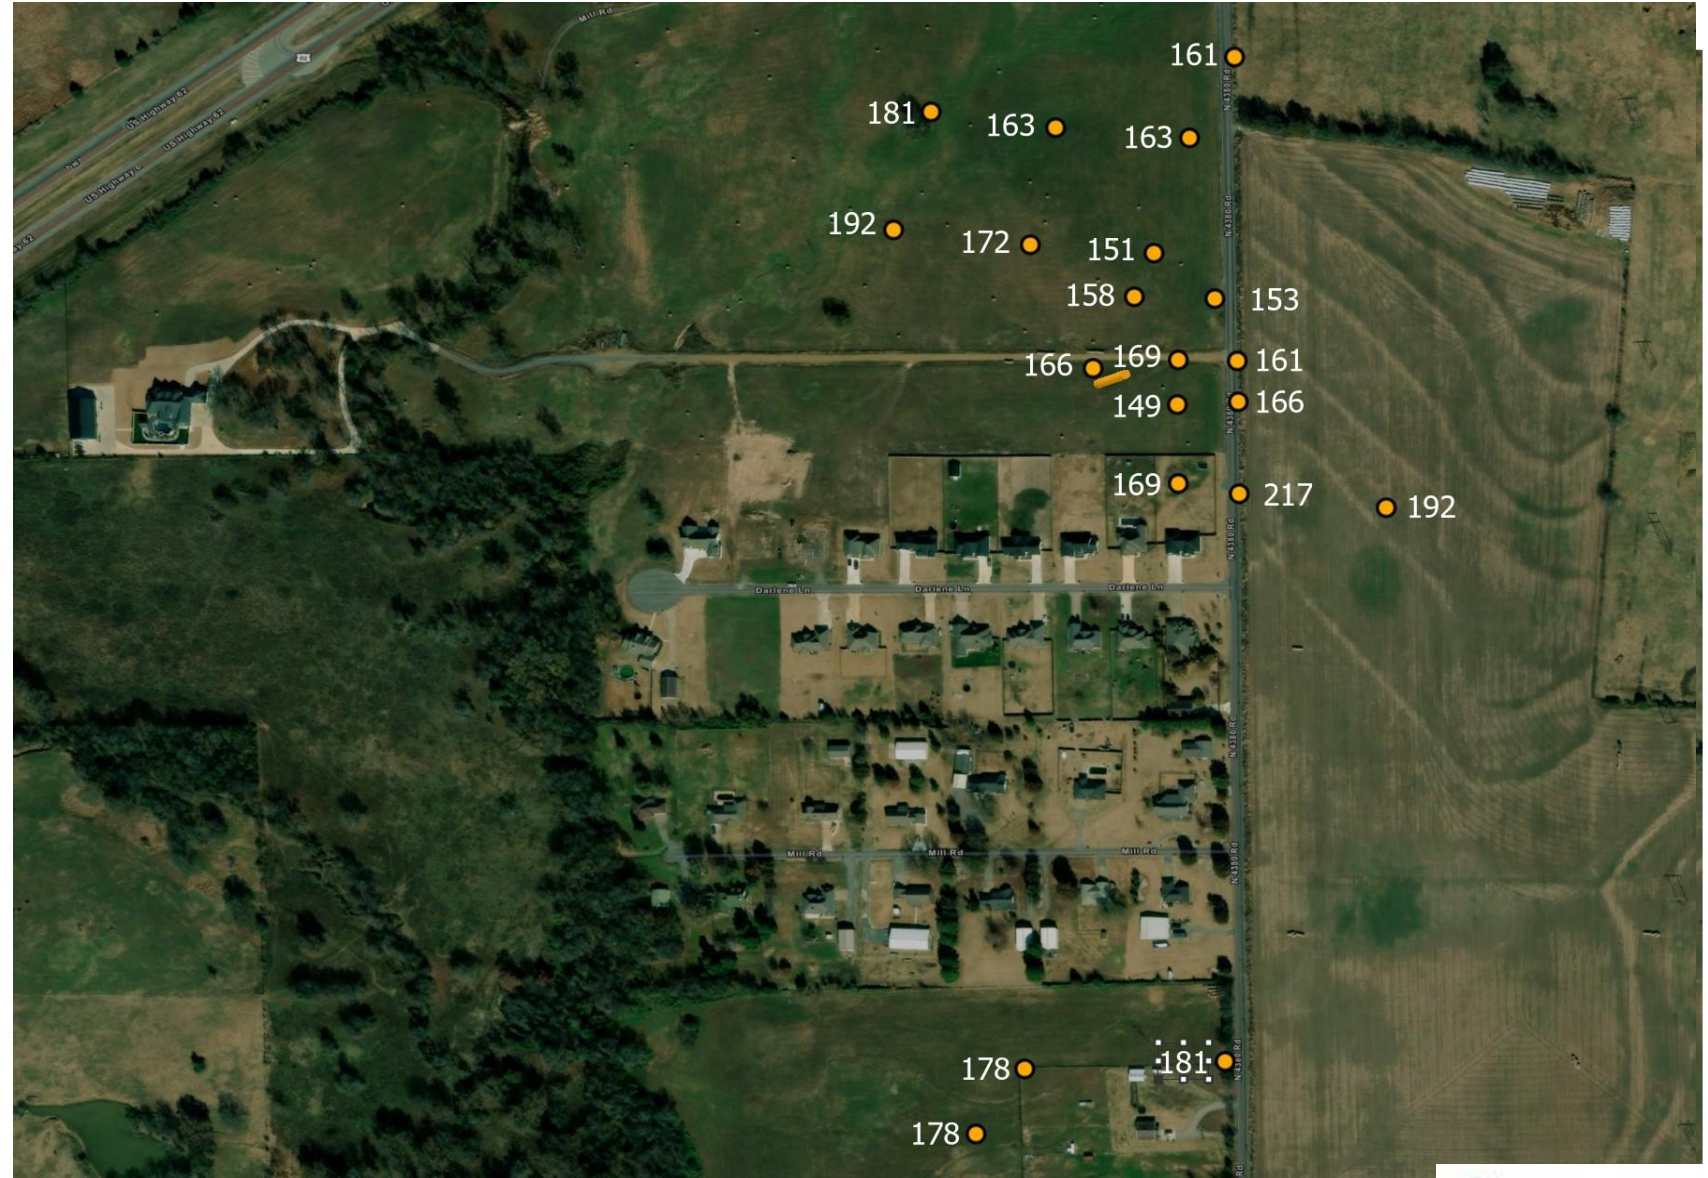
# TDEM FIELD SURVEY LOCATIONS

These are the GPS locations of each survey with conductivity values.

Each orange dot represents the center of the 40m x 40m wire loop.

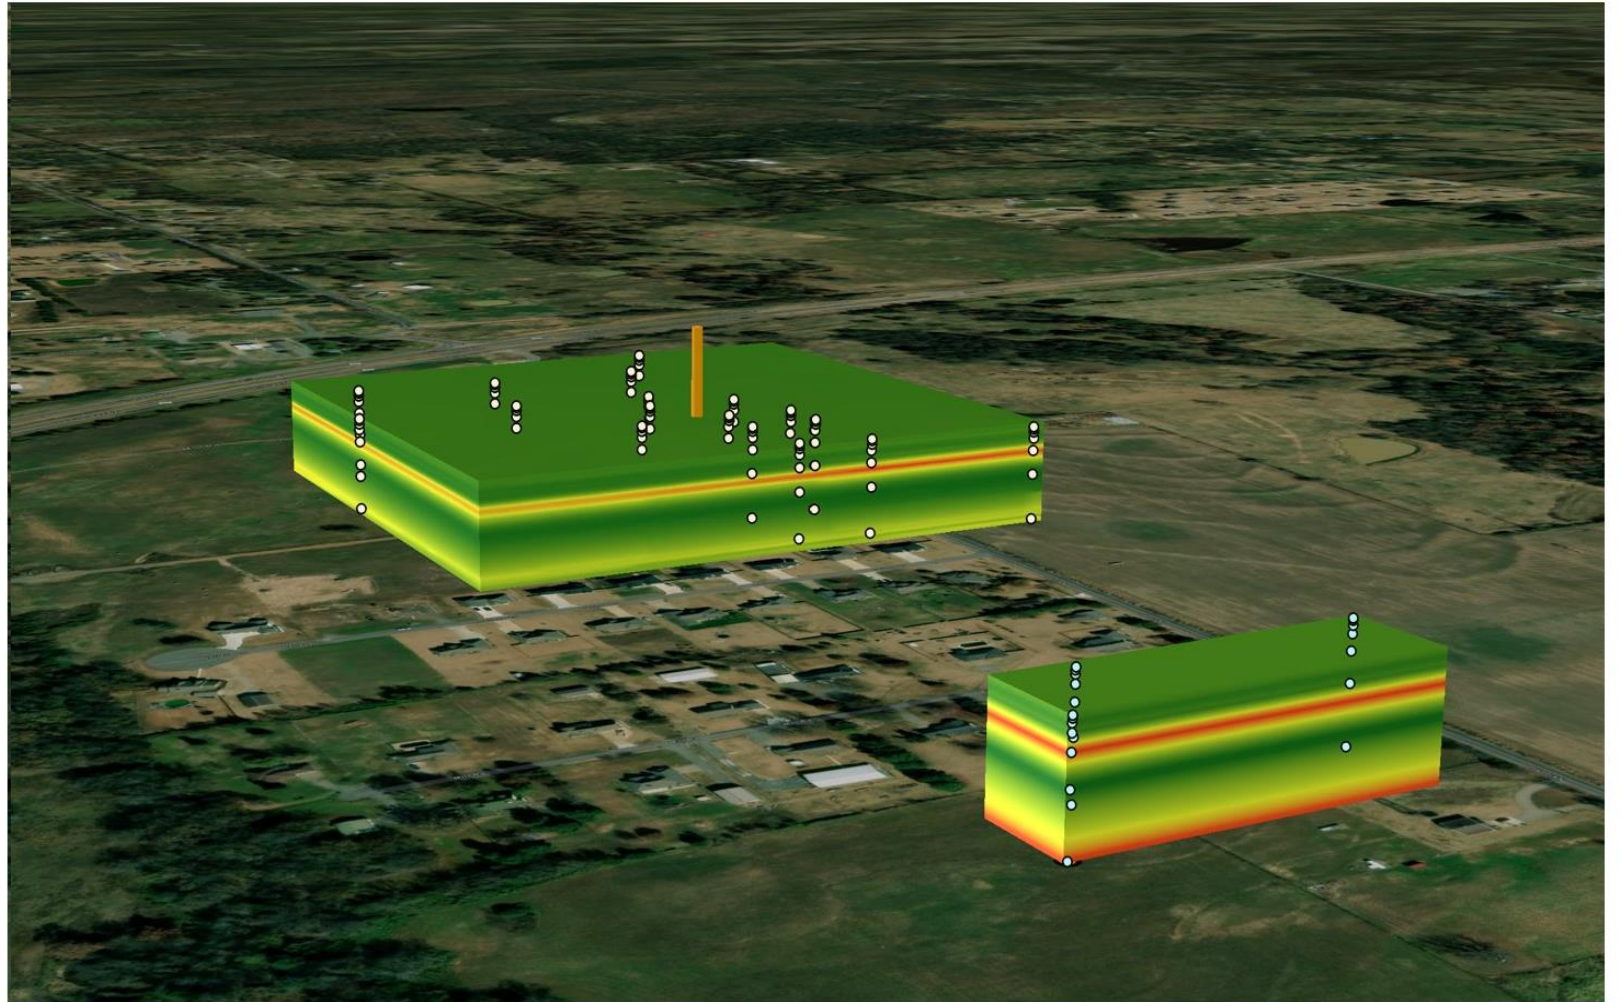
## TDEM FIELD RESULTS

This image is looking towards the northeast, two separate areas were surveyed.

The software creates a color scale from green to red, green is the lowest conductive value and red is the highest conductive value.

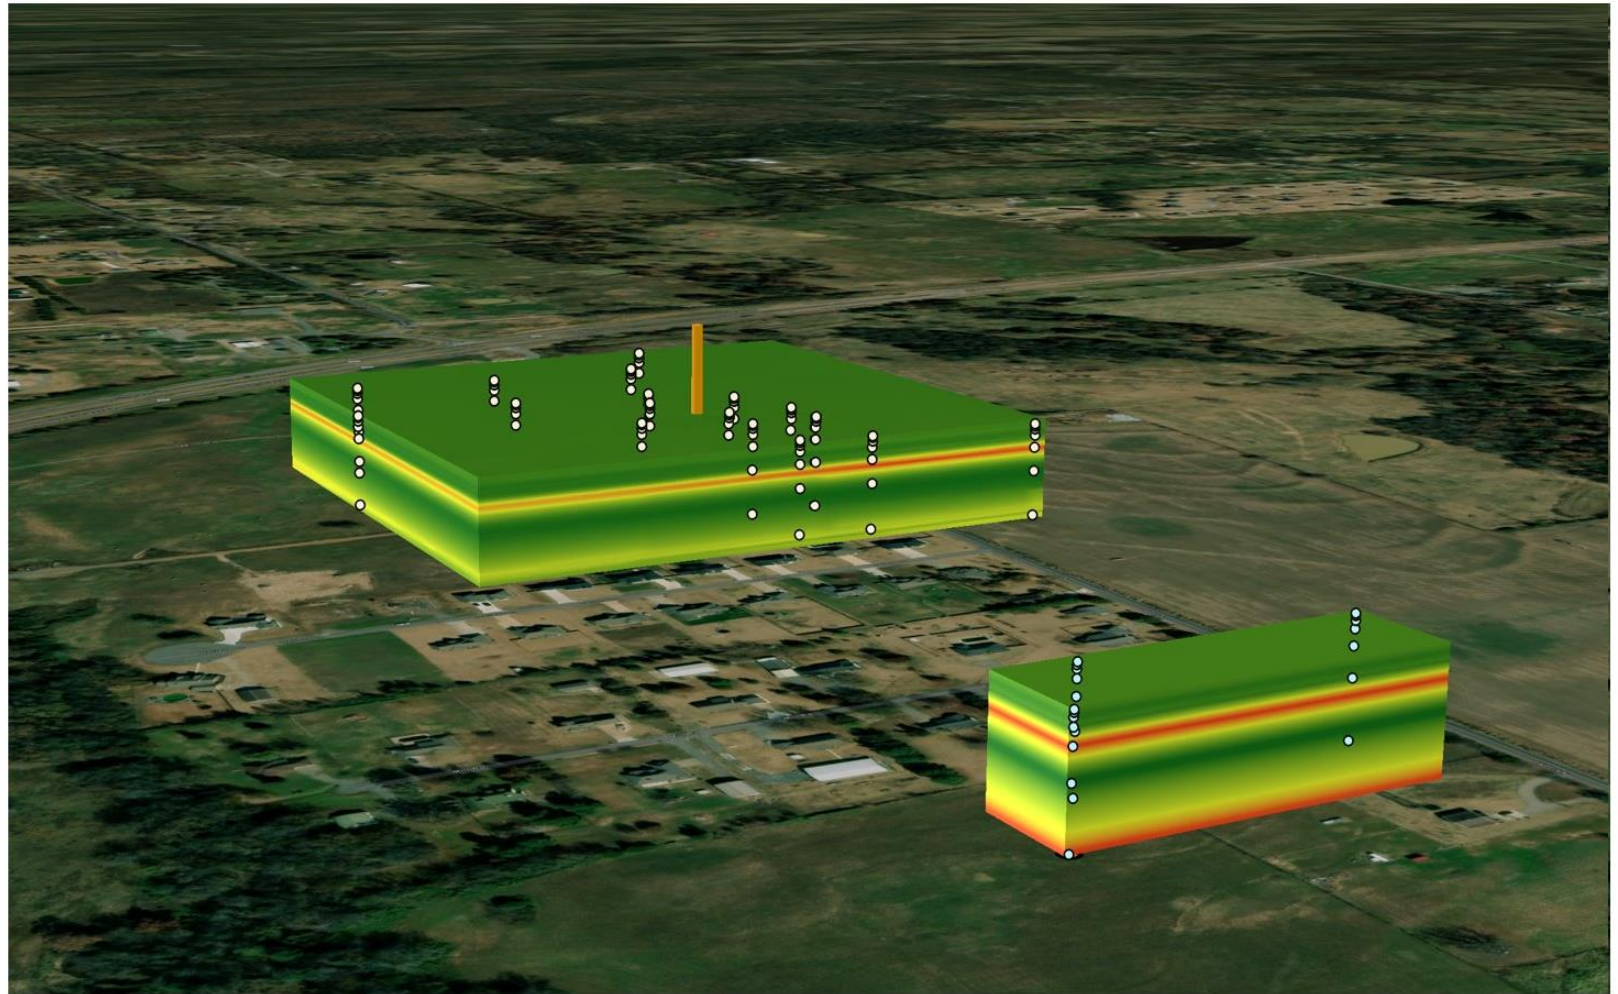
## TDEM FIELD RESULTS

The north area has a scale of 12 to 217 mS/m.

The south area has a scale of 3 to 181 mS/m.

The south area has more red coloration, but the values are actually lower, this is due to the scale change created by the software.

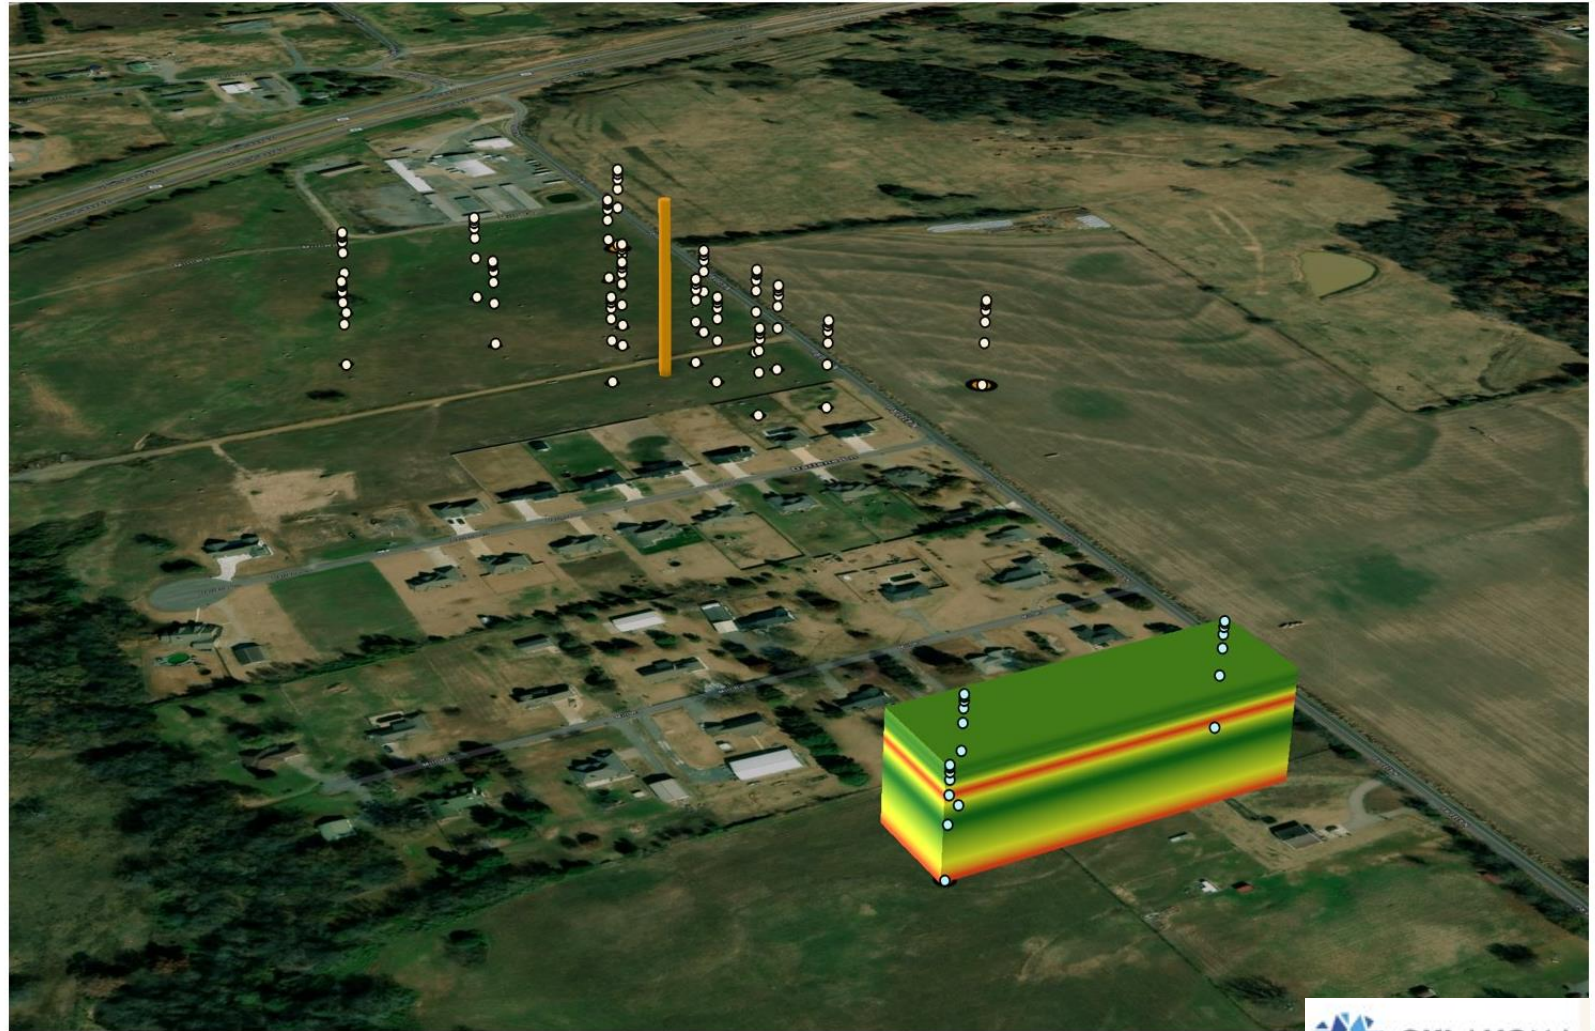
# TDEM FIELD RESULTS

Survey south of the housing area.

View is towards the northeast.

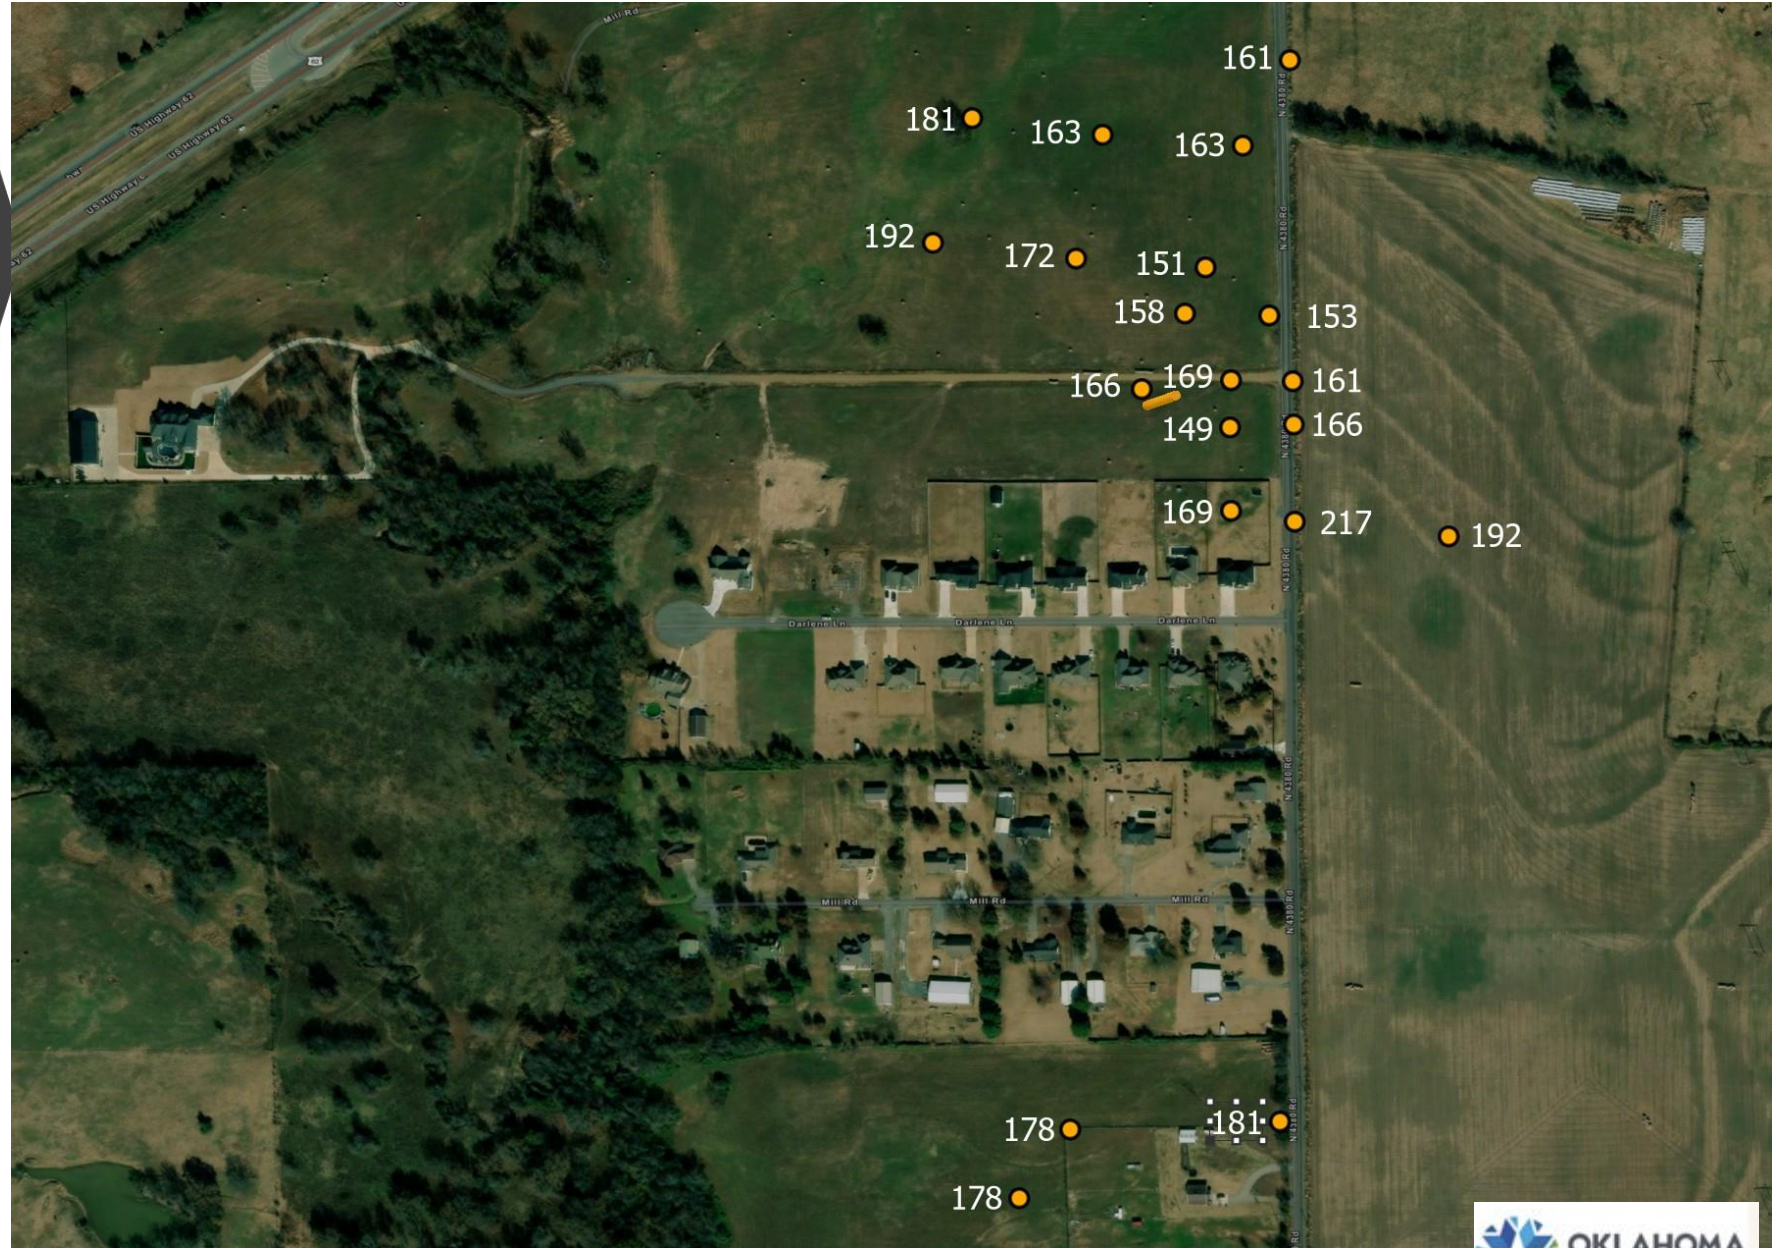
# TDEM FIELD SURVEY LOCATIONS

The values are generally consistent north, east, and south of the housing addition.
