Fracture Critical Bridge Inspection Report

NBI Bridge No.: 17051

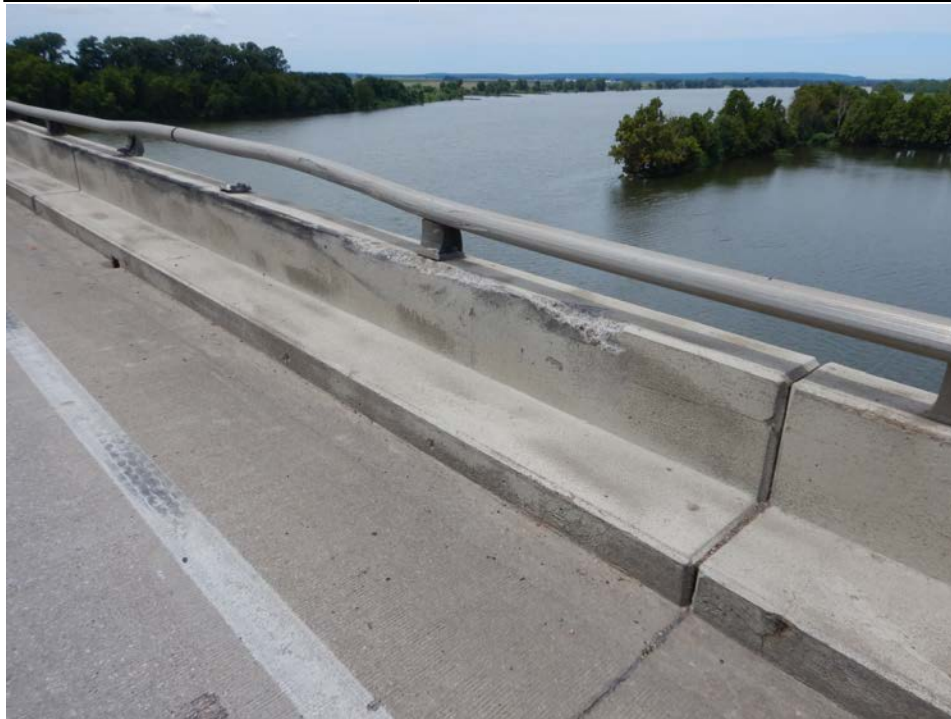
Photograph 3 - Looking northwest at the north bridge railing, span 8. Note: steel rail bent and two posts detached. Spalls in the concrete has not exposed reinforcing steel.

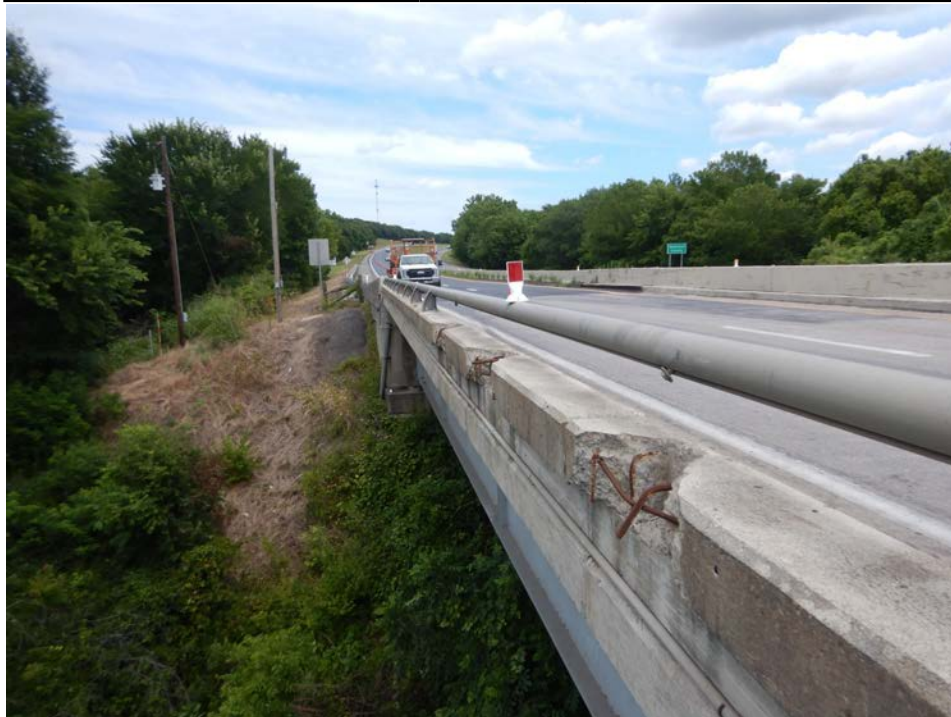
Photograph 4 - Looking southeast at the north bridge railing near mid span of span 13. Note: three spalls in the concrete railing where rail posts used to exist.

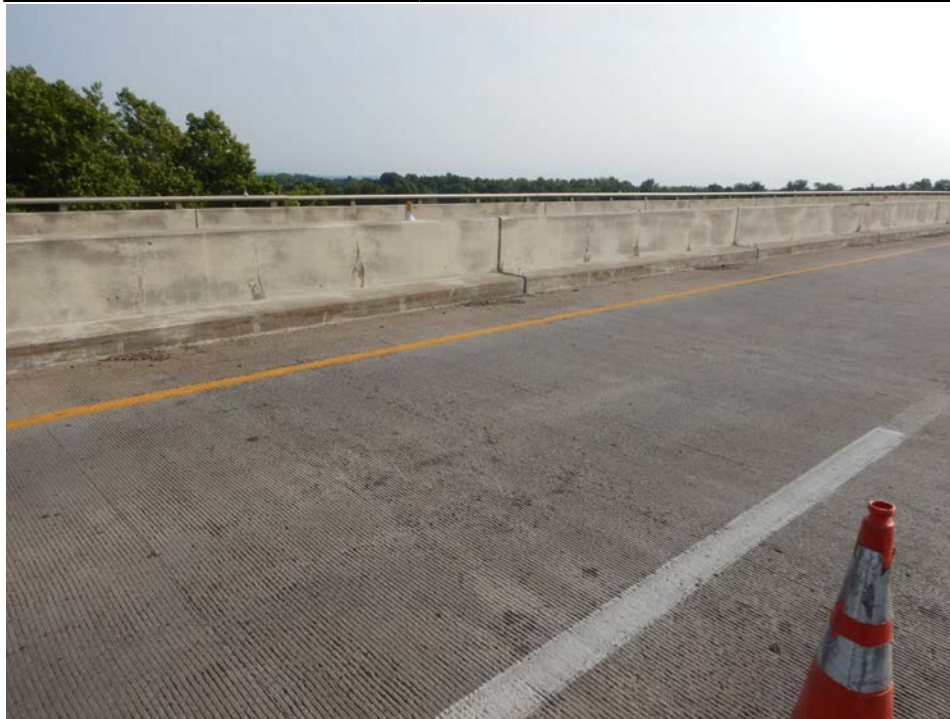
Photograph 5 - Looking northeast at the median bridge railing near mid span of span 1. Note: vertical cracks along the length of the bridge rail.

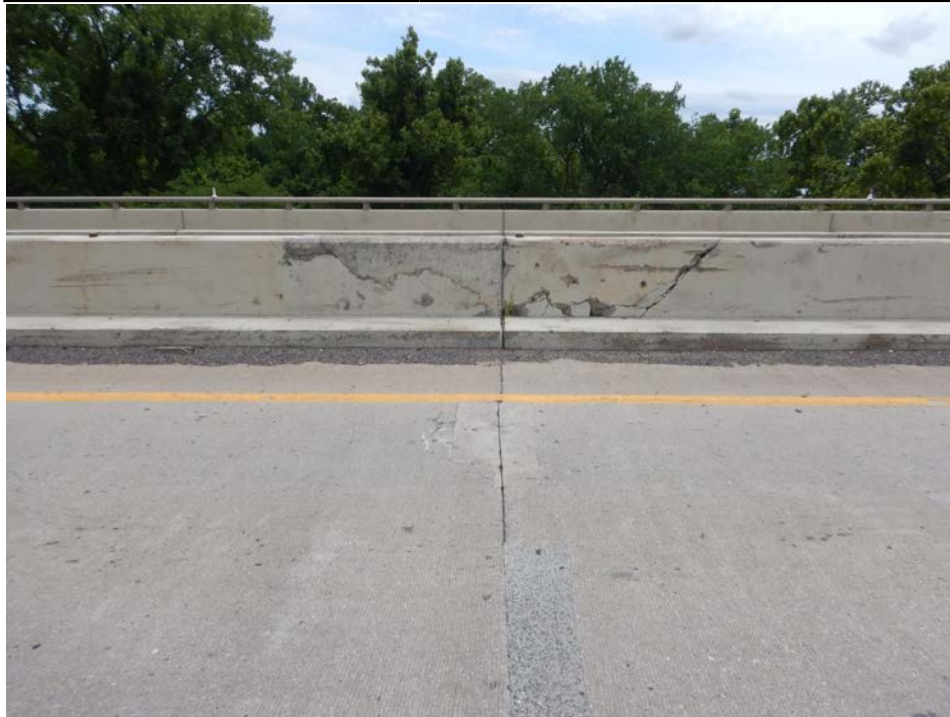
Photograph 6 - Looking south at the median railing near pier 12 . Note: spalling due to impact damage.

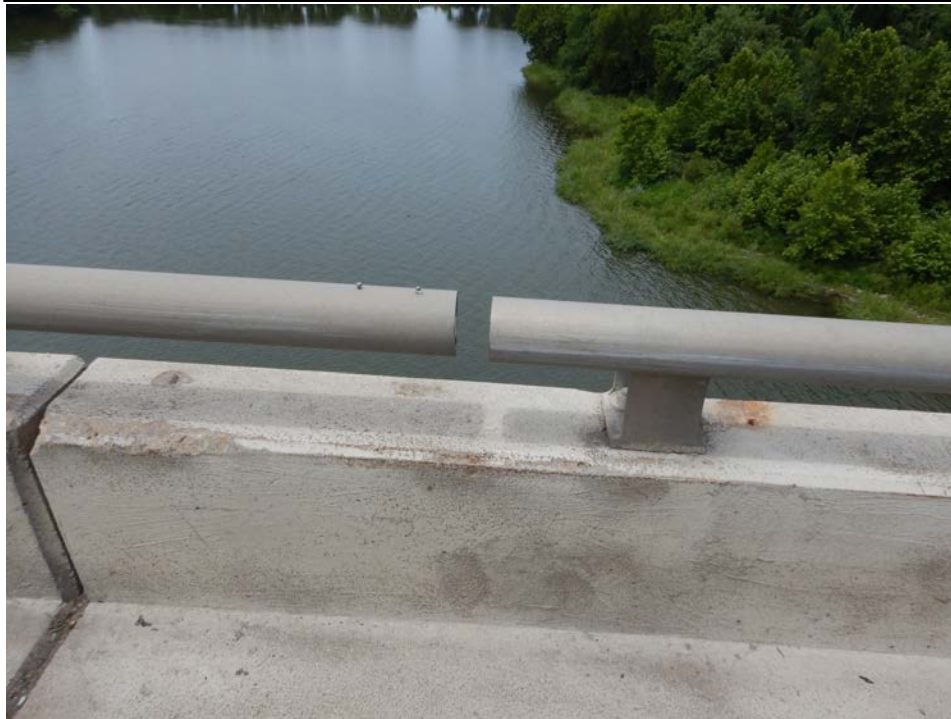
Photograph 7 - Looking north at the north bridge railing over floor beam 4, span 9. Note: splice for rail is missing.

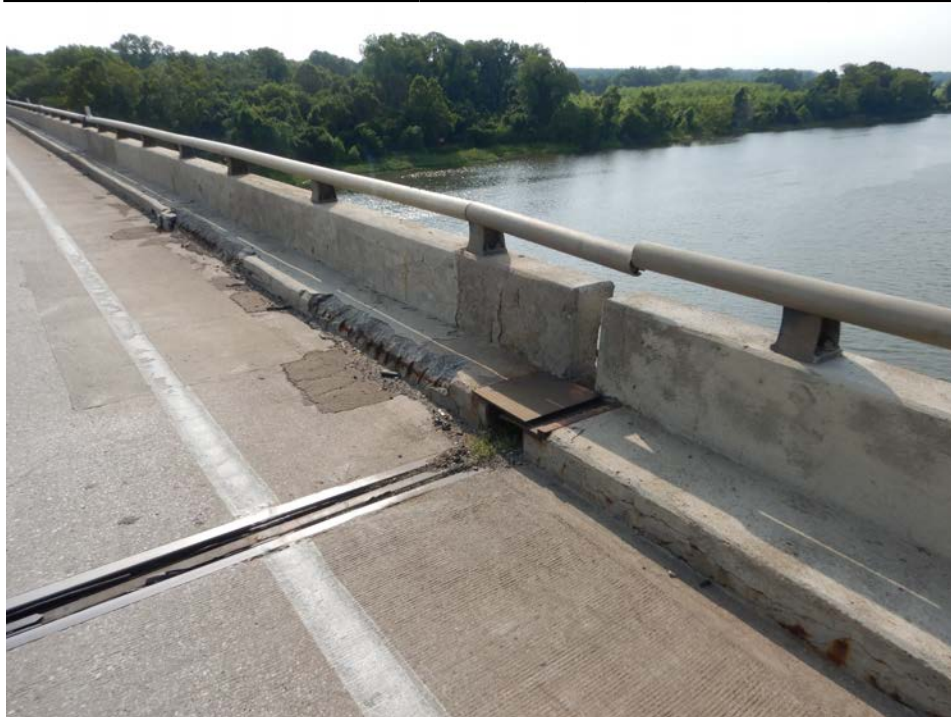
Photograph 8 - Looking southeast at the south bridge railing in over pier 6, span 7 near. Note: spalled curb and aluminum rail not spliced.

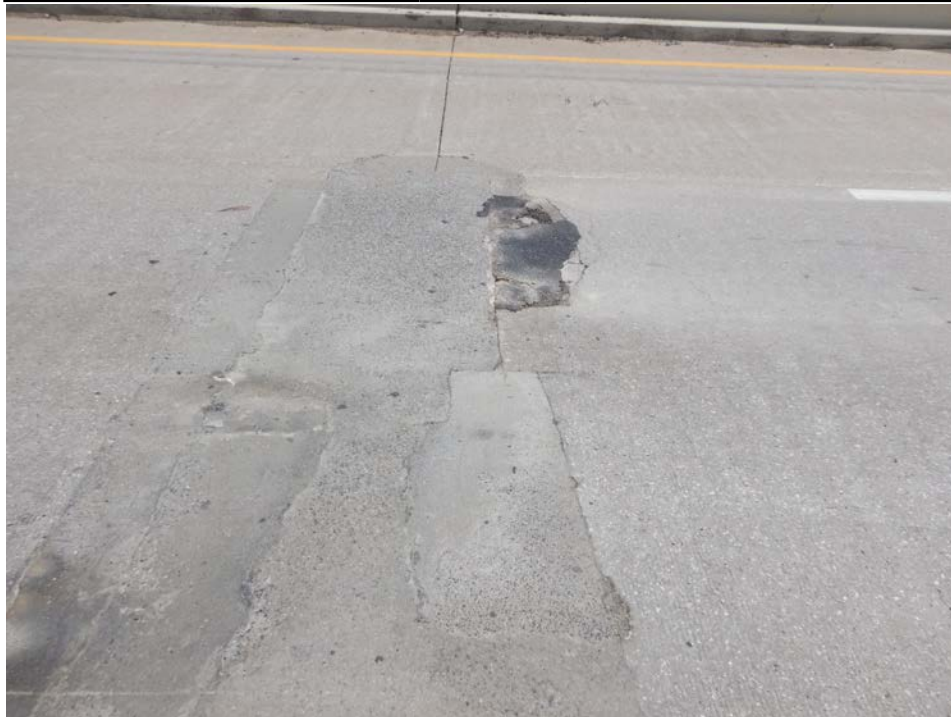
Photograph 10 - Looking south at the deck in the westbound lanes over floor beam 1, span 8. Note: patches with adjacent spalls forming along the deck control joint.

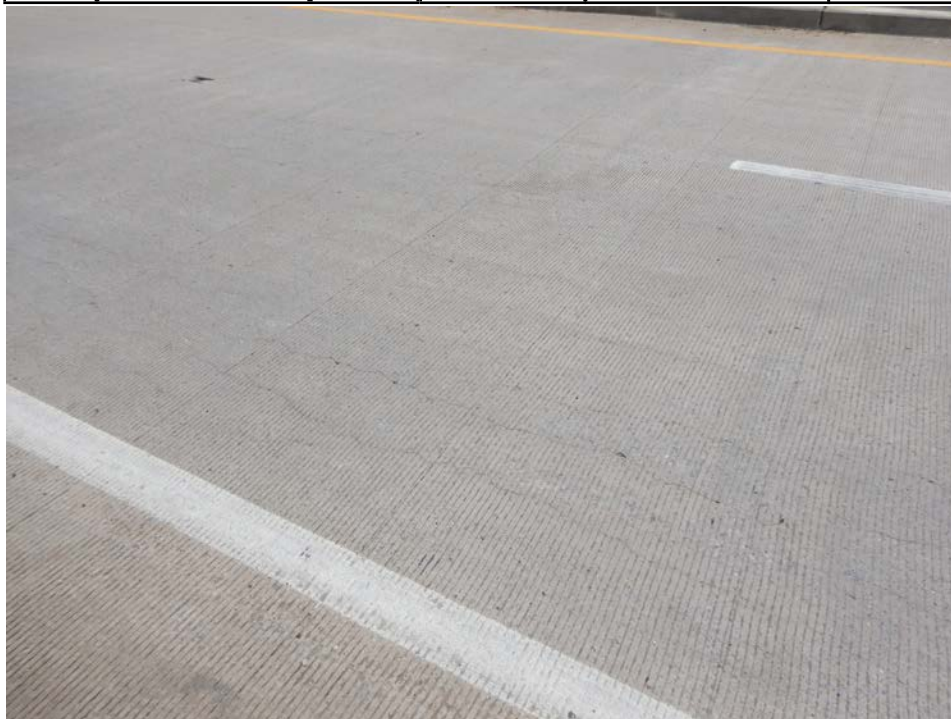
Photograph 12 - Looking southeast at the deck in the westbound lanes near mid span of span 1. Note: longitudinal cracks (typical in new section of approach beams).

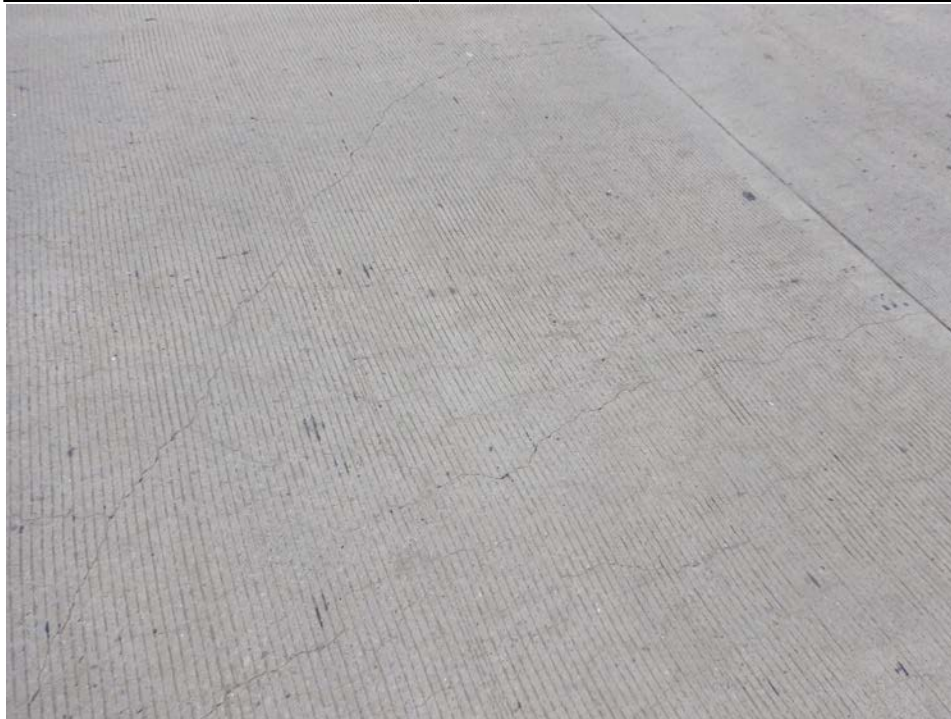
Photograph 13 - Looking south at the deck in the westbound lanes over pier 2. Note: diagonal and longitudinal cracks.

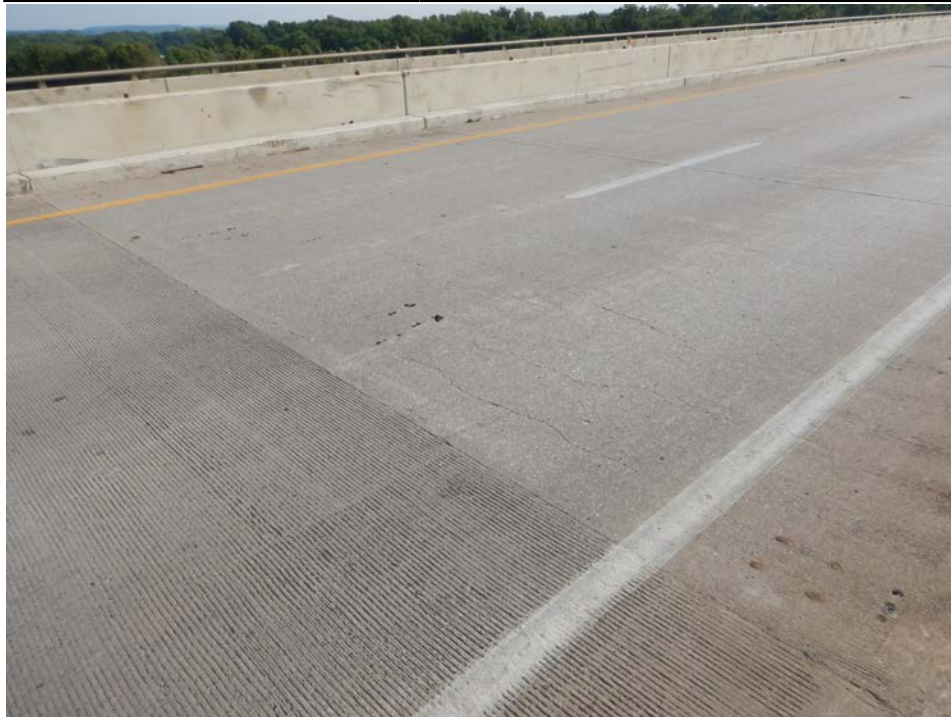
Photograph 14 - Looking northeast at the deck near floor beam 6, span 4. Note: transverse cracks in original portion of deck near the new deck section.

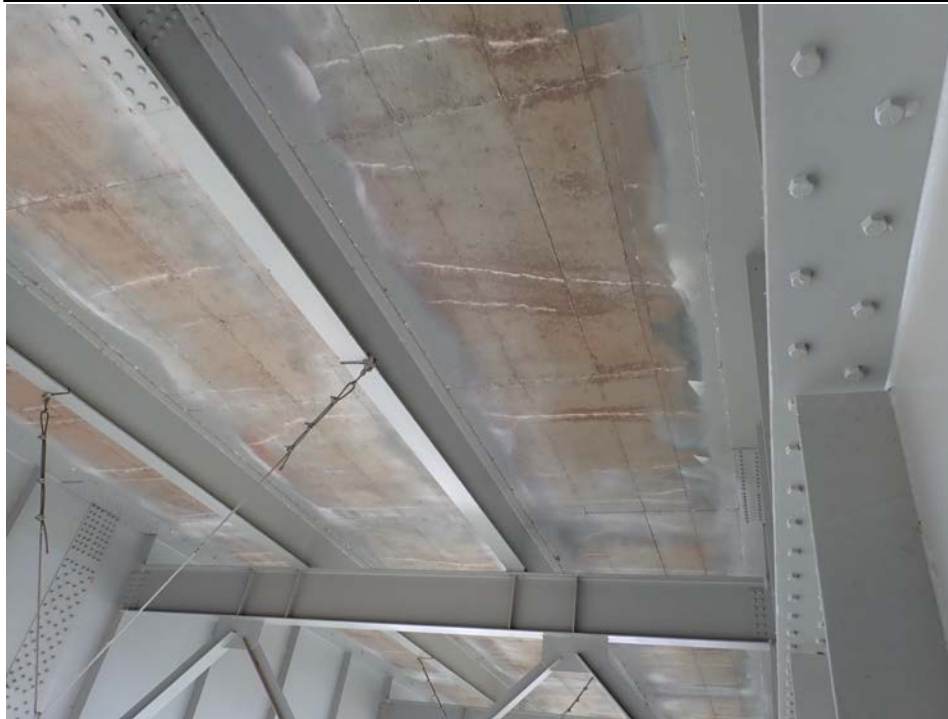
Photograph 15 - Looking northeast at the deck soffit between girders 3 and 4 near 1/3 span in span 6. Note: transverse cracking with efflorescence spaced at 3 to 6 feet.

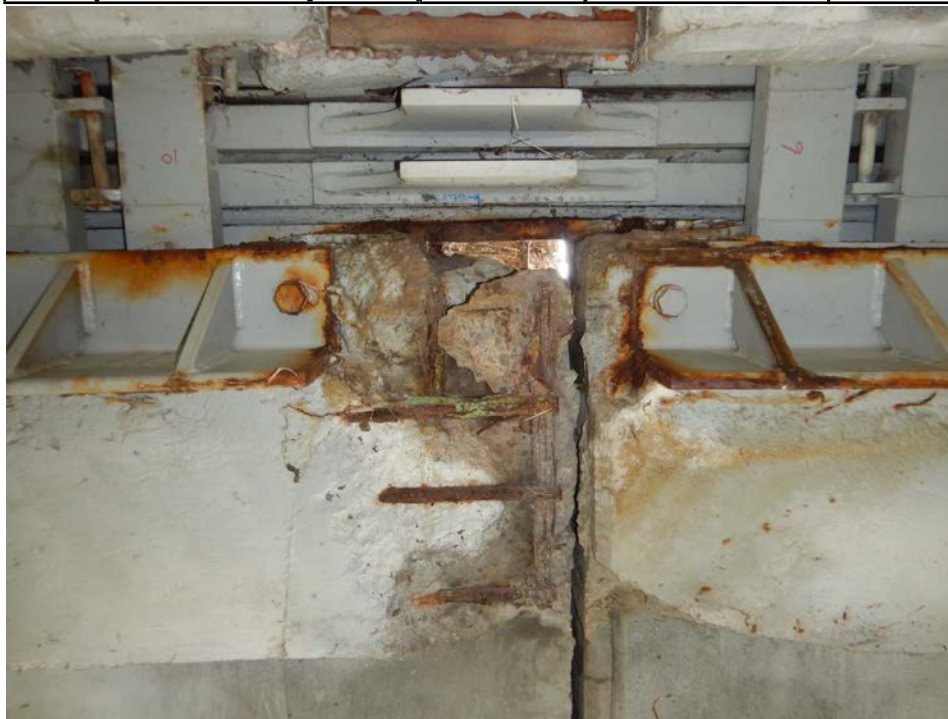
Photograph 16 - Looking east at the underside of the deck under the median at pier 3. Note: spalling with exposed reinforcing steel.

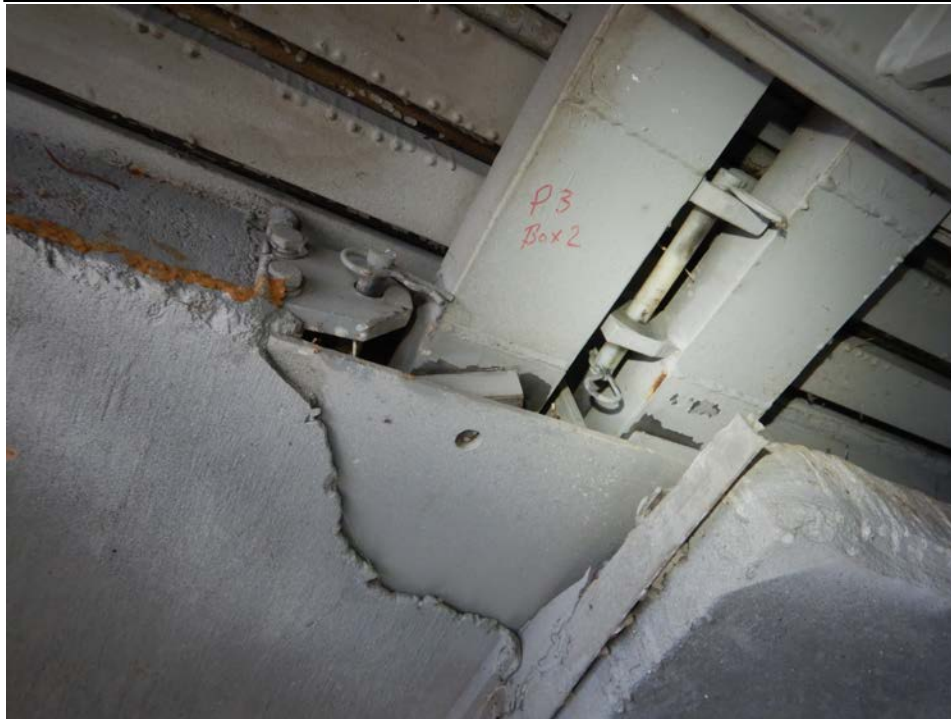
Photograph 19 - Looking northwest at the underside of the pier 3 modular joint at support box 2. Note: bottom plate of the support box is unsupported along the end of span 3. Equidistant spring between support bars is missing (typical).

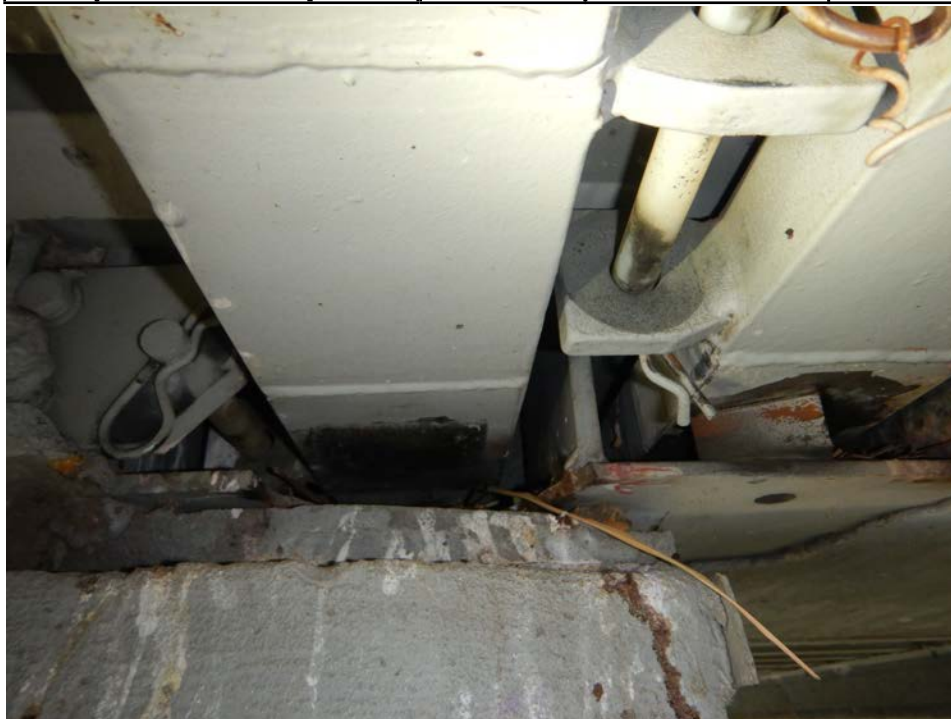
Photograph 20 - Looking west at the underside of the pier 3 modular joint at support box 3. Note: bottom plate of support box has fractured and west end of support bar 1 is unsupported. Bearing block for support bar 2 is dislodged. Stainless steel sliding surface is painted.

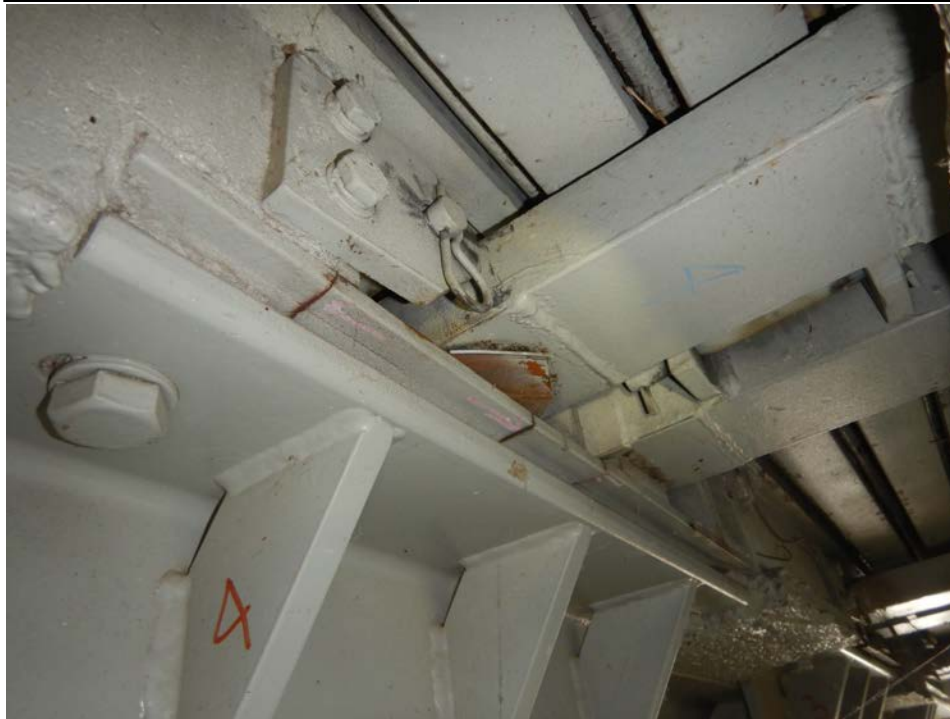
Photograph 21 - Looking southeast at the underside of the pier 3 modular joint at support box 4. Note: the bottom plate of support box has fractured and support bar 2 is unsupported.

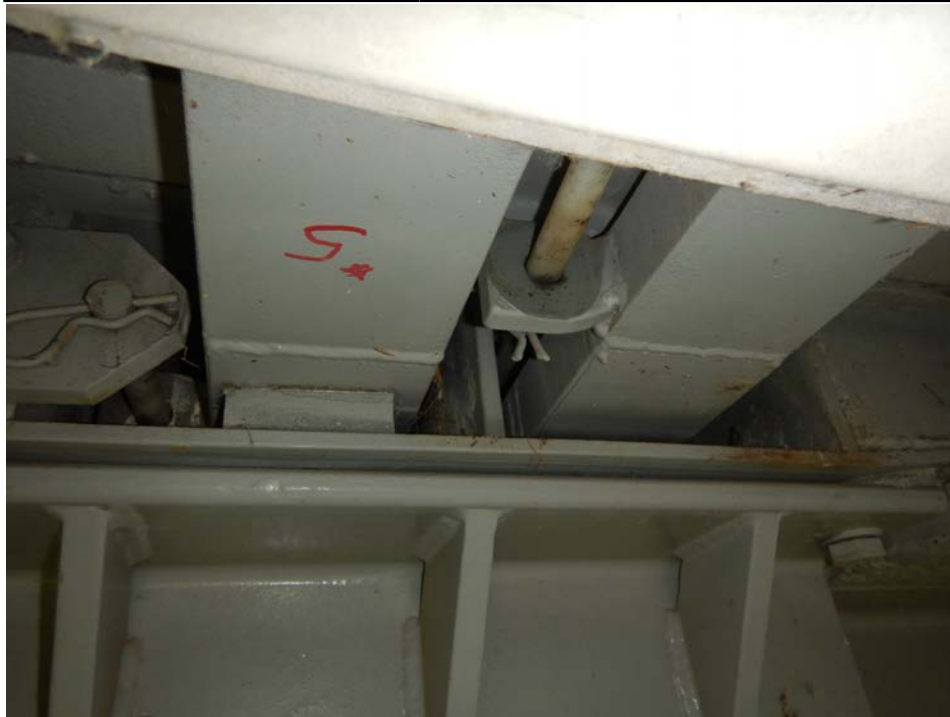
Photograph 22 - Looking east at the underside of the pier 3 modular joint at support box 5. Note: bearing block for support bar 1 is missing at the east support box. Stainless steel sliding surface is painted (typ.).

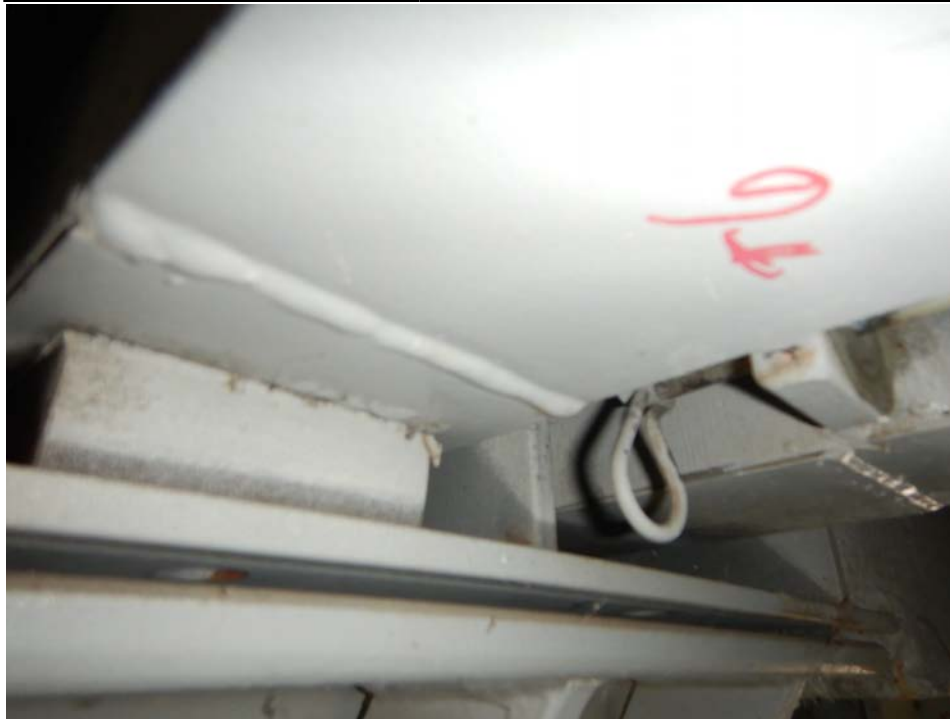
Photograph 23 - Looking southeast at the underside of the pier 3 modular joint at support box 6. Note: bearing block for support bar 1 is missing at the east support box.. Stainless steel sliding surface is painted.

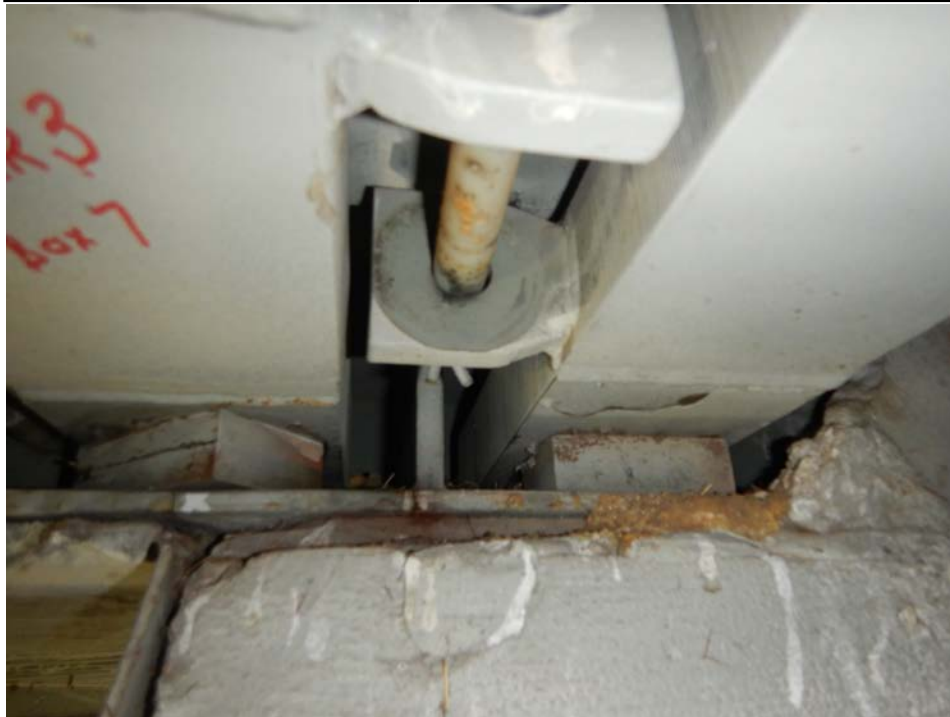
Photograph 24 - Looking west at the underside of the pier 3 modular joint at support box 7. Note: bottom plate of bearing support box is fractured adjacent to vertical plate.

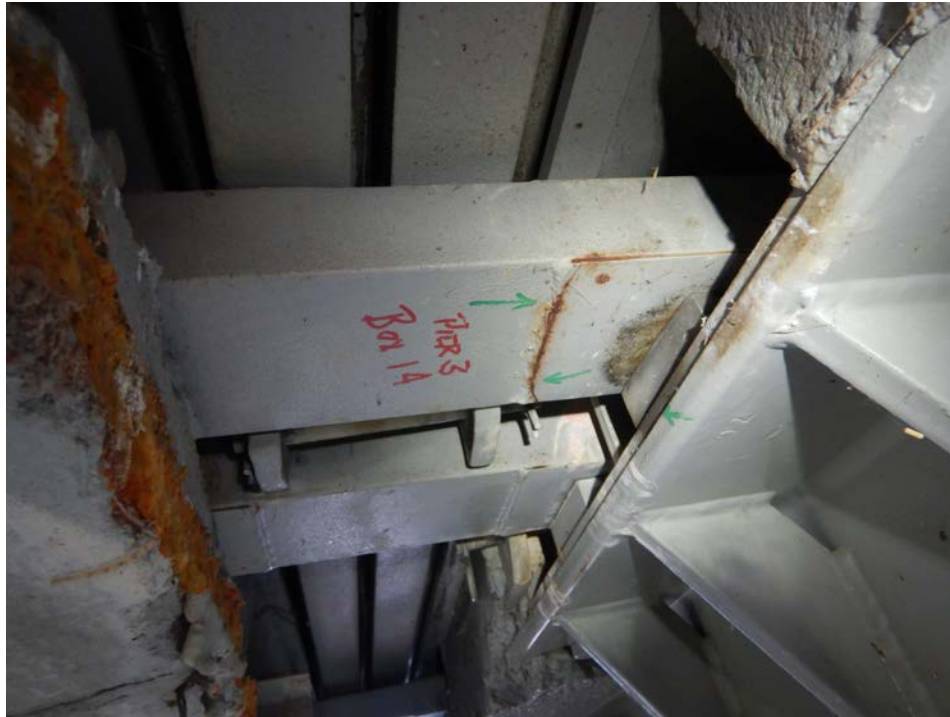
Photograph 25 - Looking northeast at the underside of the pier 3 modular joint at support box 14. Note: stainless steel plate welded to support bar 1 at the east bearing box has fractured near the west weld.

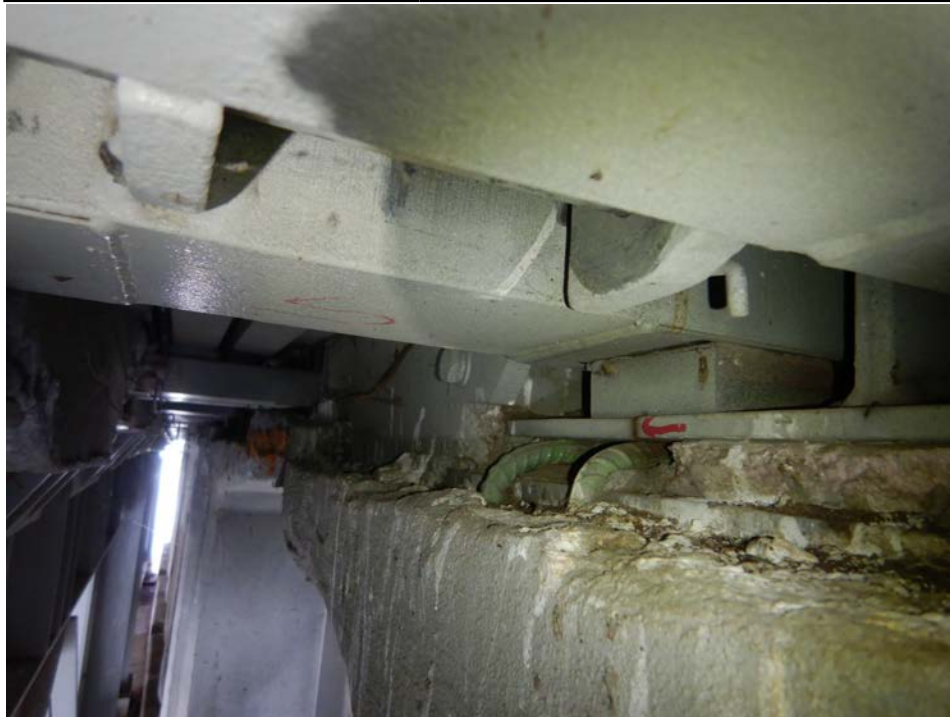
Photograph 26 - Looking southwest at the underside of the pier 3 modular joint at support box 15. Note: bottom plate of the west support box is fractured beneath the bearing block for support bar 1. Composite reinforcing extending up from beam 10 is exposed with no concrete under support box.

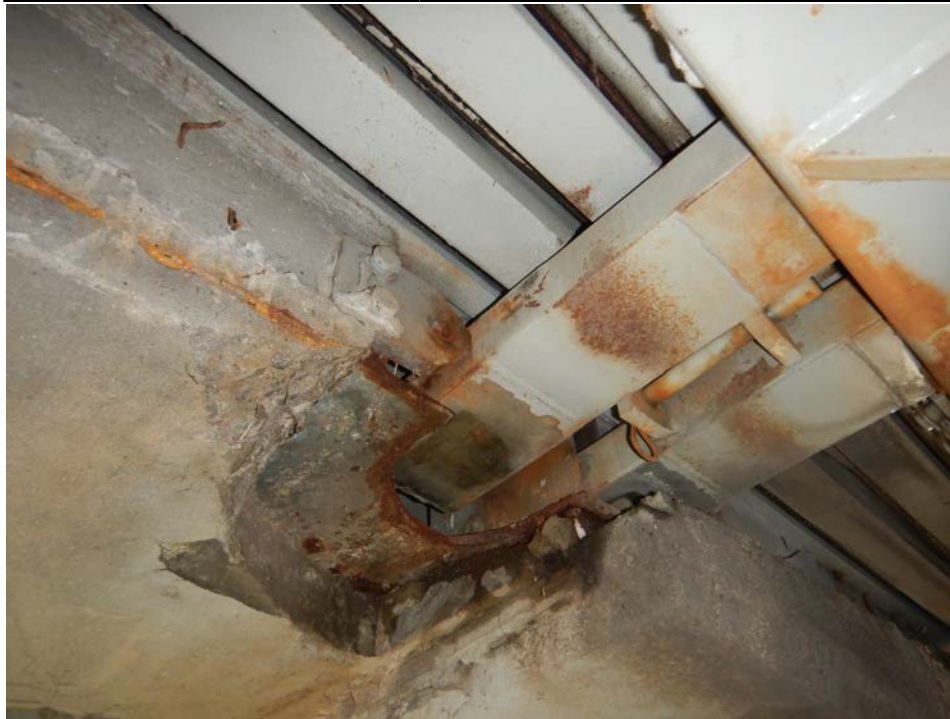
Photograph 27 - Looking northwest at the underside of the pier 3 modular joint at support box 16. Note: bottom plate of the west support box has fractured away and the west end of support bar 1 is unsupported.

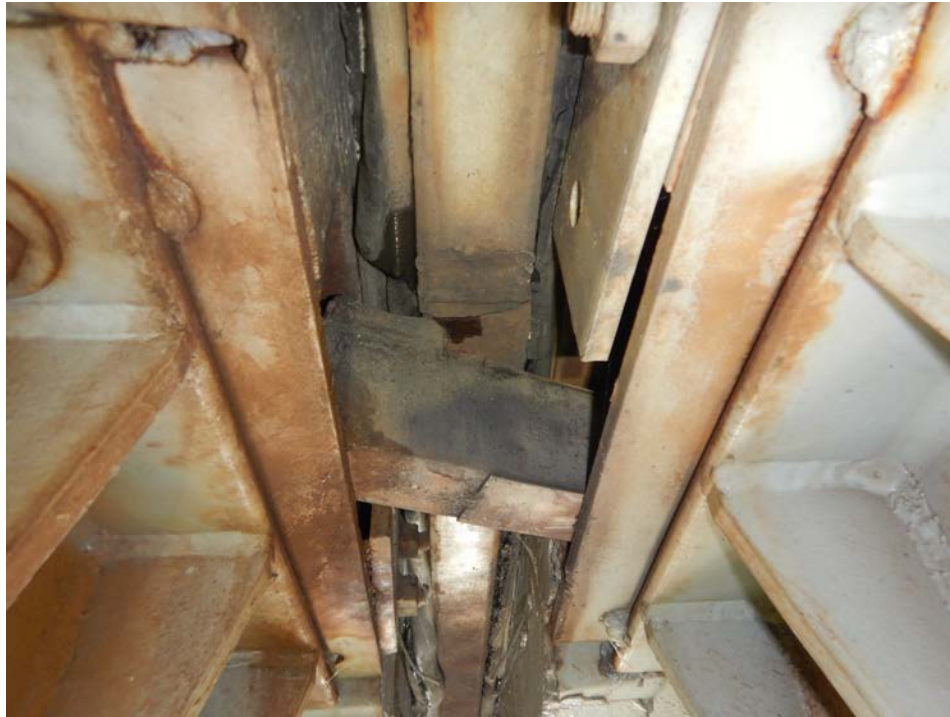
Photograph 29 - Looking south at the underside of the pier 6 modular joint at support box 2. Note: transverse separation beam fractured. Support bar has broken away from the transverse separation beam.

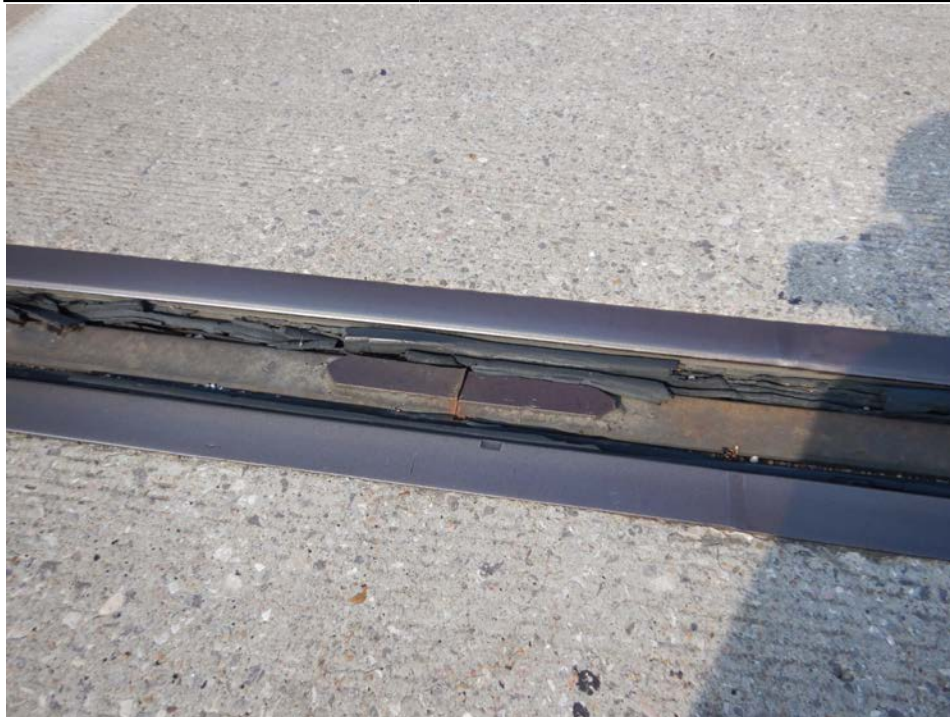
Photograph 30 - Looking west at the modular expansion joint in the south eastbound lane at pier 6. Note: repair of the transverse separation beam has failed and beam has dropped 1 inch.

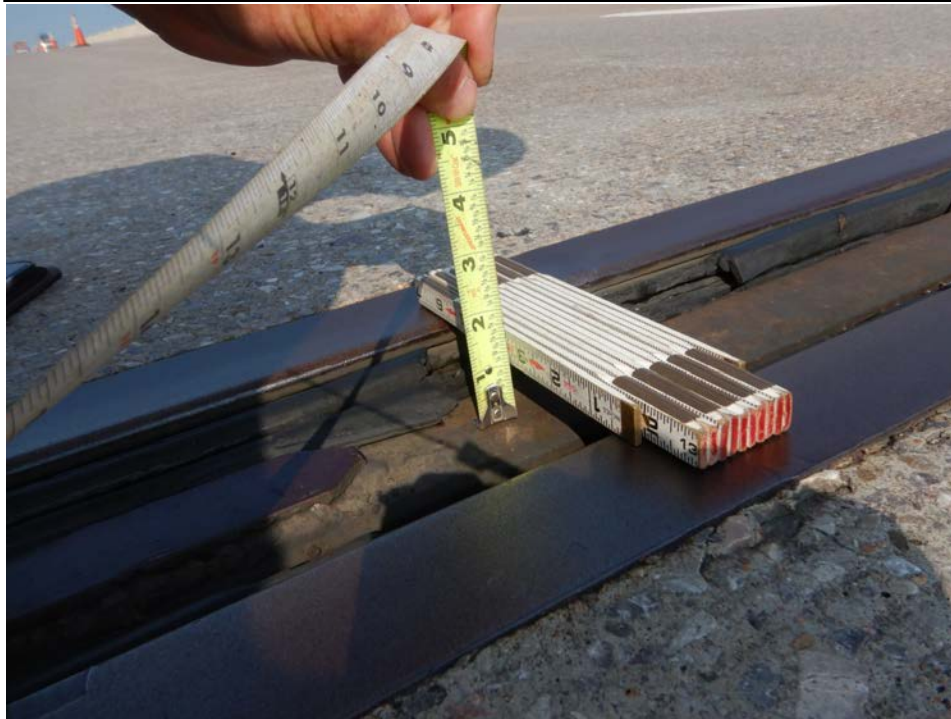
Photograph 31 - Looking northwest along the modular expansion joint in the south eastbound lanes at pier 6. Note: repair of the transverse separation beam has failed and beam has dropped 1 inch.

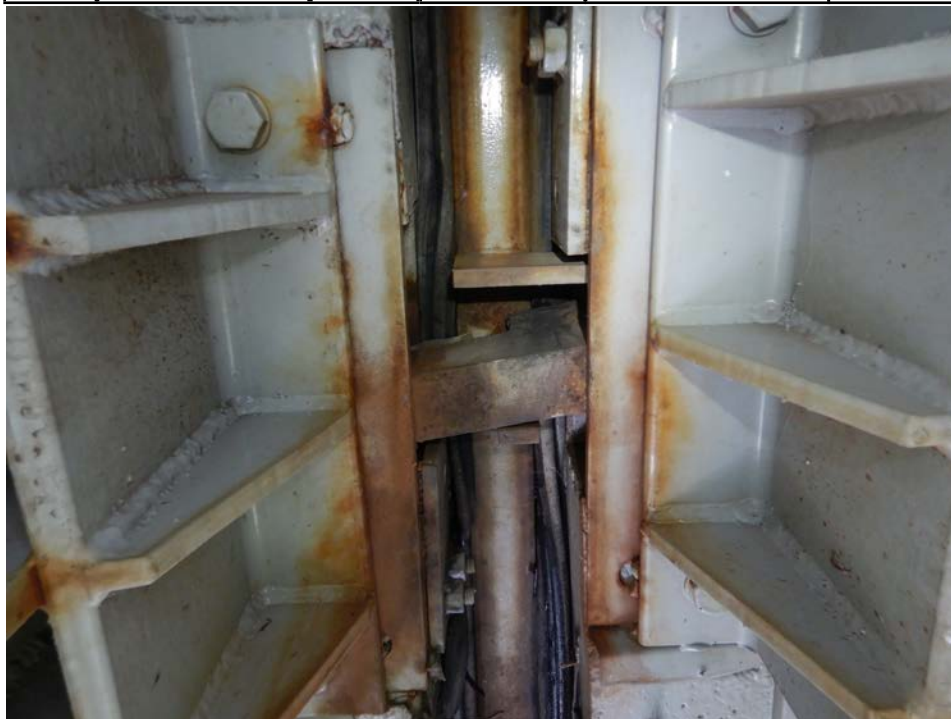
Photograph 32 - Looking south at the underside of the pier 6 modular joint at support box 3. Note: support bar has broken away from the transverse separation beam.

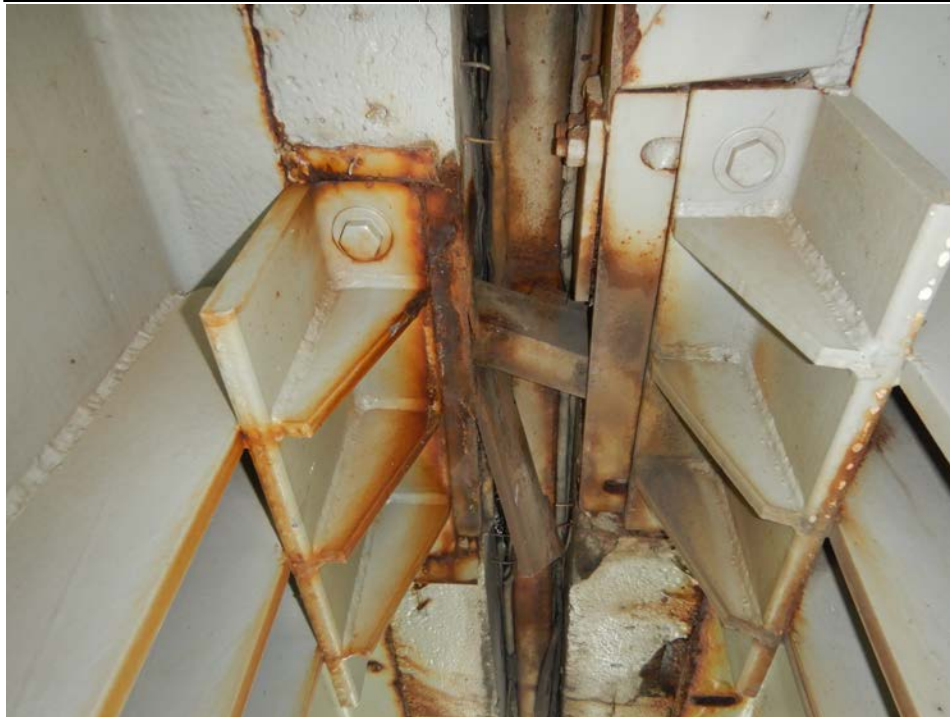
Photograph 33 - Looking north at the underside of the pier 6 modular joint at support box 13. Note: support bar has broken away from the transverse separation beam. One equidistant bar is missing and the other is loose.

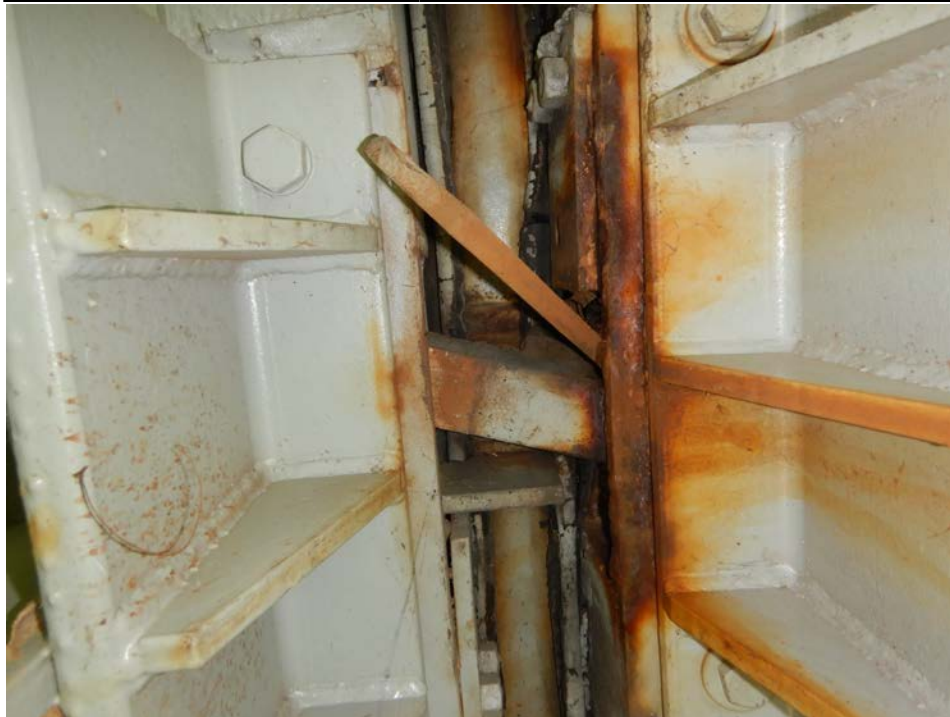
Photograph 35 - Looking up at the underside of the pier 10 modular joint at support box 4. Note: support beam is no longer attached to the transverse support beam and has slid east. South equidistant bar has broken and is wedged in place.

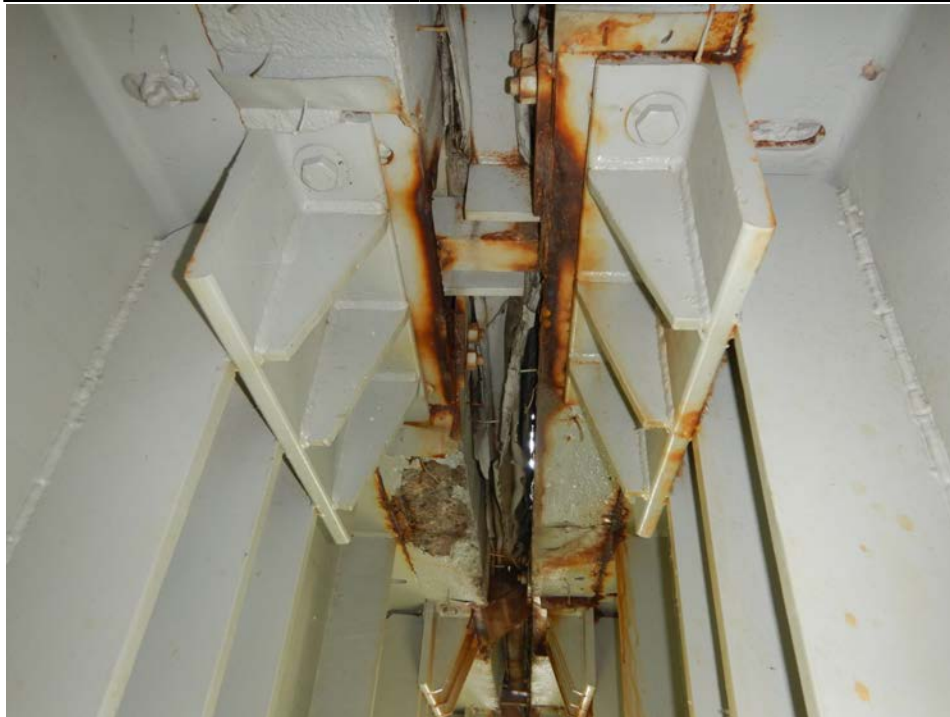
Photograph 37 - Looking north at the underside of the pier 6 modular joint between support boxes 9 and 10. Note: equidistant bar broken away at support box 10. Joint seal deteriorated and light visible through joint.

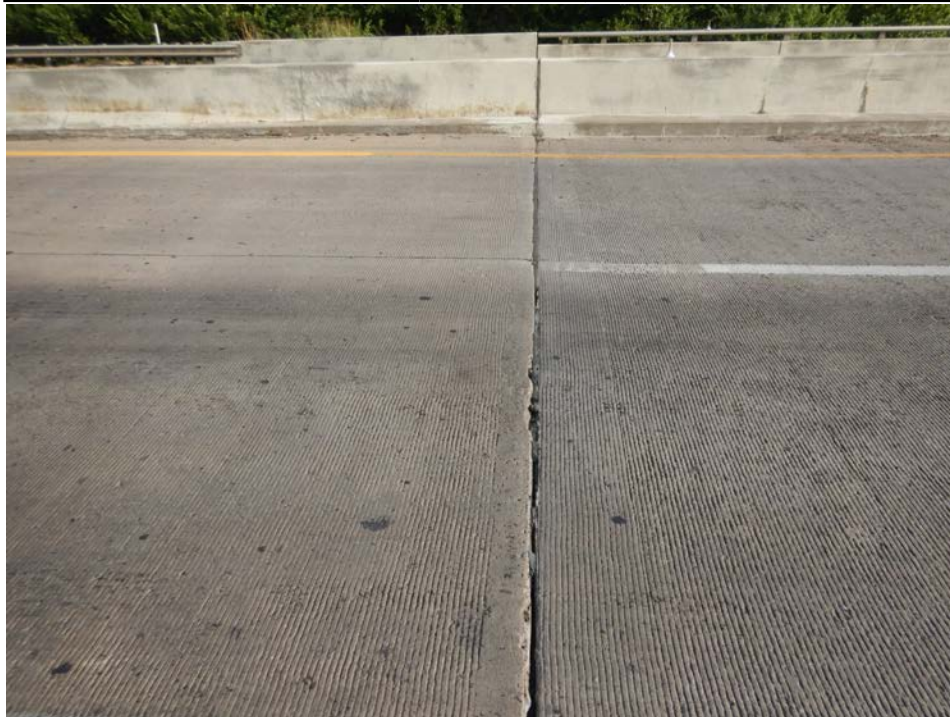
Photograph 38 - Looking north along the poured seal fixed joint at the west abutment. Note: seal is missing in south eastbound lane.

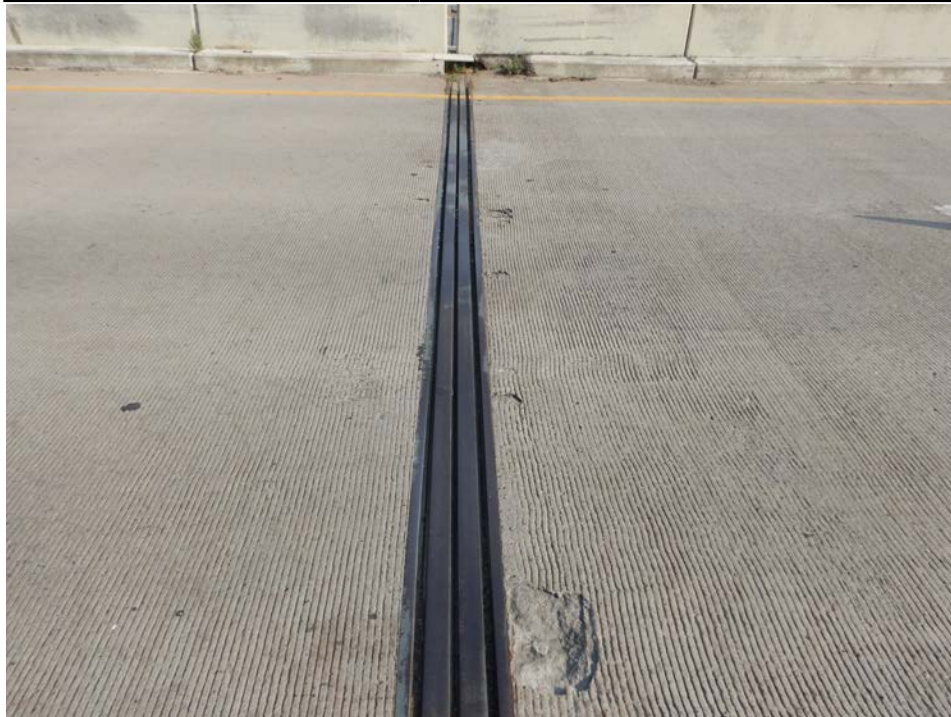
Photograph 40 - Looking north along the modular expansion joint in the eastbound lanes at pier 3. Note: spalls in the deck likely correspond with support boxes.

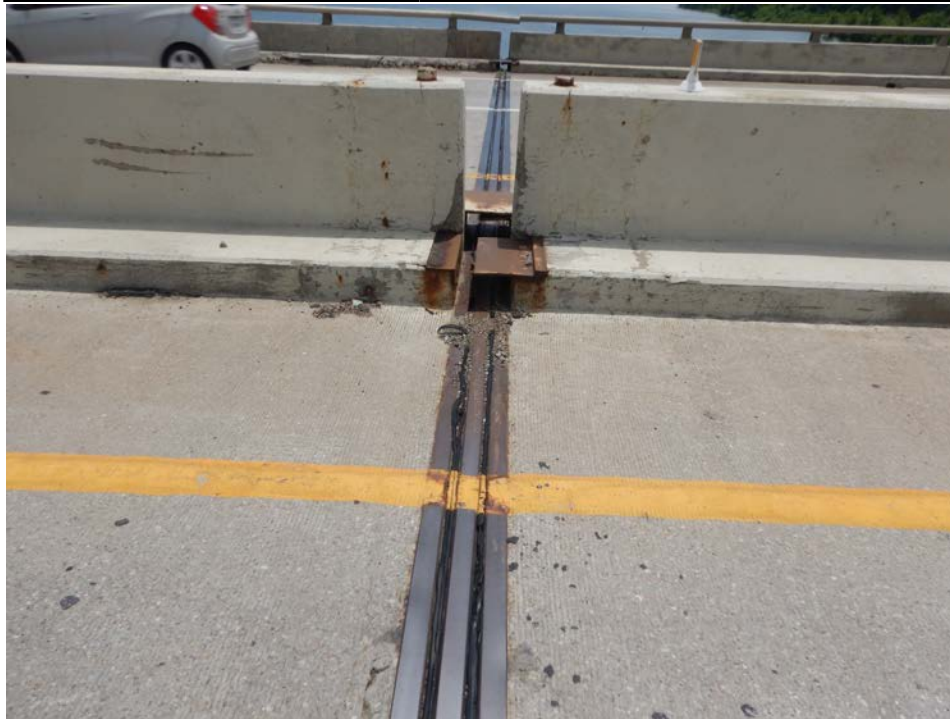
Photograph 41 - Looking south at the median at pier 6. Note: sliding plate for joint is missing.
