Fracture Critical Bridge Inspection Report

NBI Bridge No.: 17051

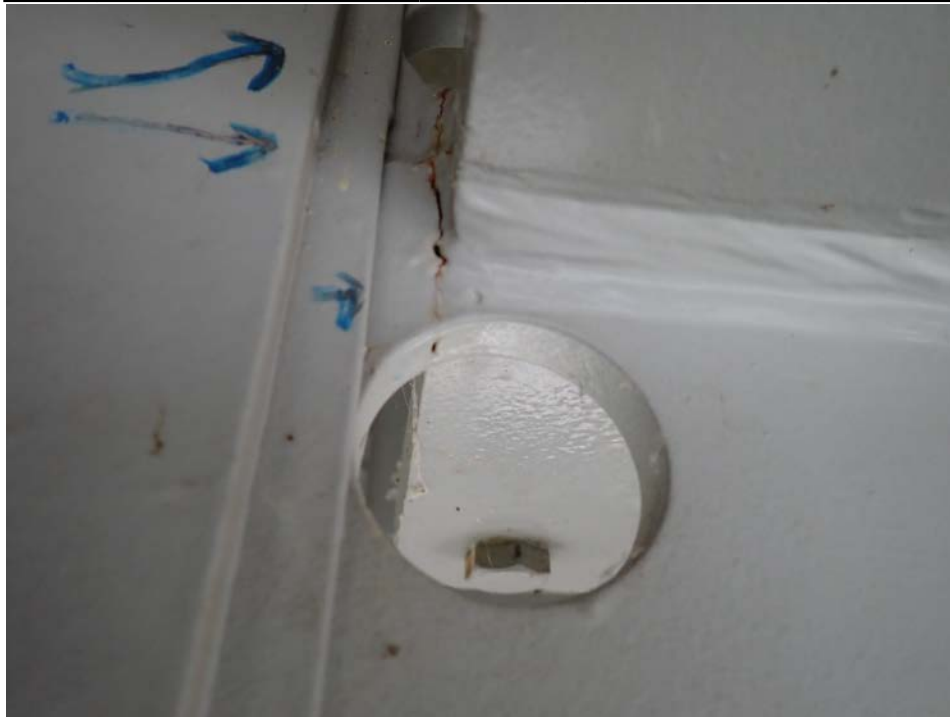
Photograph 42 - Looking north at the termination of the horizontal splice for girder 2, span 4 near floor beam 5. Note: cracks in upper and lower web of girder at horizontal splice termination have been arrested by drilled holes.

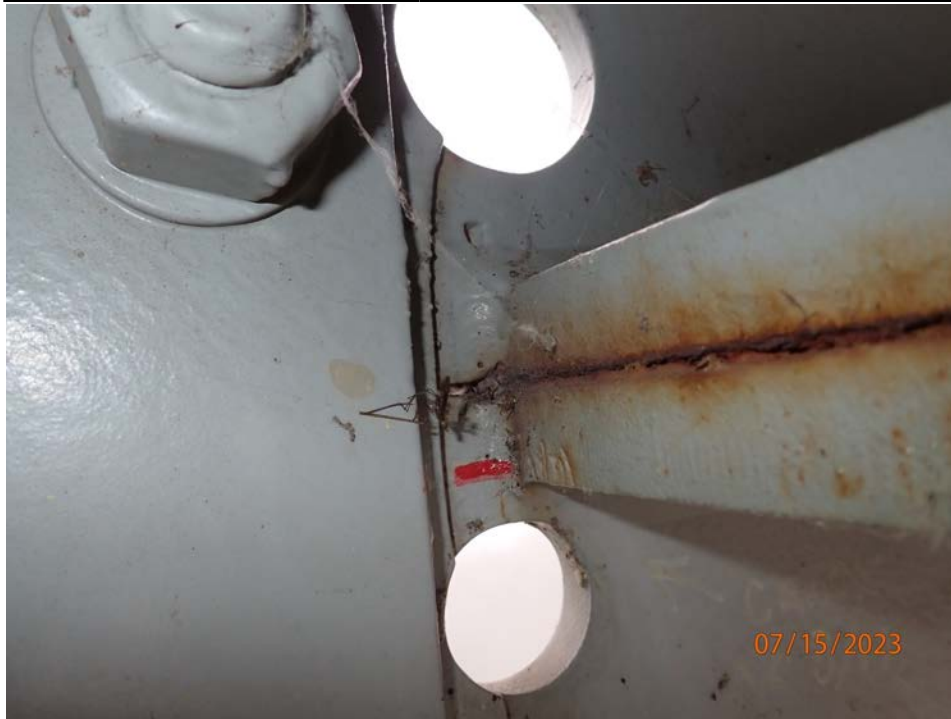
Photograph 43 - Looking north at the termination of the horizontal splice for girder 4, span 4 near floor beam 5. Note: 7/16-inch-long vertical crack in lower web between paint mark and drilled hole. Edge of fill plate for splice plate is cut by drilled holes.

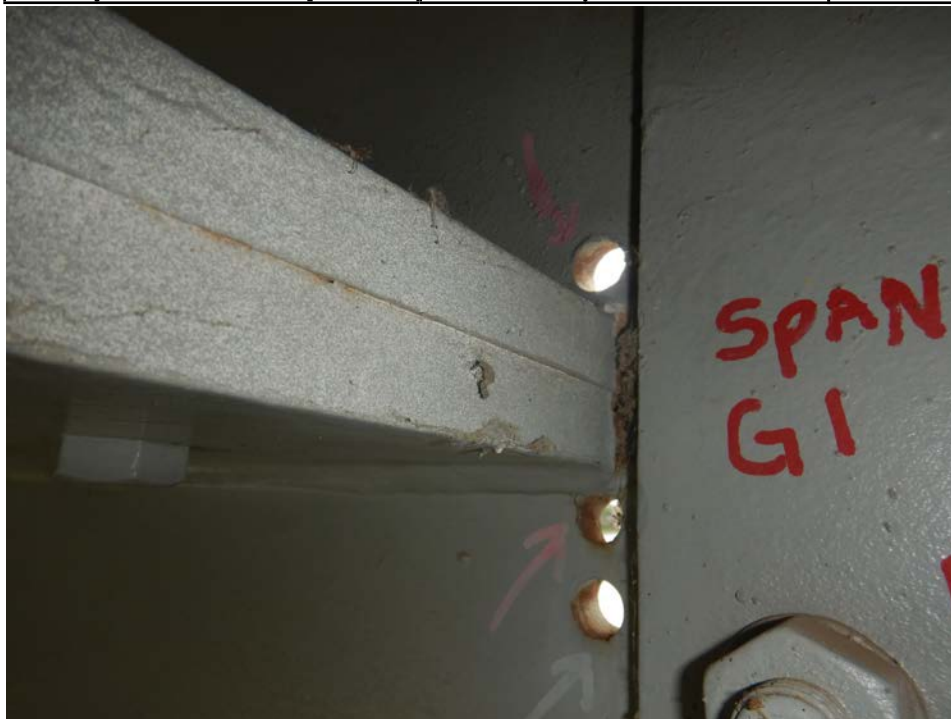
Photograph 44 - Looking south at the termination of the horizontal splice for girder 1, span 5 near floor beam 11. Note: 3/4-inch-long and 1 1/4-inch-long cracks in upper and lower web of girder at horizontal splice termination have been arrested by drilled holes.

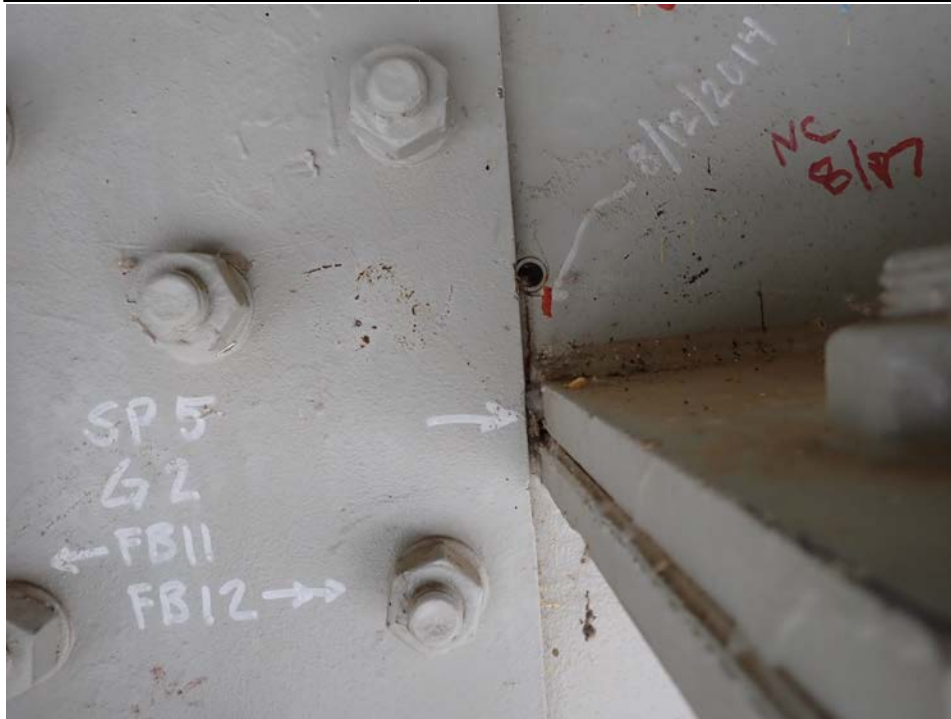
Photograph 45 - Looking north at the termination of the horizontal splice for girder 2, span 5 near floor beam 11. Note: 2-inch-long crack in upper web of girder at horizontal splice termination has been arrested by drilled hole.

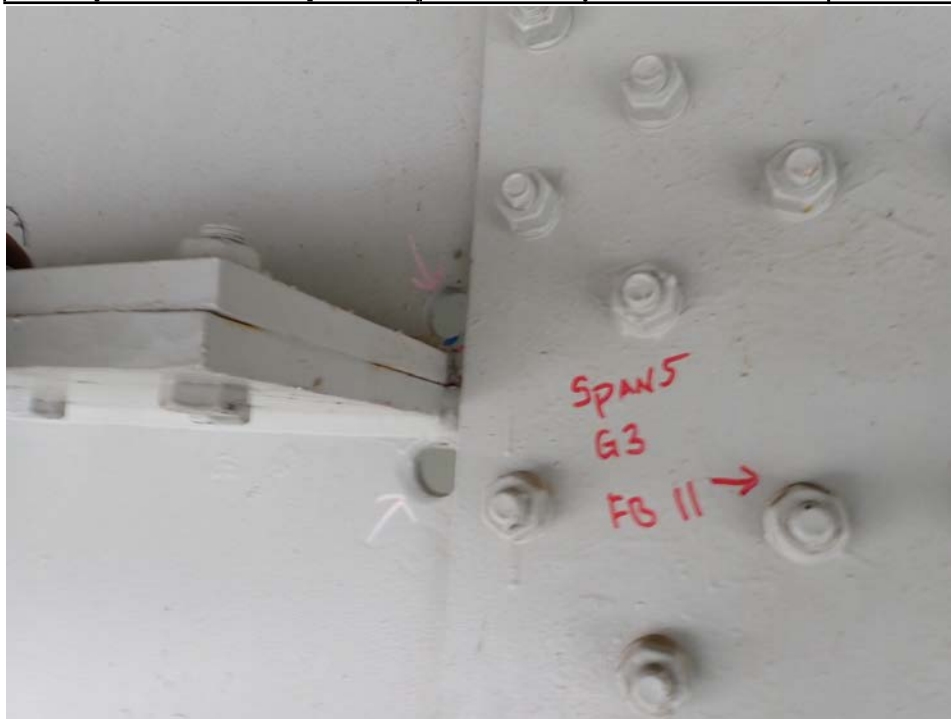
Photograph 46 - Looking southeast at the termination of the horizontal splice for girder 3, span 5 near floor beam 11. Note: 7/8-inch-long crack in upper web of girder at horizontal splice termination with drilled hole near crack termination.

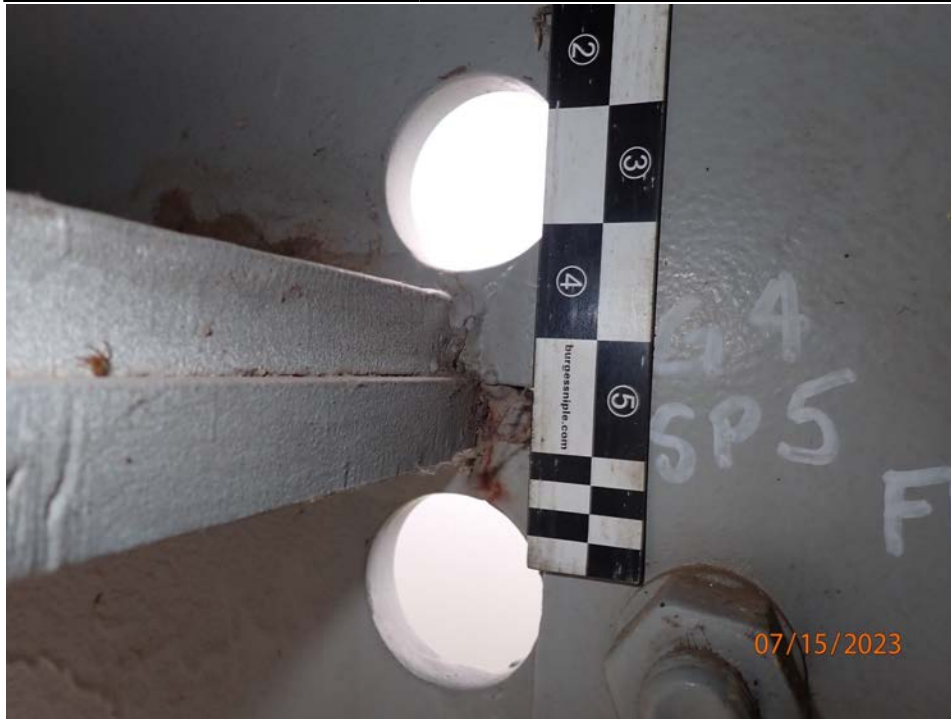
Photograph 47 - Looking north at the termination of the horizontal splice for girder 4, span 5 near floor beam 3. Note: 1 1/8-inch-long crack in upper web and 1-inch-long crack in lower web at horizontal splice termination has been arrested with drilled holes.

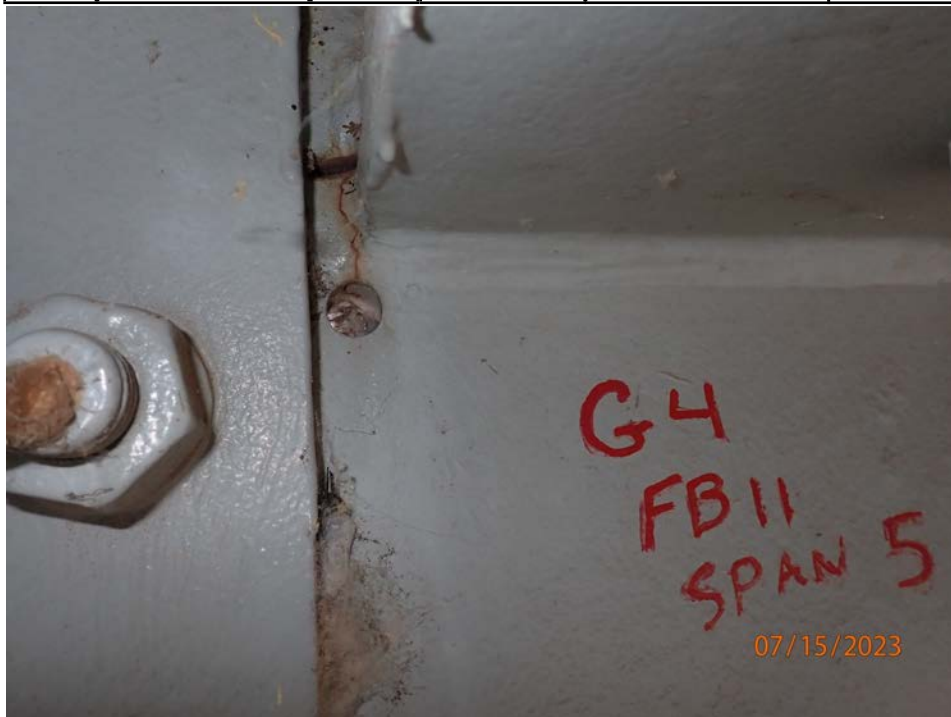
Photograph 48 - Looking north at the termination of the horizontal splice for girder 4, span 5 near floor beam 11. Note: 1-inch-long crack in lower web at horizontal splice termination has been arrested with a drilled hole.

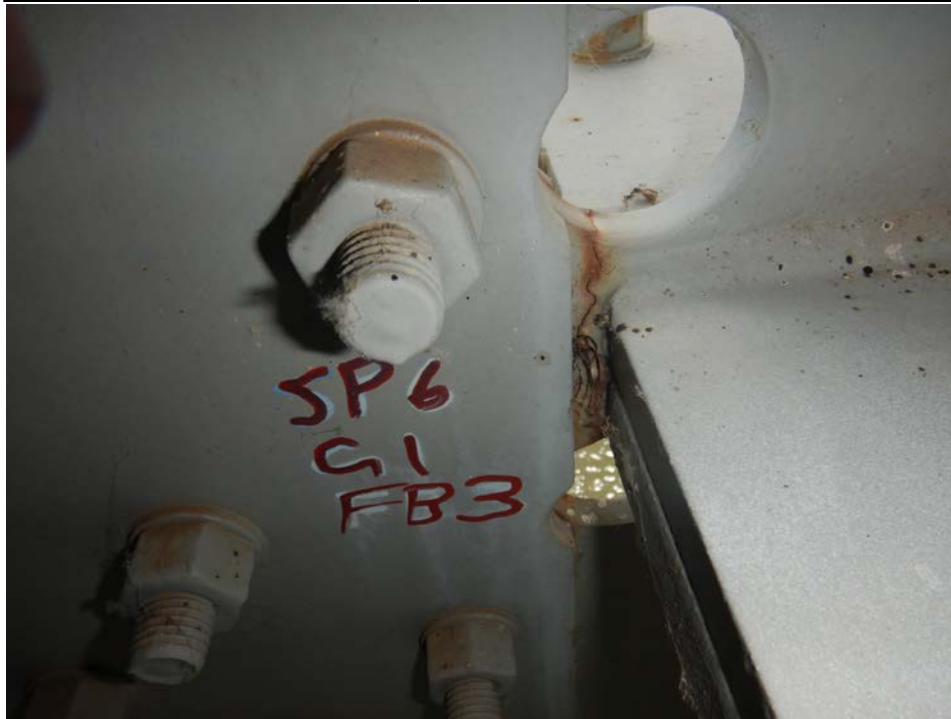
Photograph 49 - Looking south at the termination of the horizontal splice for girder 1, span 6 near floor beam 3. Note: cracks in upper and lower web at splice termination are arrested in drilled holes.

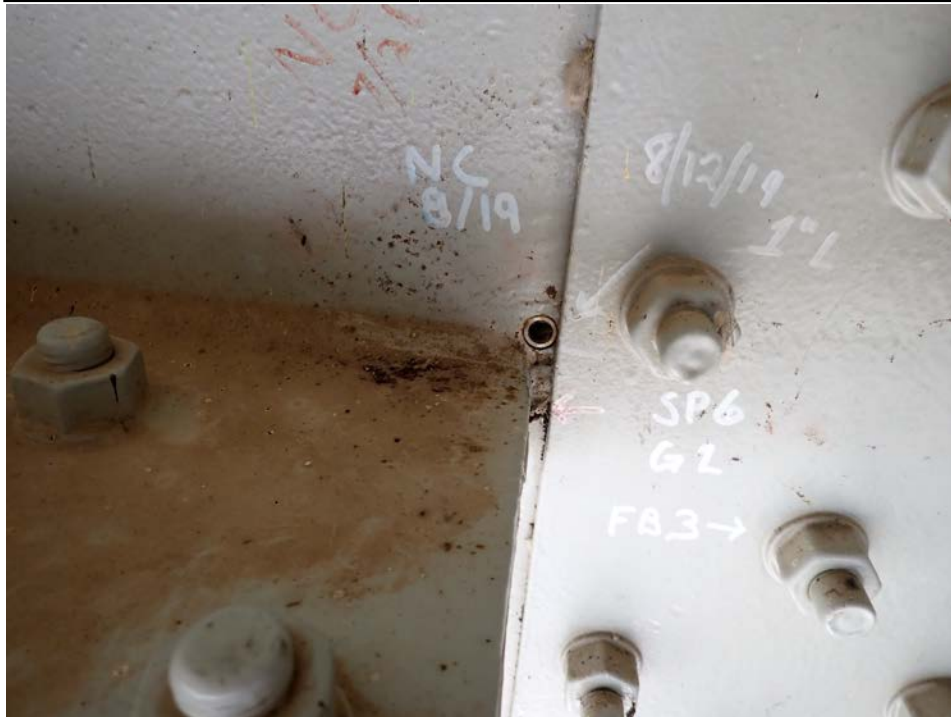
Photograph 50 - Looking north at the termination of the horizontal splice for girder 2, span 6 near floor beam 3. Note: 1-inch-long crack in upper web at horizontal splice termination has been arrested with drilled holes.

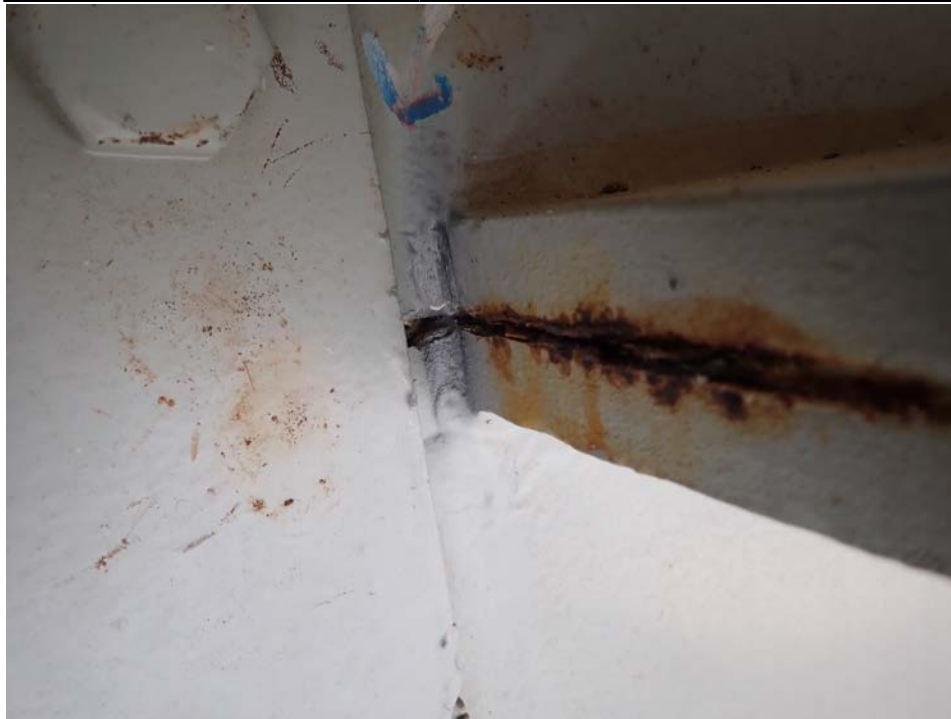
Photograph 51 - Looking south at the termination of the horizontal splice for girder 3, span 6 near floor beam 3. Note: paint crack in upper web at horizontal splice.

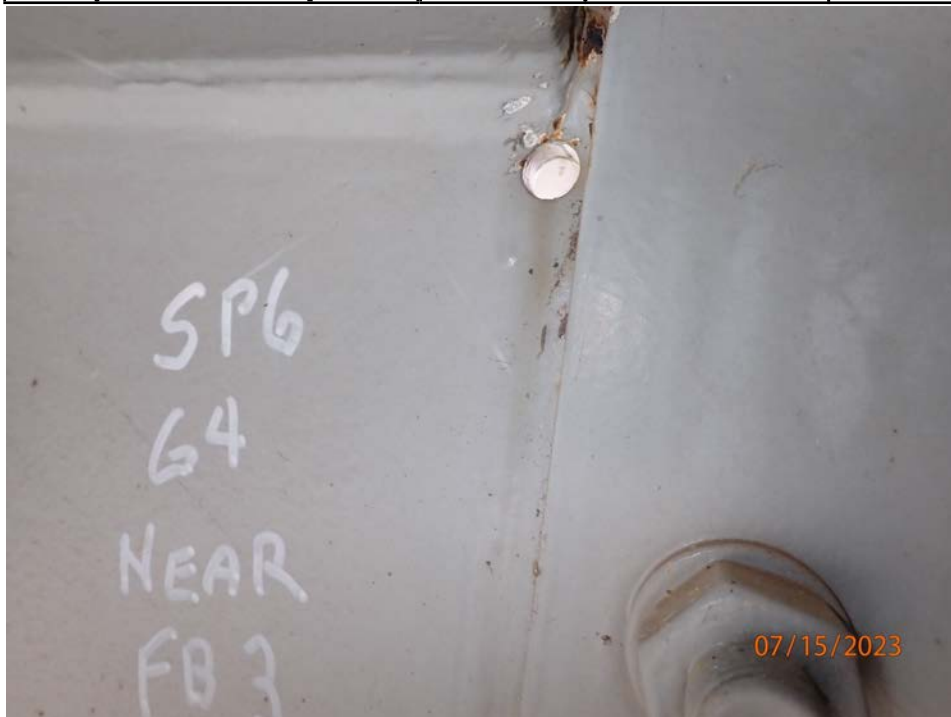
Photograph 52 - Looking north at the horizontal splice plate at girder 4 west of floor beam 3 at span 6. Note: lower web contains a 1 1/4-inch-long crack arrested with a drilled hole.

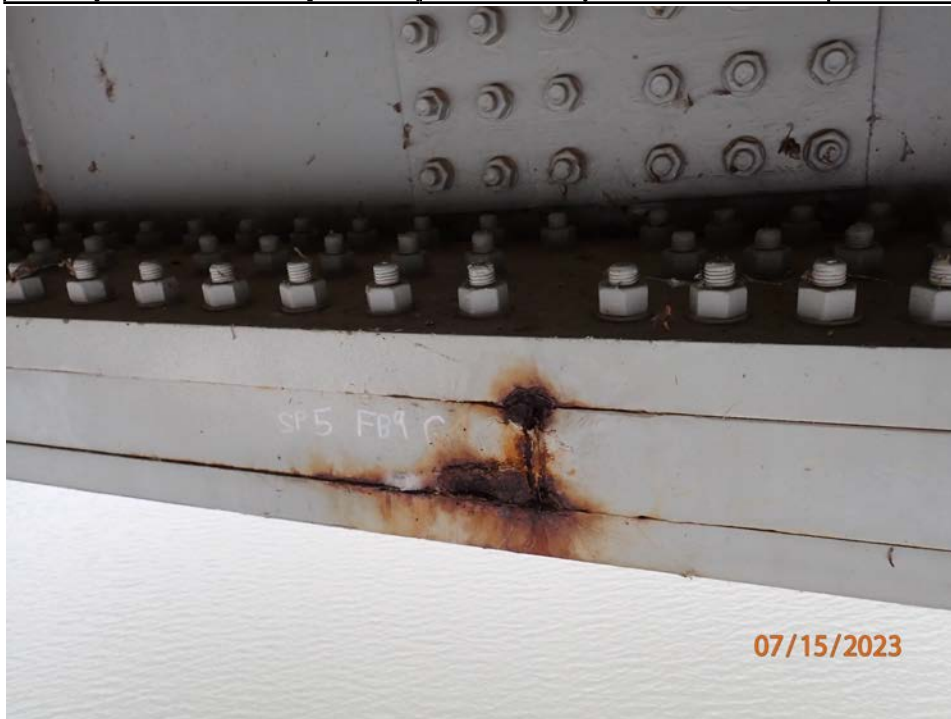
Photograph 55 - Looking northwest at the bottom flange bolted field splice for girder 4, span 5 at floor beam 9. Note: pack rust with minor section loss to the splice plates.

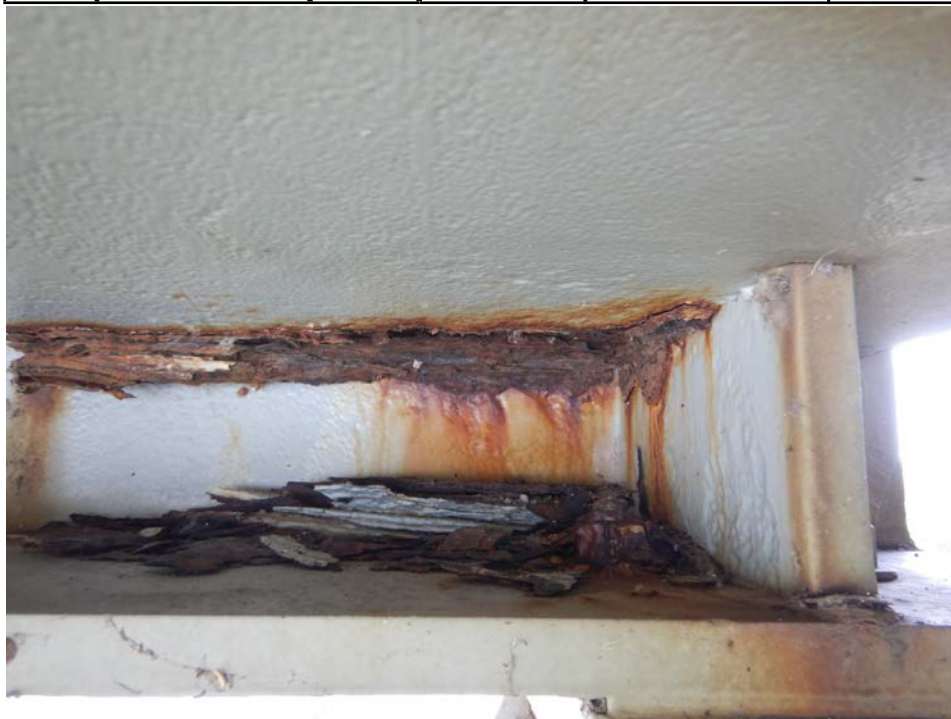
Photograph 56 - Looking north below the lateral bracing gusset plate connection to girder 4 at pier 6. Note: laminating corrosion and section loss exists in the girder web.

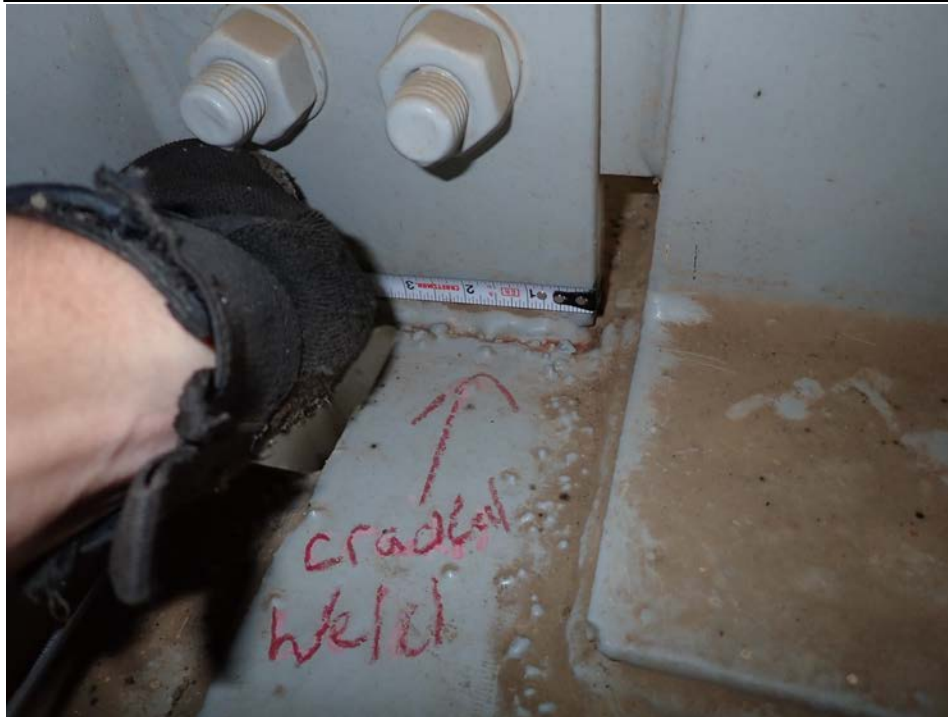
Photograph 57 - Looking west at the connection stiffener for girder 3, span 6 at floor beam 3. Note: 3-inch-long crack in the weld to the lateral bracing gusset plate.

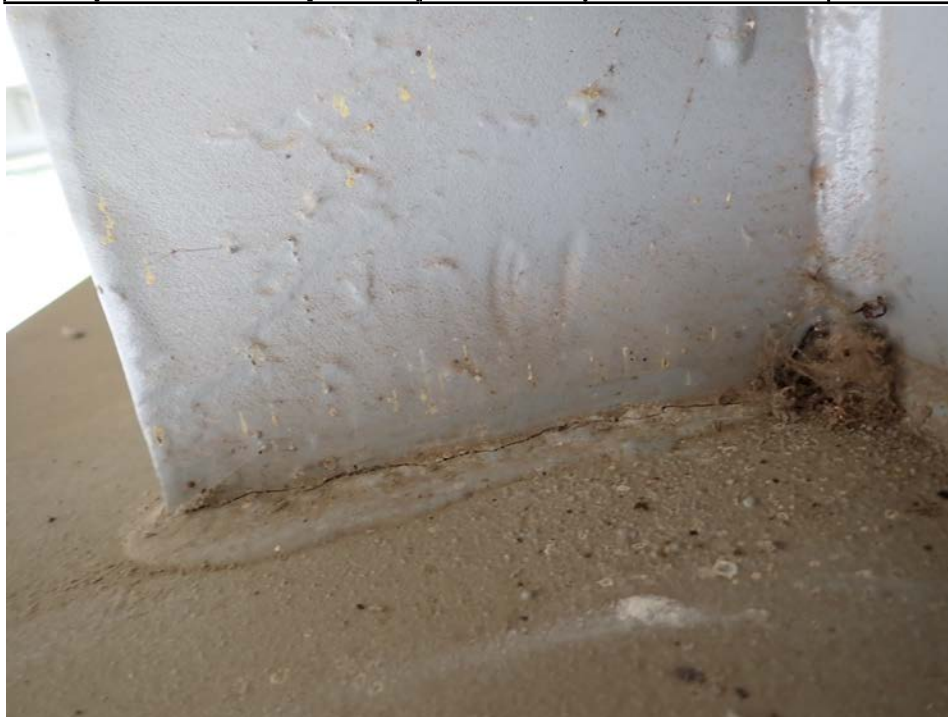
Photograph 58 - Looking east at the connection stiffener for girder 3, span 6 at floor beam 4. Note: paint crack at the interface with the girder bottom flange.

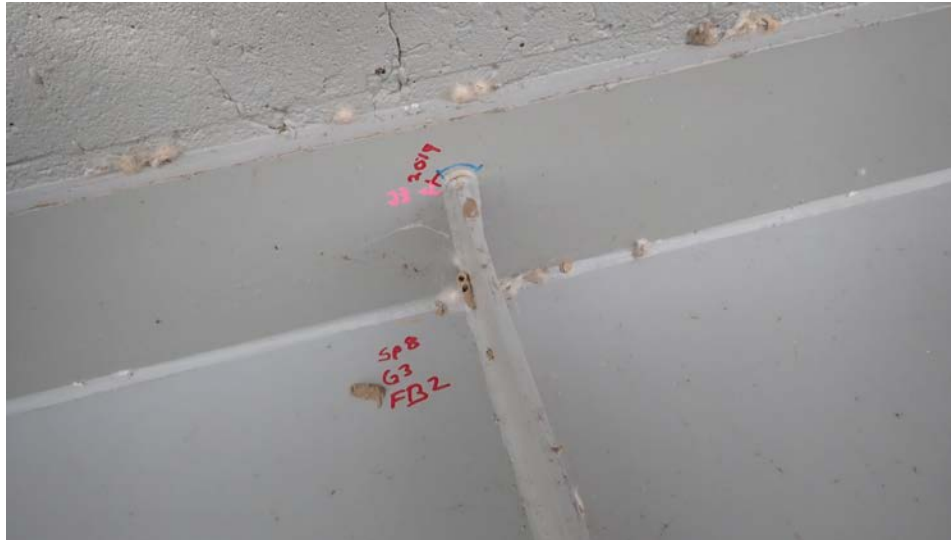
Photograph 59 - Looking south at the vertical stiffener for girder 3, span 8 at floor beam 2. Note: 1 3/4-inch-long paint crack in the weld to the top flange.

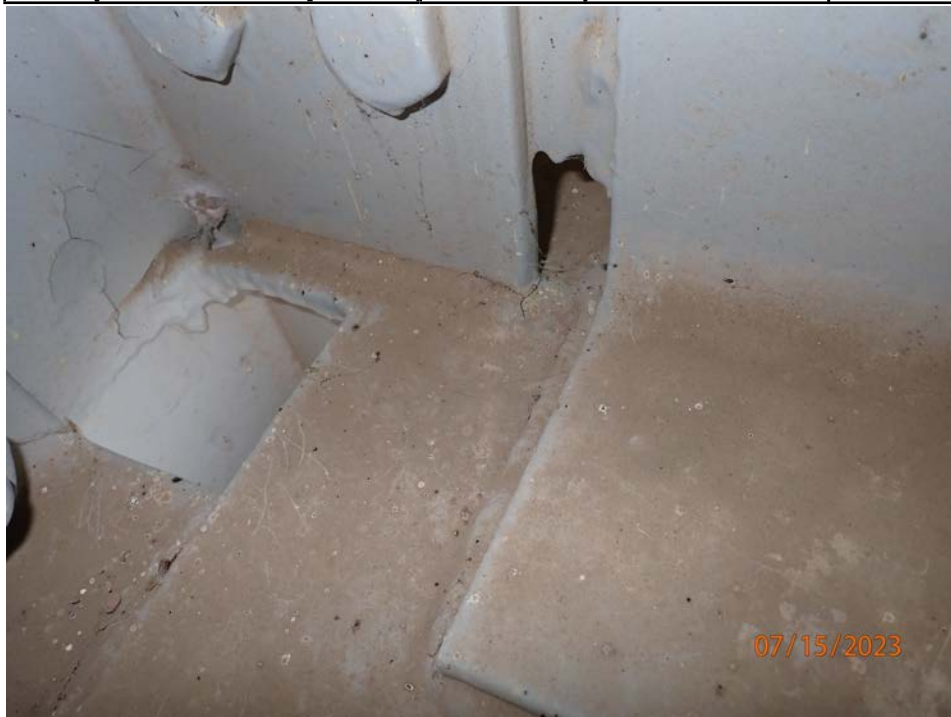
Photograph 60 - Looking east at the connection stiffener at girder 4, span 8 at floor beam 2. Note: 3 1/2-inch-long paint crack at the weld to the lateral bracing gusset plate.

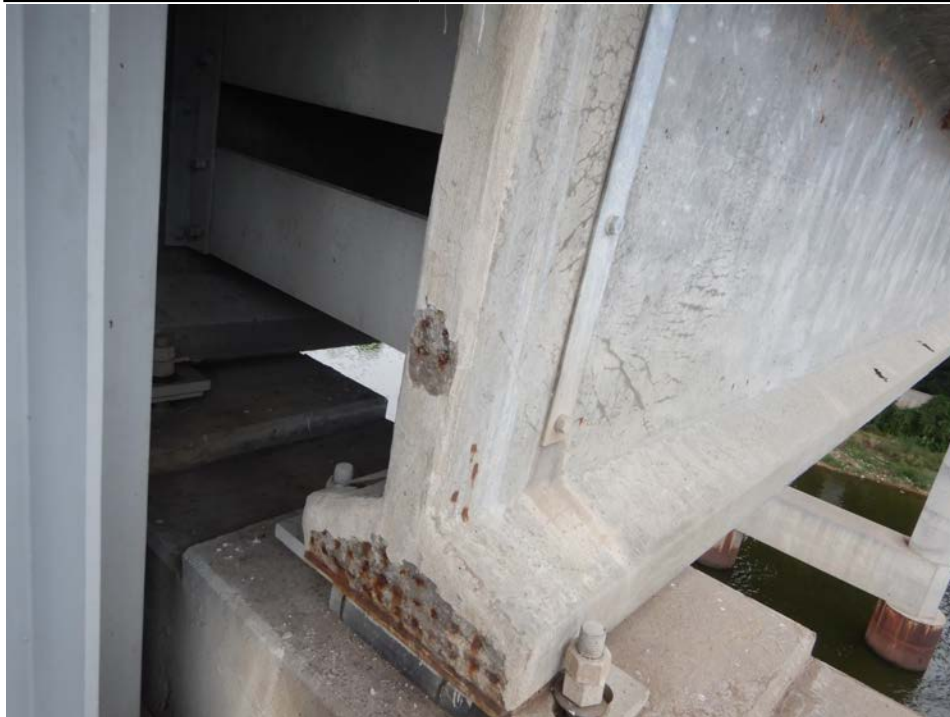
Photograph 62 - Looking southwest at prestressed beam 12, span 3 at pier 3. Note: strands exposed in the end of the beam (26 in bottom flange and 4 in web), corrosion stains and cracks with discolored concrete in web.

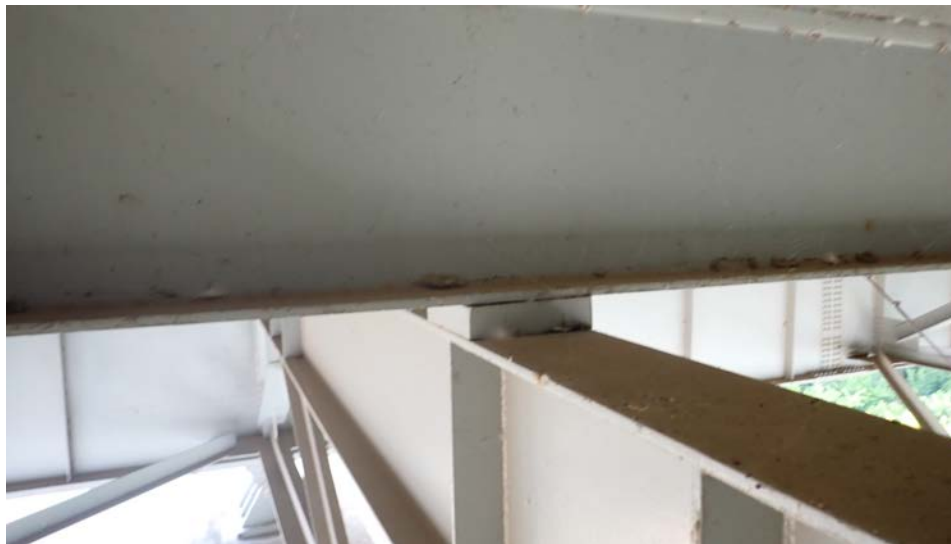
Photograph 64 - Looking northeast at stringer 3, span 10 over the floor beam 0. Note: all 4 anchor bolts are missing.

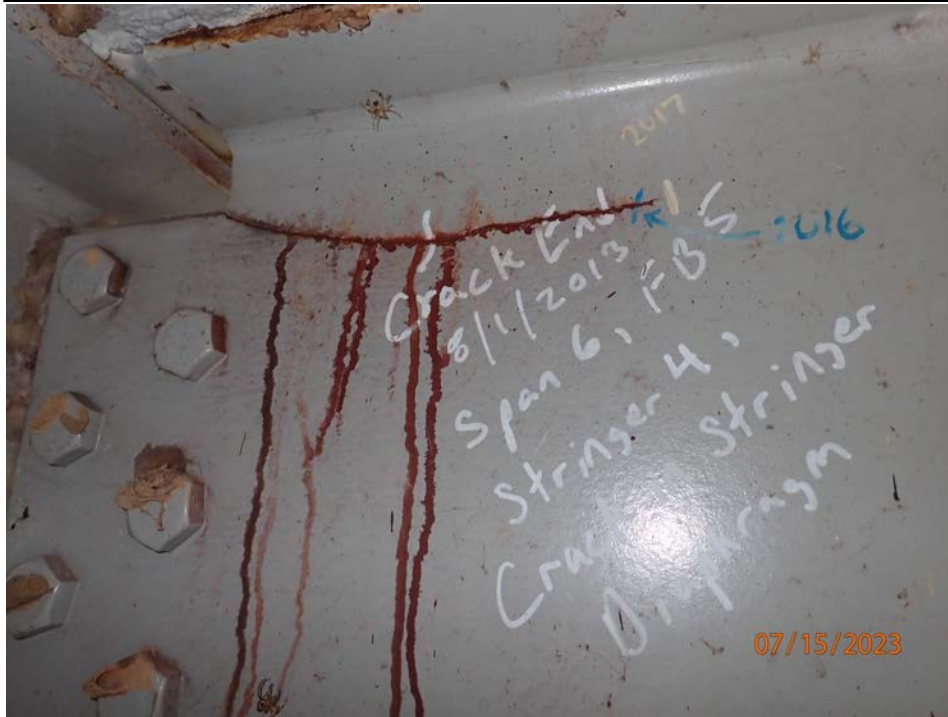
Photograph 65 - Looking east at the stringer diaphragm connection to stringer 4 at floor beam 5, span 6. Note: 8 1/2-inch-long horizontal crack in web.

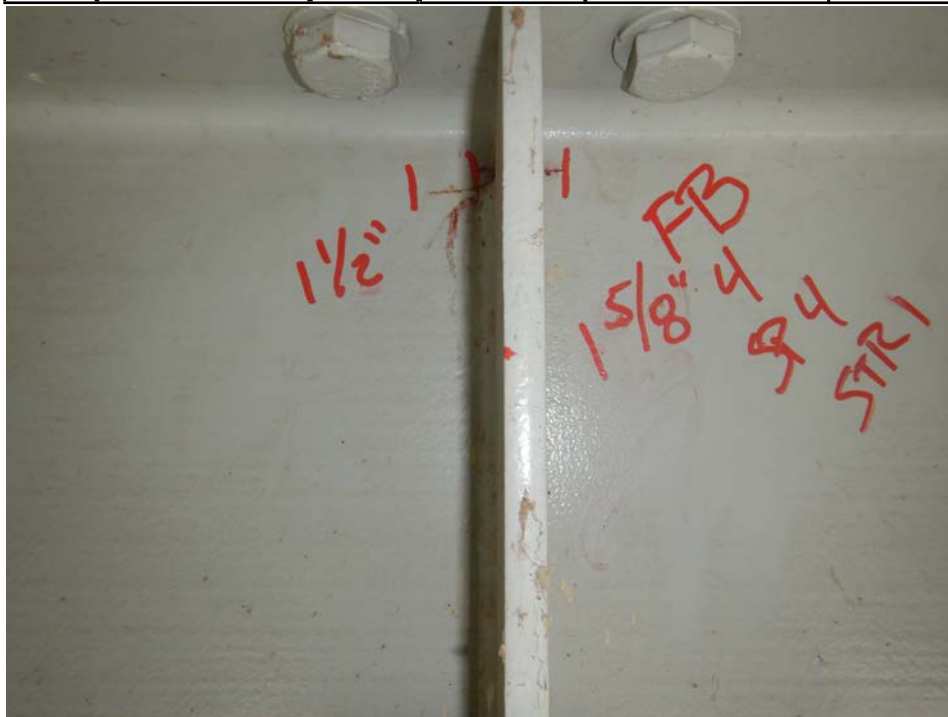
Photograph 66 - Looking west at floor beam 4 at stringer 1 in span 4. Note: 1 5/8-inch-long horizontal crack exists approximately 1/4 inch above the weld termination of the stiffener and extending north and south of the stiffener. 1 1/2-inch-long horizontal crack exists at the toe of the weld termination of the stiffener connection south.

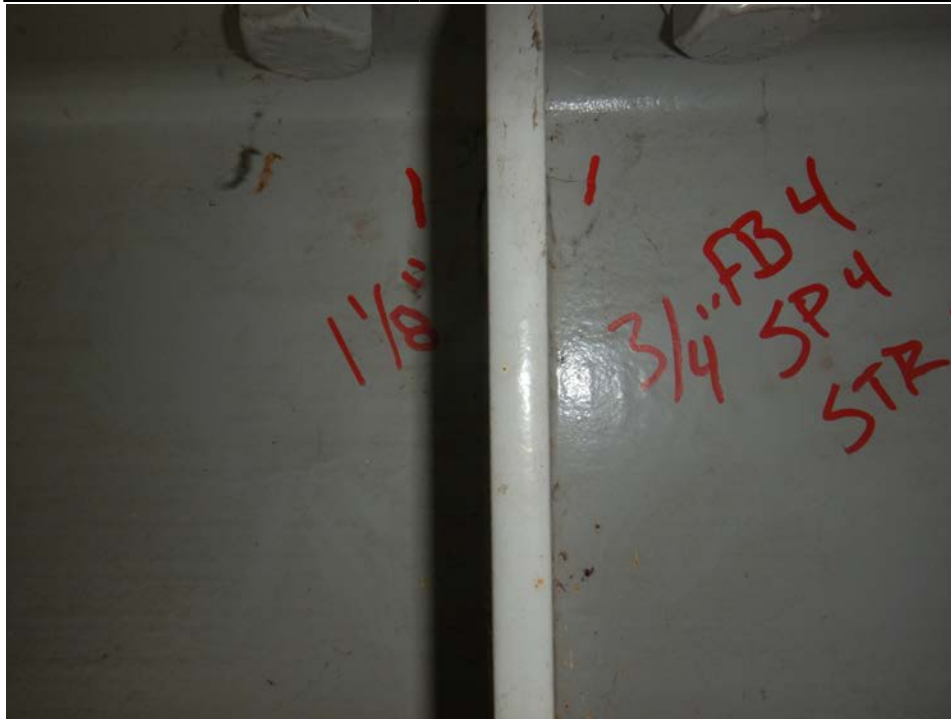
Photograph 67 - Looking west at floor beam 4 at stringer 2 in span 4 . Note: horizontal crack extends 3/4 inch north and 1 1/8 inches south of the stiffener.

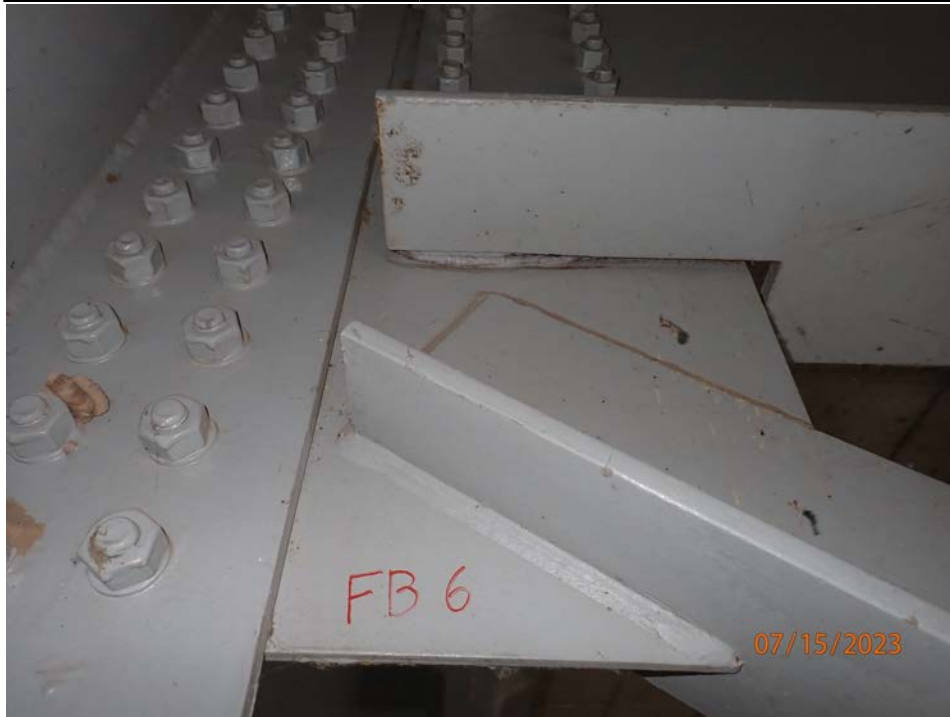
Photograph 69 - Looking east at floor beam 6, span 4 connection to girder 4. Note: 1/2-inch-thick painted over pack rust between floor beam and connection plate.

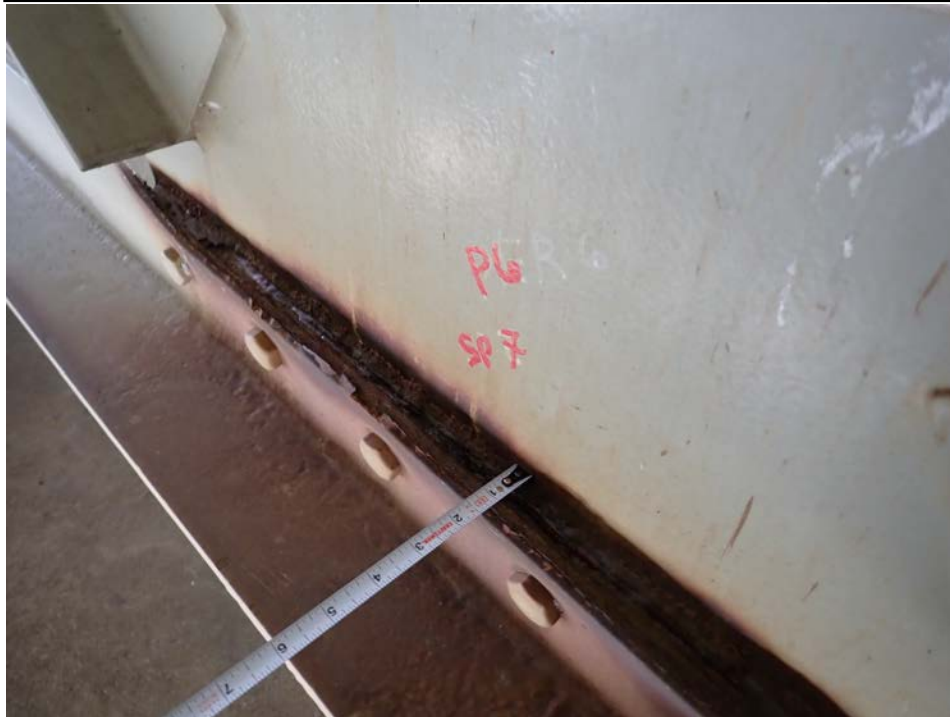
Photograph 70 - Looking northeast at floor beam 0, span 7 between girders 3 and 4. Note: 1-inch thick pack rust between lower strut and lower center gusset plate.

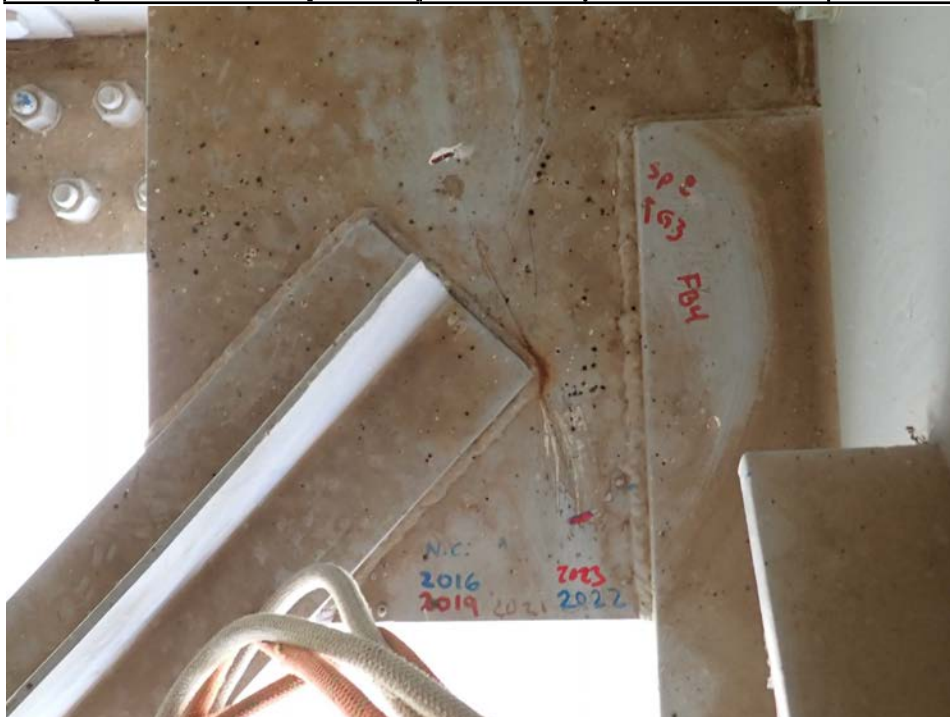
Photograph 72 - Looking southwest at the lateral bracing gusset plate connection to girder 3, span 8 at floor beam 4. Note: 8 1/2-inch-long crack running tangent to the corner of the bracing and one 3 1/2-inch-long crack along the floor beam bottom flange.

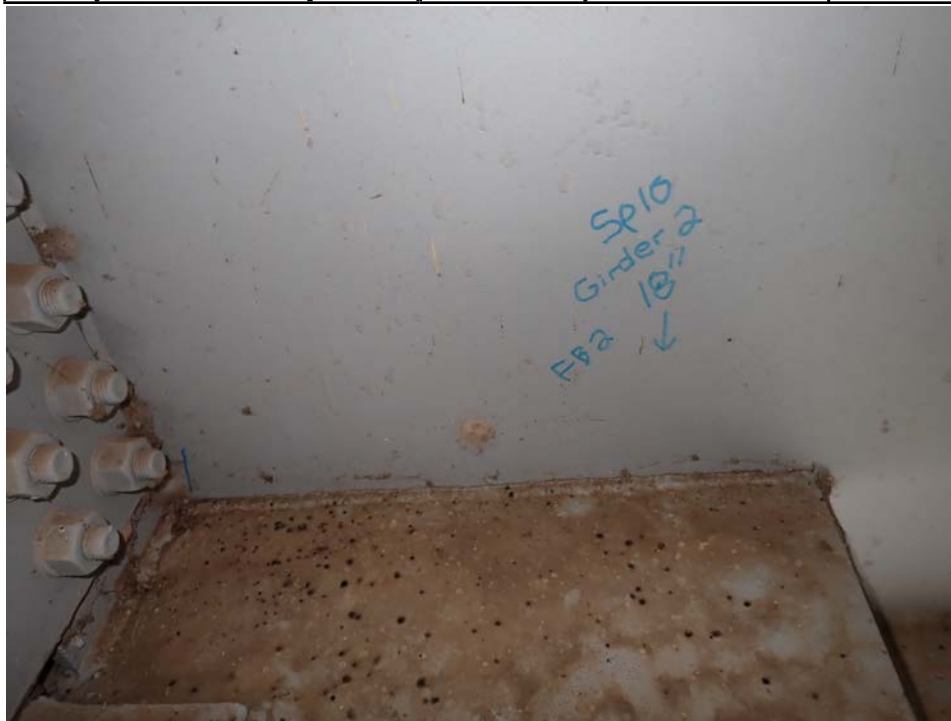
Photograph 73 - Looking north at girder 2, span 10 at floor beam 2. Note: 18-inch long crack in weld connecting gusset plate to the web.

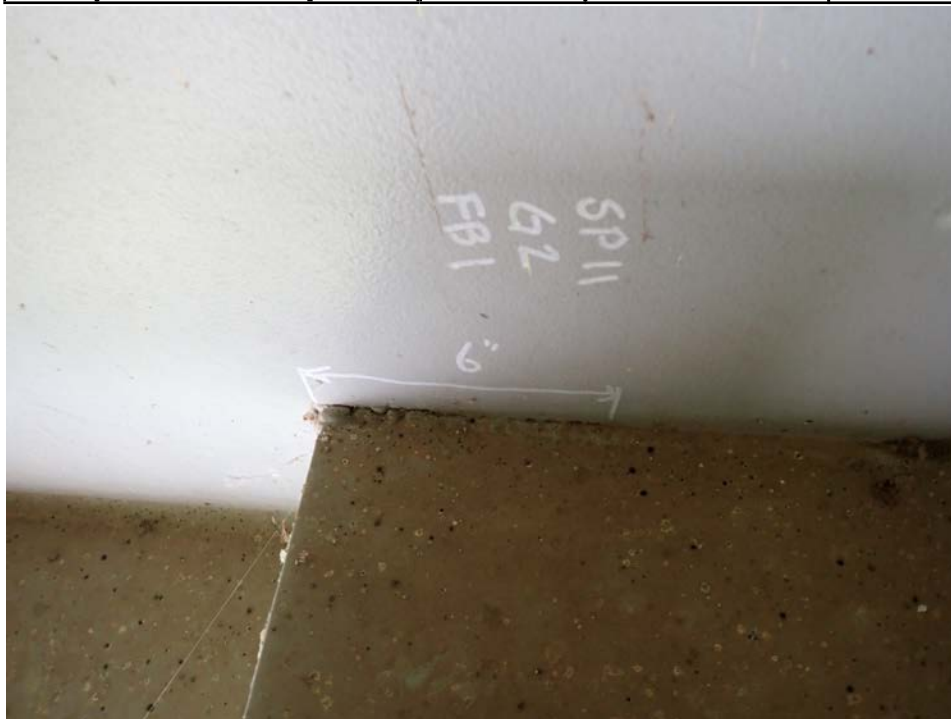
Photograph 74 - Looking north at girder 2, span 11 at floor beam 1. Note: 6-inch-long cracked weld in gusset plate weld.

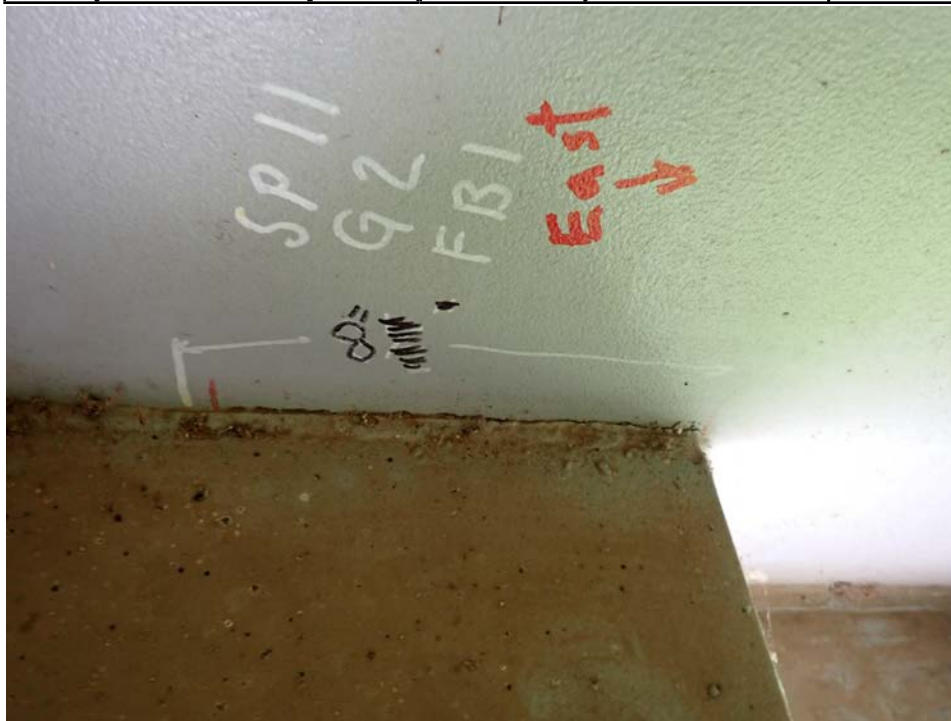
Photograph 75 - Looking north at girder 2, span 11 at floor beam 1. Note: cracked weld on gusset plate, 6 inches long, no change from previous inspection.

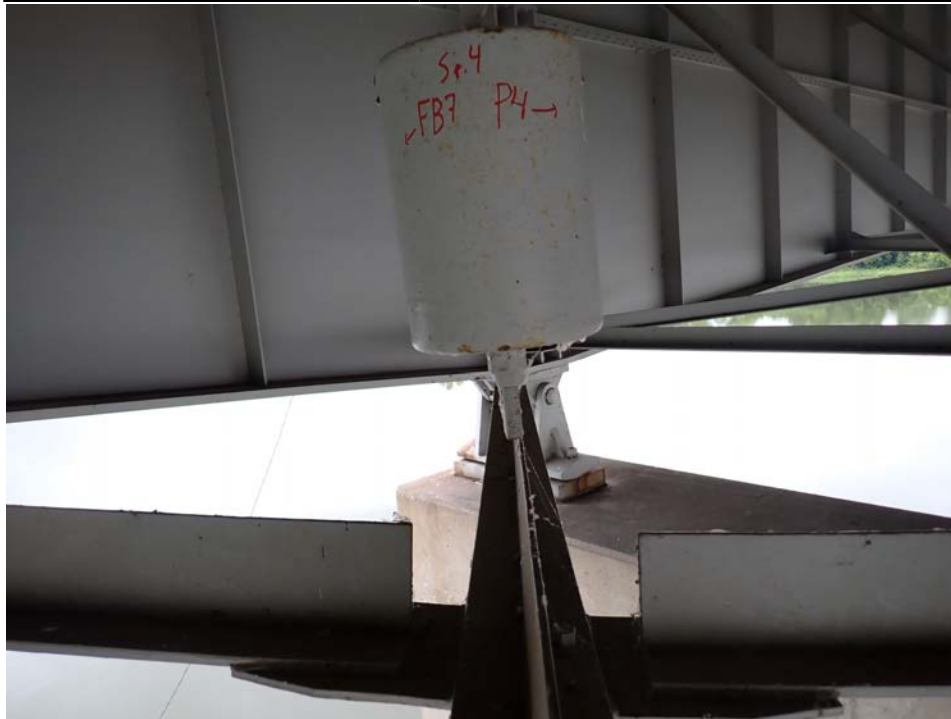
Photograph 77 - Looking northeast at the dampening canister between floor beam 7 and pier in span 4, 4. Note: canister lower anchor has broken and is no longer effective.

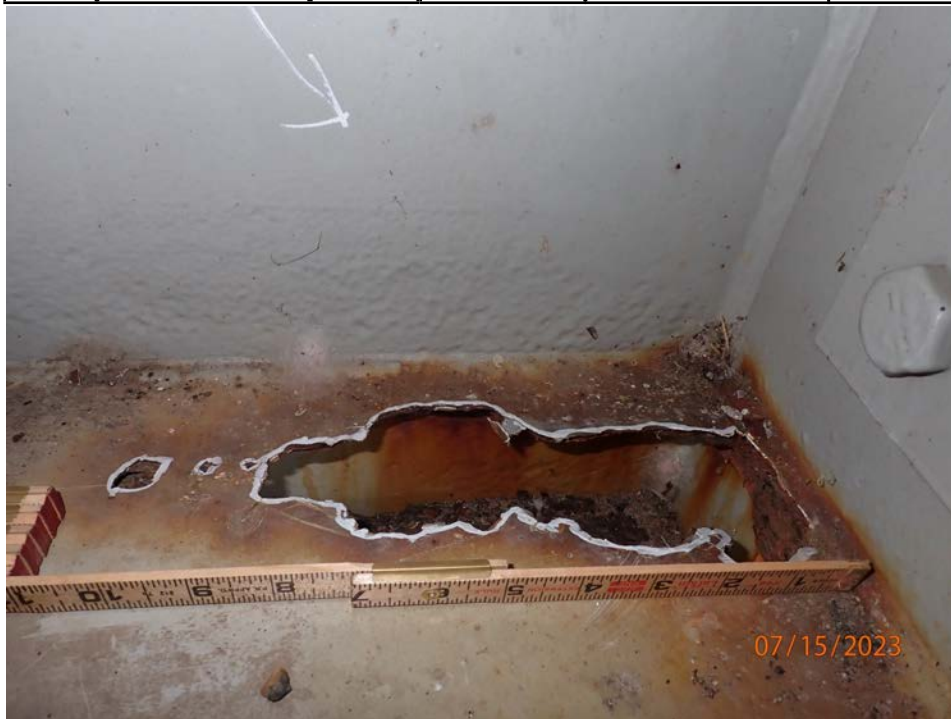
Photograph 78 - Looking north at lateral bracing gusset plate at girder 4, span 6 at pier 6. Note: 8 1/2-inch by 2 3/4-inch corrosion hole through the gusset plate.

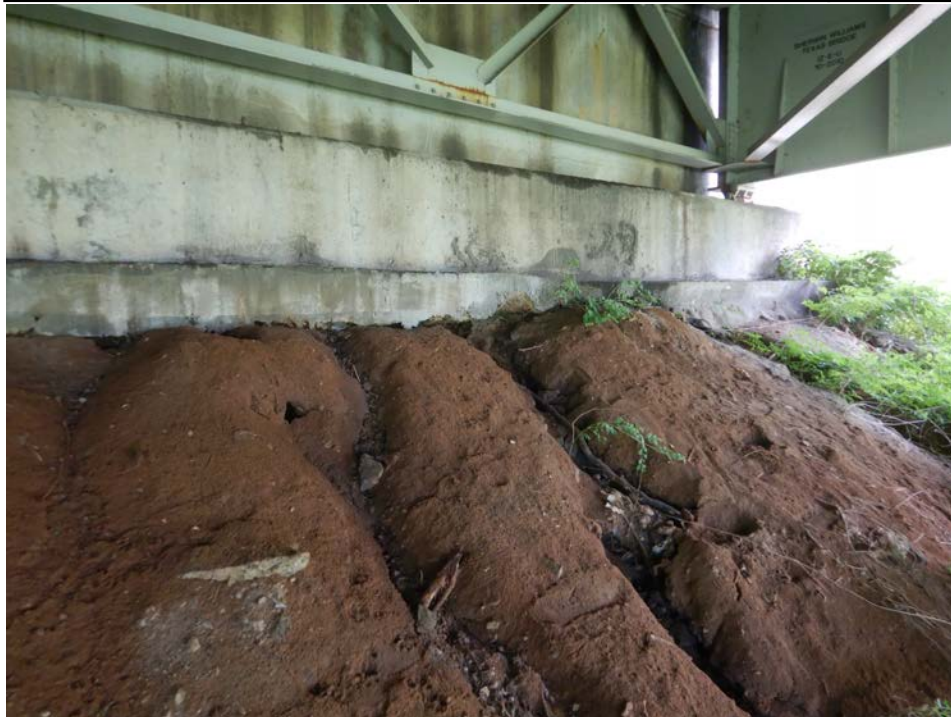
Photograph 80 - Looking southeast at the east embankment under the eastbound lanes. Note: erosion gullies from deck drainage leaking through the expansion joint is undermining the repair to encase the exposed piles.

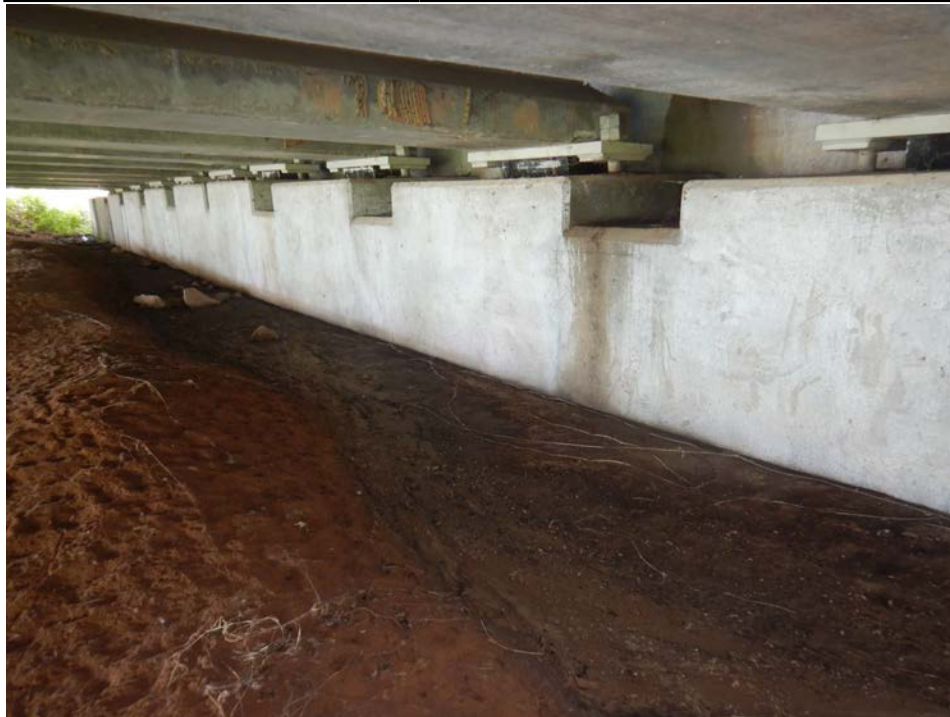
Photograph 82 - Looking southwest at the west abutment. Note: few horizontal and vertical cracks exist in the breastwall and back wall. Evidence of water leakage exists on the breastwall.
