Fracture Critical Bridge Inspection Report

NBI Bridge No.: 17051

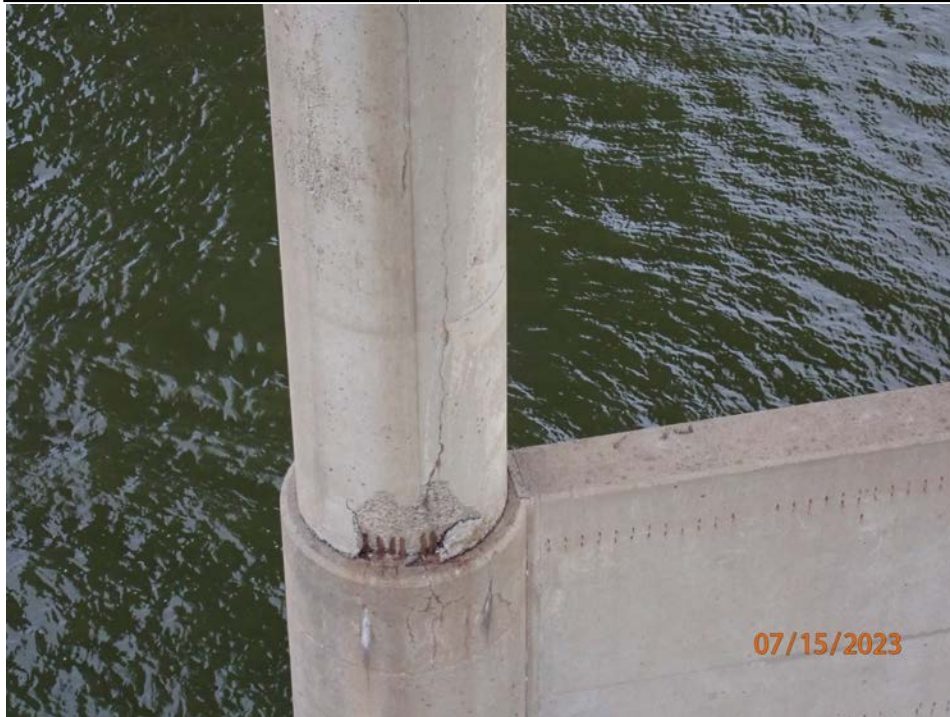
Photograph 84 - Looking east at pier 6 north column. Note: 5 square feet of spalling with exposed corroded reinforcement at the base of the column and a full height vertical crack of the column.

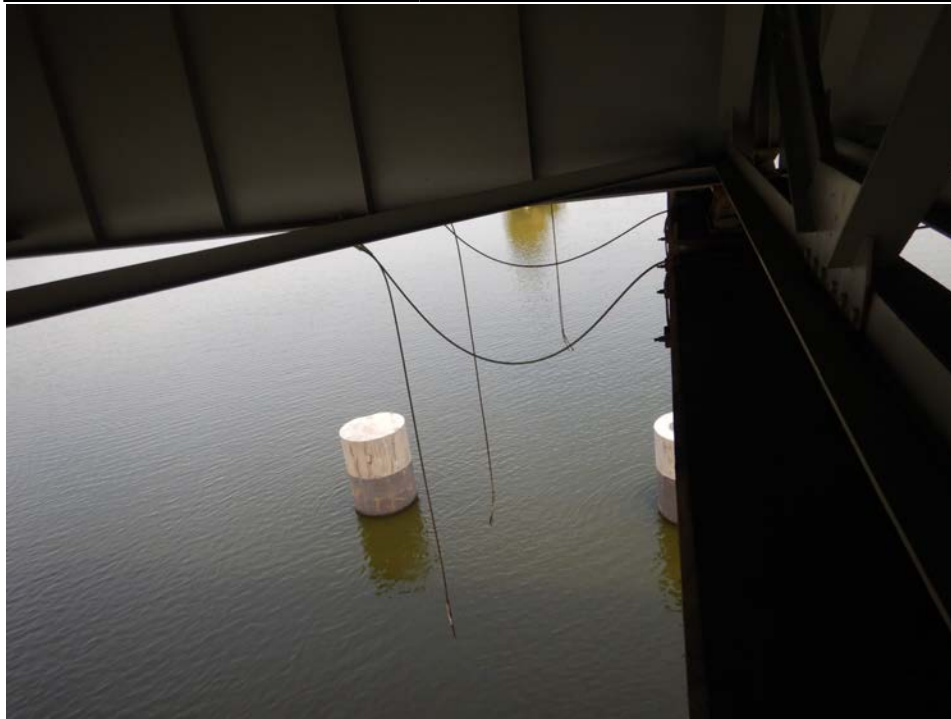
Photograph 85 - Looking north along pier 6 from girder 1. Note: seismic restraint cables are broken.

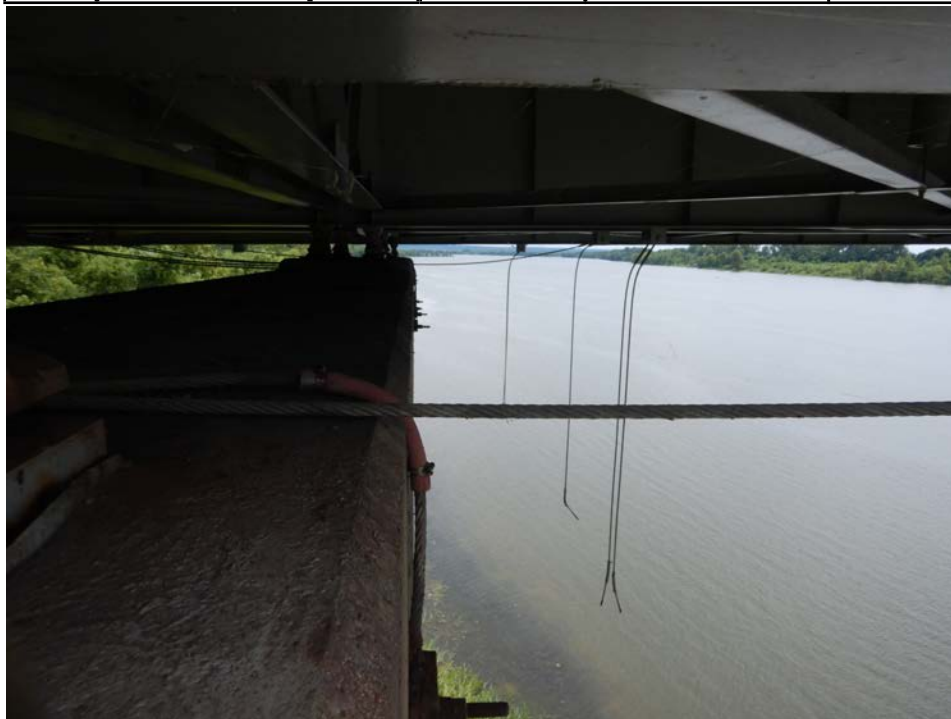
Photograph 86 - Looking south along pier 10 from girder 1. Note: both seismic restraint cables are broken at girders 1 and 3, and one is broken at girder 2.

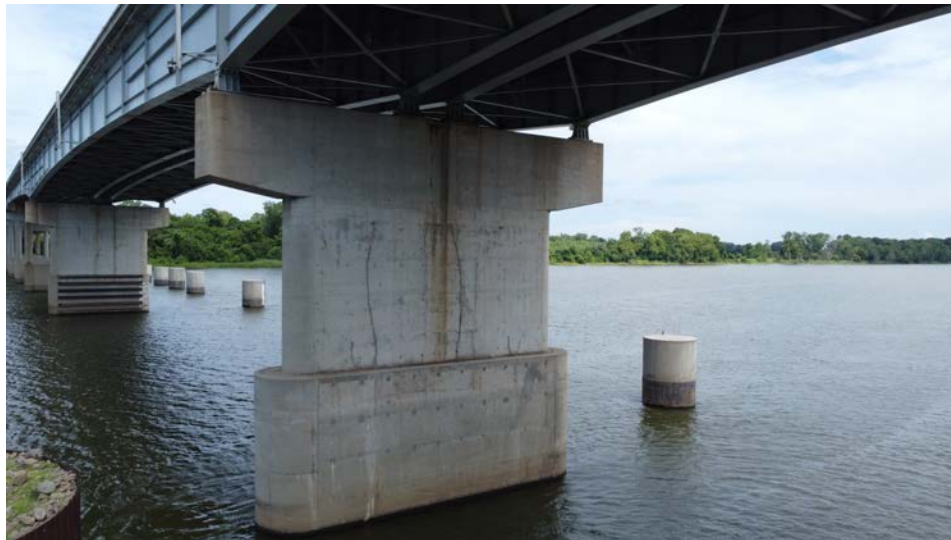
Photograph 87 - Looking southeast at pier 4. Note: sealed vertical and diagonal cracks in pier wall.

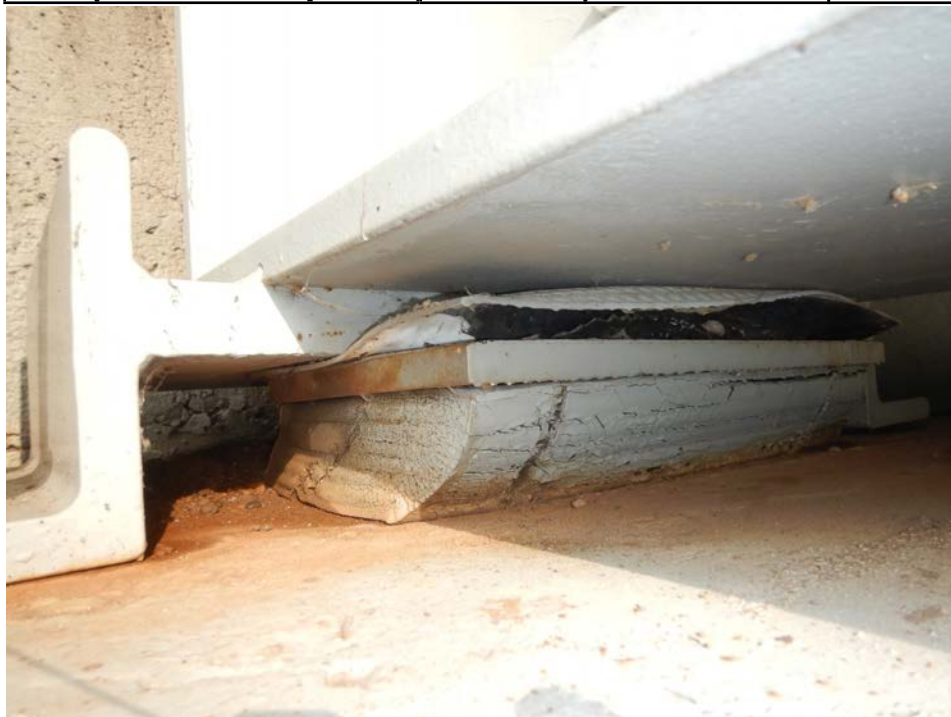
Photograph 88 - Looking northwest at the elastomeric expansion bearing for girder 1, span 4 at pier 3. Note: bearing split at northeast corner and debonded from sole plate at southeast corner. PTFE pad distorted and stainless steel surface painted.

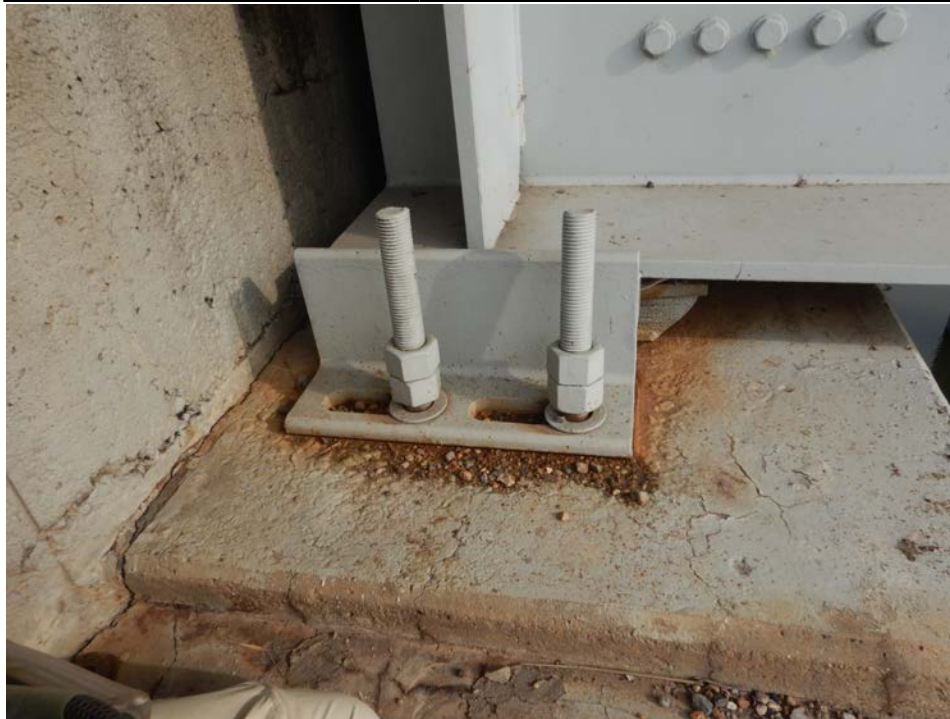
Photograph 89 - Looking north at the elastomeric expansion bearing for girder 1, span 4 at pier 3. Note: bearing assembly is near full expansion. Bearing assembly is in contact with the bearing seat with evidence of recent expansion observed.

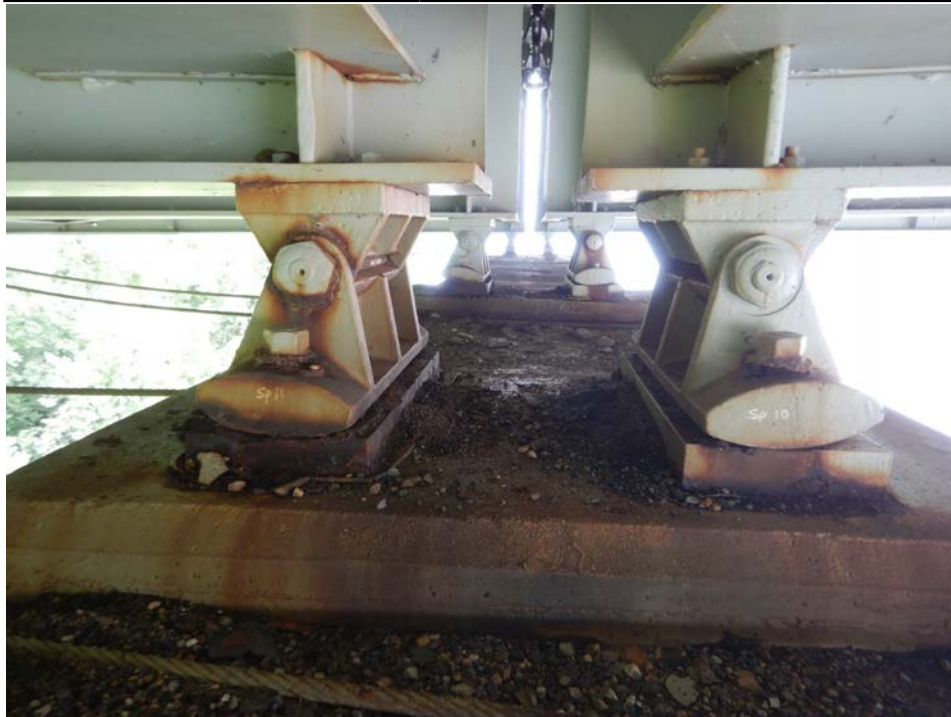
Photograph 92 - Looking south at the girder 3 expansion bearings at pier 10. Note: bearings are rocked slightly in expansion at 90F. Pack rust exists between the rocker and masonry plate.

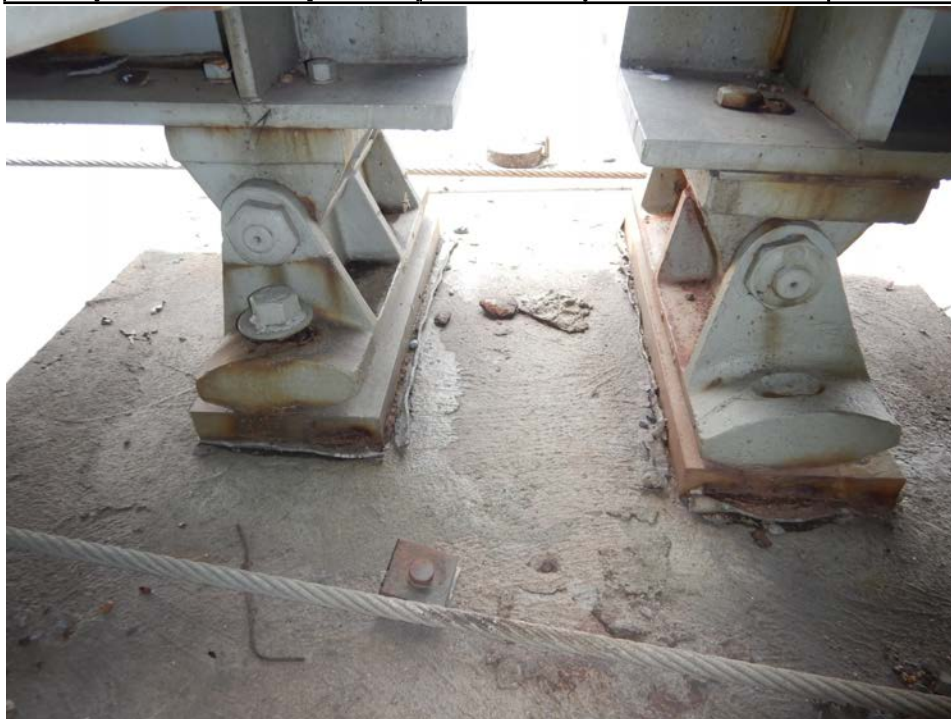
Photograph 94 - Looking south at the girder 1 expansion bearings at pier 6. Note: span 6 rocker rotated 14 degrees in expansion with anchor bolts missing. Span 7 rockers rotated 7 degrees in contraction at 85F. Brags are 8 inches tall to center of pin.
