Former First Presbyterian Church

Okemah, OK

Final Remediation Report

**Proposed Okemah Media Center
201 S. 3rd Street
Okemah, Oklahoma 74859**

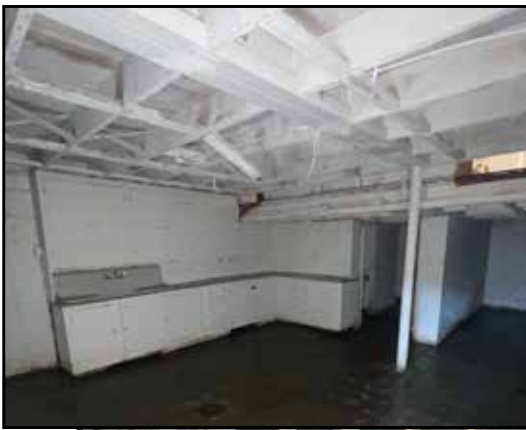
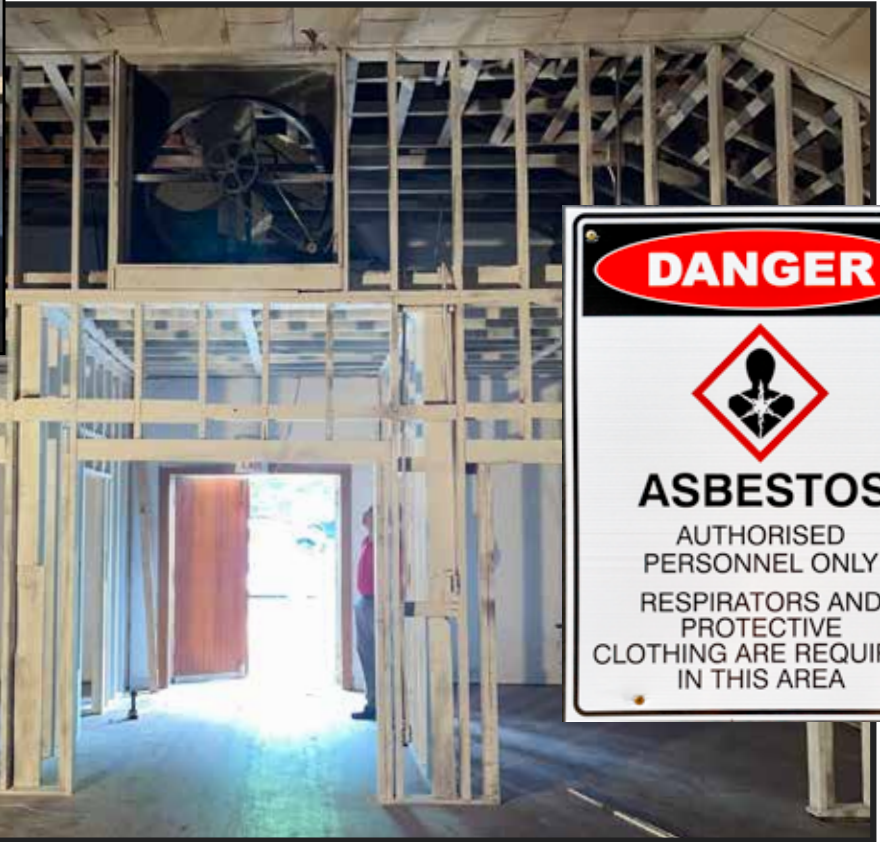
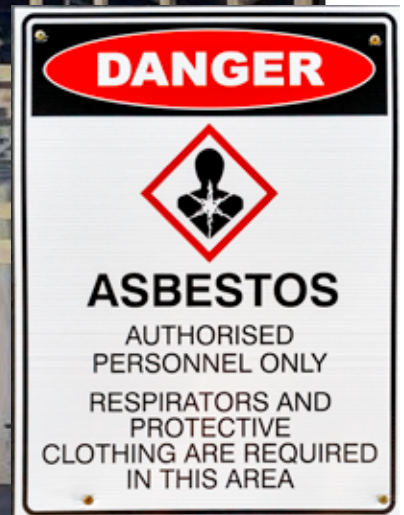
Lead-based paint and asbestos located

All asbestos was removed

- 1,000 sq. ft. of floor tile & mastic on 1st floor
- 2,800 sq. ft. of ceiling joint compound
- Abatement completed in May of 2021

(city contractor removed LBP when redoing surfaces)
