Former City Hall

Hartshorne, OK

Final Remediation Report

ASBESTOS INSPECTION

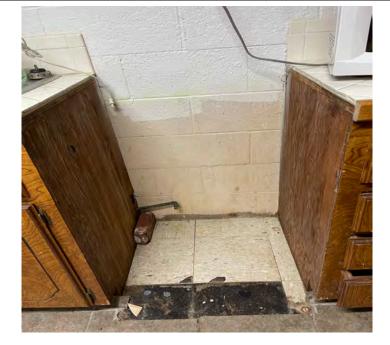
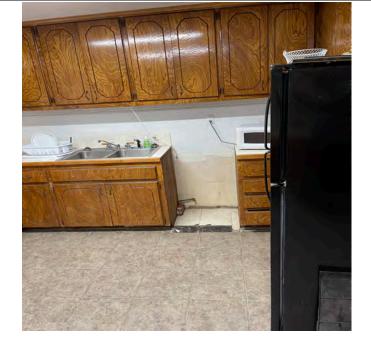
LOCATION	CONDITION	TYPE	% ASBESTOS	ESTIMATED QUANTITY	ESTIMATED ABATEMENT COST
ROOM 7 (KITCHEN) - NORTH	GOOD	MISCELLANEOUS	5-7% CHRYSOTILE	280-FT ²	\$2,500

Room 7 (Kitchen): ACM Floor tile and black mastic

- The asbestos-containing floor tile and floor-tile mastic must be abated prior to the commencement of renovation and/or demolition activities that would render these Asbestos-Containing Materials (ACM) friable
- The abatement of the asbestos-containing floor tile and floor-tile mastic are required to be carried out as Class II Work In accordance with the Occupational Safety and Health Administration (OSHA)
- An EPA National Emission Standard for Hazardous Air Pollutants (NESHAP) Notification must be submitted to and approved by the Oklahoma Department of Environmental Quality (ODEQ) ten business-days prior to the commencement of certain renovations and any demolition activities
- The Oklahoma Department of Labor (ODOL) requires Third-Party Asbestos-Abatement Air Monitoring to take place while asbestos-abatement activities are taking place
