Former Luther Town Hall

Luther, Oklahoma

Final Remediation Report

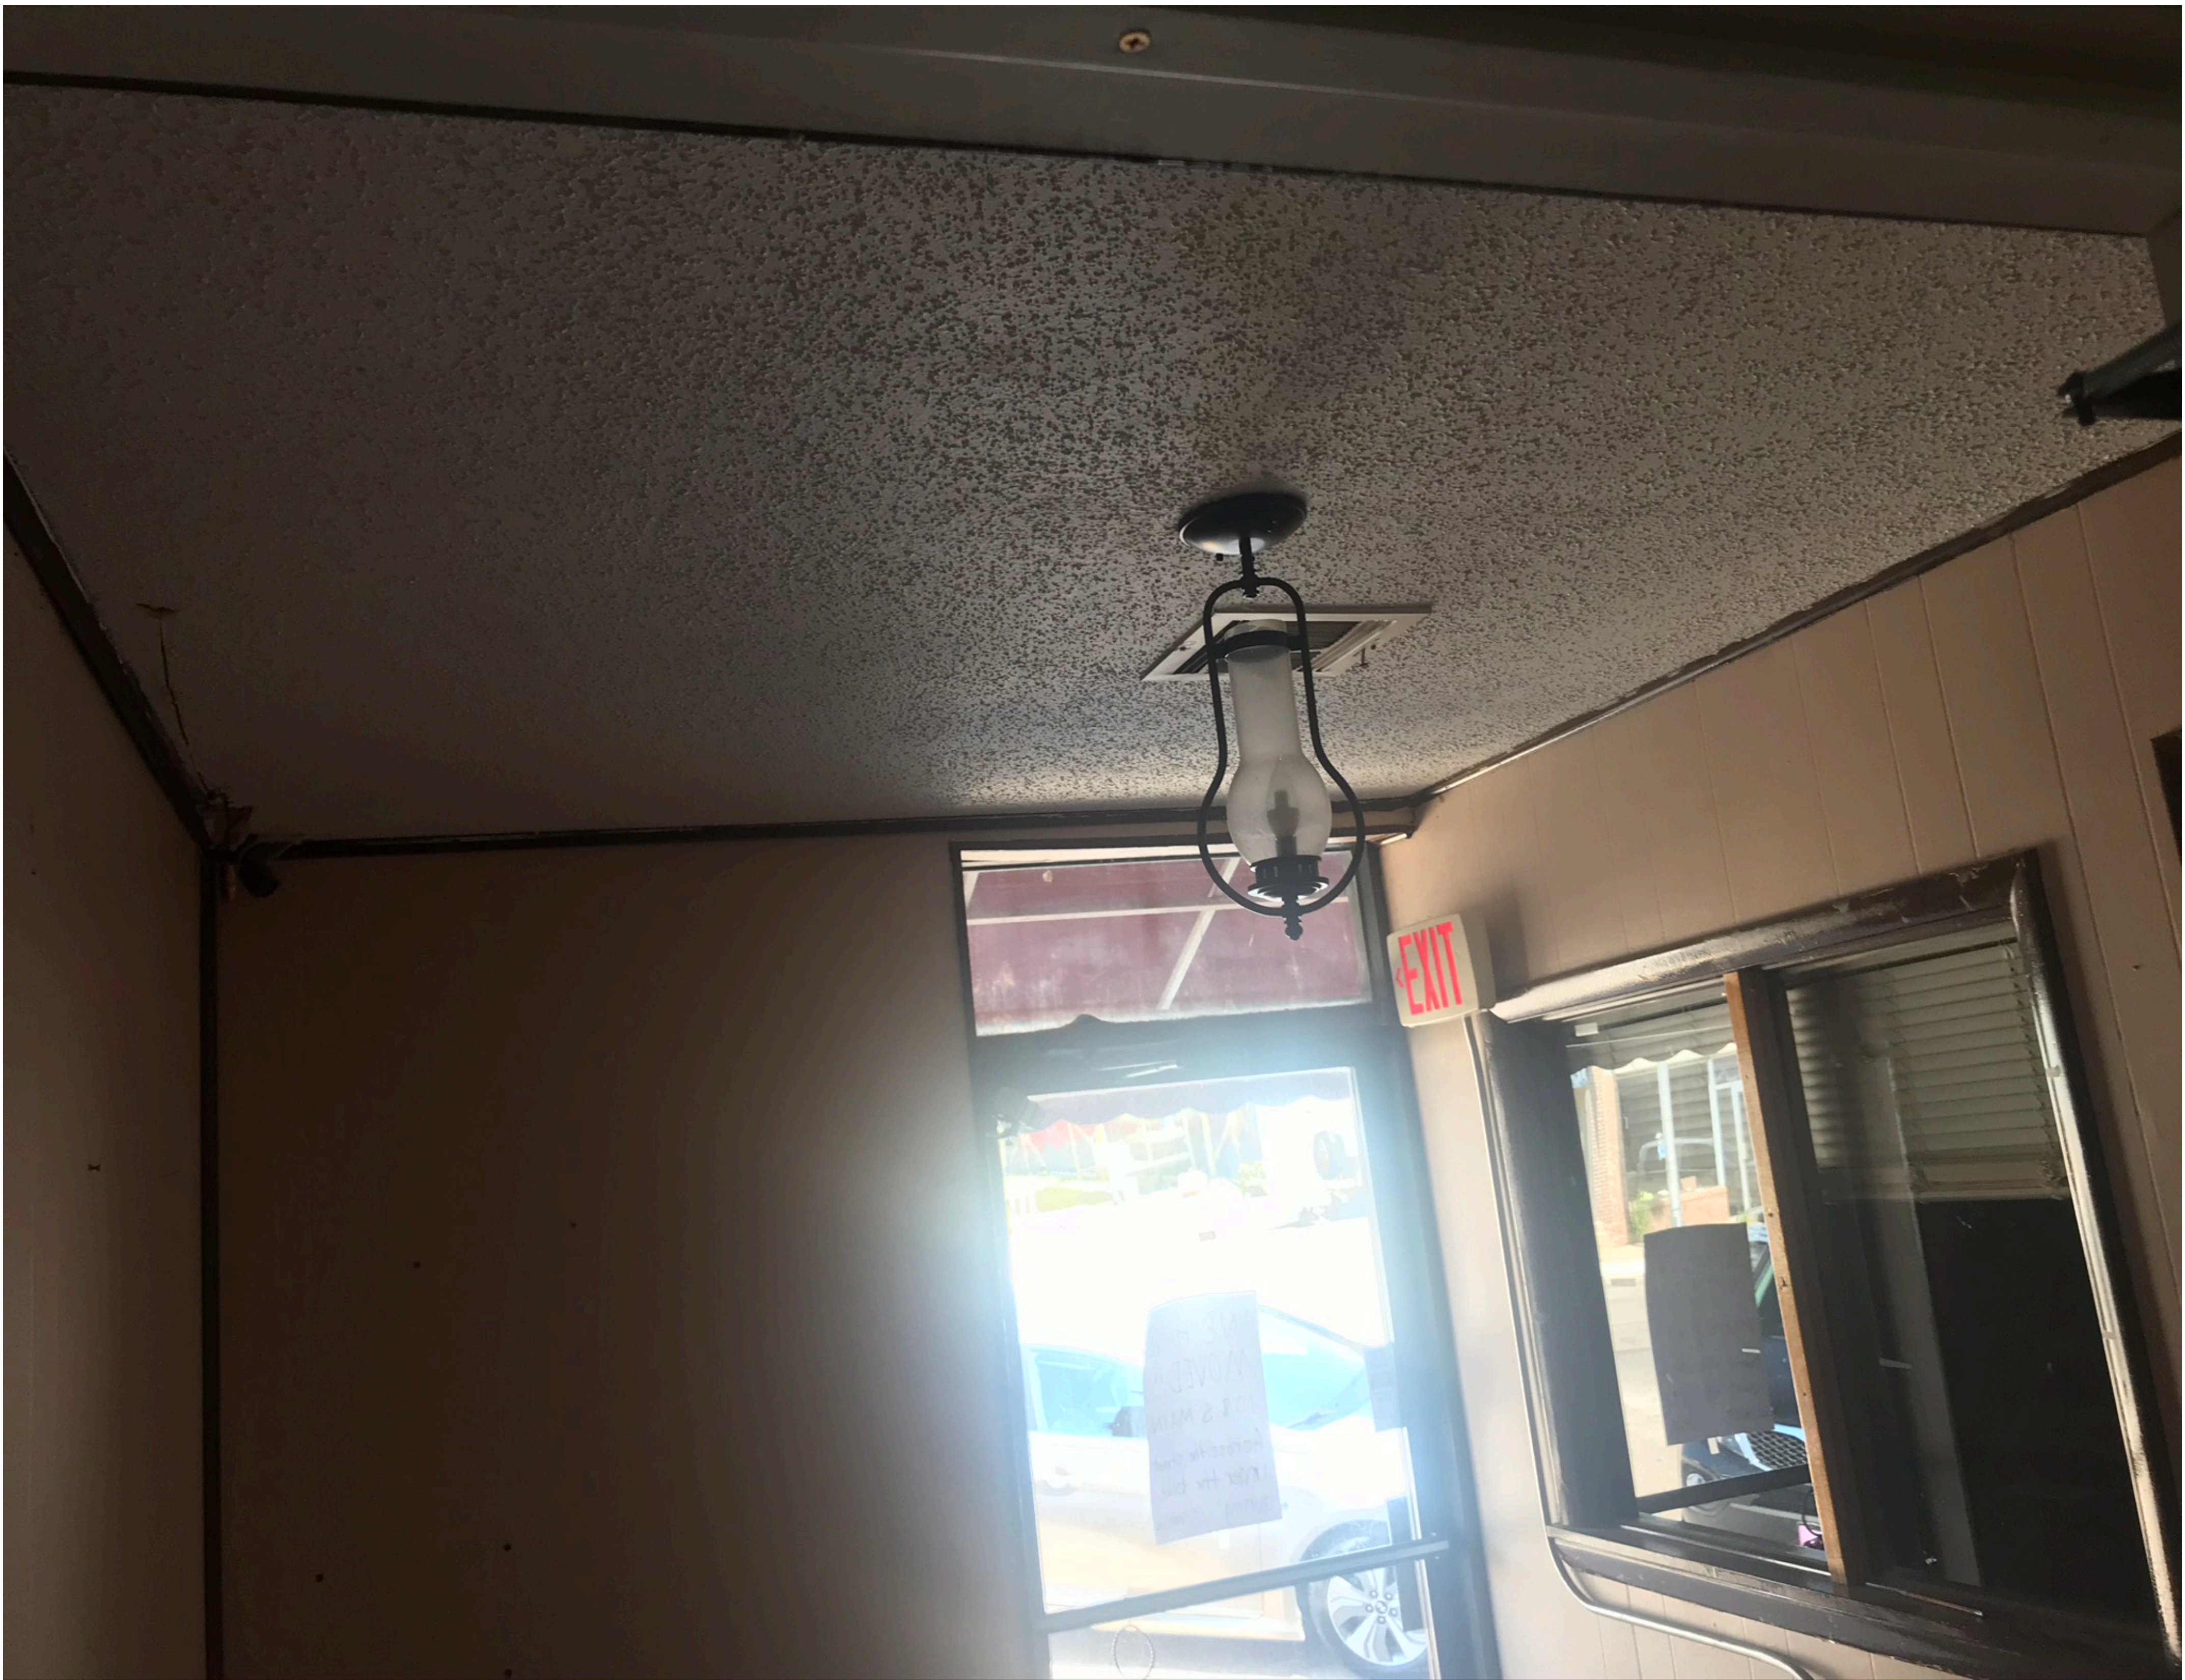
ACM CEILING SYSTEM - SAME CEILING THROUGHOUT FIRST FLOOR

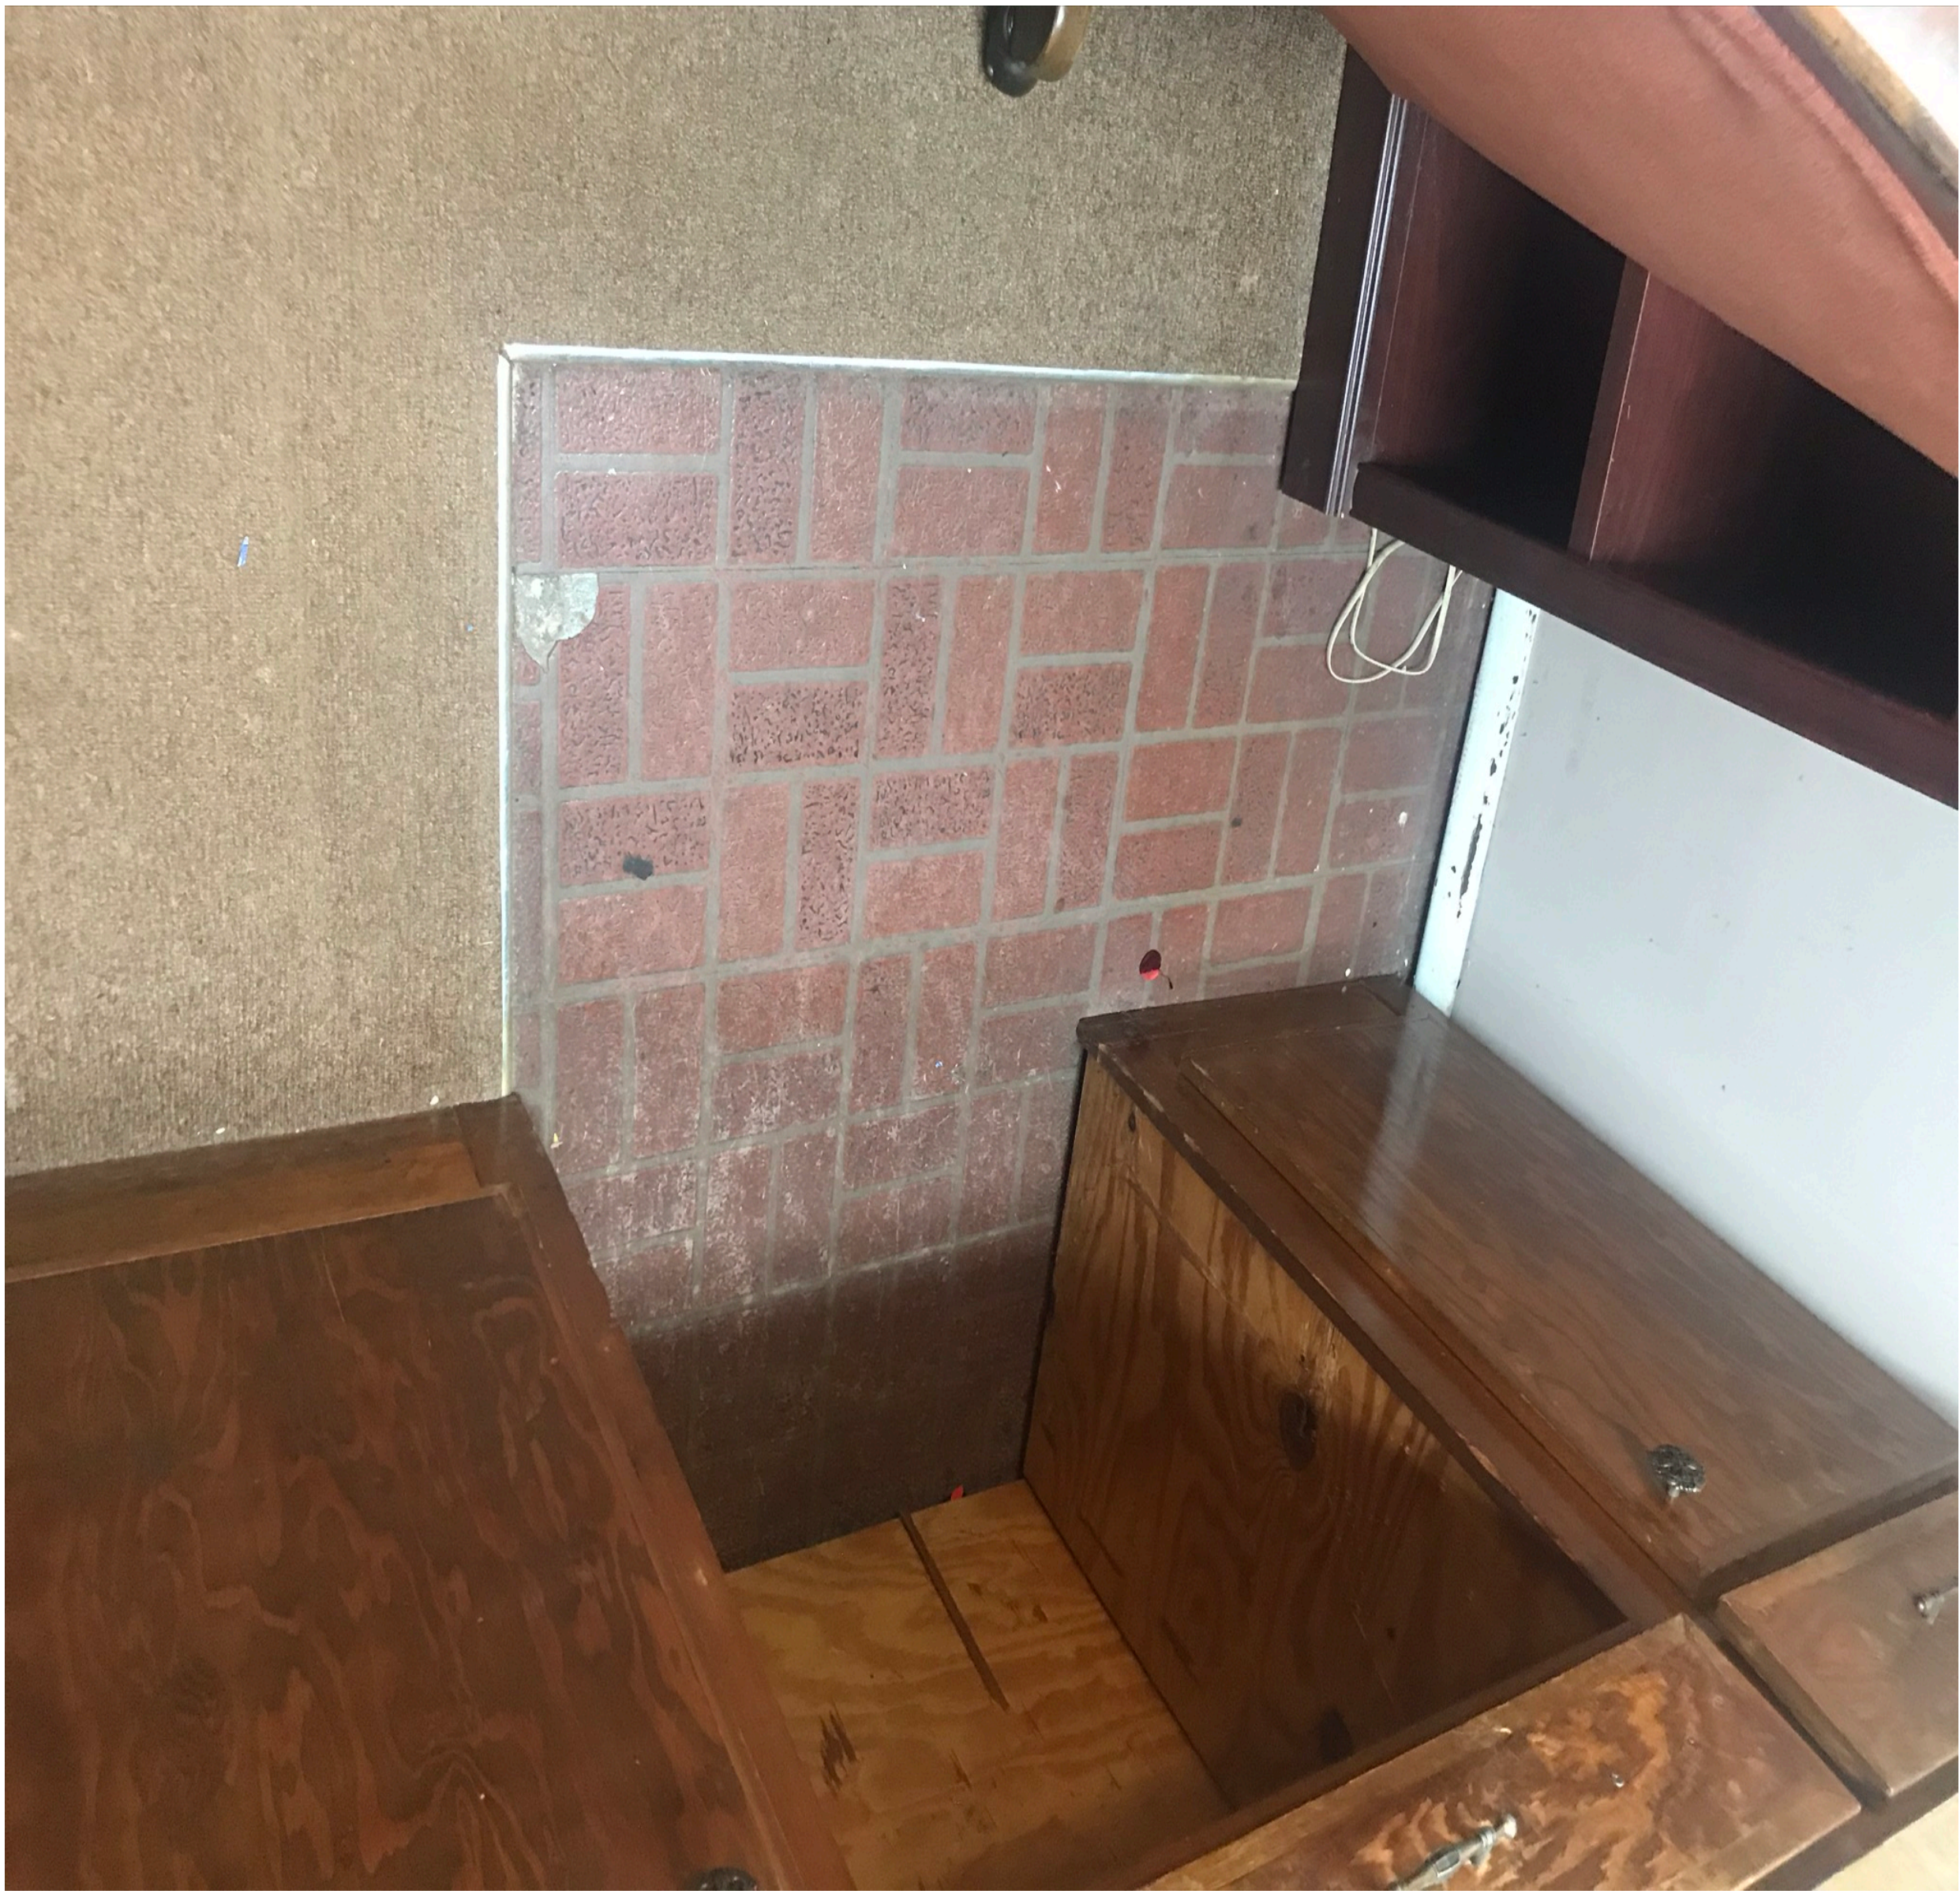
ROOM 3 - ACM VINYL FLOOR TILE

- Asbestos abatement, including:
- 1320ft² of asbestos containing joint compound and ceiling texture removal
- 24ft² of asbestos containing floor tile mastic removal

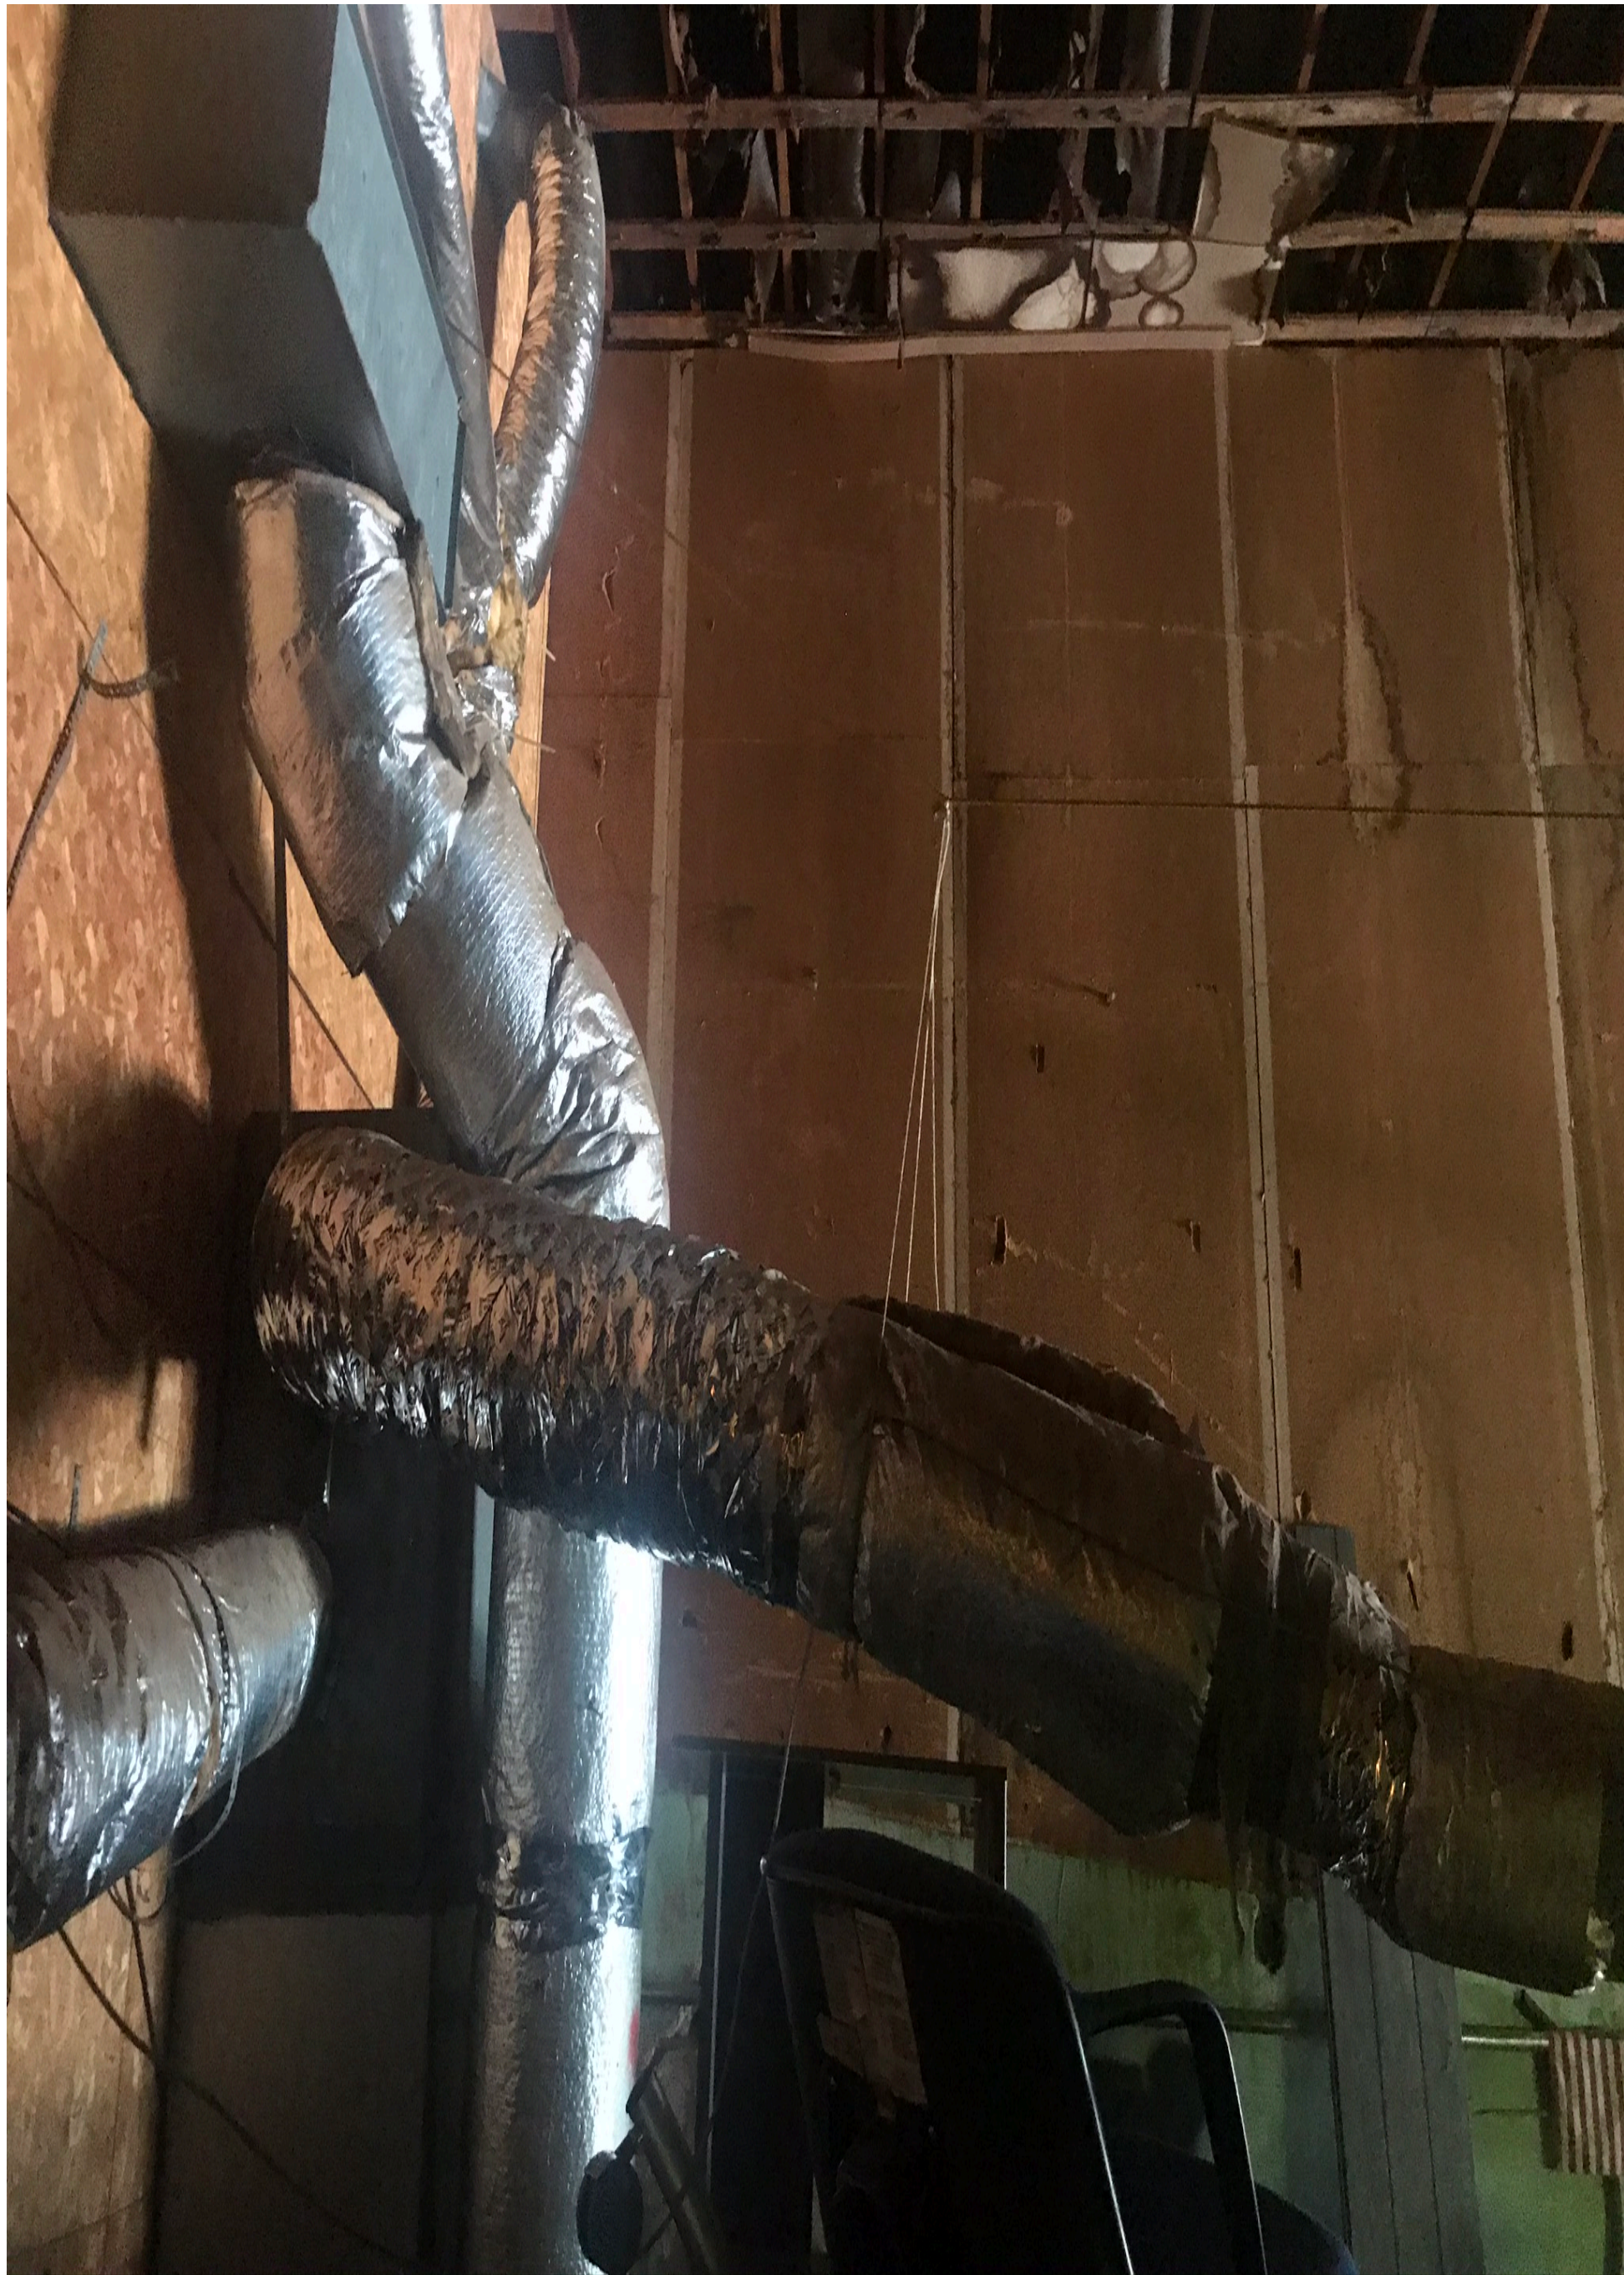
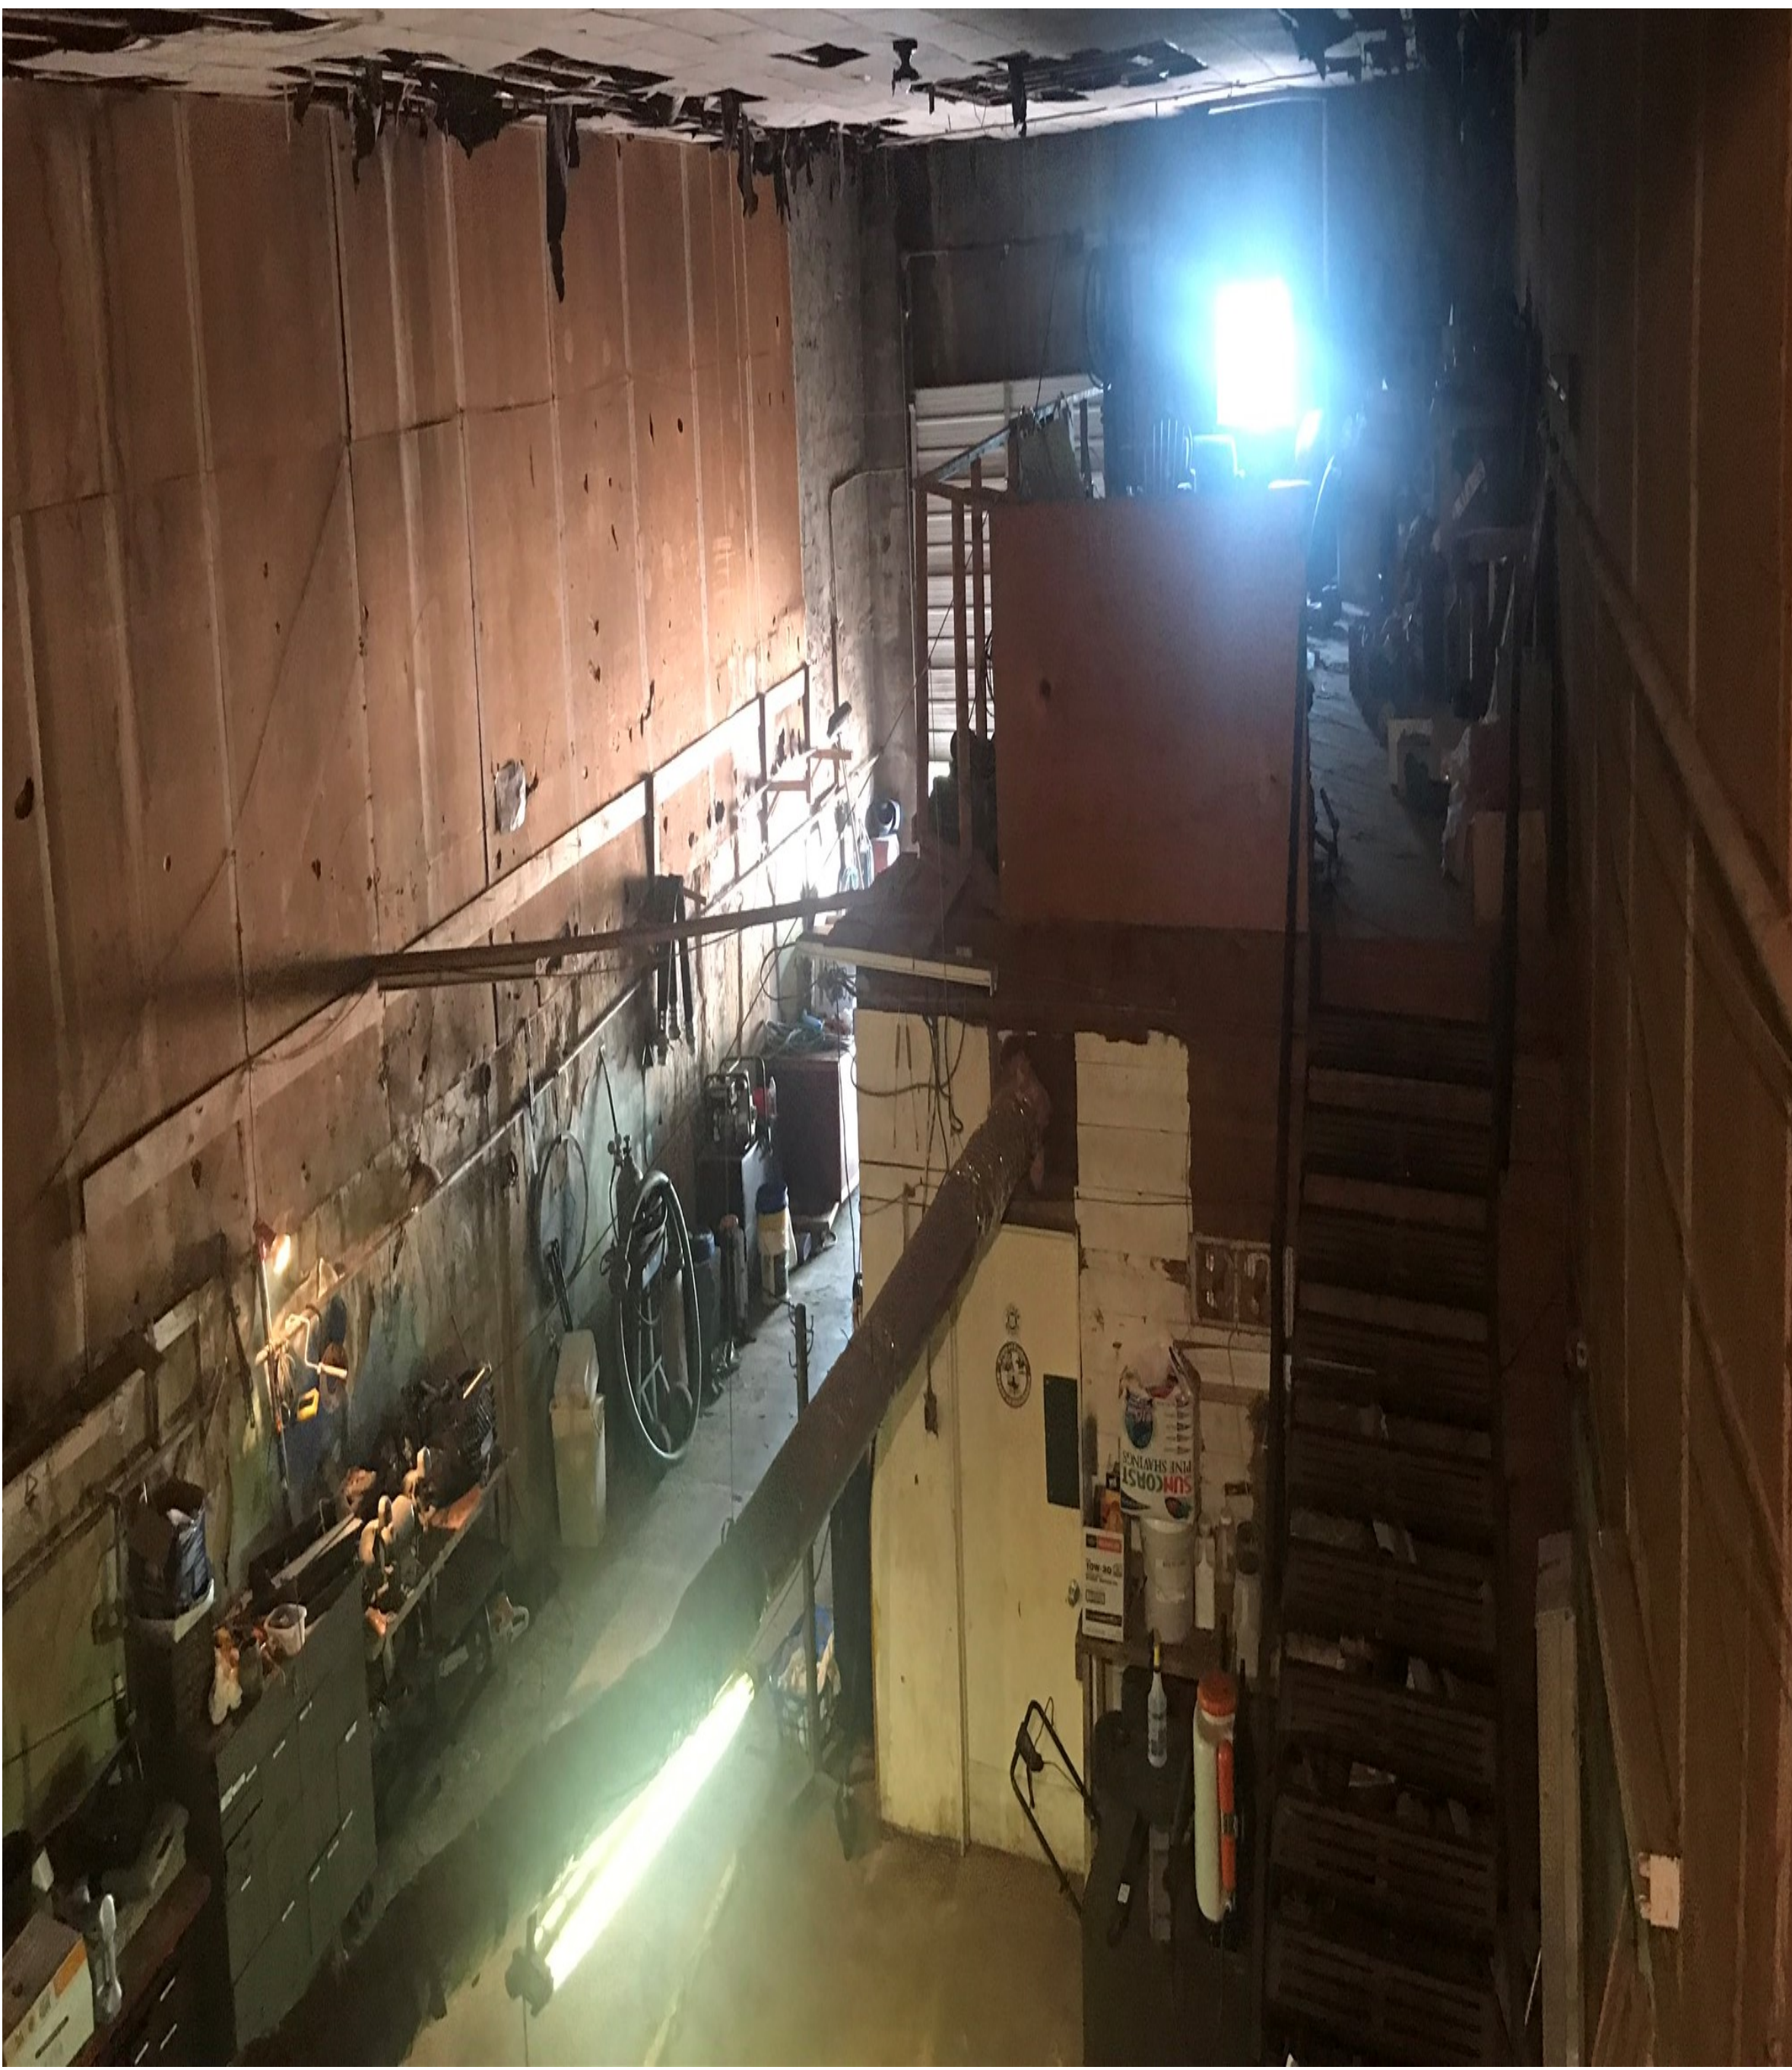
MACHINE SHOP/OFFICE - PARTICLE BOARD CEILING, WALL SIDING & PLASTER WALLS

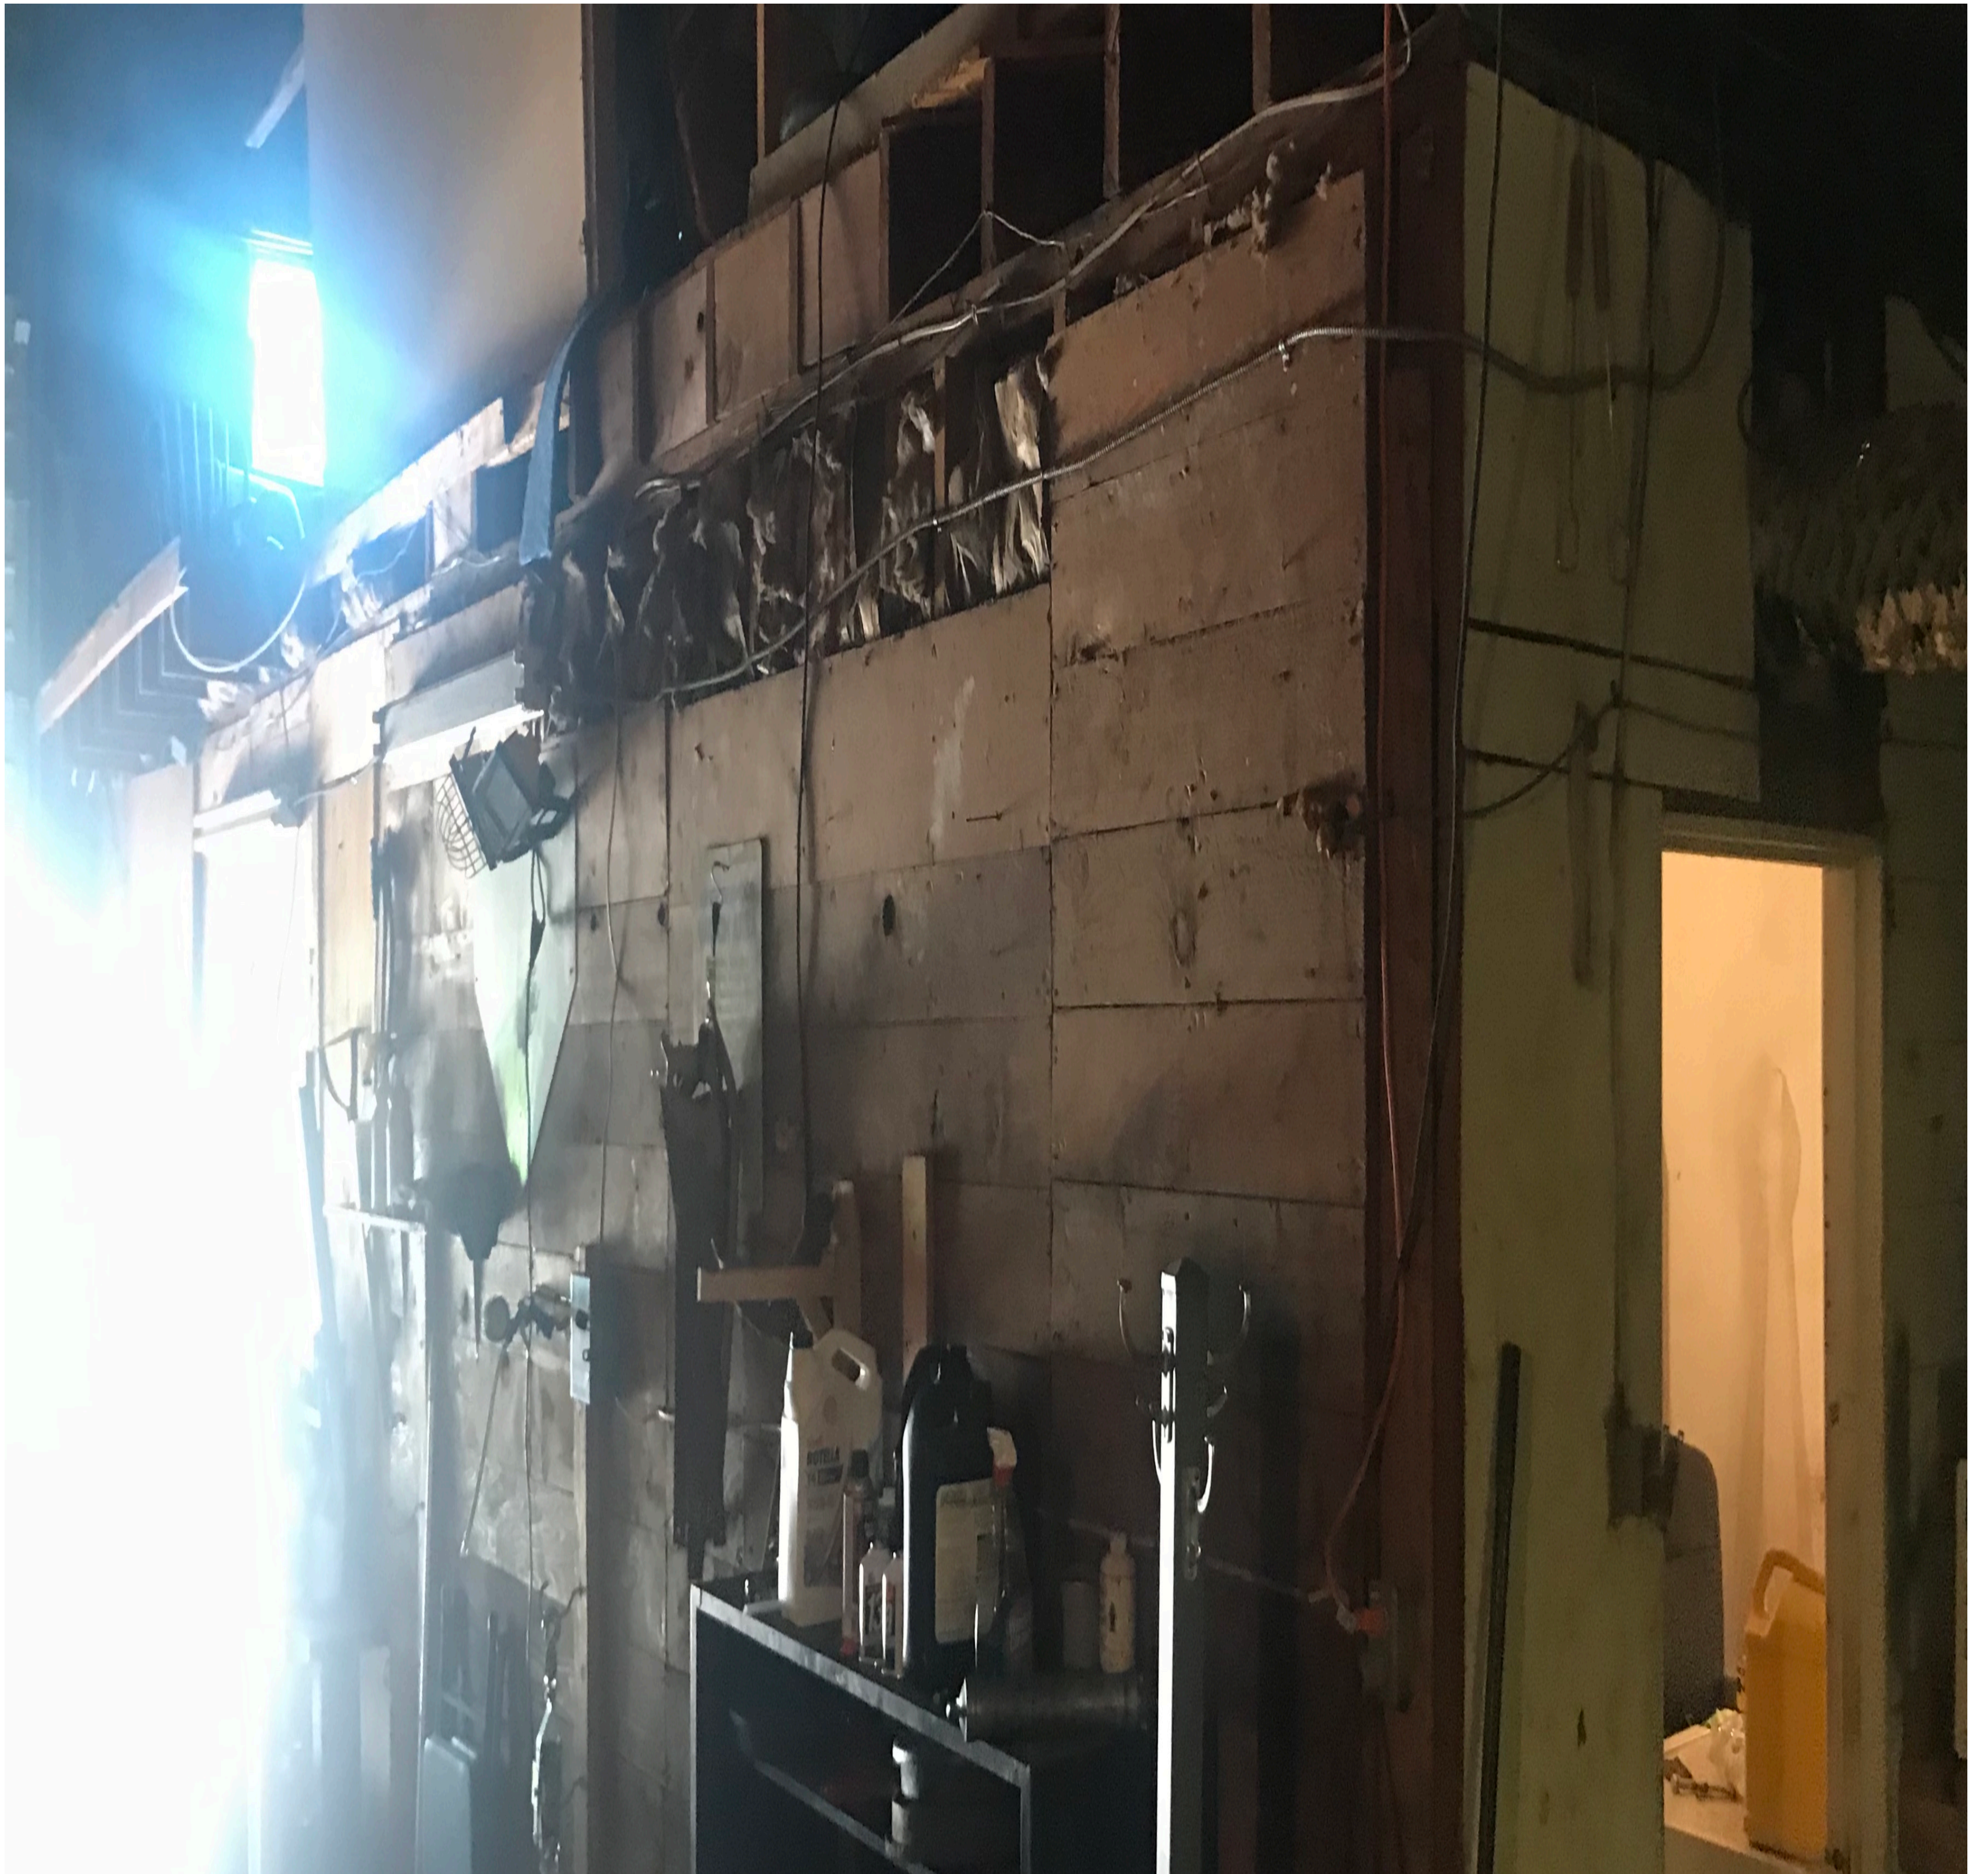
MACHINE SHOP OFFICE - COMPRISED OF WOOD & DRYWALLS
