**OPERABLE UNIT 1
OPERATION & MAINTENANCE
ANNUAL REPORT 2024-2025**

**TAR CREEK SUPERFUND SITE
OTTAWA COUNTY, OKLAHOMA**

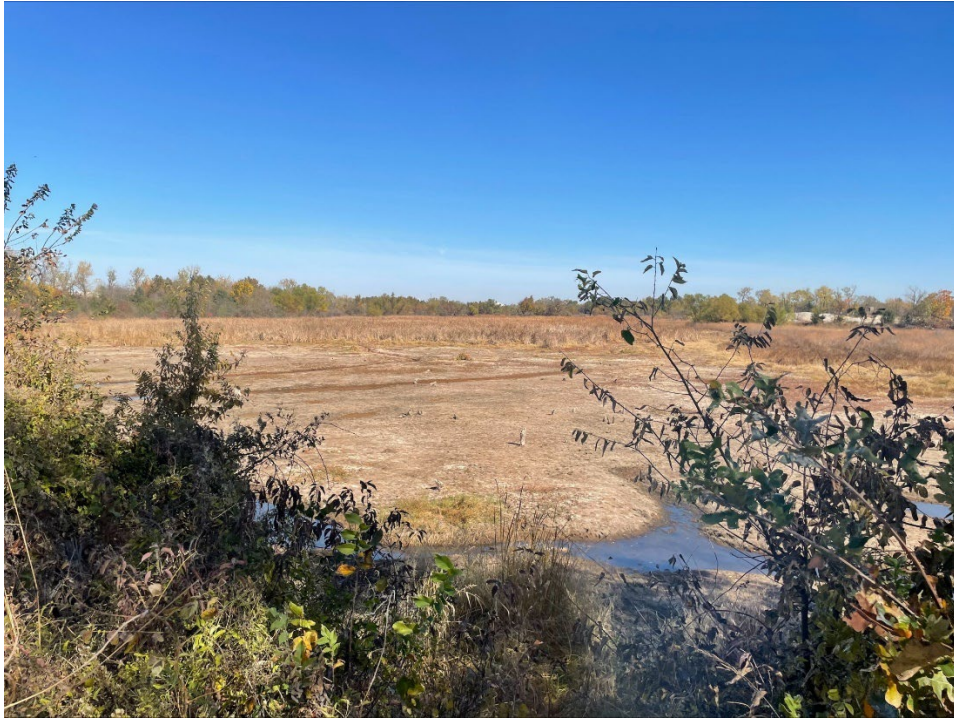
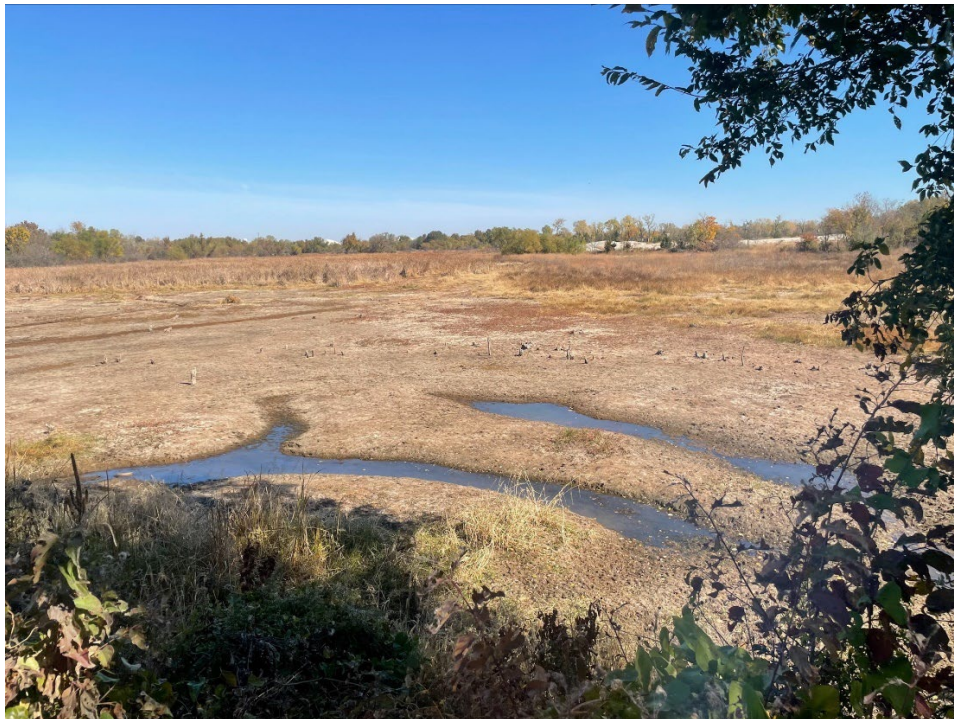
Diversion Dike

The diversion dike is in good condition for now. There is some evidence of erosion along the banks in a narrowing portion covering no more than 20 feet which may require some type of reinforcement. The area has shown no signs of change in several years and seems to have integrity for now, but there are concerns about additional damage to the area in the event of heavy flooding. In October 2024, water levels in the creek could be described as low. The streambeds were visible and there is no evidence of recent beaver activity. Any remaining materials from previous beaver dams appear to be abandoned. Average streamflow for the nearby Spring River on this date was recorded by the United States Geological Society (USGS) as 118 cubic feet per second (cfs). This is “below normal” for Spring River’s mean flow of 900 cfs. Although the water level and streamflow are below normal, there does not appear to be anything that might impede the flow once the water rises. Flow from the watershed to the north of the dike is being conveyed through the constructed channel that diverts Lytle Creek into an upper reach of Tar Creek.

2.	Erosion Areal extent _____ Depth _____ Remarks: <u>There is an area about 20+ ft experiencing some erosion on the riparian area on either side of the "road" or path on top of the dike. This is the same area we have previously noted some wildlife activity and potential erosion with the recommendation for continued monitoring. Some reinforcements on the banks of this area are anticipated to prevent additional erosion caused by wildlife and flooding. The area has remained stable and has not had any noticeable or significant change in several years.</u>	<input checked="" type="checkbox"/> Location shown on site map <input type="checkbox"/> Erosion not evident

In addition to groundwater sampling, the Douthat O-3 inspection should be upgraded to a semi-annual inspection until the need for bank stabilization due to erosion can be determined. If the property owner stops maintaining the area and vegetation growth becomes excessive hindering O-3 inspections, DEQ should take steps to have it mowed and maintained.

C. Early Indicators of Potential Remedy Problems	<p>Describe issues and observations such as unexpected changes in the cost or scope of O&M or a high frequency of unscheduled repairs that suggest that the protectiveness of the remedy may be compromised in the future.</p> <p><i>Bank or riparian area reinforcements to prevent further erosion.</i></p>

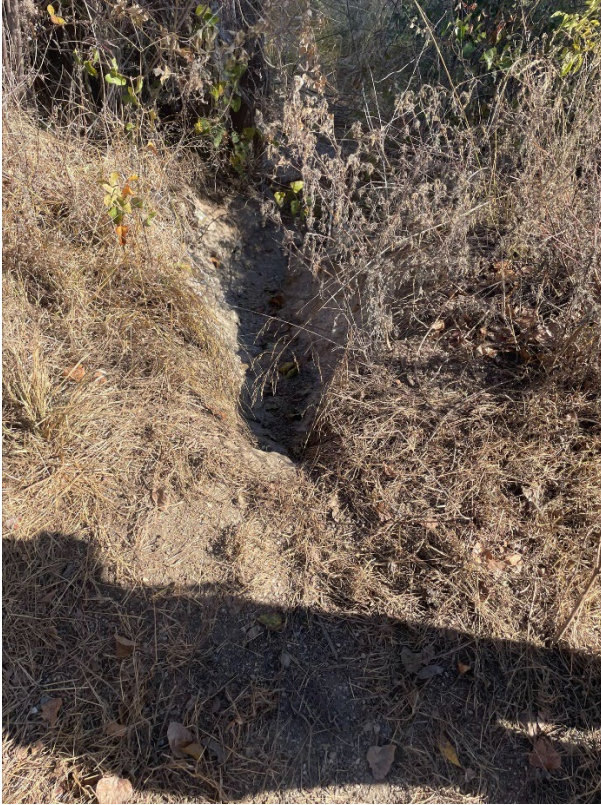
Diversion Dike

Evidence of erosion due to wildlife activity.

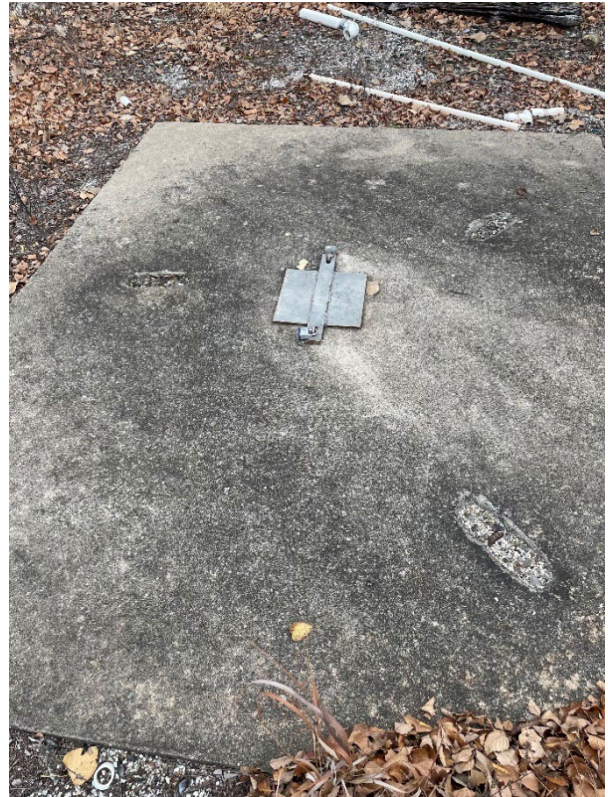
Well Cap Inspection.
