Case Study 050

#### Well with SCP in the Process of Being Plugged

## Deep Penetrating Annular Surface (DPAS™) BioSqueeze®

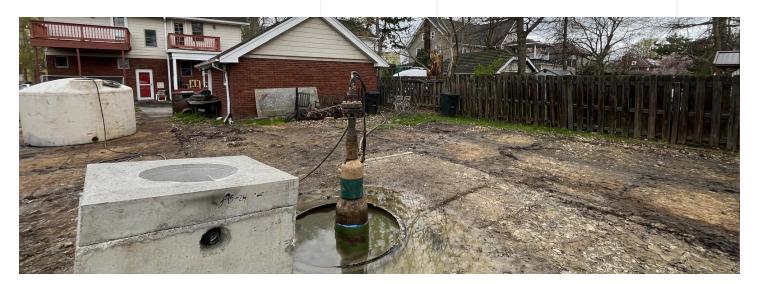
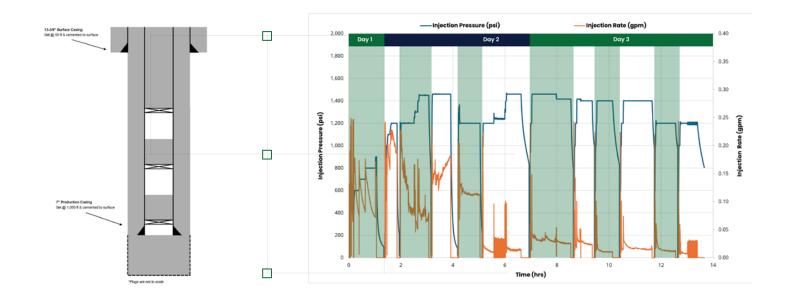
Instead of a costly re-entry requiring drillout and additional downhole squeezes, a DPAS™ BioSqueeze® was utilized to riglessly inject treatment fluids directly into leakage pathways in cement at surface. Utilizing our NanoSeal™ fluid system, bond was restored throughout the annulus (+1,000′).

The well was monitored by the Ohio Department of Natural Resources (ODNR) and no gas was detected post-treatment, enabling the well to be capped and cut for permanent abandonment.

Stage	Constant Pressure	Pump Time	Injection Rate	Volume Injected
1	900 psi	63 min	0.145 gpm	6.8 gal
2	1,200 psi	28 min	0.188 gpm	6.6 gal
3	1,450 psi	67 min	0.080 gpm	6.8 gal
4	1,460 psi	44 min	0.180 gpm	7.3 gal
5	1,360 psi	51 min	0.110 gpm	5.7 gal
6	1,460 psi	89 min	0.014 gpm	1.1 gal
7	1,460 psi	95 min	0.025 gpm	3.3 gal
8	1,416 psi	43 min	0.023 gpm	1.3 gal
9	1,400 psi	42 min	0.010 gpm	0.8 gal
10	1,400 psi	74 min	0.016 gpm	1.3 gal
11	1,225 psi	48 min	0.120 gpm	1.0 gal
12	1,200 psi	46 min	0.006 gpm	0.6 gal
