FATALITY INVESTIGATION

John Blake Bird

P&K Stone, LLC

P&K Stone, LLC Permit # LE-2836 Fatality Investigation Report

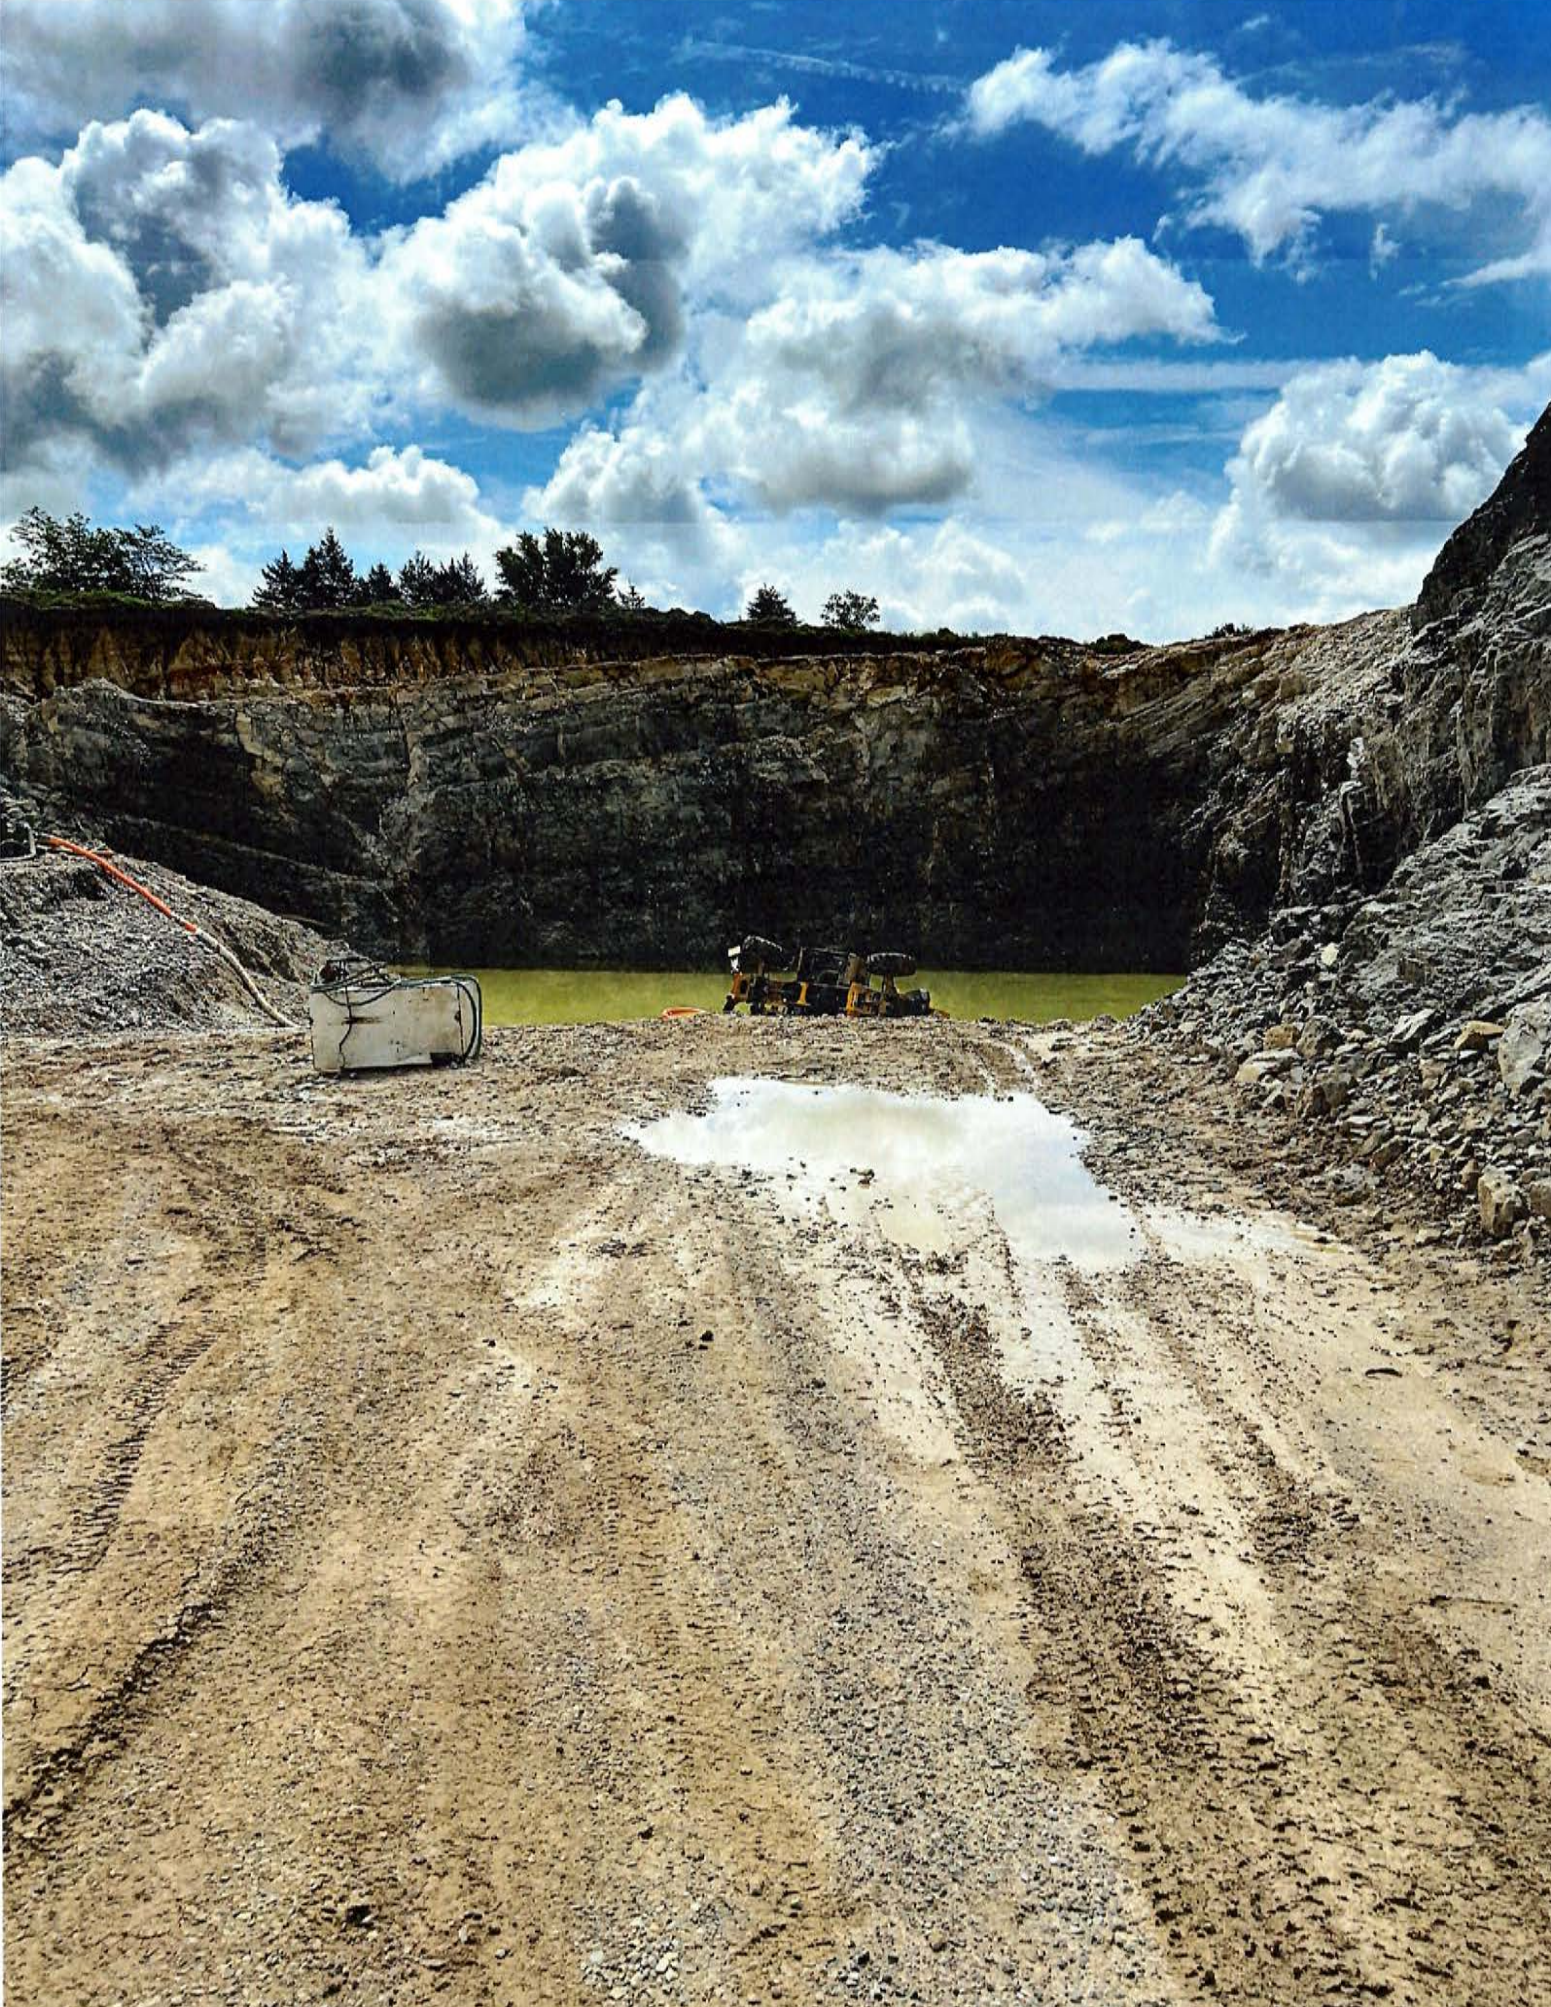
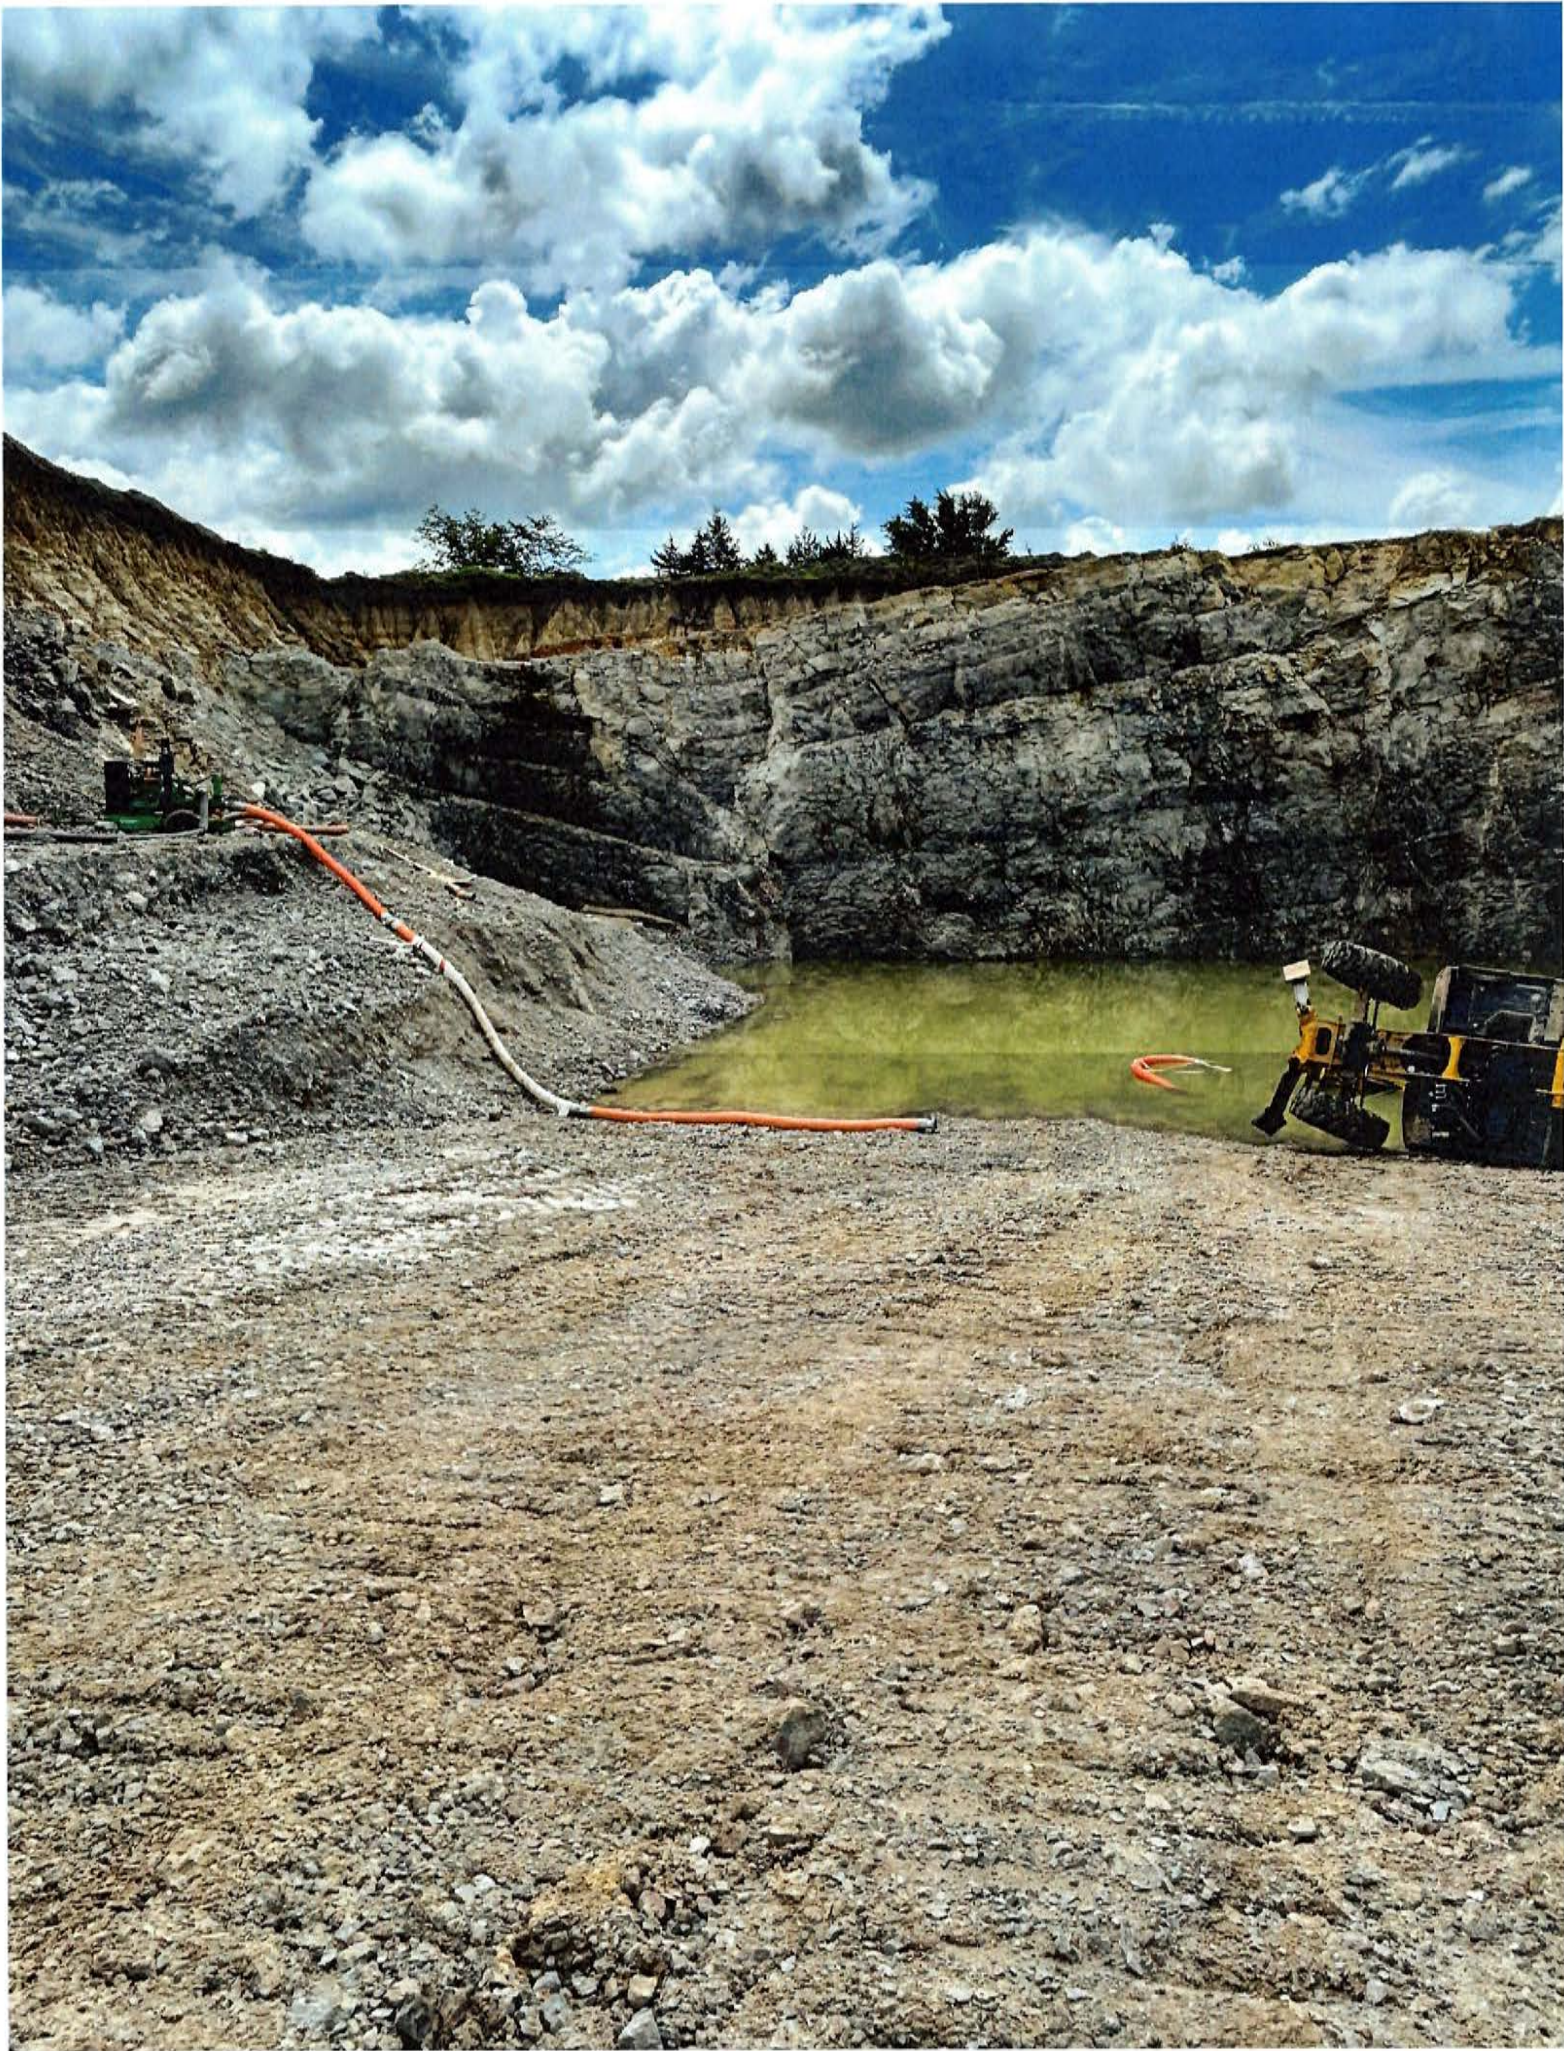
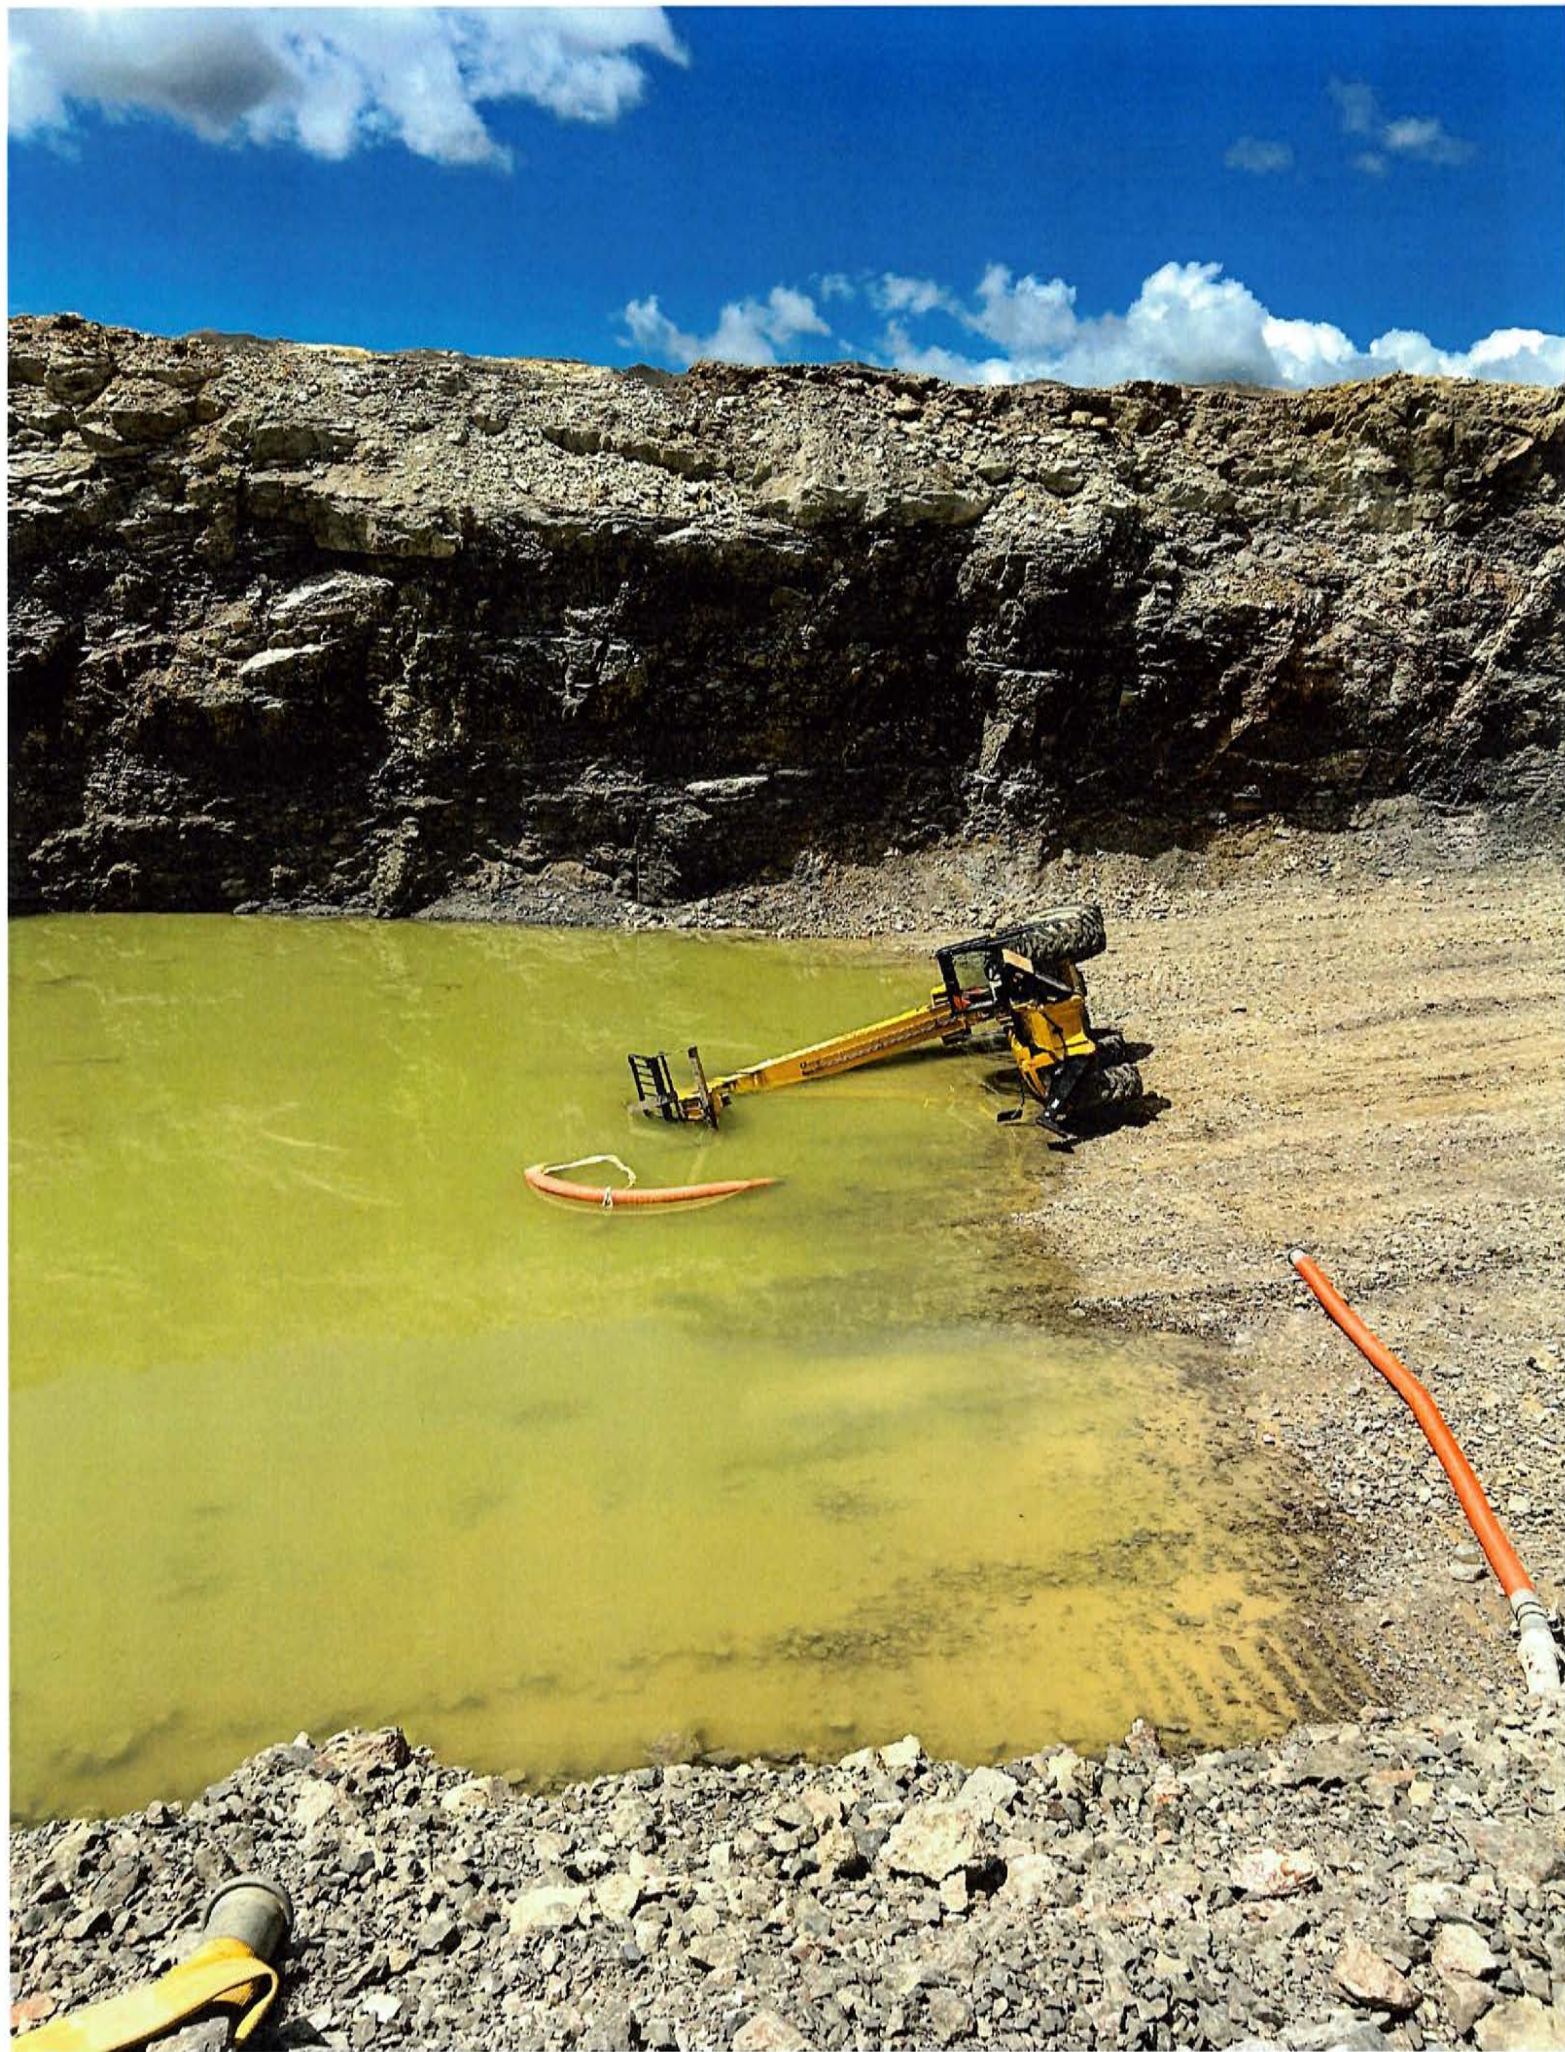
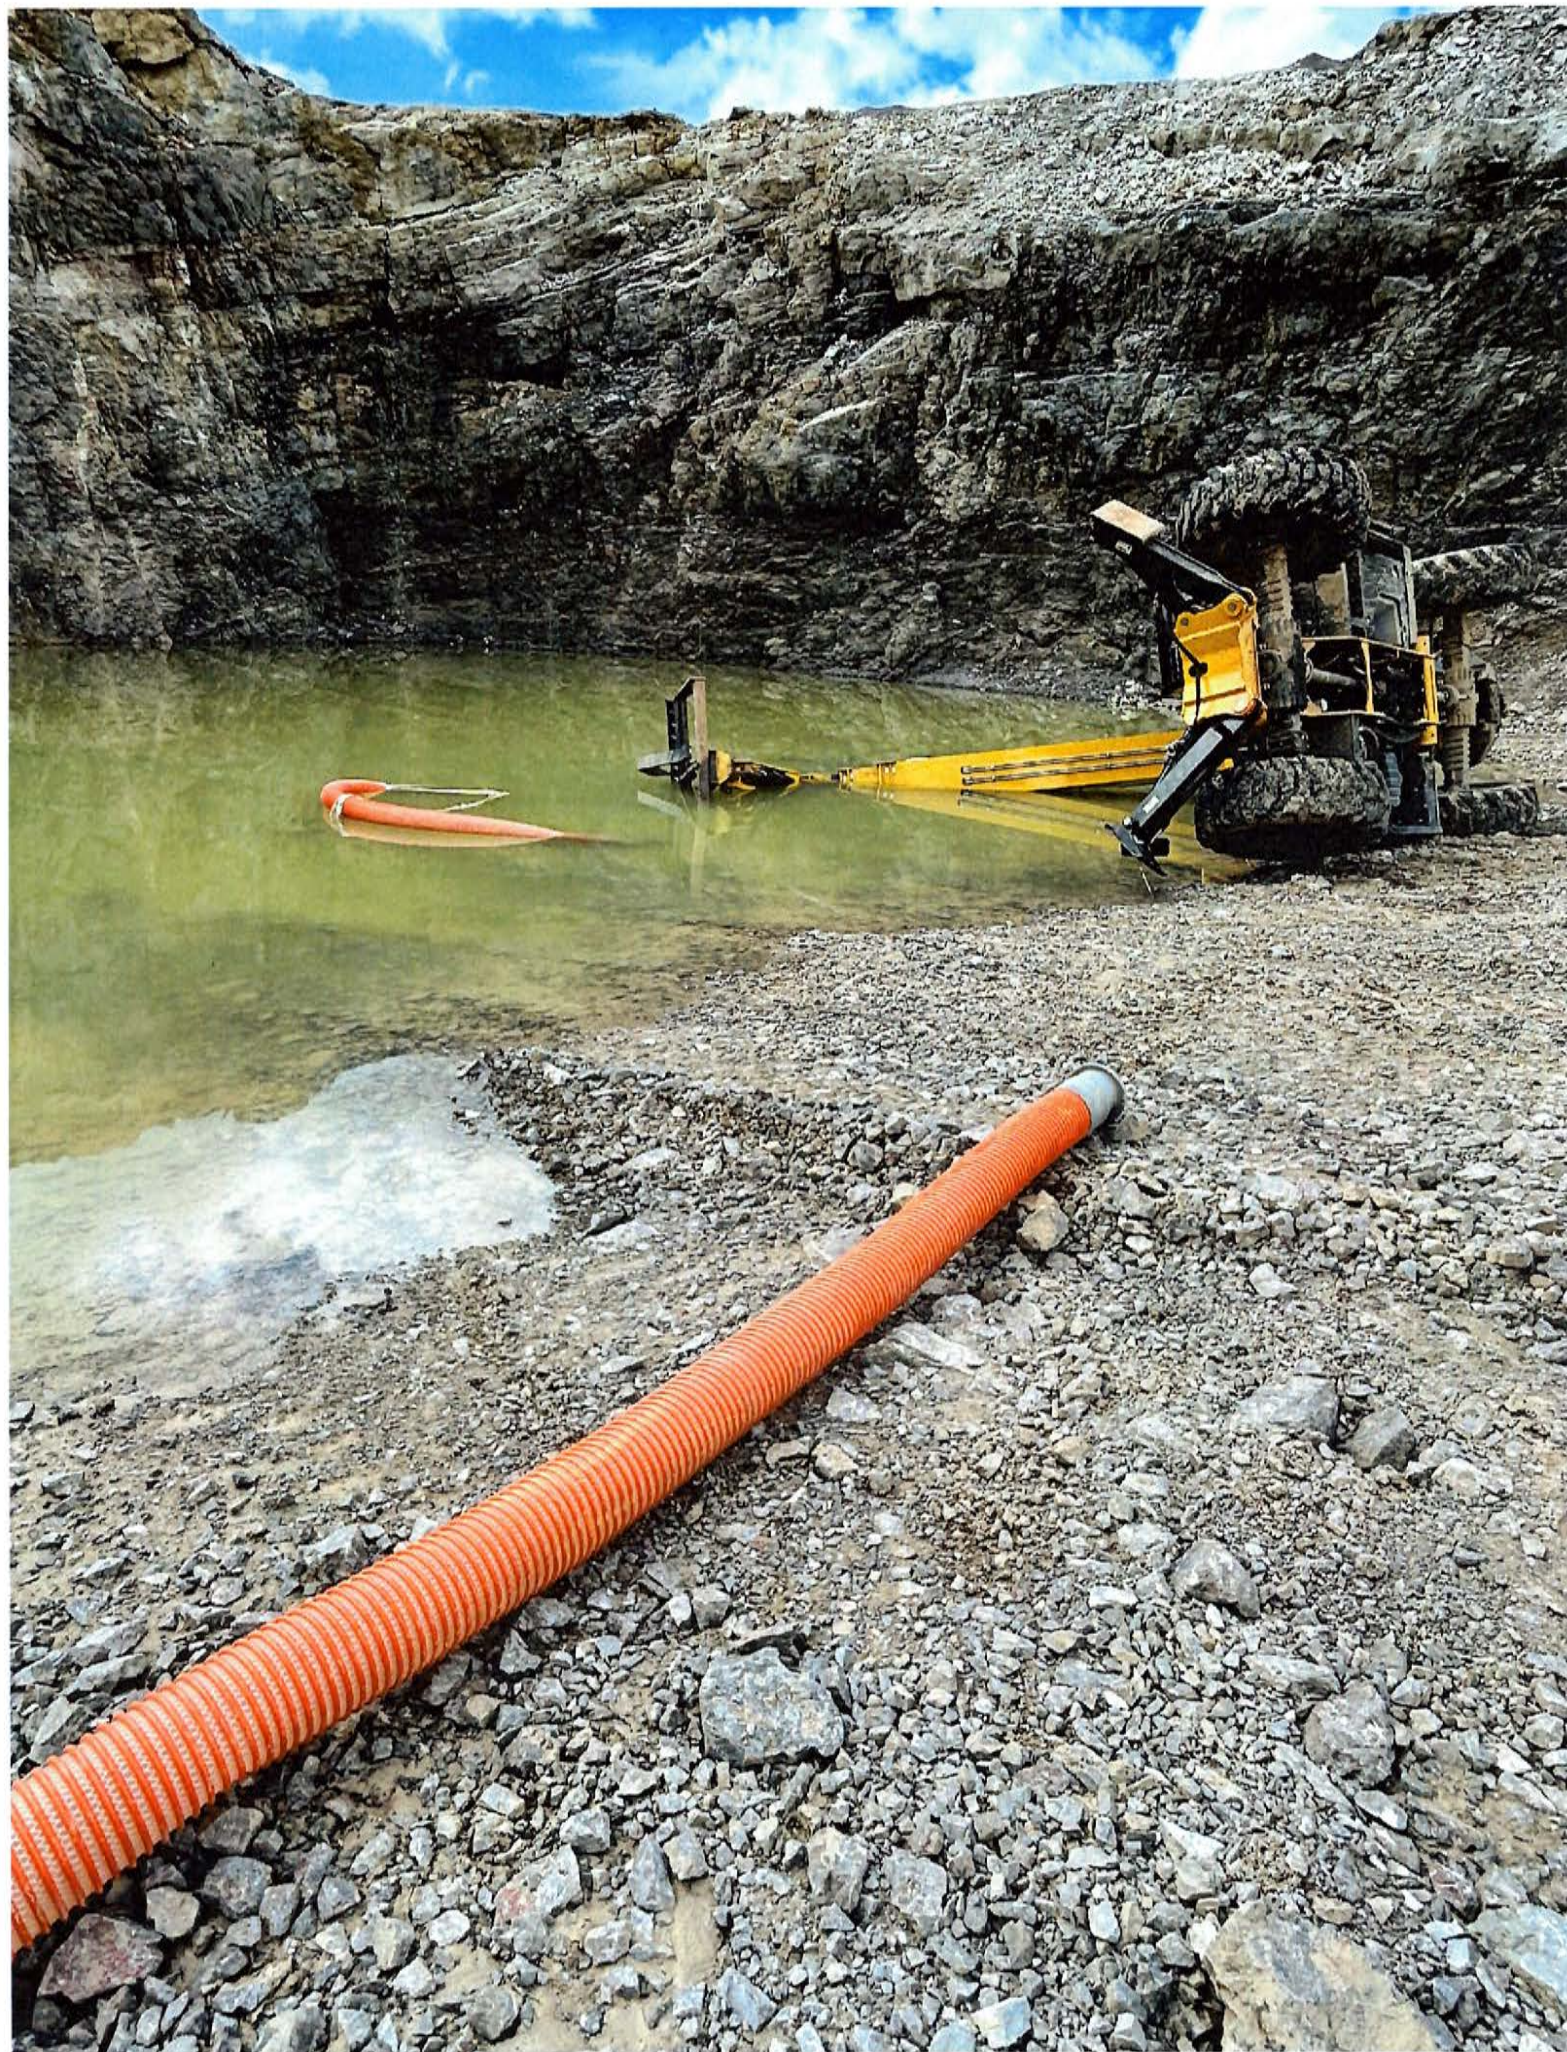
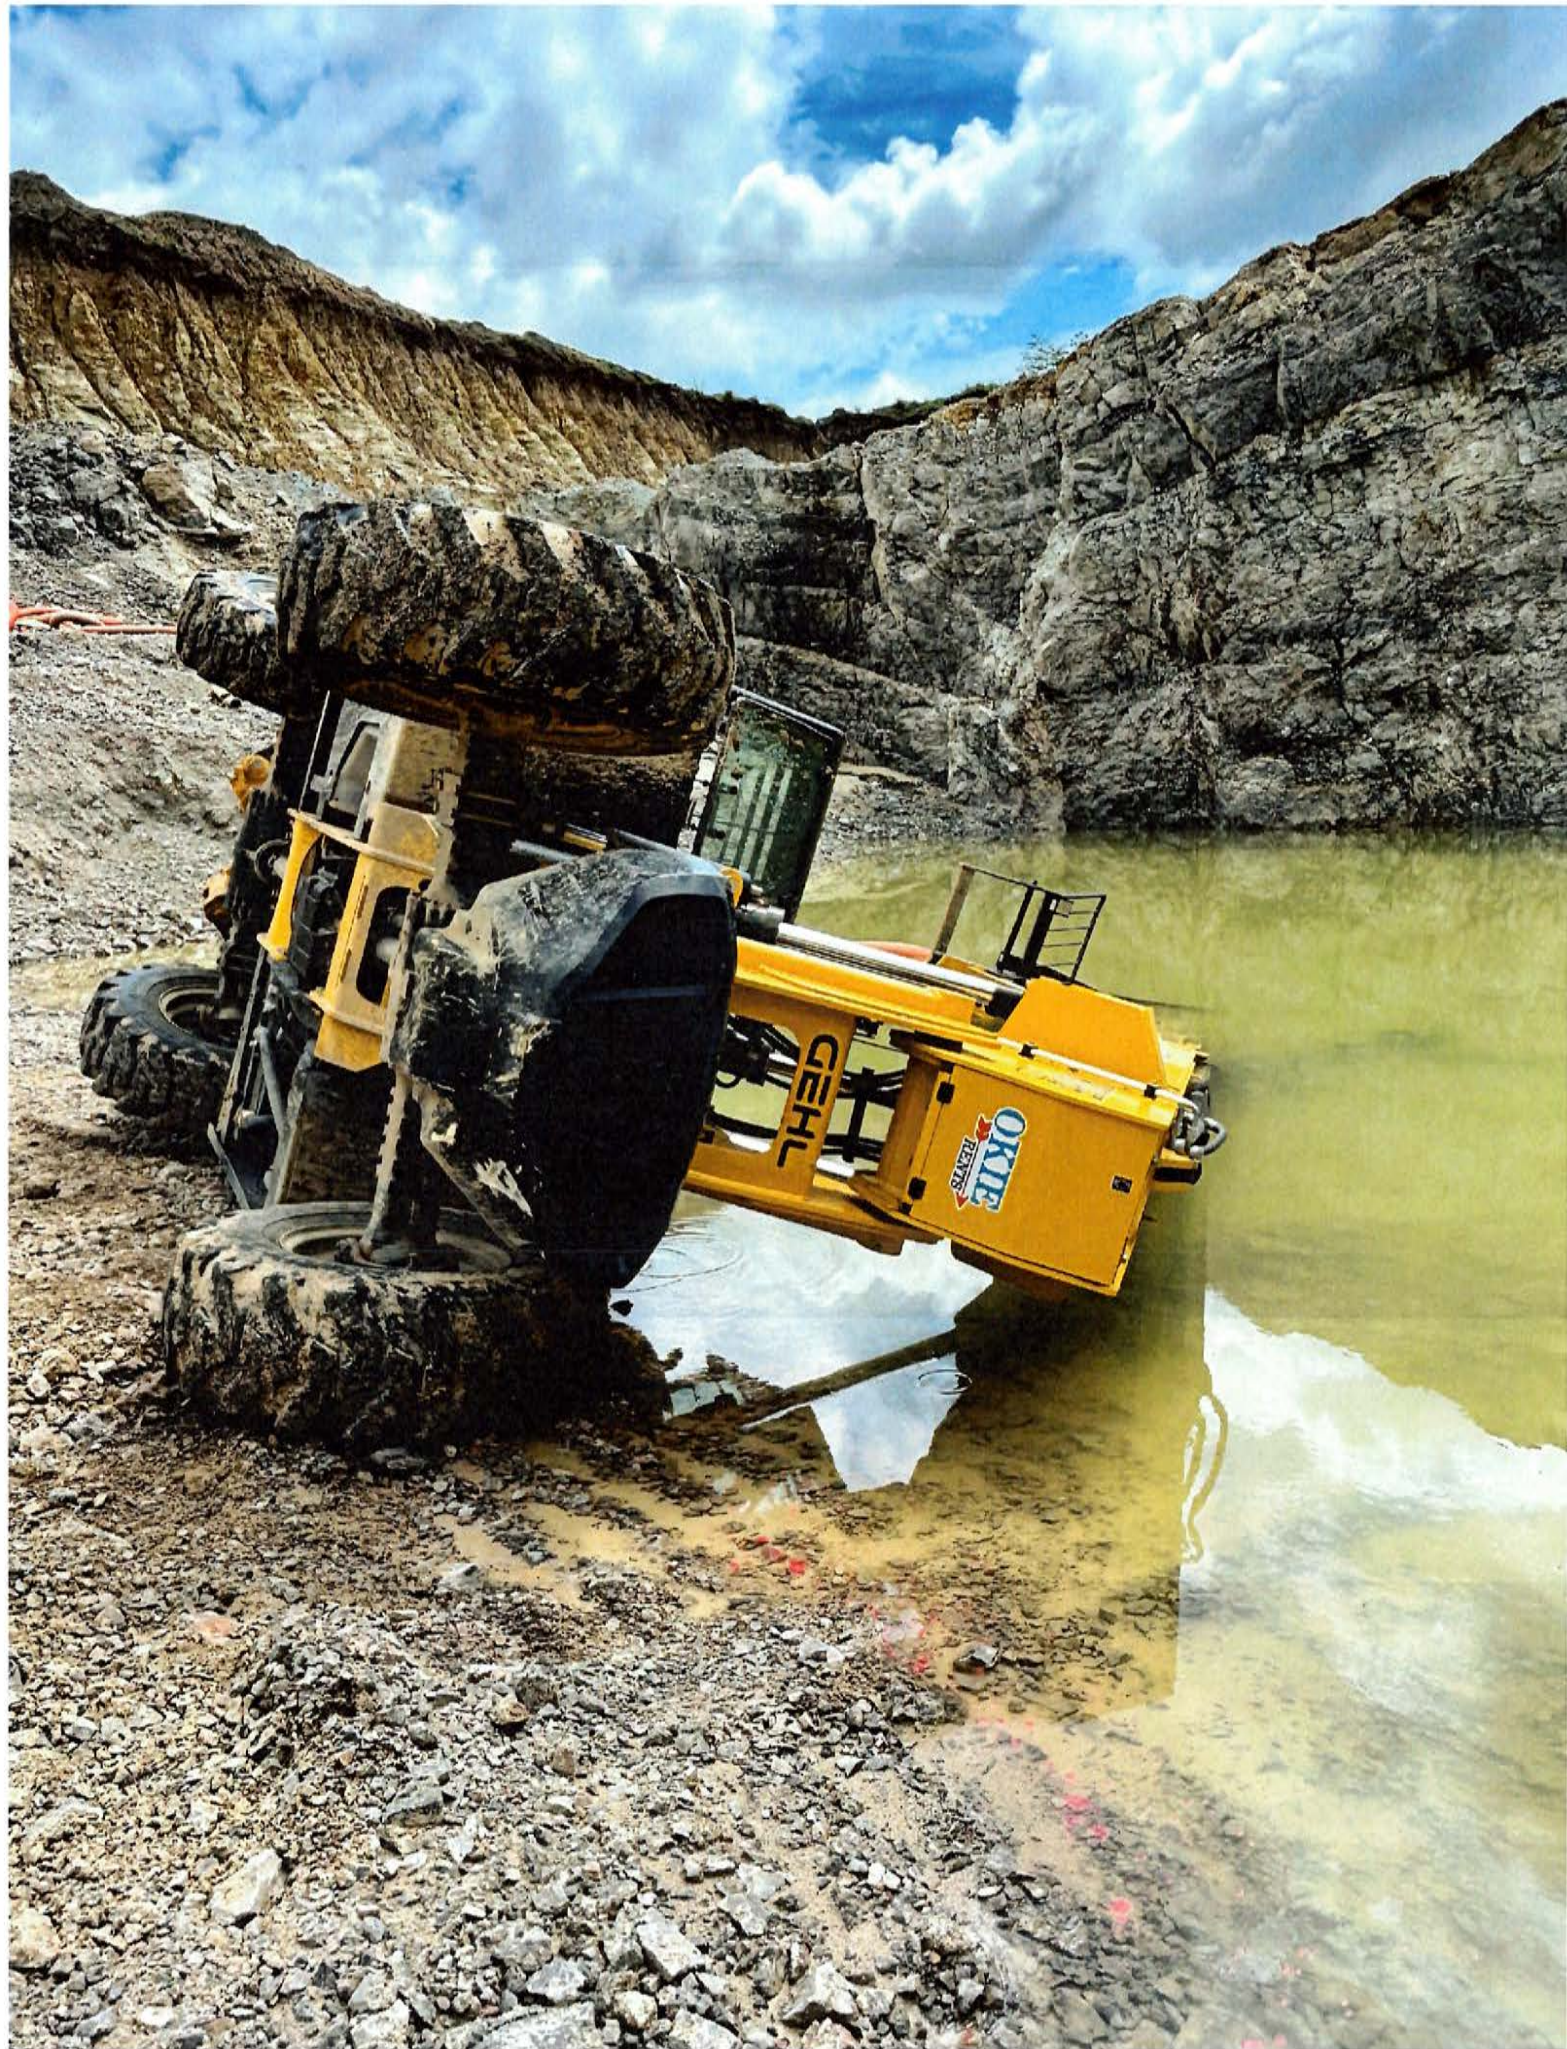
INVESTIGATION PHOTOS

A notice of violation is being issued for failure to meet this requirement. Just prior to the accident, Mr. Bird exited the cab of the equipment while the boom was fully extended in the air and a section of the suction hose hanging from one of the forks. Once Mr. Bird left the cab, all control of the equipment was lost.
