## WATERS AND WETLANDS EVALUATION REPORT

County	Bryan & Marshall	JP Number	33873(04)	Project Number	J3-3873(004)
Road Number	US-70	Water Body Name		Lake Texoma	
ROW Date		Let Date	Not programmed	Project Length	4.45 Miles
Project General Location		5 miles east of Kingston, and 10 miles west of Durant, OK			
Project Statement		Bridge and Approaches on US-70 Over Lake Texoma (Roosevelt Bridge)

Biologist Name	Megan Philips-Schaap
Company/Agency Name	Garver
Address	6100 S. Yale Avenue, Suite 1300
City, State Zip	Tulsa, Oklahoma 74136
Report Date:	February 4, 2022
Field Date:	December 1-2, 2021

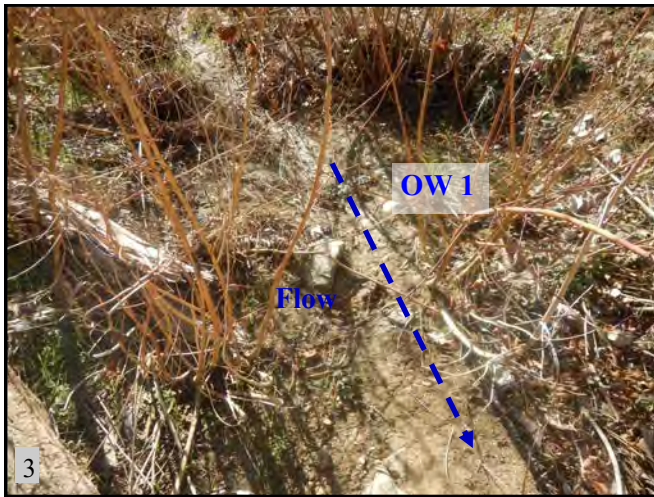
▲ (PS 2): View of OW 1, a small ephemeral stream that drains into a cove. View is upstream to the south.

OW 1 – An unnamed tributary to Lake Texoma, is not a USGS-mapped feature but was observed as an ephemeral stream during the field investigation. An estimated total of 49 linear feet (0.003 acre) of OW 1 occurs within the study footprint where it flows south to north. This short stream begins at a culvert and ends at the highly disturbed section of the lake cove where extensive trees clearing, and erosion activities have occurred from the construction east of the feature. The minimum ordinary high water mark (OHWM) was observed to be 1 foot wide, the maximum OHWM was observed to be 3 feet wide, and the average OHWM was observed to be 2 feet wide.

The estimated OHWM depth is between 1 and 2 inches. The riparian zone consists mainly of wooded and scrub-shrub vegetation. The streambanks are low, steep, disturbed, and streambank erosion potential is high. No water was observed, and the stream substrate is primarily clay loam. OW 1 likely receives water from precipitation and OW 2. During the field investigation, drift material in the channel was observed. No aquatic organisms were observed. Dominant riparian plant species observed include common buttonbush, honey-locust, sedge, aster, southern dewberry, and spotted crane's-bill. This feature is likely subject to regulation by the U.S. Army Corps of Engineers (USACE) as it is an ephemeral stream that flows into a USGS-mapped cove of a Traditional Navigable Water (TNW; Lake Texoma).

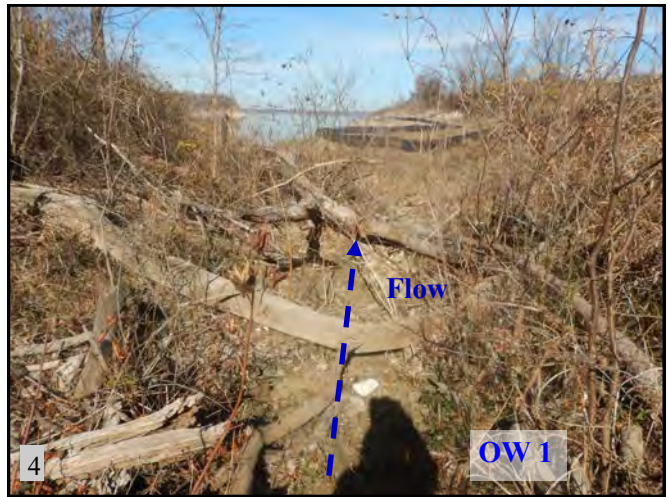
▲ (PS 2): View of OW 1 and the disturbed riparian habitat. View is downstream to the north.

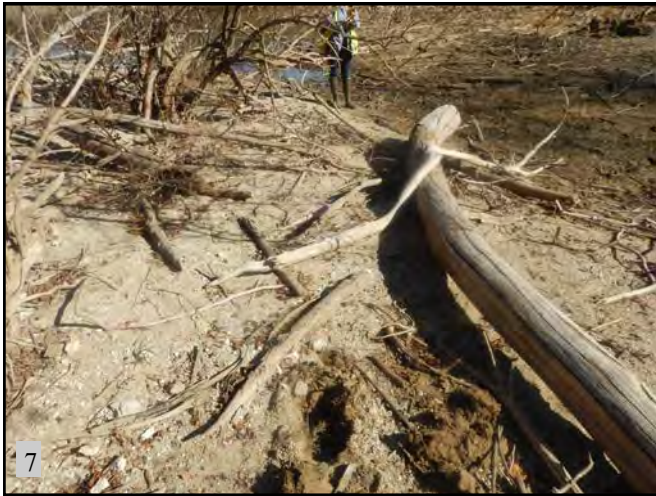
▲ (PS 2): View of Wetland 1, a small PSS wetland. View is to the east.

Wetland 1 – This wetland is an NWI-mapped feature and is classified as a L1UBHh (Lacustrine, Limnetic, Unconsolidated Bottom, Permanently Flooded, Diked/Impounded Wetland); however, it was observed as a PSS1J (Palustrine, Scrub-Shrub, Broad-Leaved Deciduous, Intermittently Flooded Wetland) during the field investigation. This wetland is located west of Lake Texoma and north of US-70. Wetland 1 has been disturbed from excavation activities to the east. This feature displayed geomorphic position, a FAC-neutral test, and soils that exhibited a depleted matrix. Vegetation observed includes common buttonbush. Approximately 0.06 acre occurs within the footprint. This feature is likely subject to regulation by the USACE as it abuts a USGS-mapped perennial cove (outside of the study area) of Lake Texoma, a TNW.

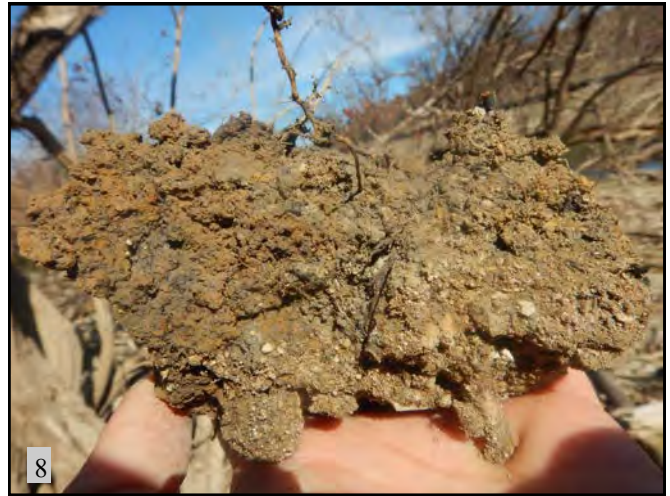
▲ (PS 2): View of hydric soils collected at DP 2 from Wetland 1.

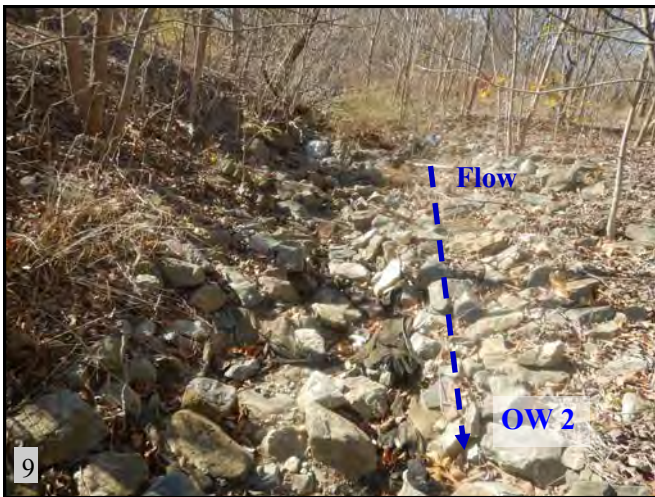
▲ (PS 2): View of OW 2, a rock lined ephemeral stream that flows into OW 1. View is upstream to the west.

OW 2 – An unnamed tributary to Lake Texoma, is not a USGS-mapped feature but was observed as an ephemeral stream during the field investigation. An estimated total of 431 linear feet (0.04 acre) of OW 2 occurs within the study footprint where it flows west to east into OW 1. The stream channel is lined with rip rap. The minimum OHWM was observed to be 3 feet wide, the maximum OHWM was observed to be 8 feet wide, and the average OHWM was observed to be 5 feet wide. The estimated OHWM depth is between 1 and 2 inches. The riparian zone consists mainly of sapling and scrub-shrub vegetation. The streambanks are low, gently sloped, lined with rip rap, and streambank erosion potential is low. No water was observed. OW 2 likely receives water from precipitation and roadway runoff. During the field investigation, rock ledges, root wads, and drift material in the channel were observed. No aquatic organisms were observed. Dominant riparian plant species observed include black willow, green ash, eastern red-cedar, southern dewberry, Johnson grass, and nodding wild rye. This feature is likely subject to regulation by the USACE as it is an ephemeral tributary to a USGS-mapped cove of a TNW (Lake Texoma).

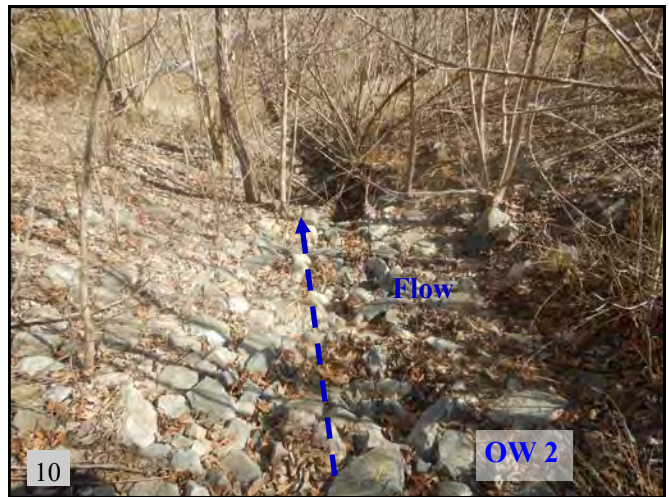
▲ (PS 2): View of OW 2, a rock lined ephemeral stream that flows into OW 1. View is downstream to the north.

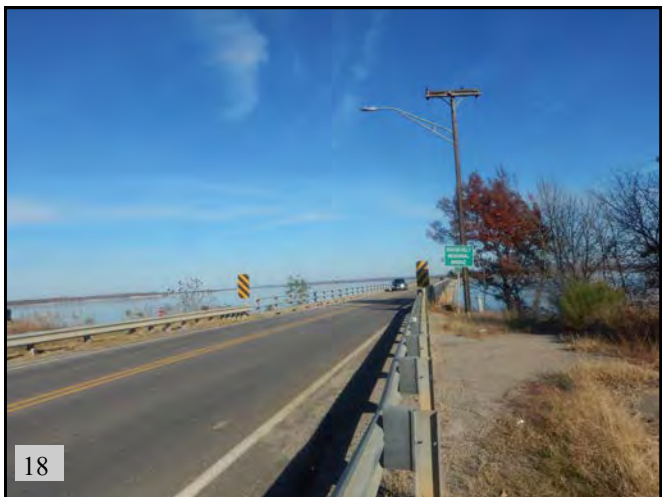
18

▲ (PS 4): View of the Roosevelt Bridge from the west side of Lake Texoma. View is to the east.

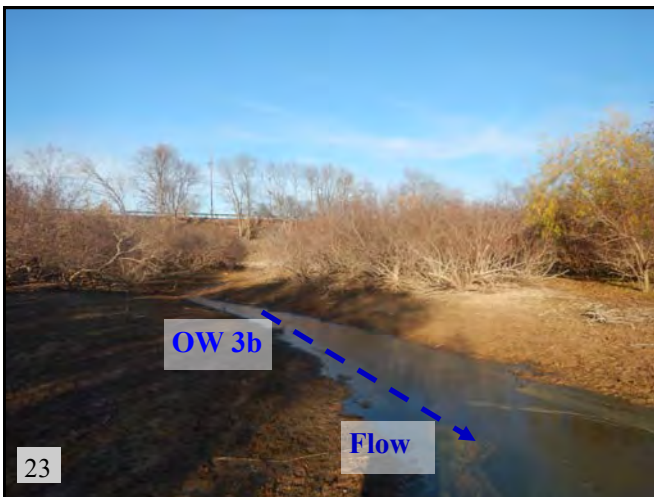
23

▲ (PS 6): View of perennial stream, OW 3b. View is upstream to the northeast.

OW 3b – A USGS-mapped perennial cove of Lake Texoma, was observed as a perennial stream feature during the field investigation. An estimated total of 267 linear feet (0.06 acre) of OW 3b occurs within the study footprint. This stream is located east of Lake Texoma and south of US-70. The minimum OHWM was observed to be 1 foot wide, the maximum OHWM was observed to be 30 feet wide, and the average OHWM was observed to be 11 feet wide. The estimated OHWM depth is between 1 and 2 inches. The riparian zone consists mainly of wooded and scrub-shrub vegetation. The streambanks are low, have a 4:1 slope, are not well vegetated, and streambank erosion potential is moderate. Water was clear reddish brown, and the stream substrate is primarily clay loam. OW 3b likely receives back water from Lake Texoma, groundwater, roadway runoff, and precipitation. During the field investigation, wetlands were observed along both banks (Wetland 2). Large fish were observed during the field investigation. Dominant riparian plant species observed include black willow, common buttonbush, southern dewberry, and tapered rosette grass. This feature is likely subject to regulation by the USACE as it is a USGS-mapped perennial stream of a USGS-mapped TNW (Lake Texoma).

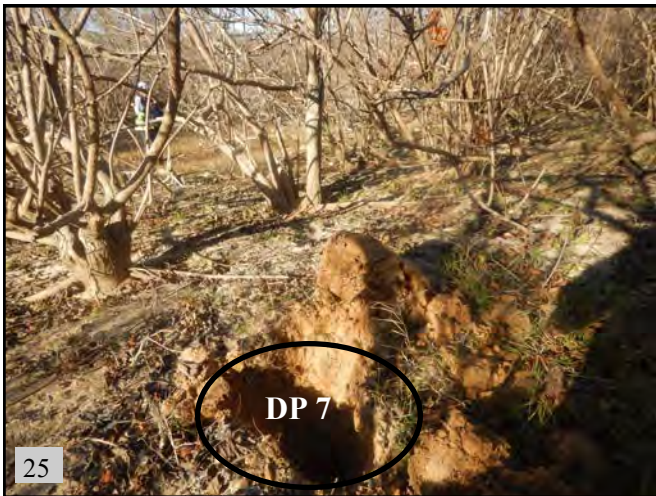
▲ (PS 6): View of Wetland 2, a large PSS wetland around OW 3b. View is to the west.

Wetland 2 – This wetland is an NWI-mapped feature and is classified as a L1UBHh; however, it was observed as a PSS1J during the field investigation. This wetland is located east of Lake Texoma and south of US-70. Wetland 2 was observed as a fringe PSS wetland on both banks of OW 3b. This feature displayed sediment deposits, geomorphic position, a FAC-neutral test, and soils with a depleted matrix. Vegetation observed includes buttonbush. Approximately 1.31 acres occur within the footprint. This feature is likely subject to regulation by the USACE as it abuts a USGS-mapped perennial cove of Lake Texoma, a TNW.

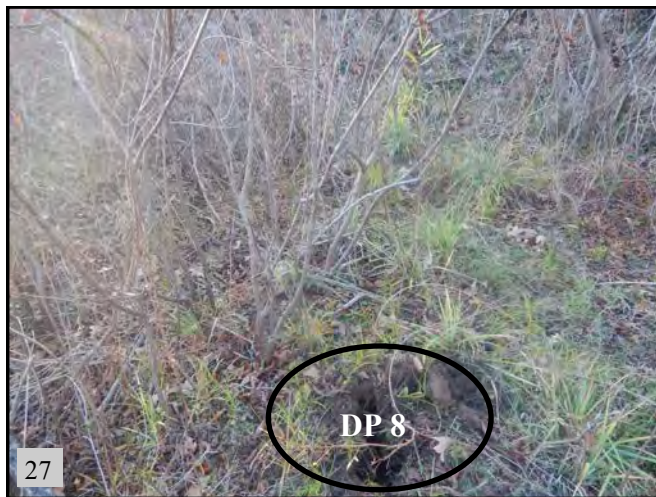
▲ (PS 6): View of Wetland 3, a PSS wetland located west of Wetland 2. View is to the north.

Wetland 3 – This wetland is a NWI-mapped feature and is classified as a L1UBHh; however, it was observed as a PSS1J during the field investigation. This wetland is located south of US-70 and west of Wetland 2. This feature displayed geomorphic position, a FAC-neutral test, and soils with a depleted matrix. Vegetation observed include black willow, common buttonbush, and sedge. Approximately 0.25 acre occurs within the footprint. This feature is likely subject to regulation by the USACE as it abuts a USGS-mapped perennial cove (outside of the study area) of Lake Texoma, a TNW.

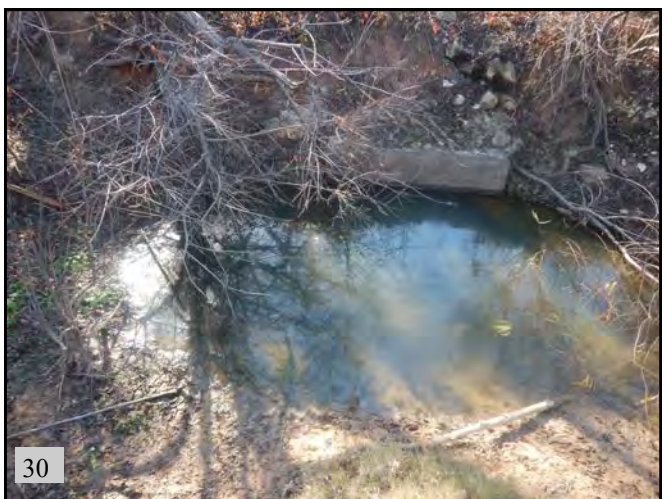
▲ (PS 7): View of flooded structure that OW 4a, 4b, and OW 5 flow into. View is to the south.

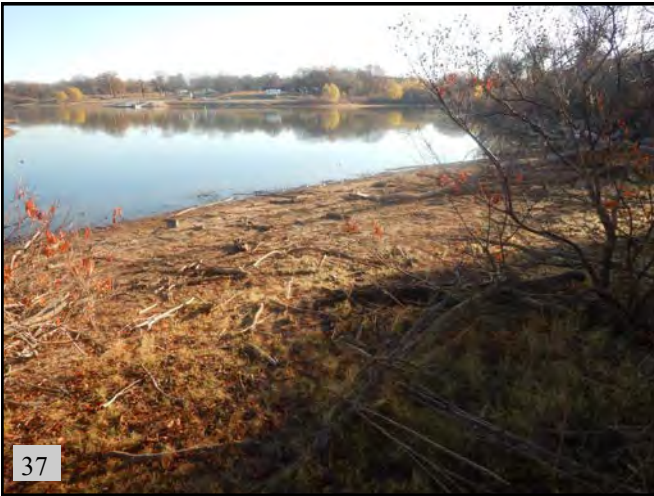
37

▲ (PS 9): View of the west section of OW 3c, a perennial cove of Lake Texoma. View is to the east.

OW 3c – A NWI-mapped perennial cove of Lake Texoma, is classified and observed during the field investigation as a L1UBHh. An estimated total of 3.52 acres of OW 3c occurs within the study footprint. This cove is located north of north of US-70. The estimated water depth is between 2 and 8 feet. Water was clear dark brown, and the substrate is primarily loam. OW 3c receives back water from Lake Texoma, groundwater, and precipitation. During the field investigation, a wetland along the west bank (Wetland 4) was observed. No aquatic organisms were observed but it is assumed that multiple fish, reptile, amphibian, and mussel species are present. Dominant plant species observed along the banks include black willow, common buttonbush, heliotrope, speedwell, rough cocklebur, and tapered rosette grass. This feature is likely subject to regulation by the USACE as it is a perennial cove of a USGS-mapped TNW (Lake Texoma).

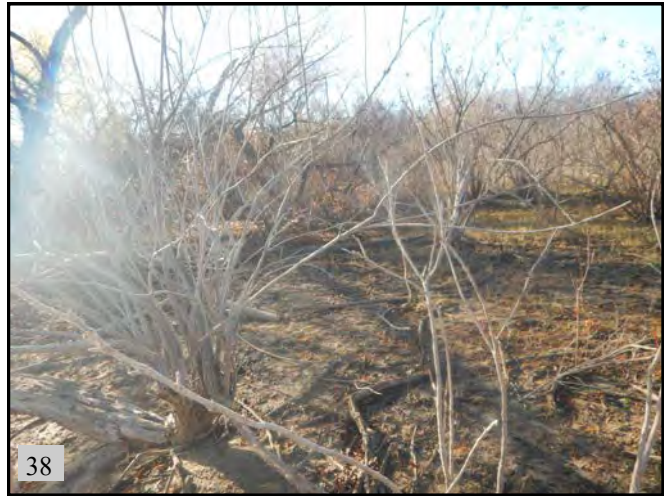
38

▲ (PS 9): View of Wetland 4, a linear PSS wetland. View is to the north.

Wetland 4 – A small section of this wetland is classified as a L1UBHh on the NWI map; however, it was observed as a PSS1J during the field investigation. This wetland is located north of US-70 and directly abuts the west side of OW 3c. This feature displayed a high water table, saturated soils, geomorphic position, a FAC-neutral test, and soils with a depleted matrix. Vegetation observed include common buttonbush and sedge. Approximately 0.35 acre occurs within the footprint. This feature is likely subject to regulation by the USACE as it abuts a USGS-mapped perennial cove of Lake Texoma, a TNW.

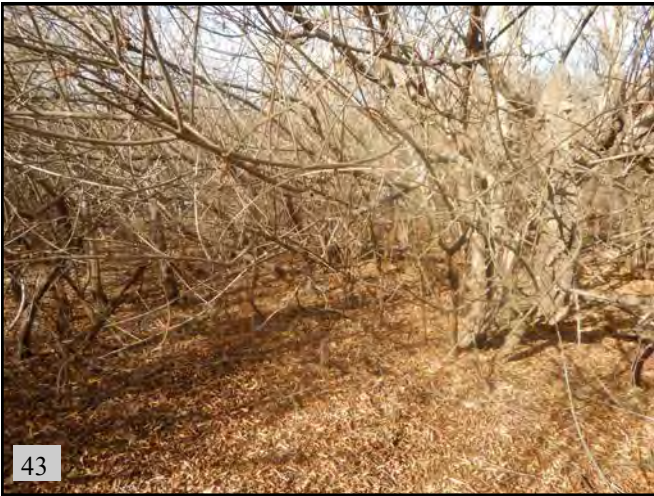
▲ (PS 11): View of Wetland 5, a large PSS wetland on the east side of OW 3d. View is to the north.

Wetland 5 – A small section of this wetland is classified as a L1UBHh on the NWI map; however, it was observed as a PSS1J during the field investigation. This wetland is located south of US-70 and was observed as a PSS fringe wetland on the east side of OW 3d. This feature displayed a sparsely vegetated concave surface, geomorphic position, a FAC-neutral test, and soils with a depleted matrix. Vegetation observed include black willow, common buttonbush, sedge, and southern dewberry. Approximately 0.95 acre occurs within the footprint. This feature is likely subject to regulation by the USACE as it abuts a USGS-mapped perennial Relatively Permanent Water (RPW; OW 3d) that has a direct surface water connection to Lake Texoma, a TNW.

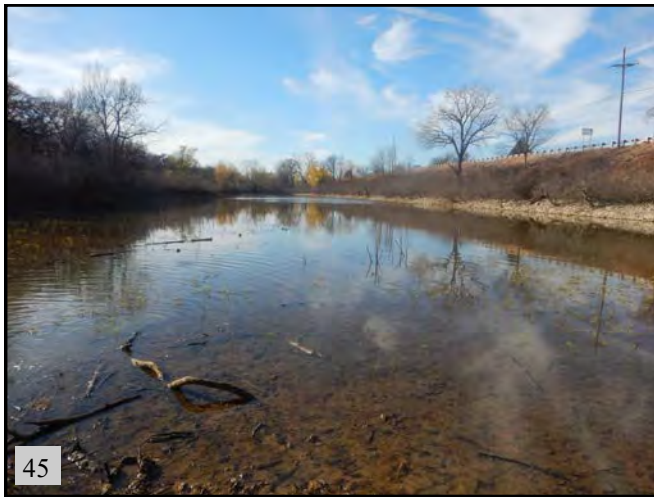
▲ (PS 11): View of OW 3d, a large perennial lake overflow area south of US-70. View is to the west.

OW 3d – A NWI-mapped perennial waterbody, is classified and observed during the field investigation as a L1UBHh. A reinforced concrete bridge (RCB) under US-70 conveys water between OW 3d and OW 3c. An estimated total of 2.62 acres of OW 3d occurs within the study footprint. This lake overflow is located south of US-70. The estimated water depth is between 1 and 2.5 feet. Water was clear dark brown, and the substrate is primarily loam. OW 3d likely receives back water from Lake Texoma, groundwater, and precipitation. During the field investigation, wetlands along the east and west banks were observed. No aquatic organisms were observed during the field investigation. Dominant plant species observed along the banks include black willow, common buttonbush, osage-orange, aster, fringed greenbrier, southern dewberry, sedge, and tapered rosette grass. This feature is likely subject to regulation by the USACE as it is a perennial overflow of a USGS-mapped TNW (Lake Texoma).
