**Programmatic/Individual Categorical Exclusion**

| Date | <b>8/8/2025</b> | Project Number | <b>J3-4334(004)FP</b> |
| Project Description from JPINFO | <b>Bridge &amp; Approaches I-40: Over Arkansas River, begin MP 290, east 1.0 mile</b> | | |

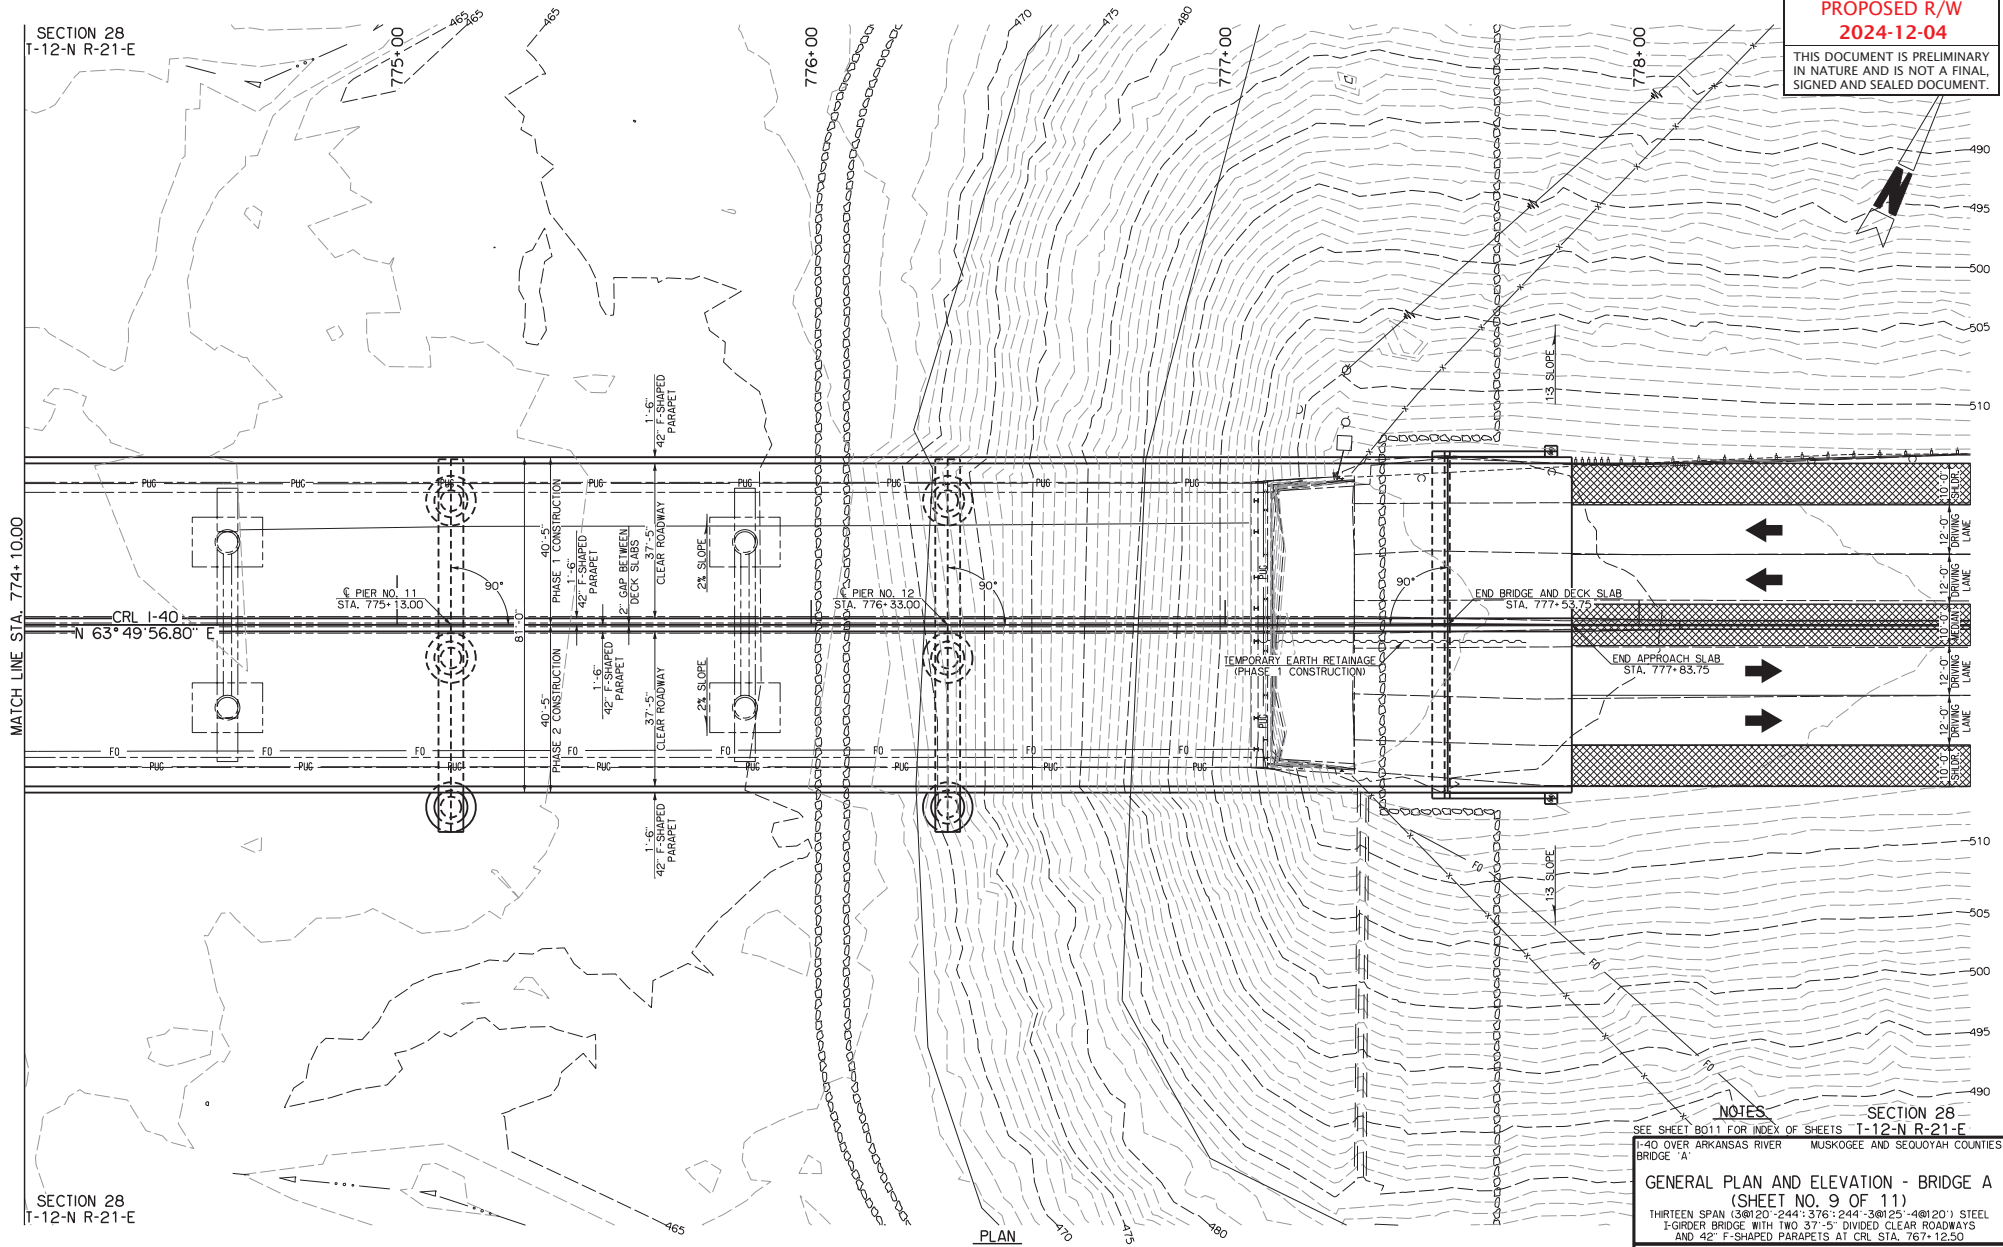
PLAN

SECTION 28  
T-12-N R-21-E  
GENERAL PLAN AND ELEVATION - BRIDGE A  
(SHEET NO. 9 OF 11)  
THIRTEEN SPAN (3@120'-244'; 376'-244'-3@125'-4@120') STEEL  
I-GIRDER BRIDGE WITH TWO 37'-5" DIVIDED CLEAR ROADWAYS  
AND 42" F-SHAPED PARAPETS AT CRL STA. 767+12.50  
STATE JOB NO. 34334(104) SHEET NO. B009

MATERIAL:  
CLASS A CONCRETE,  $f'_c = 3,000$  PSI  
CLASS AA CONCRETE,  $f'_c = 4,000$  PSI  
REINFORCING STEEL,  $f_y = 60,000$  PSI  
STRUCTURAL STEEL M270 (GRADE 50W),  $F_y = 50,000$  PSI  
STAINLESS STEEL A240 (TYPE 316),  $F_y = 30,000$  PSI

LOADINGS:  
AASHTO HL-93  
OKLAHOMA DOT 9 AXLE OVERLOAD TRUCK (175 KIP)  
OKLAHOMA DOT 16 AXLE OVERLOAD TRUCK (315 KIP)  
20 PSF FUTURE WEARING SURFACE

DESIGN:  
AASHTO LRFD BRIDGE DESIGN SPECIFICATIONS, 9TH EDITION  
ANSI/AASHTO/AWS D1.5 BRIDGE WELDING CODE  
ANSI/AWS D1.6 STRUCTURAL WELDING CODE - STAINLESS STEEL
