**WIDEN, RESURFACE & BRIDGE SH-66:
FROM SH-102, EAST 4.0 MILES
TO US-177
LINCOLN COUNTY
J/P# 34318(04)**

OKLAHOMA
Transportation

CC Environmental, LLC
PO Box 1292
Norman, OK 73070

Programmatic/Individual Categorical Exclusion

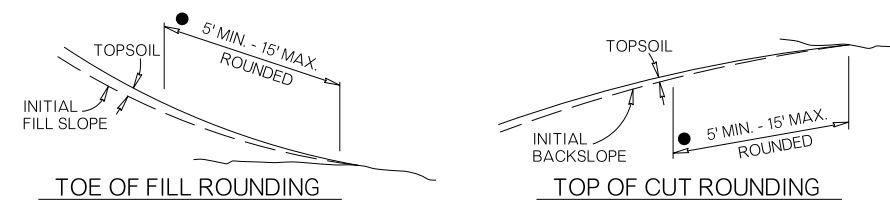
ROUNDING DETAIL

- INTERSECTION OF CUT AND/OR FILL SLOPES WITH GROUND LINE TO BE ROUNDED AS PART OF FINISHING OPERATIONS. ROUNDED SHALL BE 5' MINIMUM FOR SMALLER CUTS AND FILLS TO 15' MAXIMUM FOR LARGER CUTS AND FILLS OR AS DESIGNATED BY THE ENGINEER. COST OF ROUNDED TO BE INCLUDED IN PRICE BID FOR OTHER ITEMS OF WORK.

THE GRADING LINE AS SHOWN ON THE TYPICAL AND CROSS SECTIONS IS TO THE TOP OF THE TOPSOIL. EARTHWORK QUANTITIES WERE NOT ADJUSTED FOR SALVAGE AND THE TOPSOIL QUANTITY IS INCLUDED IN THE MASS LINE BALANCE.
- (3) DISTANCE MEASURED VERTICALLY FROM EDGE OF FINISHED GRADE SHOULDER.
- (4) PRIME COAT TO BE APPLIED TO THE TOP OF THE STABILIZED SUBGRADE AND THE TOP OF THE AGGREGATE BASE.
- (5) UNLESS OTHERWISE NOTED ON CROSS SECTION.
- (6) SEE ROUNDING DETAIL. SHEET 0002.

THE GRADING LINE AS SHOWN ON THE TYPICAL AND CROSS SECTIONS IS TO THE TOP OF THE TOPSOIL. EARTHWORK QUANTITIES WERE NOT ADJUSTED FOR SALVAGE AND THE TOPSOIL QUANTITY IS INCLUDED IN THE MASS LINE BALANCE.
- (3) DISTANCE MEASURED VERTICALLY FROM EDGE OF FINISHED GRADE SHOULDER.
- (4) PRIME COAT TO BE APPLIED TO THE TOP OF THE STABILIZED SUBGRADE AND THE TOP OF THE AGGREGATE BASE.
- (5) UNLESS OTHERWISE NOTED ON CROSS SECTION.
- (6) SEE ROUNDING DETAIL, SHEET 0002.

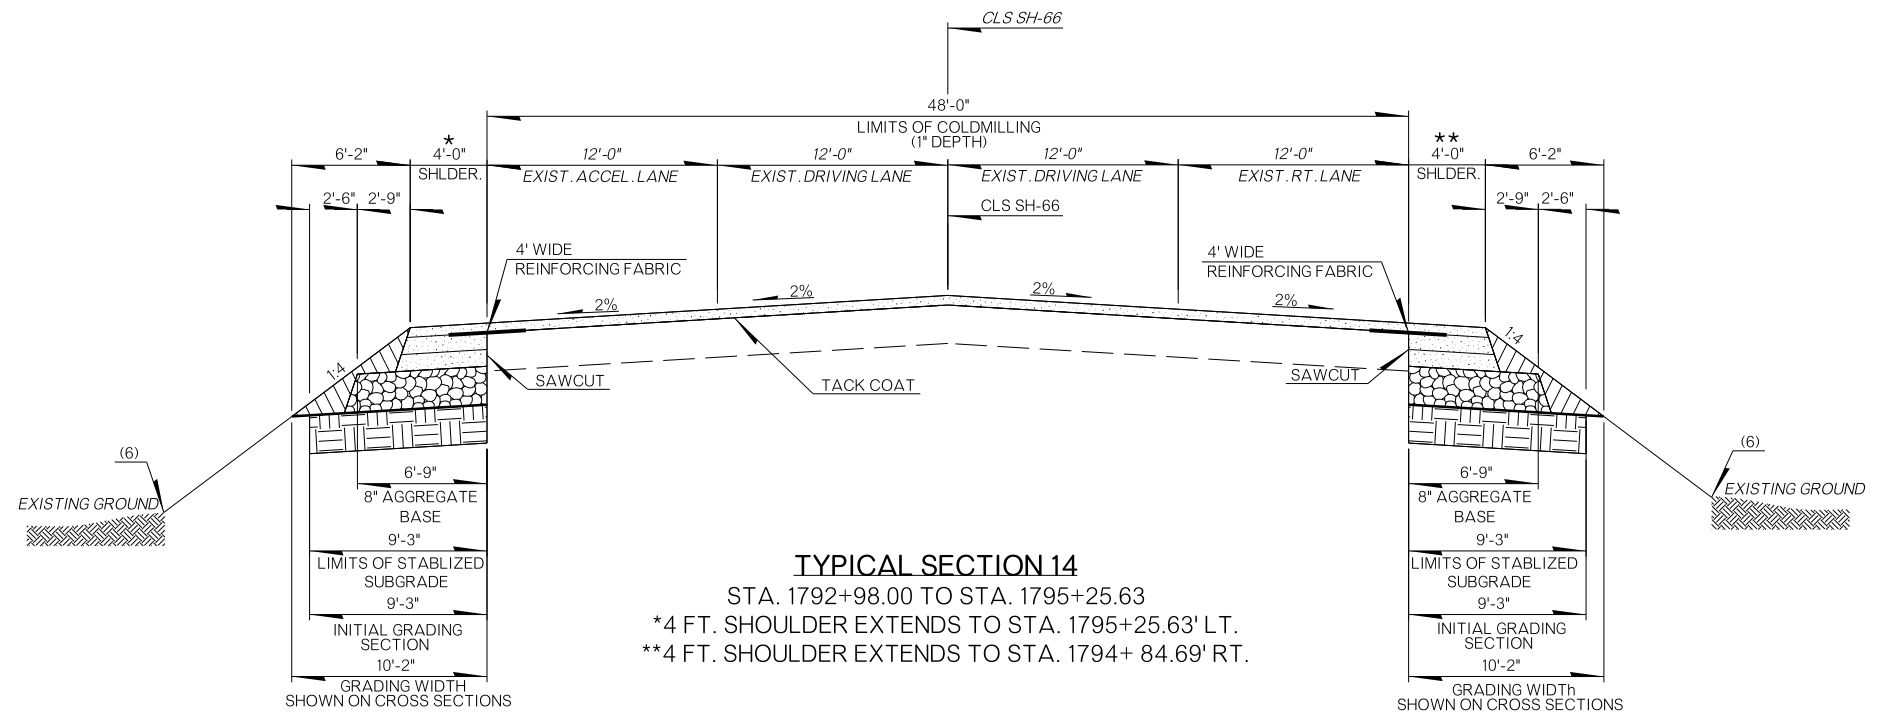
TYPICAL SECTION 14
 STA. 1792+98.00 TO STA. 1795+25.63
 *4 FT. SHOULDER EXTENDS TO STA. 1795+25.63' LT.
 **4 FT. SHOULDER EXTENDS TO STA. 1794+ 84.69' RT.

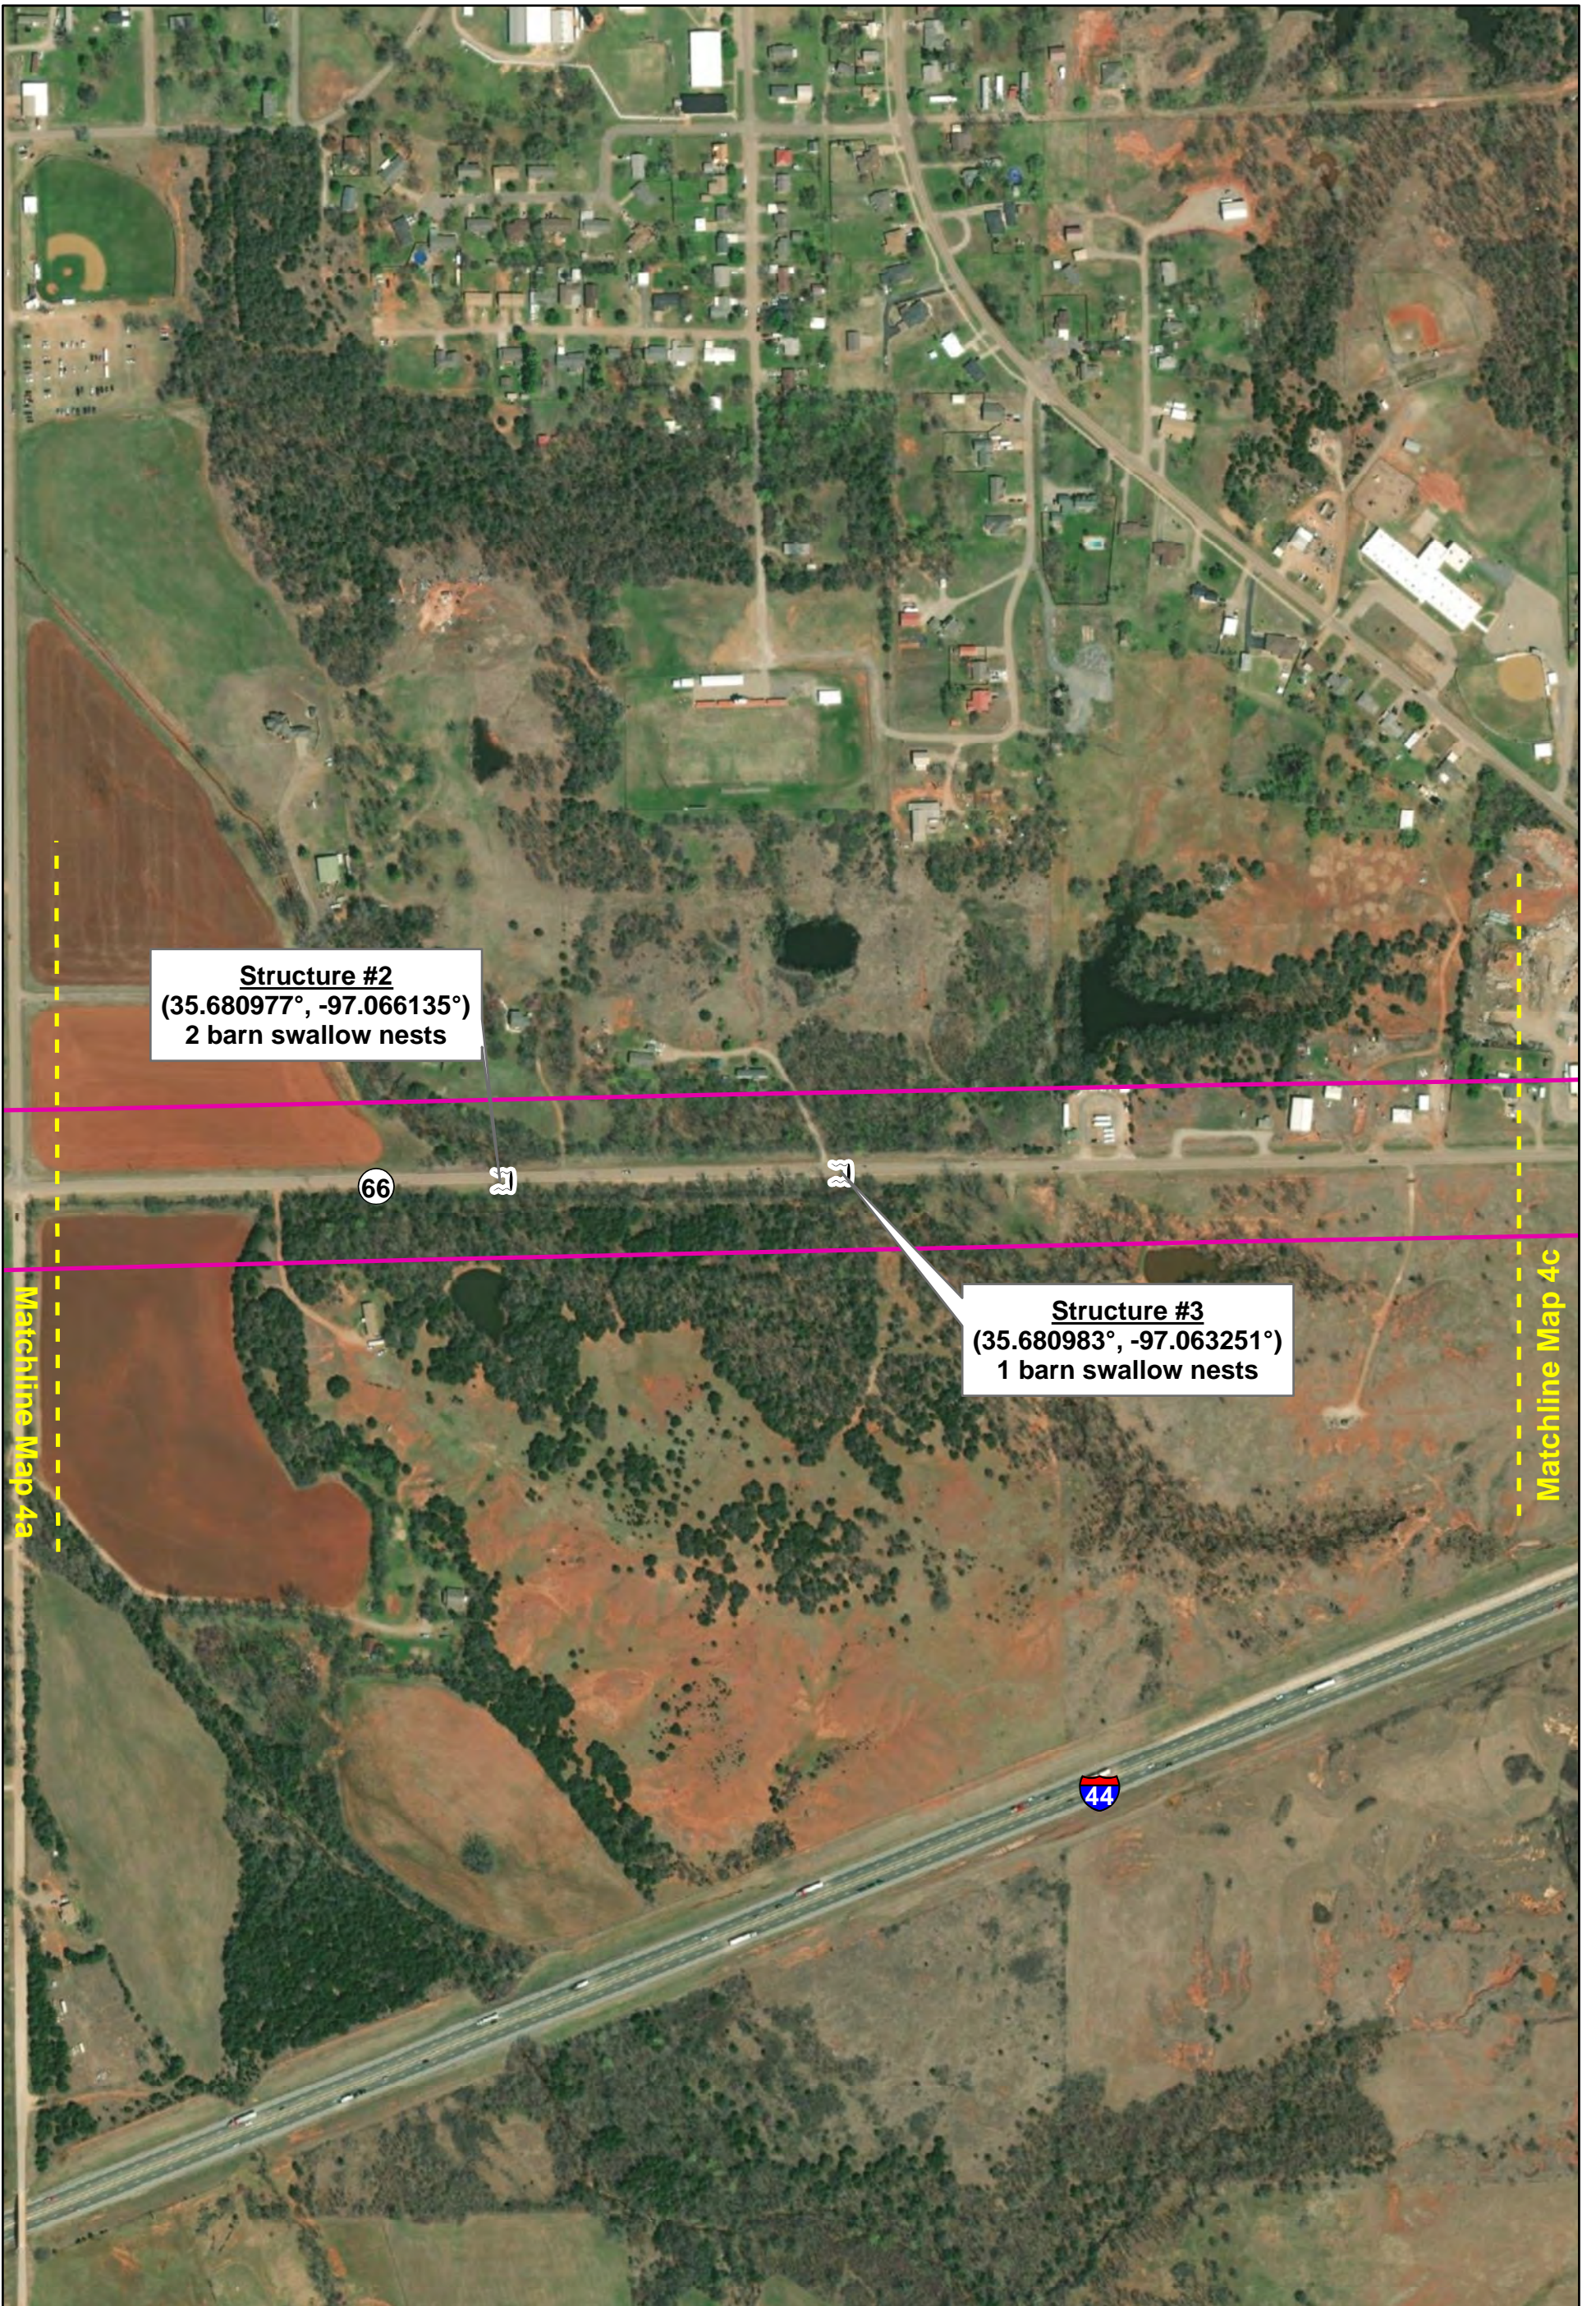
Structure #2
 (35.680977°, -97.066135°)
 2 barn swallow nests

Structure #3
 (35.680983°, -97.063251°)
 1 barn swallow nests

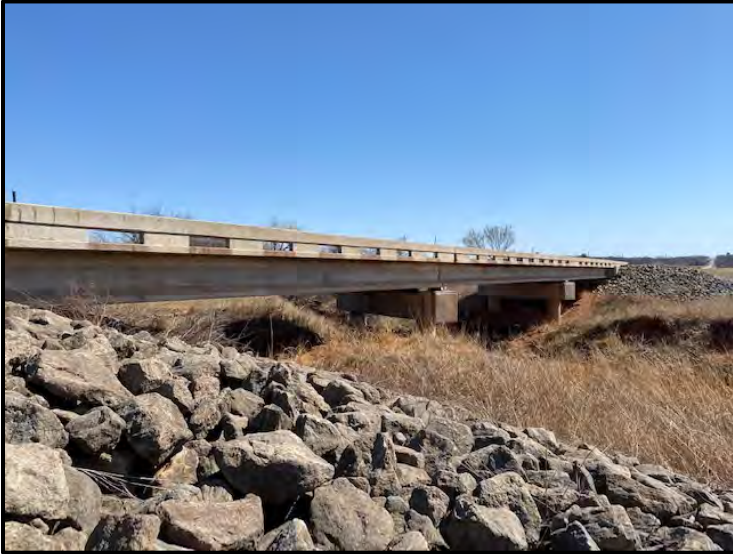
Photograph 2: NBI: 26639 over R2UBHx-01 (Captain Creek), migratory bird nests present.

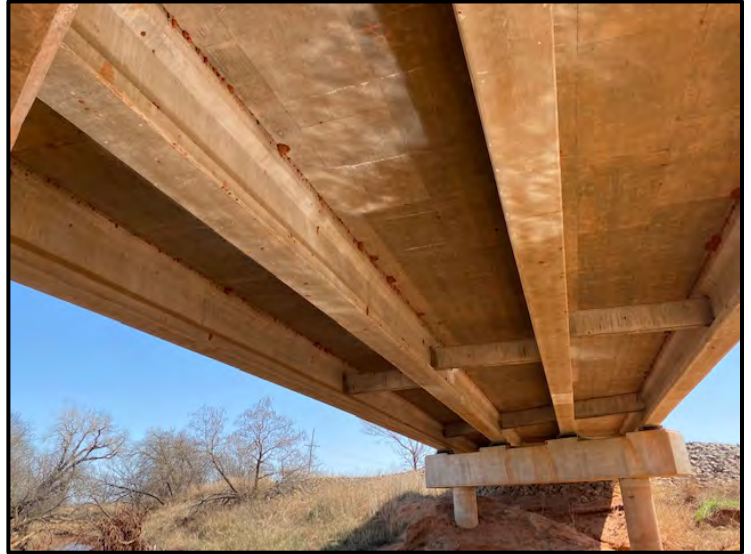
Photograph 3: Beneath NBI: 26639.

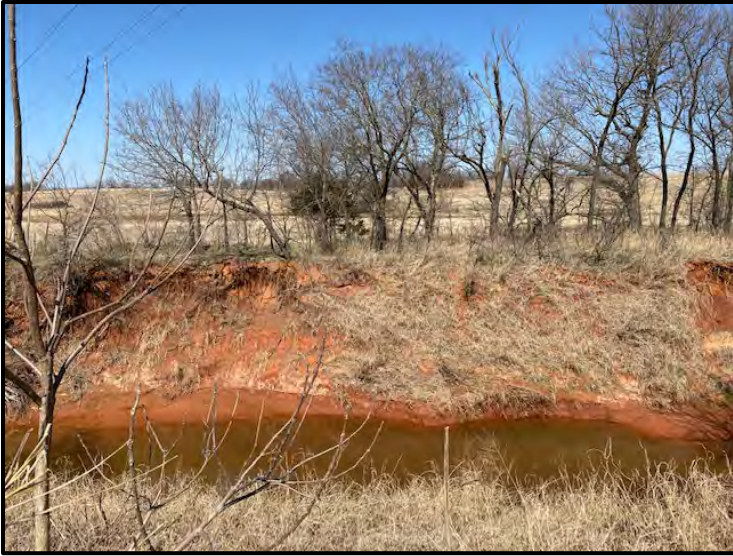
Photograph 6: Steeply sloped bank of R2UBHx-01 (Captain Creek).

Disturbances to the study area consisted of patches of developed areas, construction and maintenance disturbances, buried and overhead utilities, standing water, and drainage erosion (**Figure 3, Photos 6, 7 and 8**). Long term use of the land adjacent to the study area for agricultural activities has likely contributed to disturbances and erosion. The agricultural fields showed evidence of extensive plowing (**Figure 3, Photo 2**). Shovel tests were placed along two transects on either side of the roadway for a total of four transects (**Figure 2**). Wherever possible, shovel tests were placed outside of existing right-of-way where soils were less likely to have been impacted by previous roadway construction. A livestock pasture with large bulls was deemed unsafe and inaccessible for shovel testing. This area was subjected to visual inspection from outside of the fences (Figure 2e). Shovel tests were terminated at depths ranging from 7 to 70 cmbs at culturally sterile subsoil, inundated soils, gravel/root impasse, bedrock, or disturbances such that intact cultural deposits were unlikely. The average depth of shovel test termination was 39 cmbs.

Photograph 6: Steeply sloped bank of R2UBHx-01 (Captain Creek).

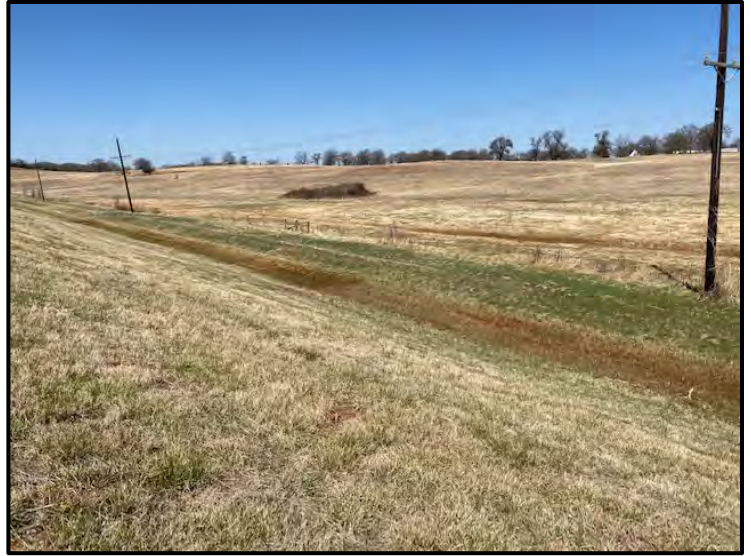
Photograph 7: R4SBC-01 (Unnamed Tributary to Captain Creek) north of roadway.

Photograph 7: R4SBC-01 (Unnamed Tributary to Captain Creek) north of roadway.

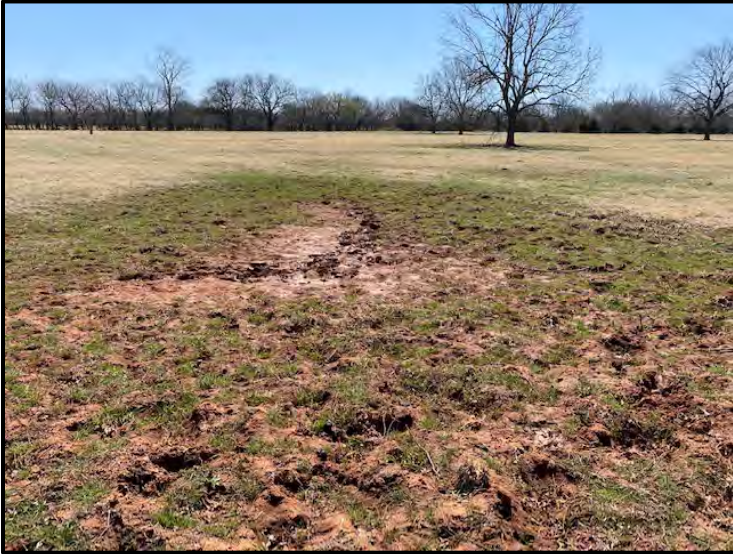
Photograph 8: Location of PUSCx (no wetland feature present).

Photograph 8: Location of PUSCx (no wetland feature present).

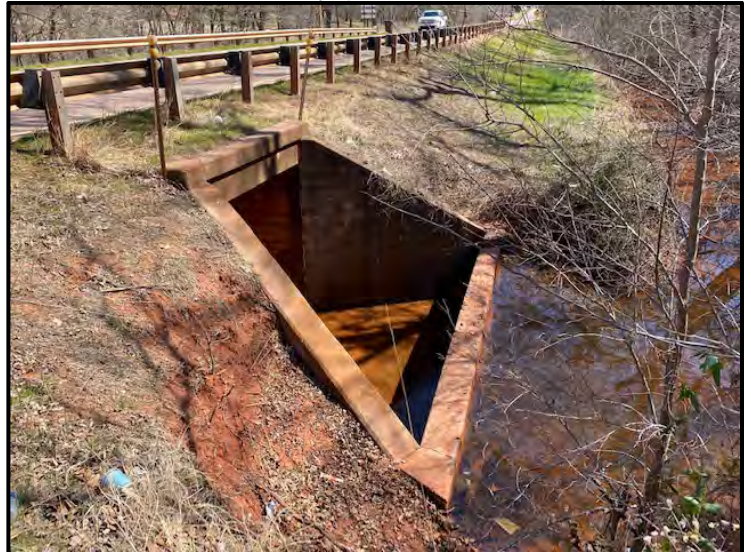
Photograph 11: Structure 2 at R4SBC-02 (Unnamed trib to Captain Creek), migratory bird nests present.

Photograph 11: Structure 2 at R4SBC-02 (Unnamed trib to Captain Creek), migratory bird nests present.

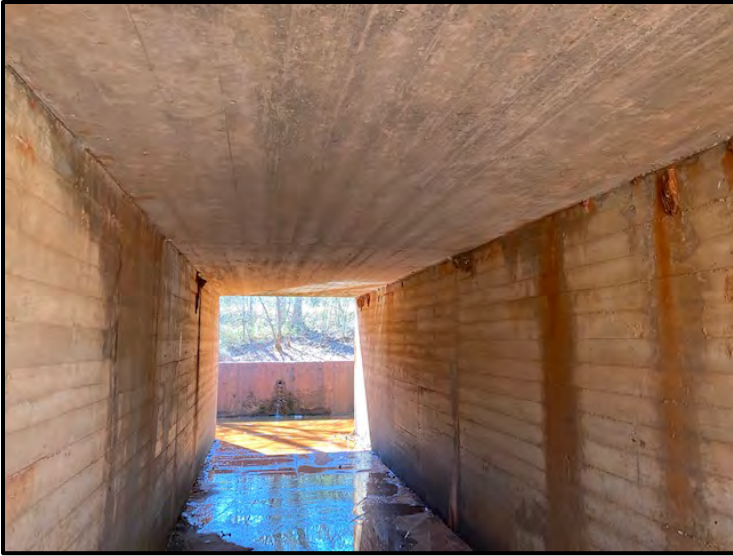
Photograph 12: Beneath Structure 2, barn swallow nest.

Photograph 12: Beneath Structure 2, barn swallow nest.

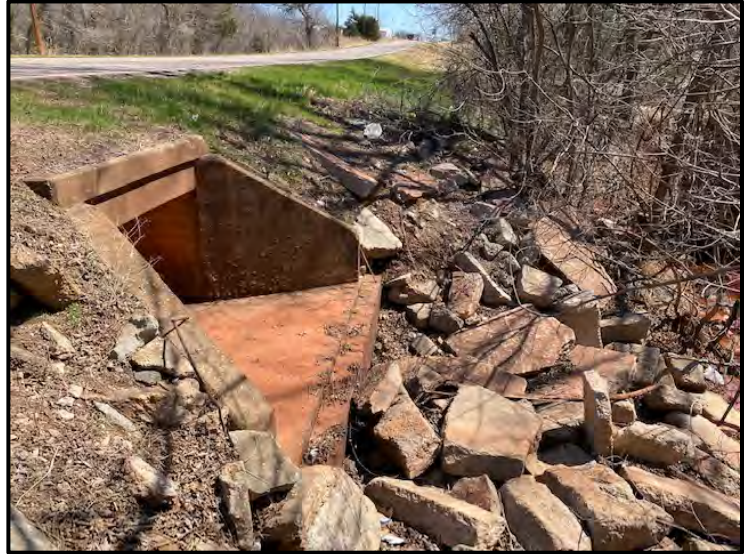
Photograph 15: Structure 3 at NDF-1, migratory bird nests present.

Photograph 15: Structure 3 at NDF-1, migratory bird nests present.

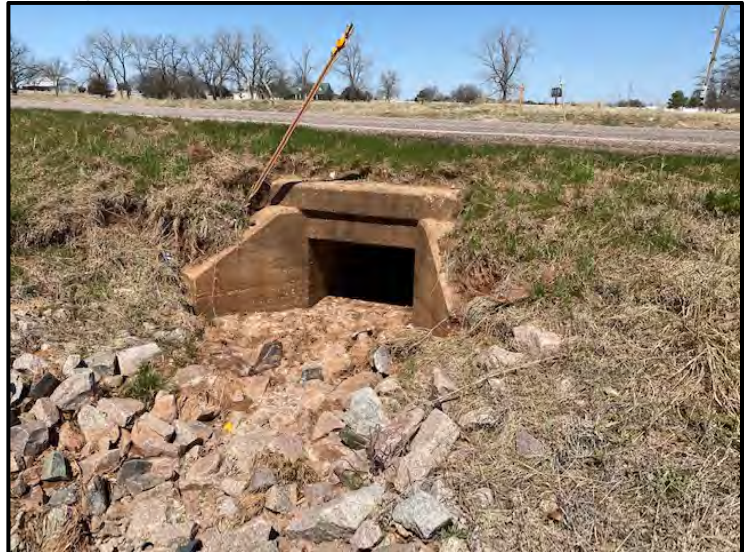
Photograph 17: Structure 4, no migratory bird nests or water feature present.

Photograph 17: Structure 4, no migratory bird nests or water feature present.

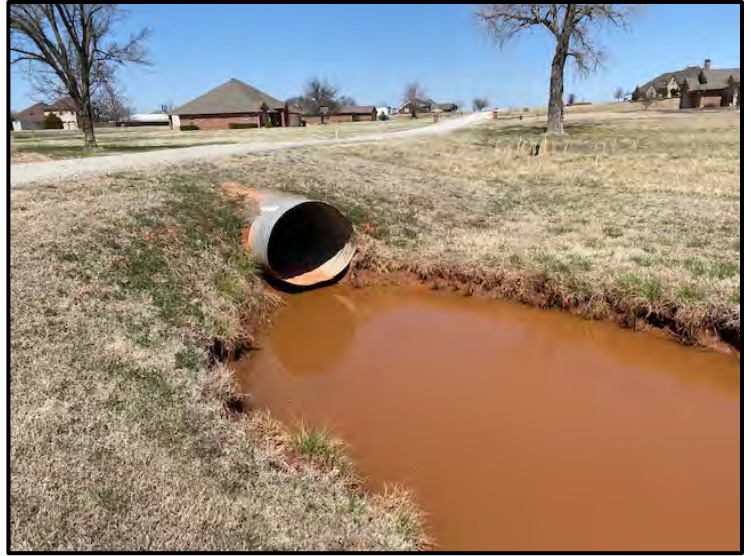
Photograph 19: Structure 5 at R4SBC-04, no migratory bird nests present.

Photograph 19: Structure 5 at R4SBC-04, no migratory bird nests present.

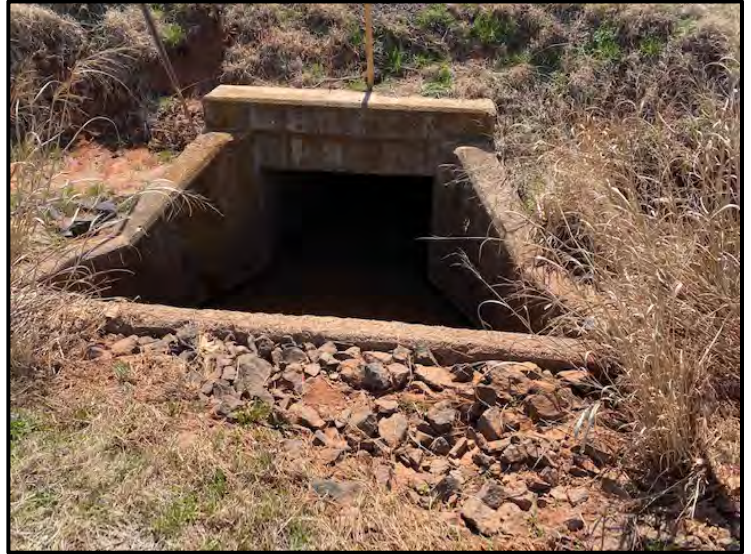
Photograph 21: Structure 6 at R4SBC-04 (Unnamed trib to Spring Creek), no migratory bird nests present.

Photograph 21: Structure 6 at R4SBC-04 (Unnamed trib to Spring Creek), no migratory bird nests present.

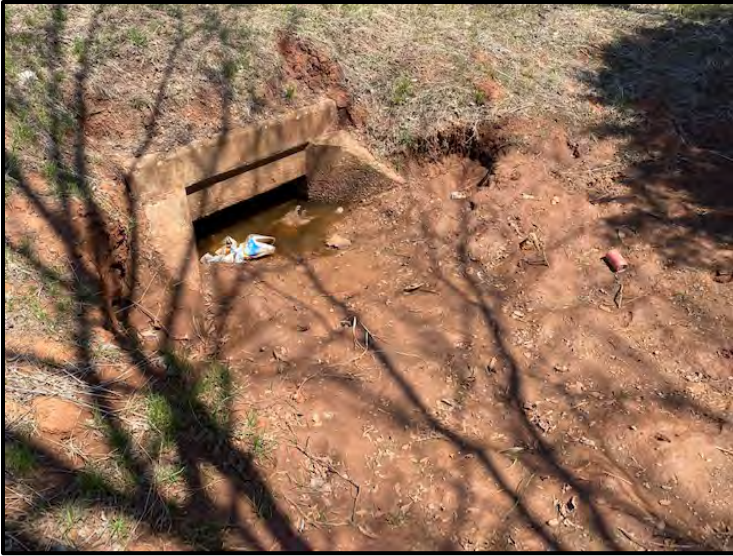
Photograph 24: Structure 7, no migratory bird nests or water feature present.

Photograph 24: Structure 7, no migratory bird nests or water feature present.

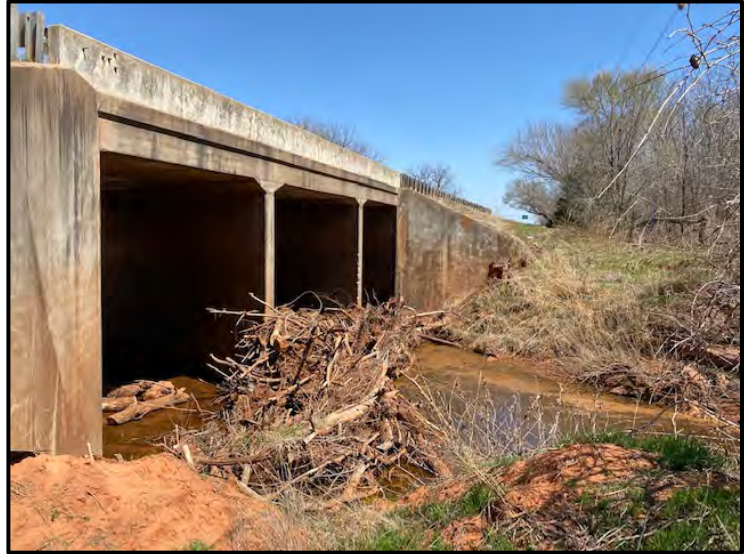
Photograph 27: Structure 8 (NBI: 12596) over R4SBA-01 (Spring Creek), migratory bird nests present.

Photograph 27: Structure 8 (NBI: 12596) over R4SBA-01 (Spring Creek), migratory bird nests present.

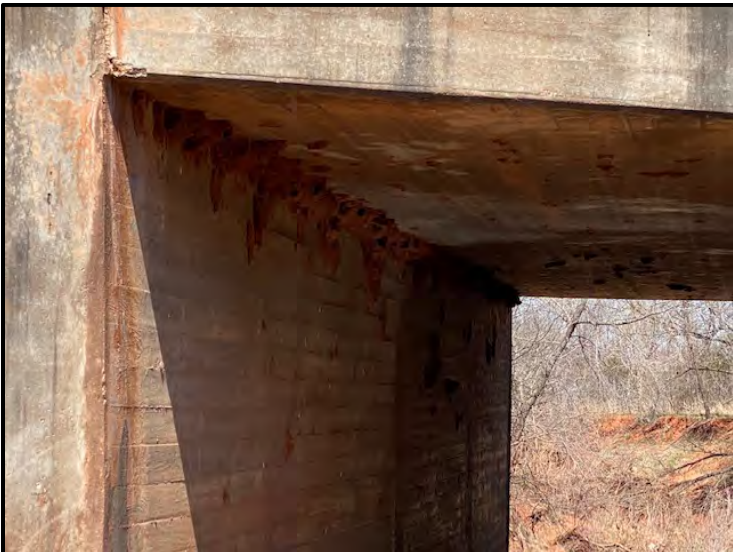
Photograph 28: Cliff swallow nests beneath Structure 8 (NBI: 12596).

Photograph 28: Cliff swallow nests beneath Structure 8 (NBI: 12596).

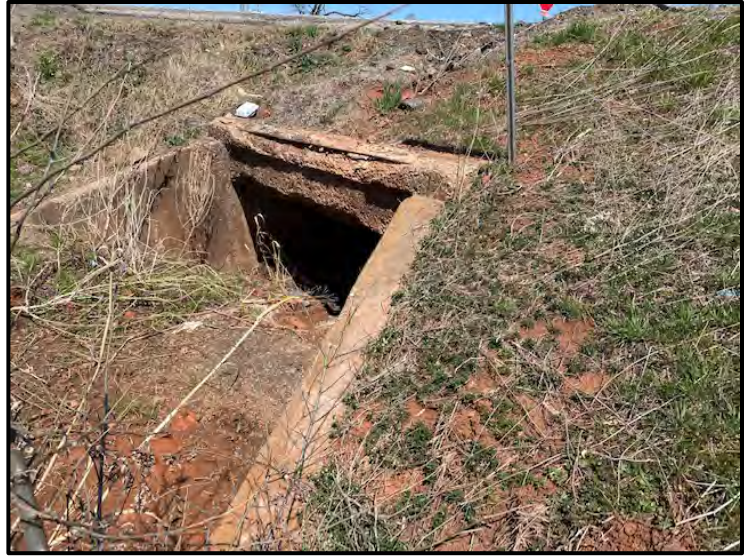
Photograph 31: Structure 9 at R4SBC-05, migratory bird nest present.

Photograph 31: Structure 9 at R4SBC-05, migratory bird nest present.

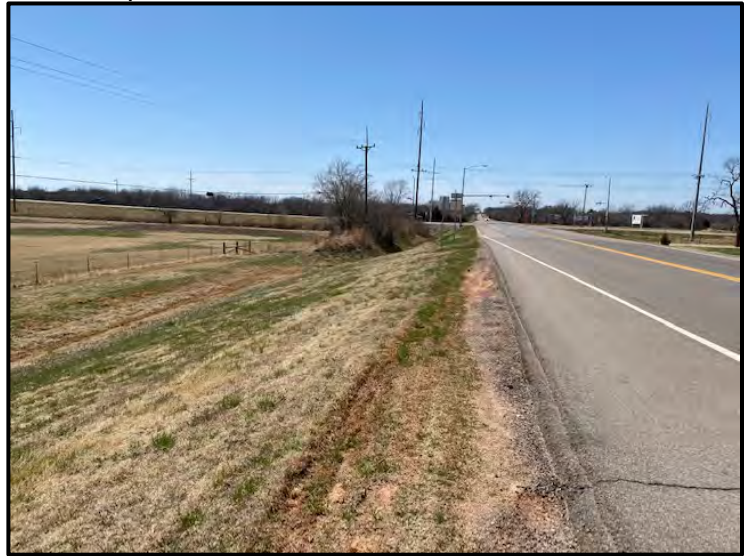
Photograph 33-A: East boundary study area, facing west toward study area.

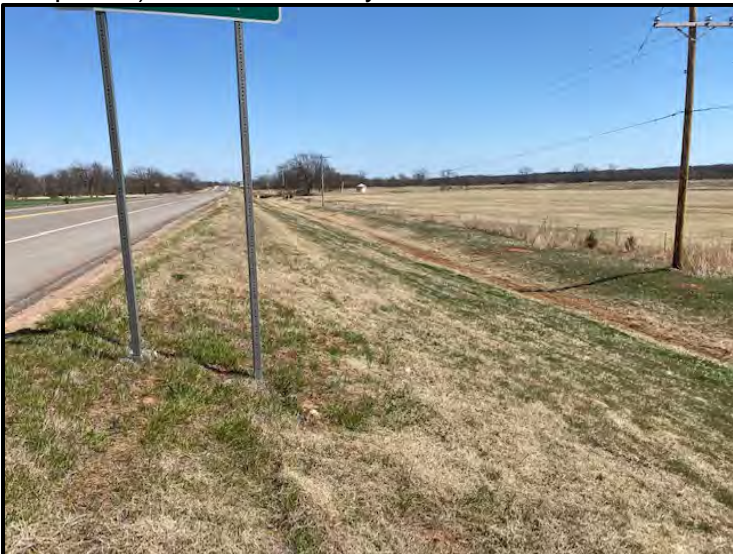
Photograph 33-B: East boundary study area, facing east outside of study area.

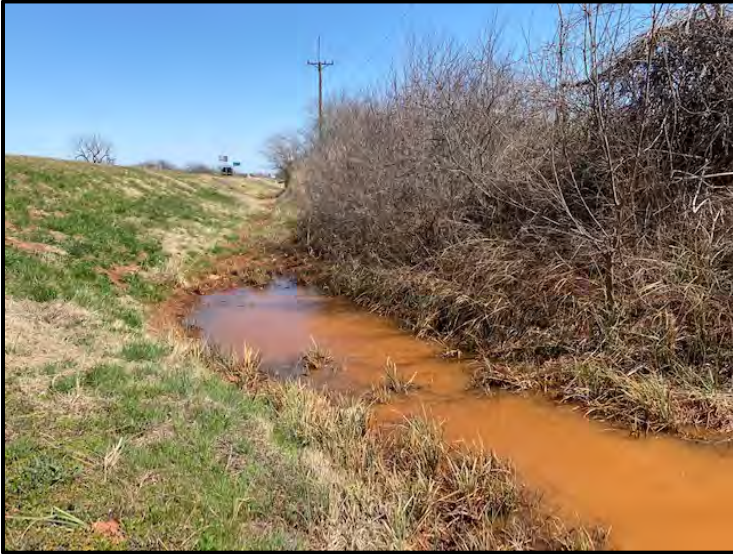
Photograph 32: R4SBC-05 (Unnamed Tributary to Deep Fork) south of roadway.

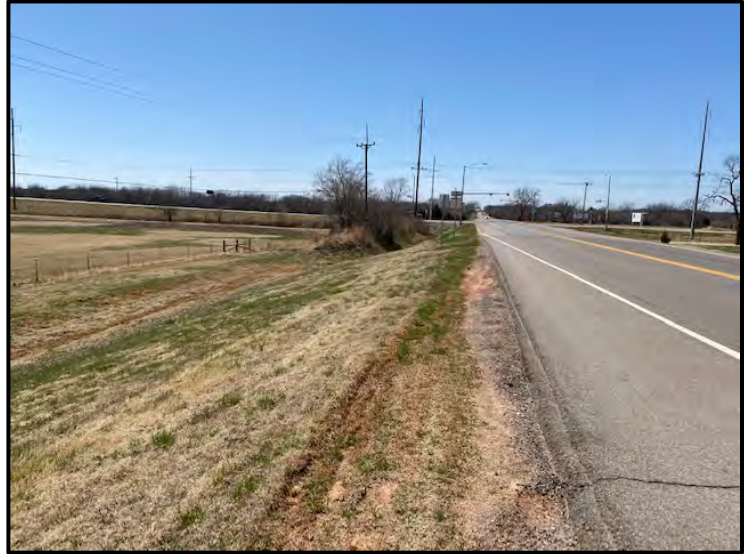
Photograph 33-A: East boundary study area, facing west toward study area.

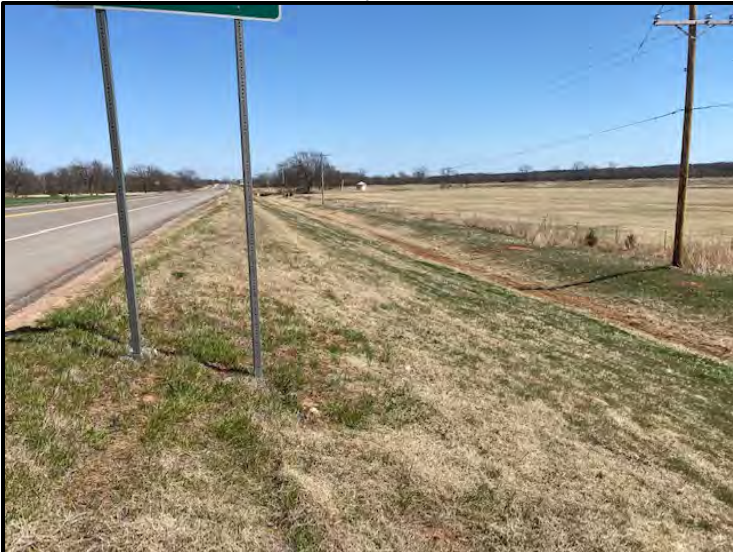
Photograph 33-B: East boundary study area, facing east outside of study area.

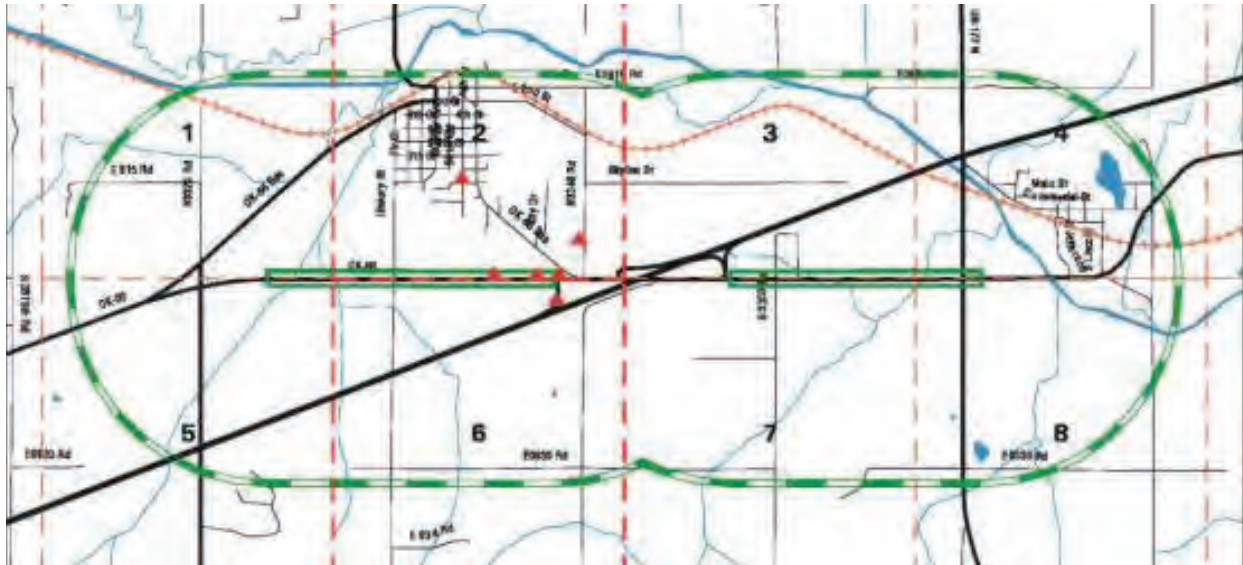
The study area is depicted below with EDR sites marked with red triangles.

EDR map locations were transposed to maps included within the 4/5/2022 Memo. The Bus Barn site is mapped in Wellston, north and topographically separated from the study area. The Wellston OK2 AST site is reported approximately .2 mile north of the study area near the origin of a drainage swale that drains to the west. Due to distance and topography, these sites are not considered to be Recognized Environmental Conditions (REC).

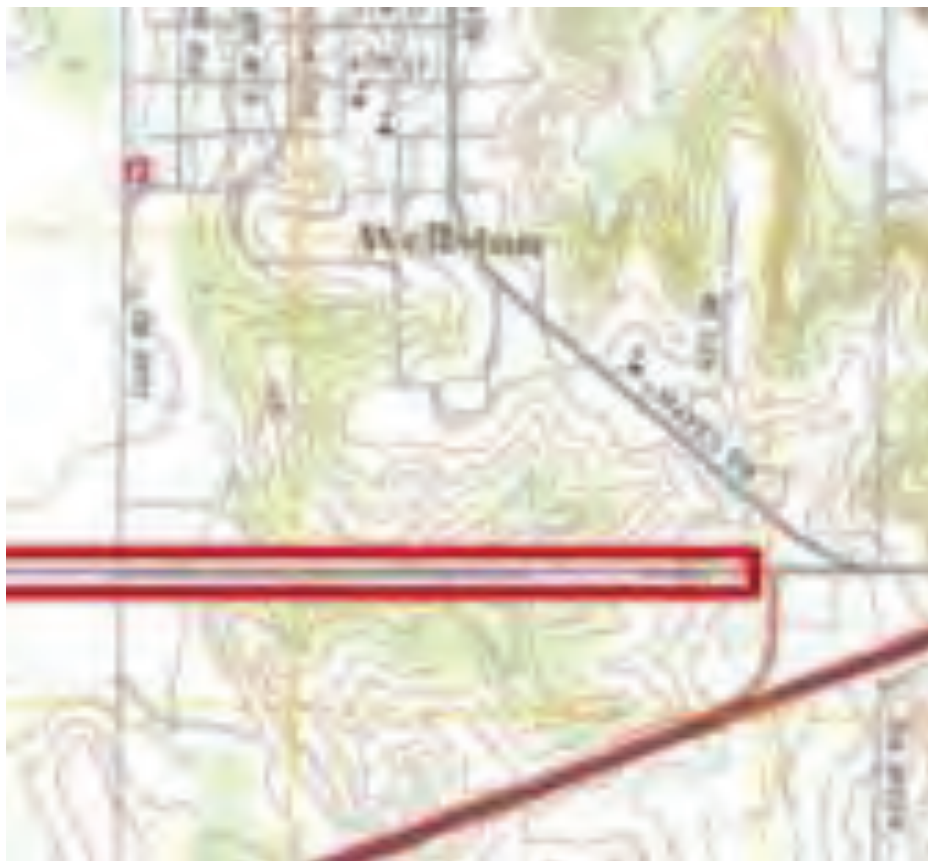
Topography for the EDR sites area falls to the west toward Captain Creek, with a ridge on the eastern boundary of the west alignment falling to the east toward Spring Creek, as follows:

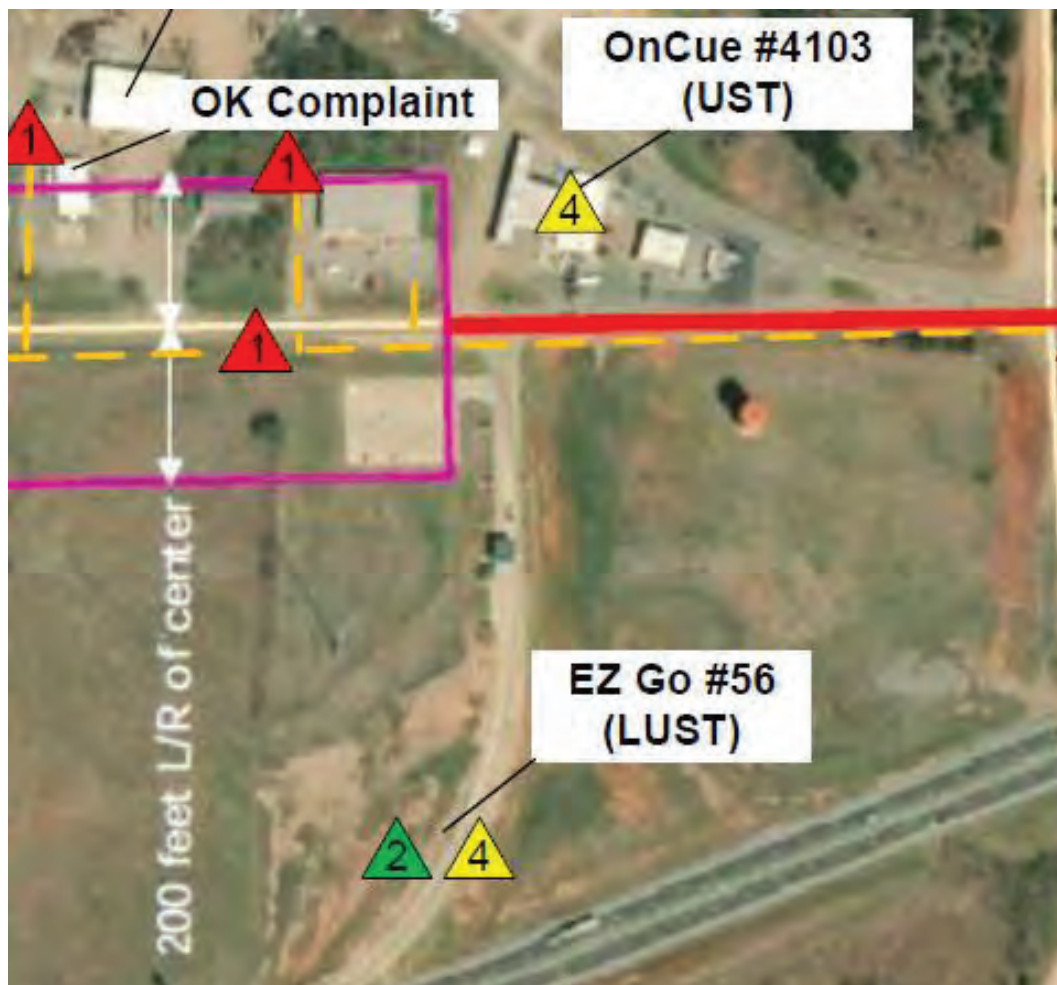
The EZ Go Leaking Underground Storage Tank (LUST) site is located south of OnCue. Groundwater is reported to flow southwest toward a drainage that crosses the highway to the west. Due to distance along the flow path this site is not considered a REC.
