# DOLPHIN REMOVAL & REPLACEMENT STUDY

January 2019

The Tulsa Port of Catoosa wishes to remove and replace several failing or deteriorating mooring dolphins in the main channel. In the summer of 2014 the Port conducted an underwater inspection of 15 dolphins. The aerial in Figure 1 depicts all of the dolphins inspected with yellow numbers. The inspection report is in Appendix A and referred to as *Marcan Report*. All of the inspected Dolphins showed signs of deterioration, some requiring immediate repair or decommissioning. **The scope of this study is to investigate construction methods for removal and replacement of the dolphins, determine the most feasible construction methods and the associated opinion of probable cost and recommend project phasing.**

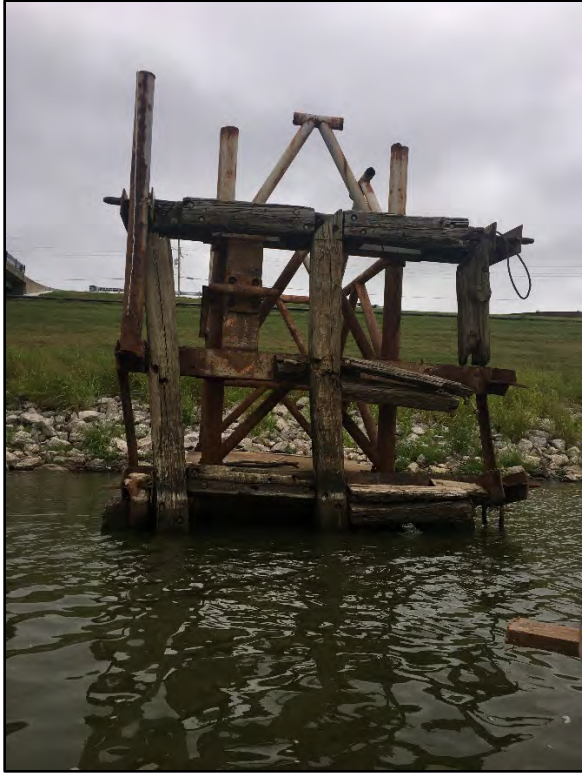
Photo 1 – Tower Dolphin

The existing tower structures are represented in Photos 1-3 and in the isometric drawing in Figure 2. They were constructed at the same time and in a similar fashion to the T-Head Wharf. Plans for the T-Head Wharf structure are included in Appendix B. We don't have access to as-built plans for the actual tower dolphins. In the summer of 2014 the Port conducted an underwater inspection of 15 dolphins. This report is in Appendix A and referred to as *Marcan Report*. All of the inspected Dolphins showed signs of deterioration, some requiring immediate repair or decommissioning. We know these structures were not constructed strictly according to the plans (they don't have a battered pile) so using the Marcan dive report and physical observations, we created the isometric drawing in Figure 2. They are in various states of disrepair as indicated in the photos and in the dive report. The Port has identified Dolphins 0-4, 4, 5, 14 and 15 as most needing to be removed or removed and replaced. Dolphins 10-13 have had some pier encasement done to prolong their life.

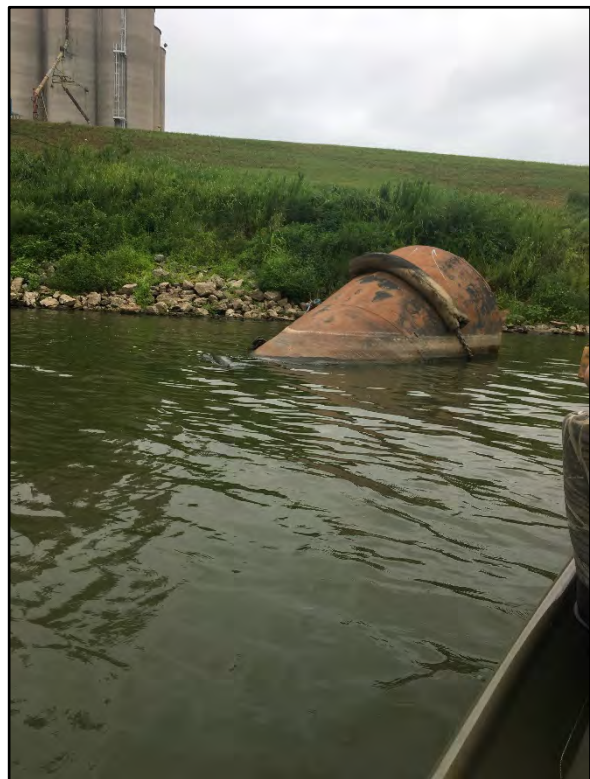
Photo 4 – Tipped Can Dolphin

The Port wishes to remove the failing can dolphin circled north of the Galvilon West loading structure but not replace it. There is another can dolphin south of the Galvilon West loading structure that has completely failed and is under water. Removal of this structure is not currently considered necessary.

The existing tipped can structure is shown in Photo 4 and in the details in Appendix C – 1973 Caisson Details. The can pictured is on the north side of the Galvilon West loading structure. The one on the south side is completely under water. These two structures were constructed in 1973 and both were hit by barges. The as-built plans indicated that they are made of steel casing with a concrete bottom and top with aggregate in between. The as-built plans called for them to be anchored to the channel bottom with eight six-inch diameter holes filled with concrete with one #11 rebar in each hole. According to the Marcan Report, the north can structure is still attached to one (or more) of the six-inch holes. The Port is not interested in moving the south structure but wants to remove the north structure.

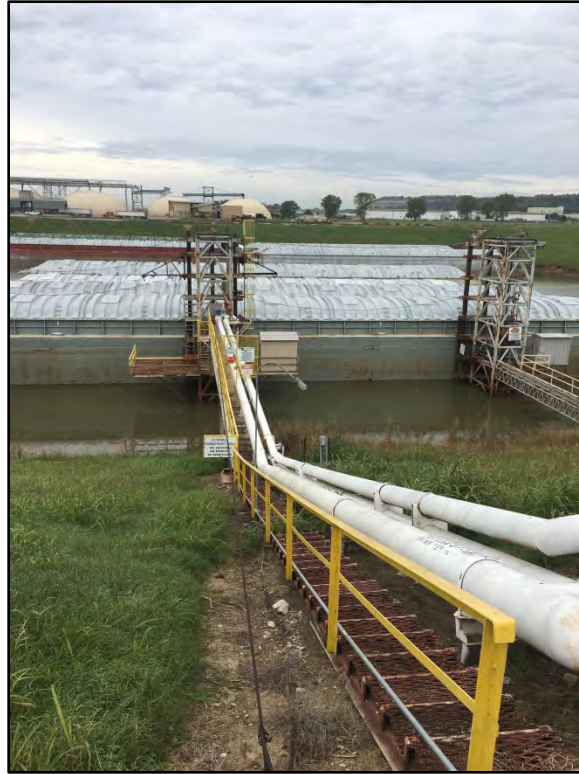
Photo 6 – Dolphins 11 and 12

Dolphins 10-13 in the northeast corner of the channel are identified as needing to be replaced. They currently serve two port industries. Discussions with these industries and with the Port staff about future plans led us to propose replacing these four dolphins with two can dolphins connected by a platform.

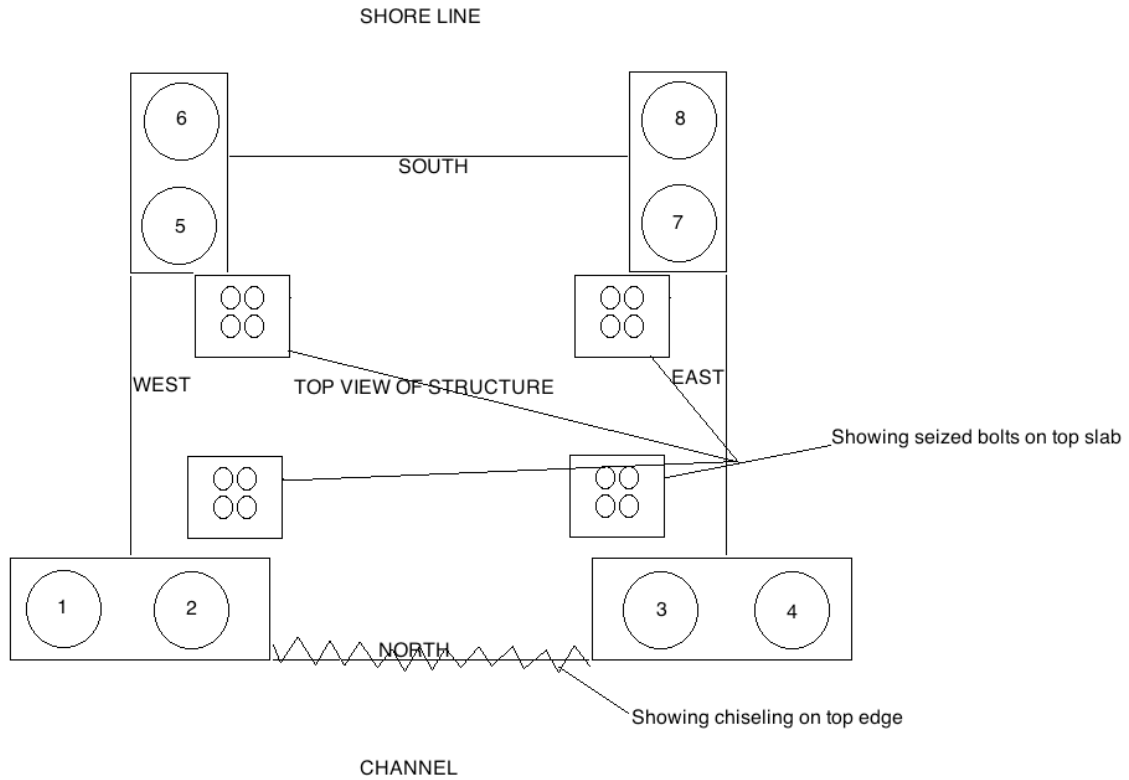
# MOORING STRUCTURE #1

**WATERLINE TO MUDLINE IS ROUGHLY 7.5' DEEP ON THE CHANNEL SIDE**

Note all bolt sets were rusted and appeared seized.

**South** side of pile one shows major deterioration, with a loss in circumference greater than 6" and consisted of heavy chiseling and softening of concrete. Pieces were falling off by touch.

**West** side of pile one shows major deterioration, with a loss in circumference greater than 6" and consisted of heavy chiseling and softening of concrete. Pieces were falling off by touch.

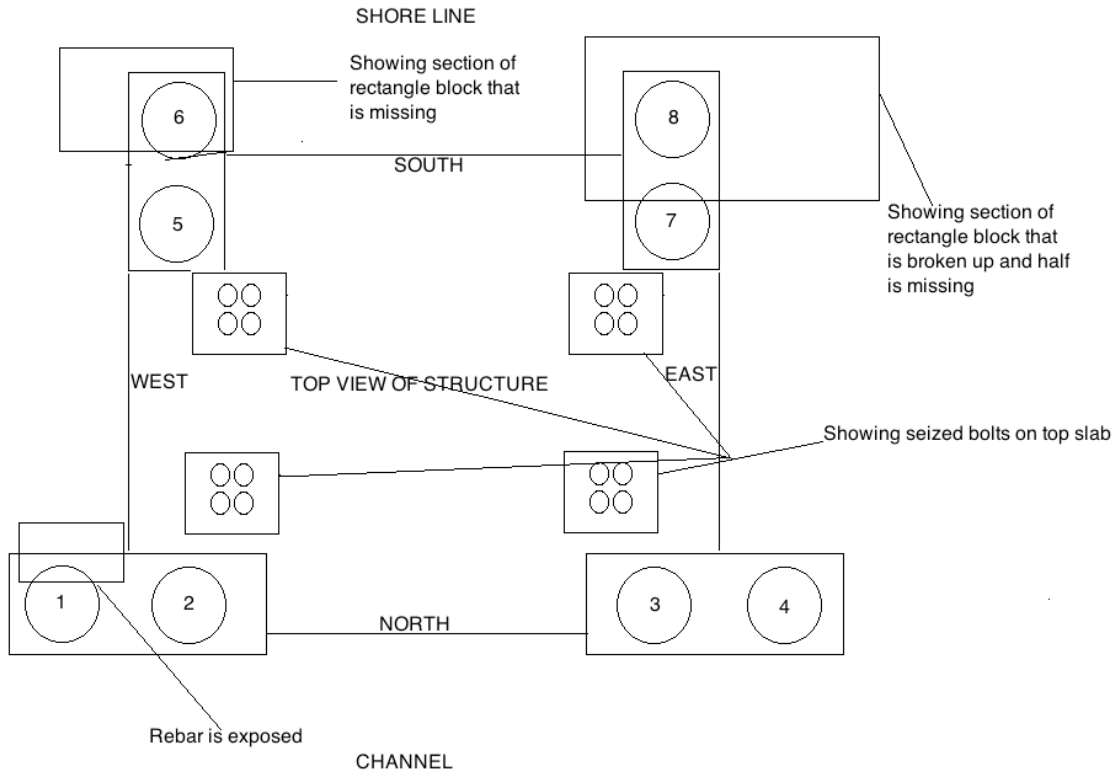
## MOORING STRUCTURE #2

#### **WATERLINE TO MUDLINE IS ROUGHLY 7-7.5' DEEP**

Note all bolt sets were rusted and appeared seized.

**South** side of pile one shows major deterioration, with a loss in circumference greater than 6" and consisted of heavy chiseling and softening of concrete. Pieces were falling off by touch.

**West** side of pile one shows major deterioration, with a loss in circumference greater than 6" and consisted of heavy chiseling and softening of concrete. Pieces were falling off by touch.

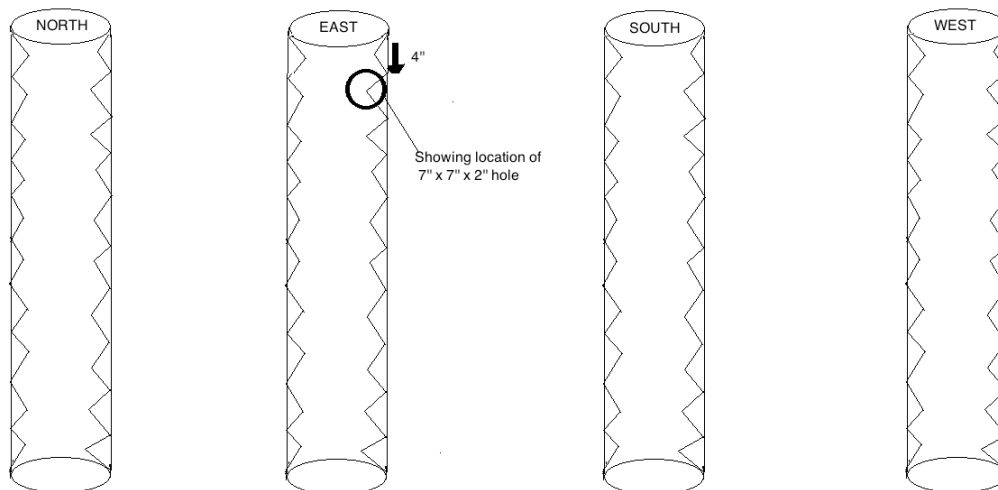
### Pile #4

**South** side of pile one shows major deterioration, with a loss in circumference greater than 6" and consisted of heavy chiseling and softening of concrete. Pieces were falling off by touch. Pile formed an hourglass shape as noted in illustration and showing exposed rebar 10" down from the bottom of the rectangular block. This is a sign of structural failure.

**West** side of pile one shows major deterioration, with a loss in circumference greater than 6" and consisted of heavy chiseling and softening of concrete. Pieces were falling off by touch. Pile formed an hourglass shape as noted in illustration and showing exposed rebar 10" down from the bottom of the rectangular block. This is a sign of structural failure.

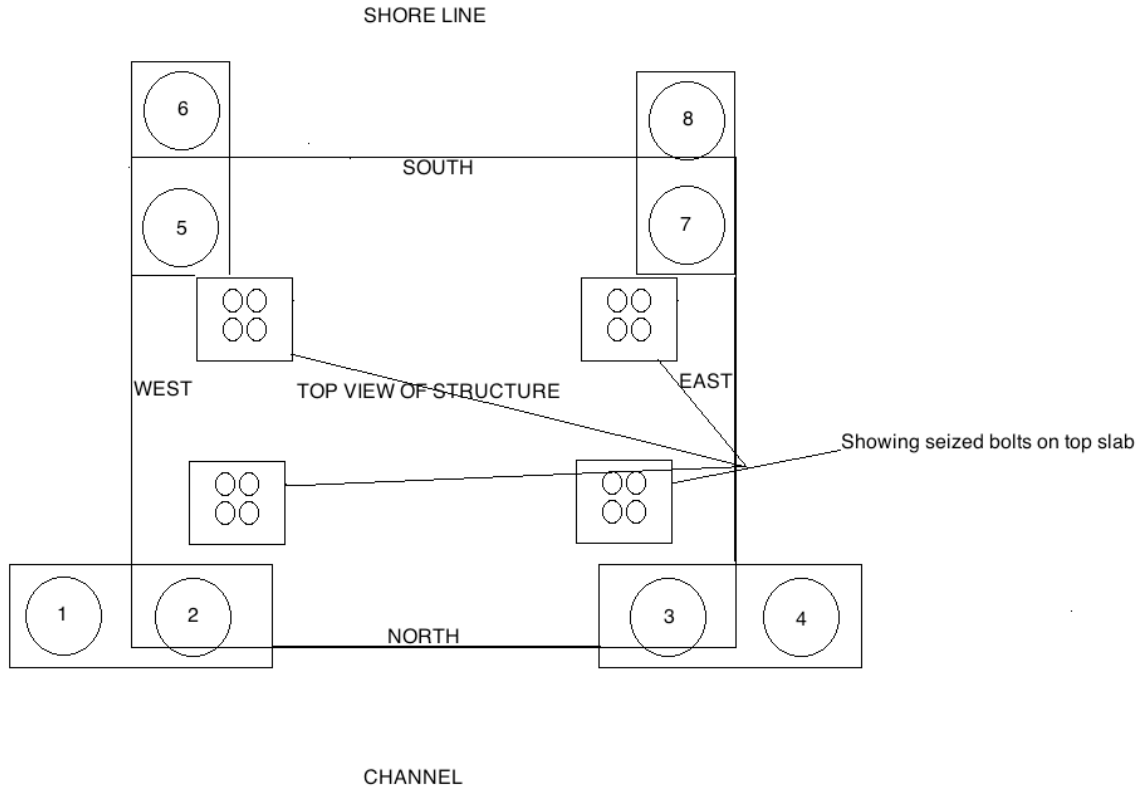
### MOORING STRUCTURE #3

**WATERLINE TO MUDLINE IS ROUGHLY 6.5'-7' DEEP ON THE CHANNEL SIDE.**

**South** side of pile one shows major deterioration, with a loss in circumference greater than 6" and consisted of heavy chiseling and softening of concrete. Pieces were falling off by touch. Pile formed an hourglass shape as noted in illustration and showing exposed rebar. This is a sign of structural failure.

**West** side of pile one shows major deterioration, with a loss in circumference greater than 6" and consisted of heavy chiseling and softening of concrete. Pieces were falling off by touch. Pile formed an hourglass shape as noted in illustration and showing exposed rebar. This is a sign of structural failure.

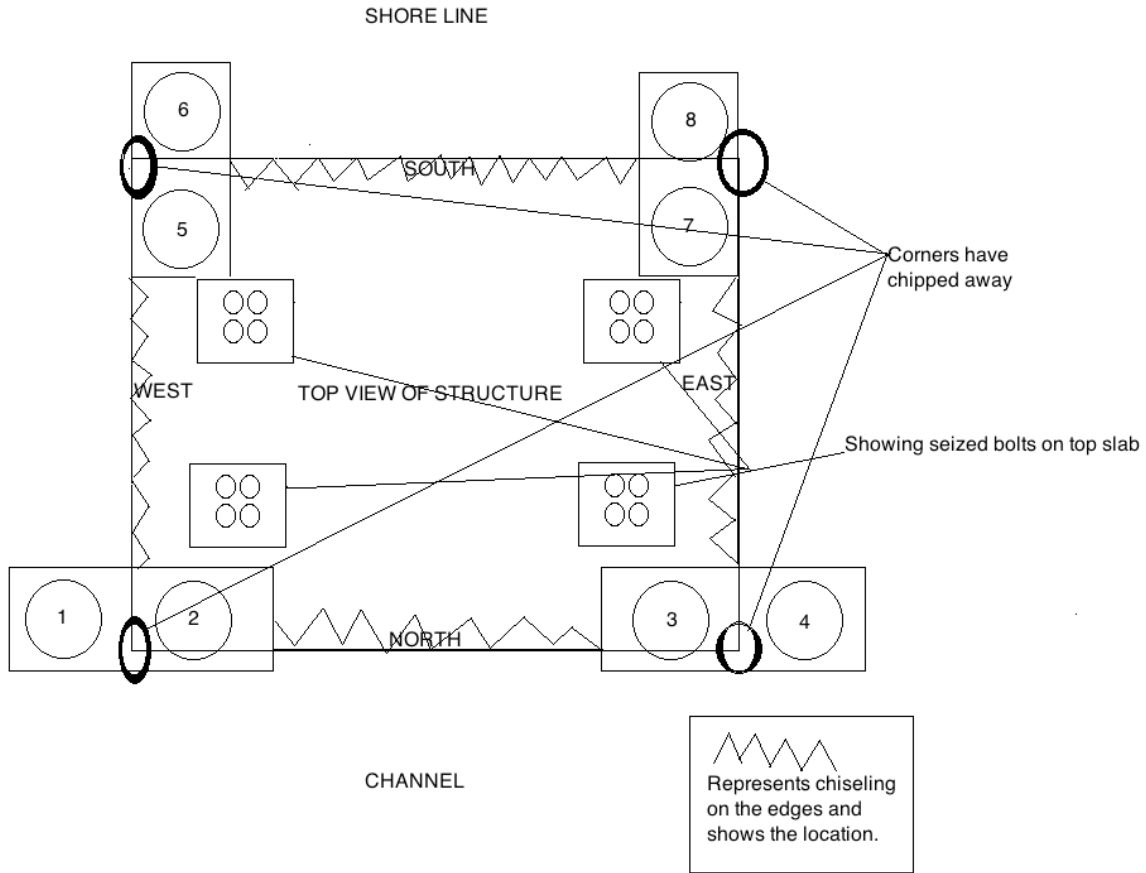
# MOORING STRUCTURE #4

**WATERLINE TO MUDLINE IS ROUGHLY 10' DEEP ON THE CHANNEL SIDE**

**South** side of pile one shows major deterioration, with a loss in circumference greater than 6" and consisted of heavy chiseling and softening of concrete. Pieces were falling off by touch. Also, noted in illustration, south side revealed exposed rebar.

**West** side of pile one shows major deterioration, with a loss in circumference greater than 6" and consisted of heavy chiseling and softening of concrete. Pieces were falling off by touch.

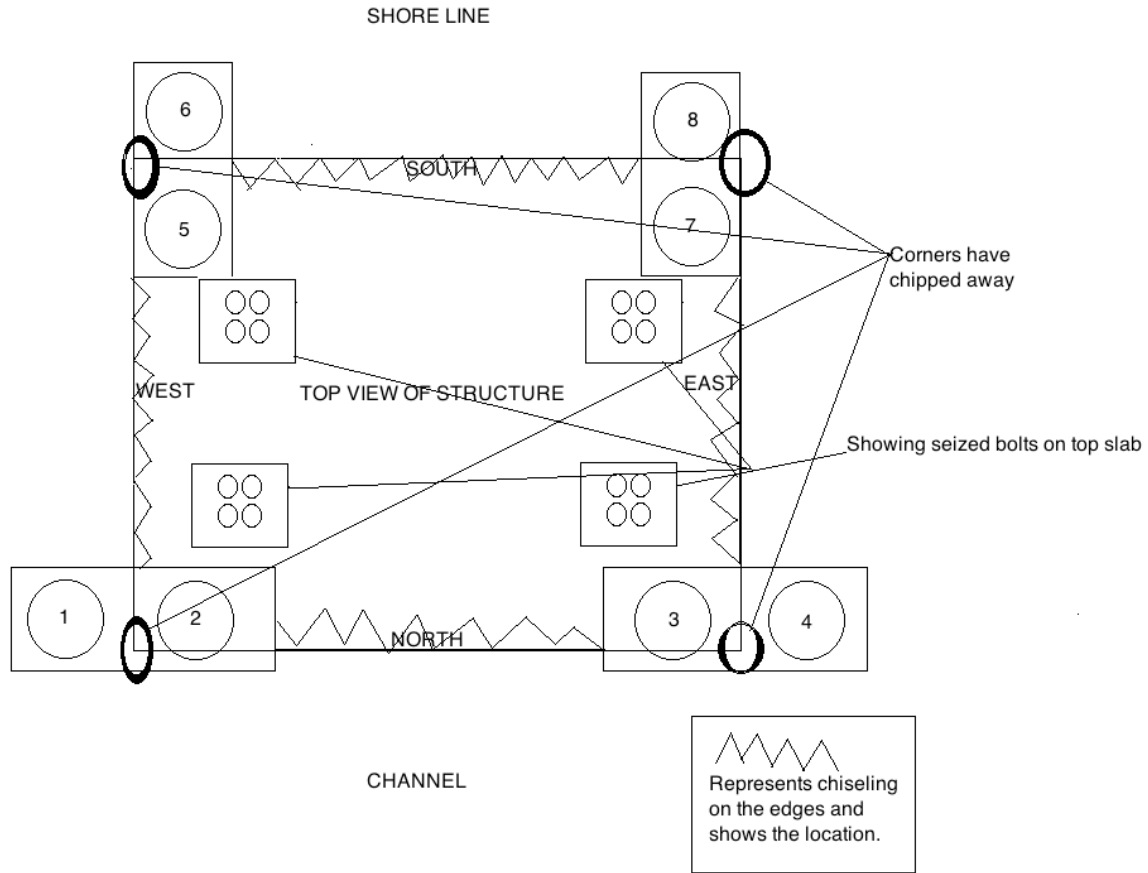
# MOORING STRUCTURE #5

DANGER  
CONDEMNED  
STRUCTURE  
NO MOORING

**WATERLINE TO MUDLINE IS ROUGHLY 10' DEEP ON THE CHANNEL SIDE**

**South** side of pile one shows major deterioration, with a loss in circumference greater than 6" and consisted of heavy chiseling and softening of concrete. Pieces were falling off by touch. Also, noticed as illustrated below that pile 1 was not attached and laying over on its side at the mud line.

**West** side of pile one shows major deterioration, with a loss in circumference greater than 6" and consisted of heavy chiseling and softening of concrete. Pieces were falling off by touch. Also, noticed as illustrated below that pile 1 was not attached and laying over on its side at the mud line.

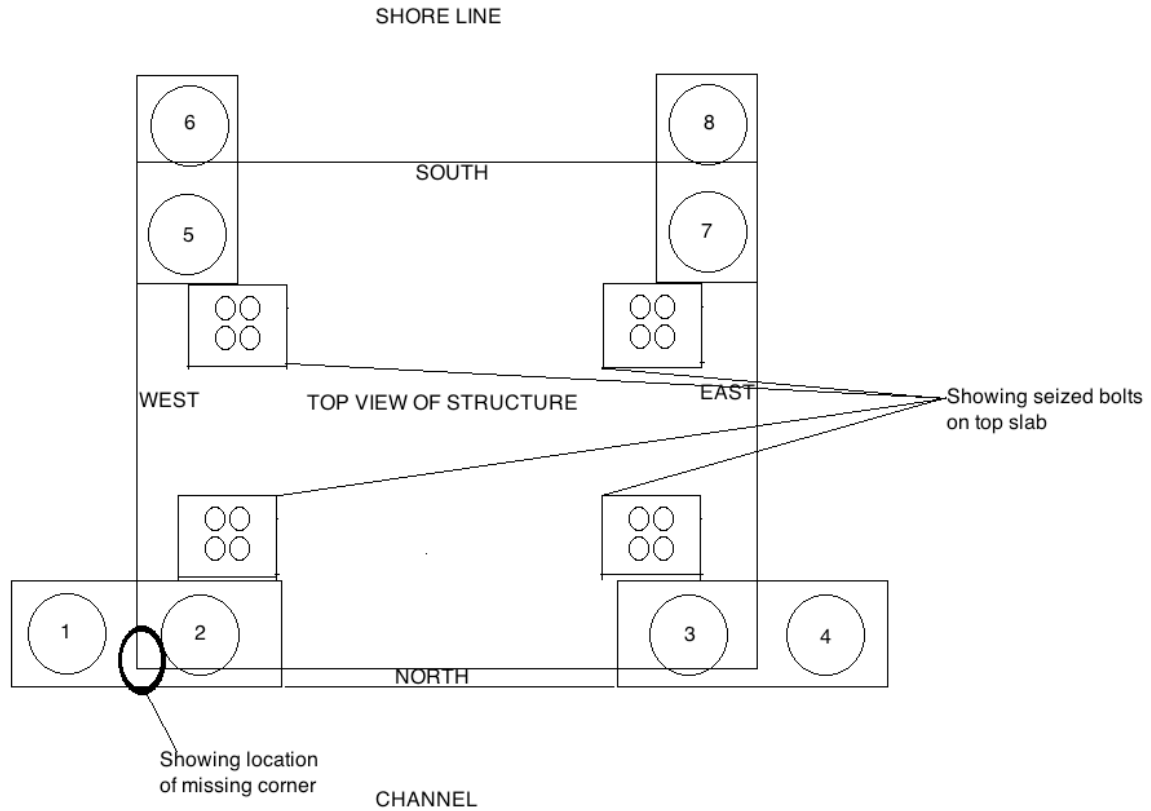
Top slab

**WATERLINE TO MUD LINE IS ROUGHLY 10' DEEP ON THE CHANNEL SIDE**

Note all bolt sets were rusted and appeared seized.

Debris was found submersed under the structured and consisted of logs and wire rope.

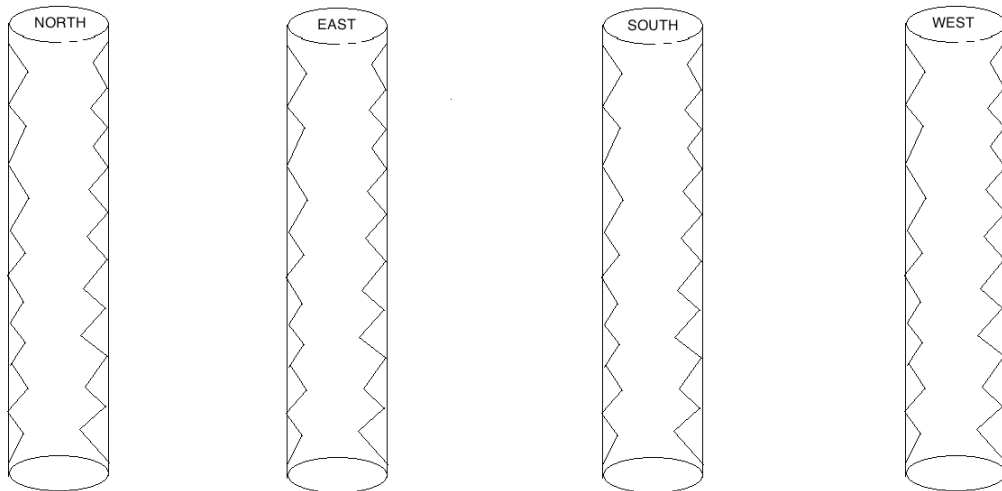
### PILE #2

**North** side of pile one shows major deterioration, with a loss in circumference greater than 6" and consisted of heavy chiseling and softening of concrete. Pieces were falling off by touch.

**East** side of pile one shows major deterioration, with a loss in circumference greater than 6" and consisted of heavy chiseling and softening of concrete. Pieces were falling off by touch.

**South** side of pile one shows major deterioration, with a loss in circumference greater than 6" and consisted of heavy chiseling and softening of concrete. Pieces were falling off by touch.

**West** side of pile one shows major deterioration, with a loss in circumference greater than 6" and consisted of heavy chiseling and softening of concrete. Pieces were falling off by touch.

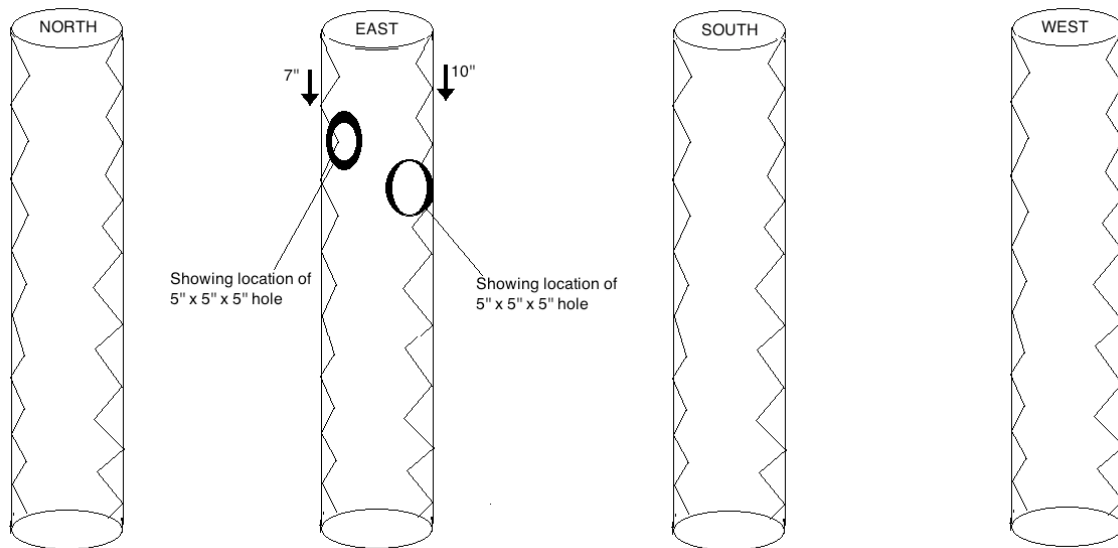
### PILE #4

**North** side of pile one shows major deterioration, with a loss in circumference greater than 6" and consisted of heavy chiseling and softening of concrete. Pieces were falling off by touch.

**East** side of pile one shows major deterioration, with a loss in circumference greater than 6" and consisted of heavy chiseling and softening of concrete. Pieces were falling off by touch.

**South** side of pile one shows major deterioration, with a loss in circumference greater than 6" and consisted of heavy chiseling and softening of concrete. Pieces were falling off by touch.

**West** side of pile one shows major deterioration, with a loss in circumference greater than 6" and consisted of heavy chiseling and softening of concrete. Pieces were falling off by touch.

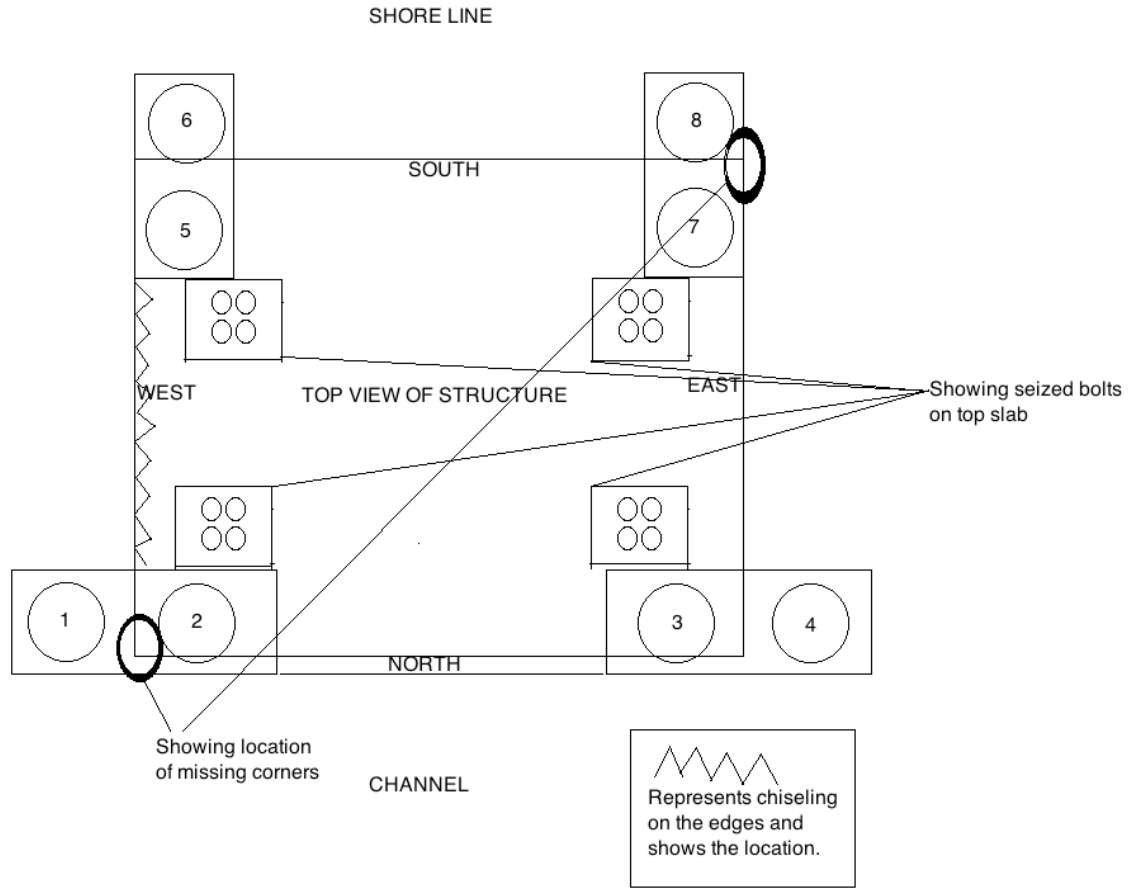
Top slab

**WATERLINE TO MUD LINE IS ROUGHLY 10' DEEP ON THE CHANNEL SIDE**

Note all bolt sets are rusted and appeared seized.

The west top edge of the top slab has chiseling and deterioration.

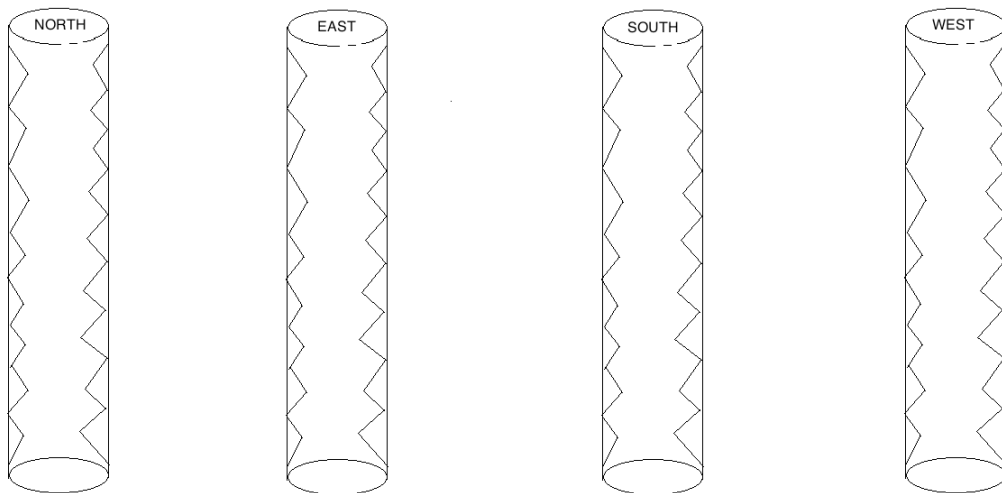
### PILE #2

**North** side of pile one shows major deterioration, with a loss in circumference greater than 6" and consisted of heavy chiseling and softening of concrete. Pieces were falling off by touch.

**East** side of pile one shows major deterioration, with a loss in circumference greater than 6" and consisted of heavy chiseling and softening of concrete. Pieces were falling off by touch.

**South** side of pile one shows major deterioration, with a loss in circumference greater than 6" and consisted of heavy chiseling and softening of concrete. Pieces were falling off by touch.

**West** side of pile one shows major deterioration, with a loss in circumference greater than 6" and consisted of heavy chiseling and softening of concrete. Pieces were falling off by touch.

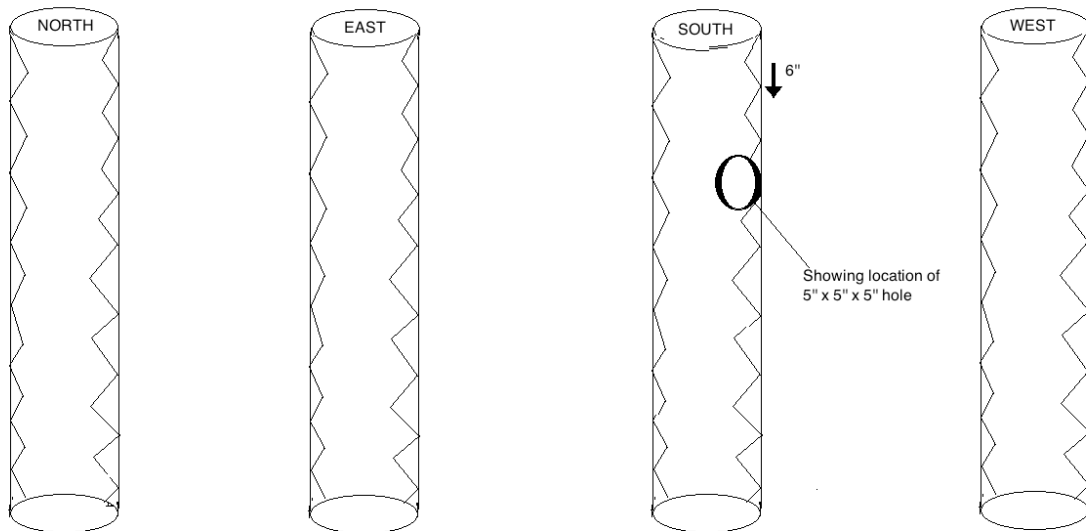
### PILE #4

**North** side of pile one shows major deterioration, with a loss in circumference greater than 6" and consisted of heavy chiseling and softening of concrete. Pieces were falling off by touch.

**East** side of pile one shows major deterioration, with a loss in circumference greater than 6" and consisted of heavy chiseling and softening of concrete. Pieces were falling off by touch.

**South** side of pile one shows major deterioration, with a loss in circumference greater than 6" and consisted of heavy chiseling and softening of concrete. Pieces were falling off by touch.

**West** side of pile one shows major deterioration, with a loss in circumference greater than 6" and consisted of heavy chiseling and softening of concrete. Pieces were falling off by touch.

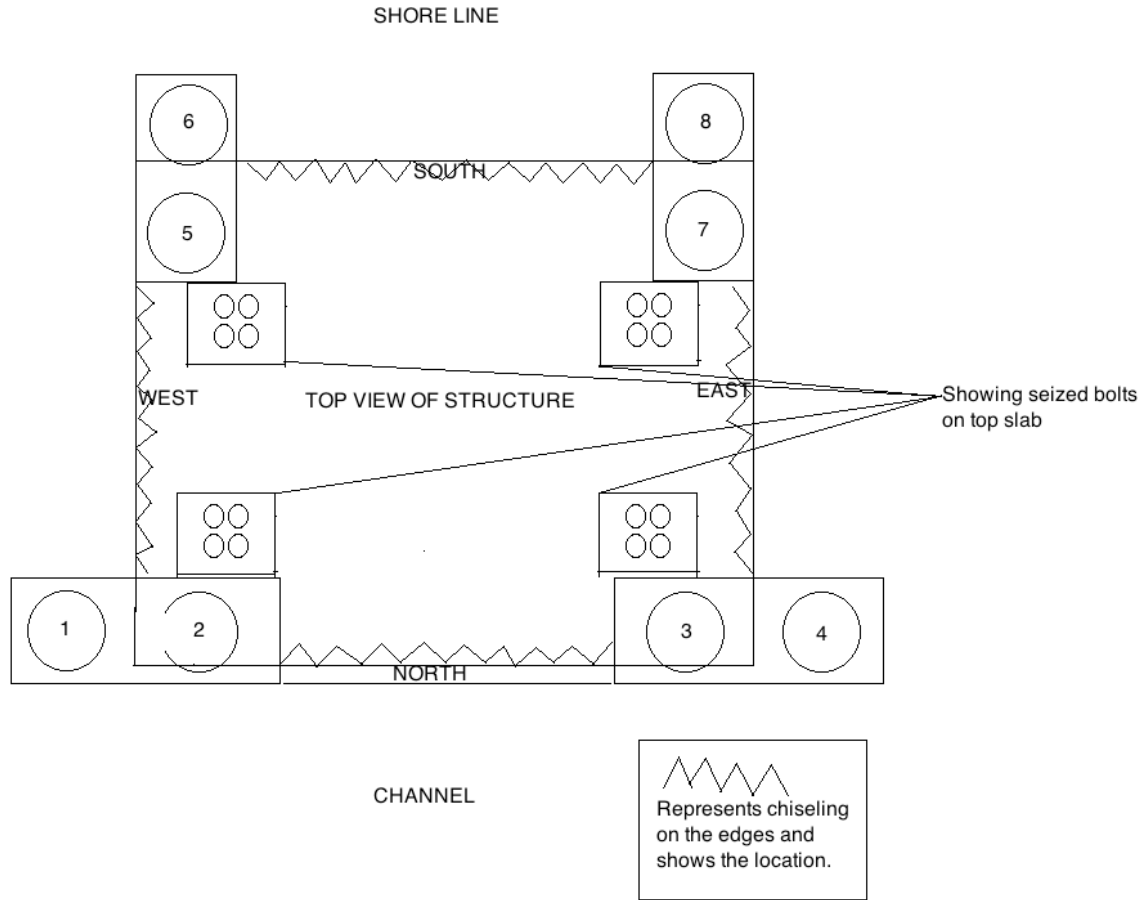
Top slab

**WATERLINE TO MUD LINE IS ROUGHLY 10' DEEP ON THE CHANNEL SIDE**

Note all bolt sets are rusted and appeared seized.

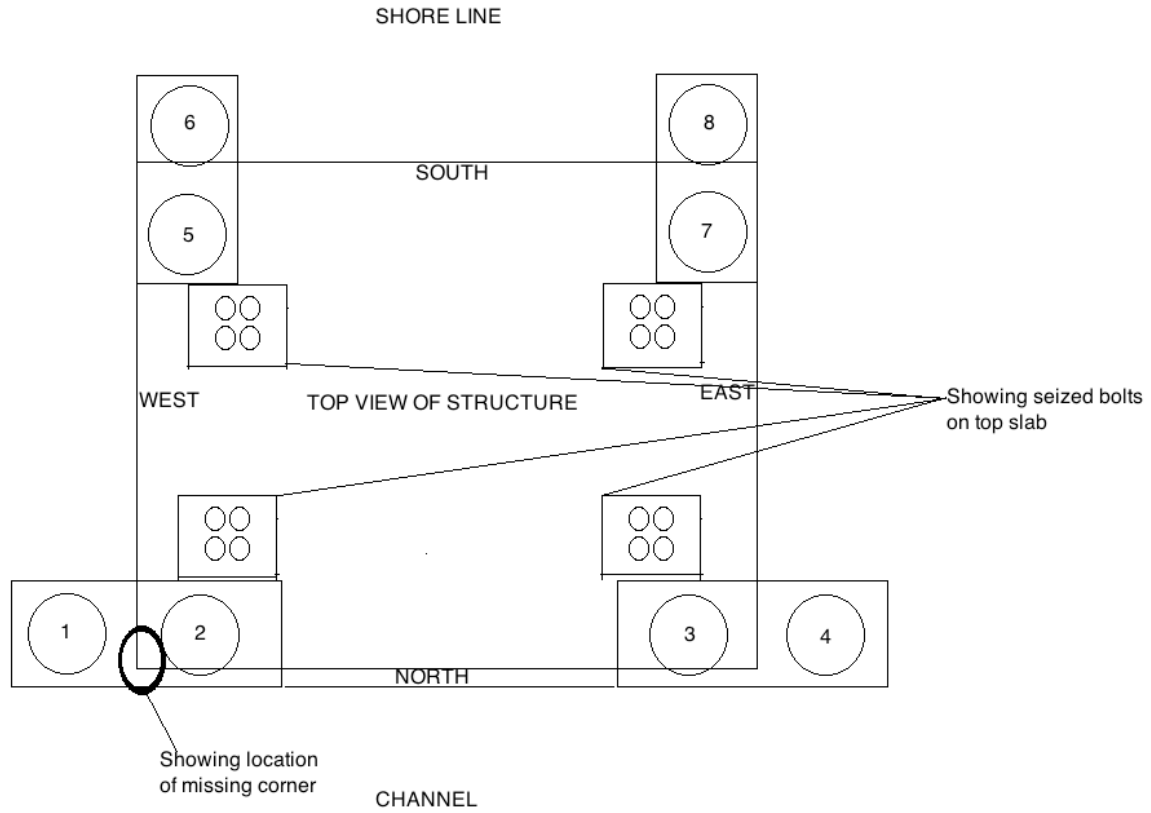
## Top Slab

WATERLINE TO MUD LINE IS ROUGHLY 10' DEEP ON THE CHANNEL SIDE

Note, all bolt sets are rusted and appeared seized.

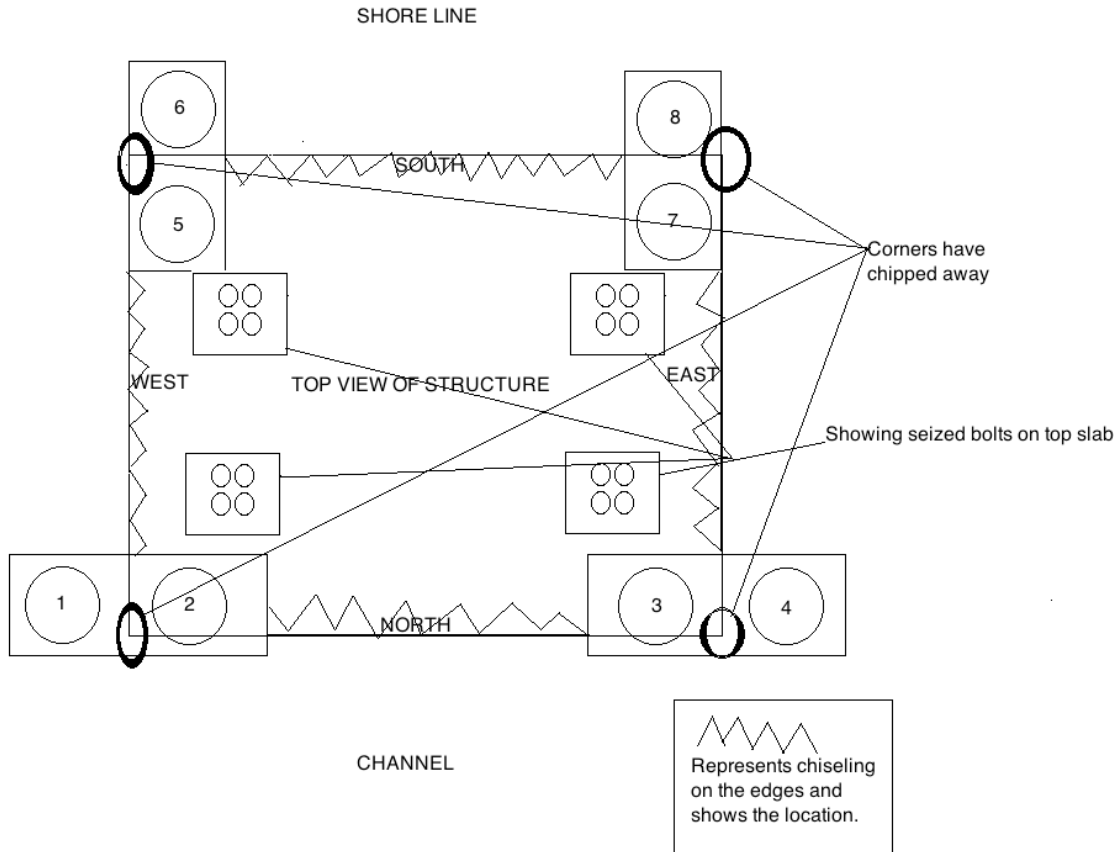
Top slab

**WATERLING TO MUD LINE IS ROUGHLY 10'6" DEEP ON THE CHANNEL SIDE**

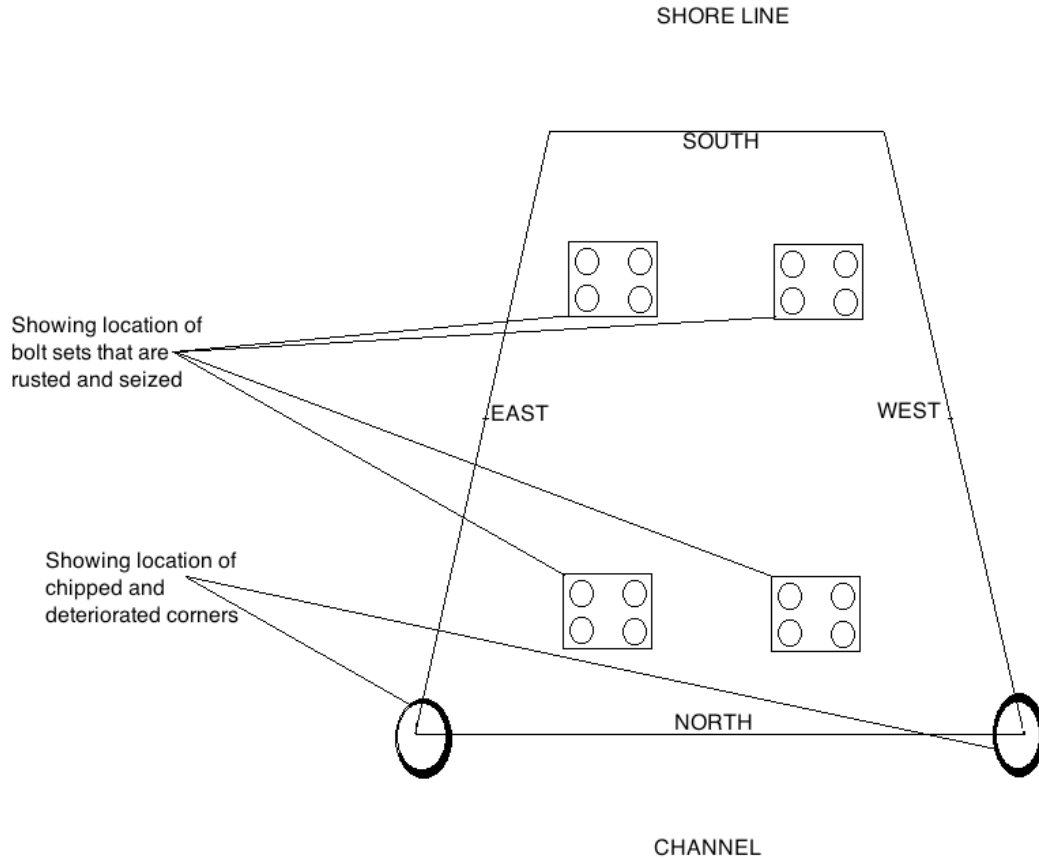
Top slab

**WATERLINE TO MUD LINE IS ROUGHLY 10' 6" DEEP ON CHANNEL SIDE**

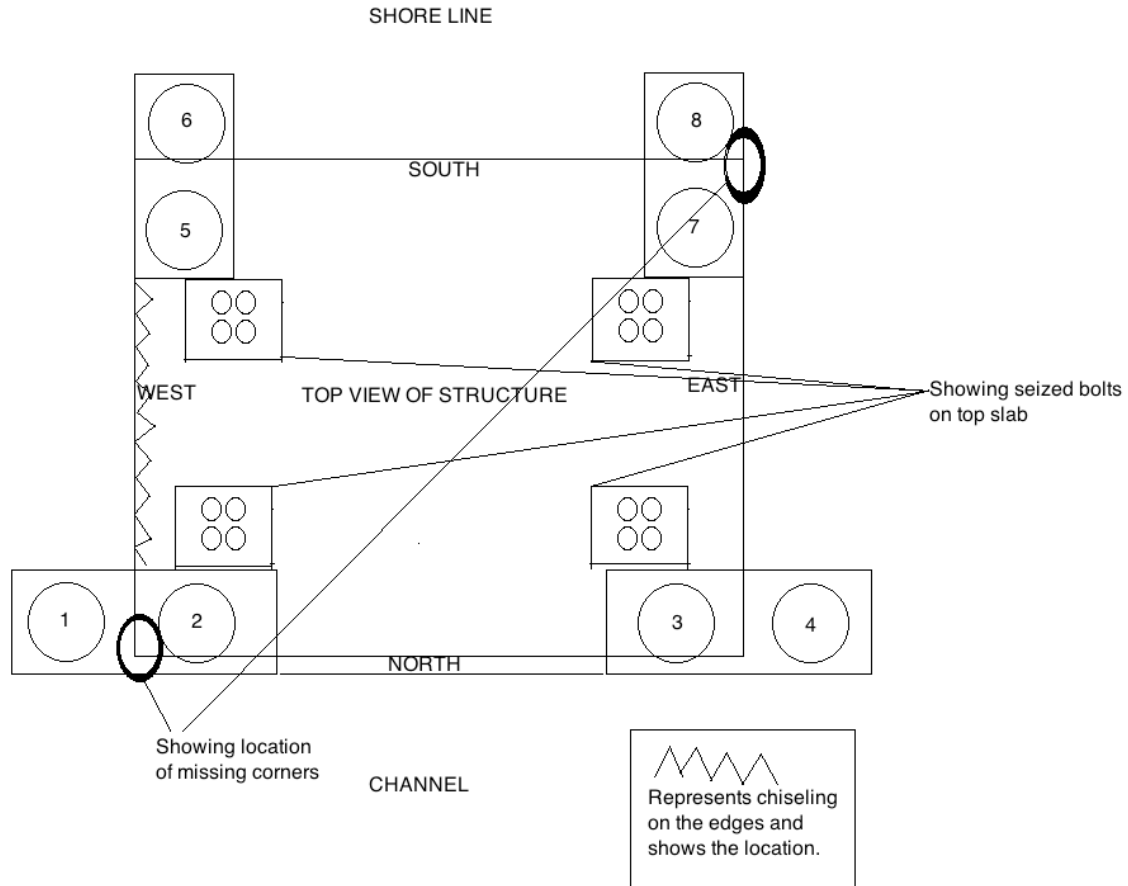
Top slab

**WATERLINE TO MUD LINE IS ROUGHLY 10'6" DEEP ON THE CHANNEL SIDE**

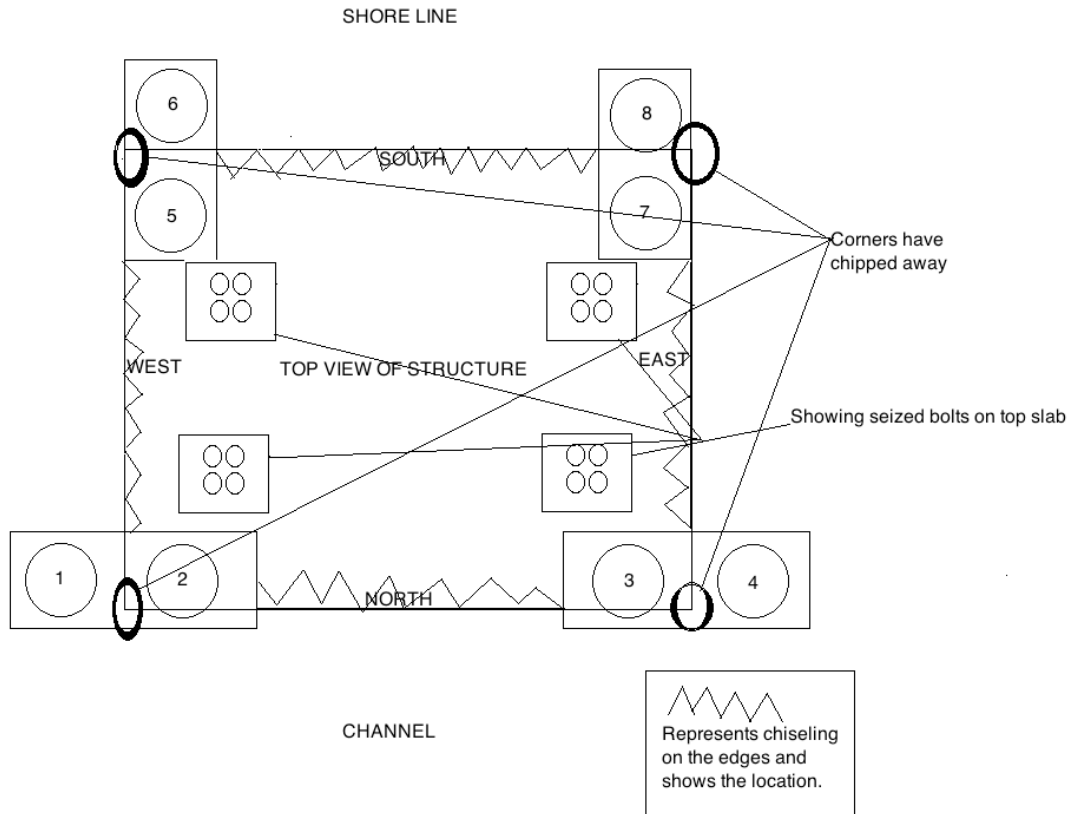
Top slab

**WATERLINE TO MUDLINE IS ROUGHLY 10' DEEP ON THE CHANNEL SIDE**

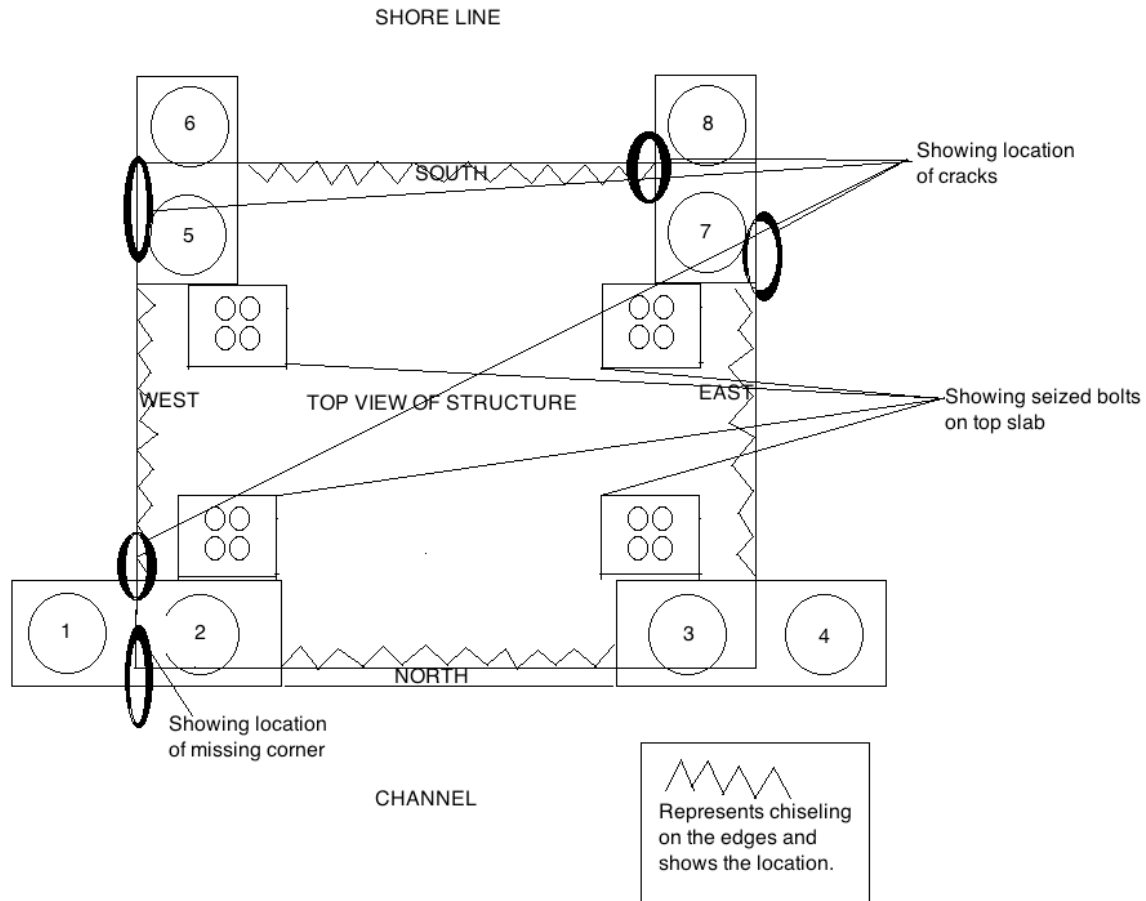
## Top slab

WATERLINE TO MUD LINE IS ROUGHLY 6' 6" DEEP ON CHANNEL SIDE.

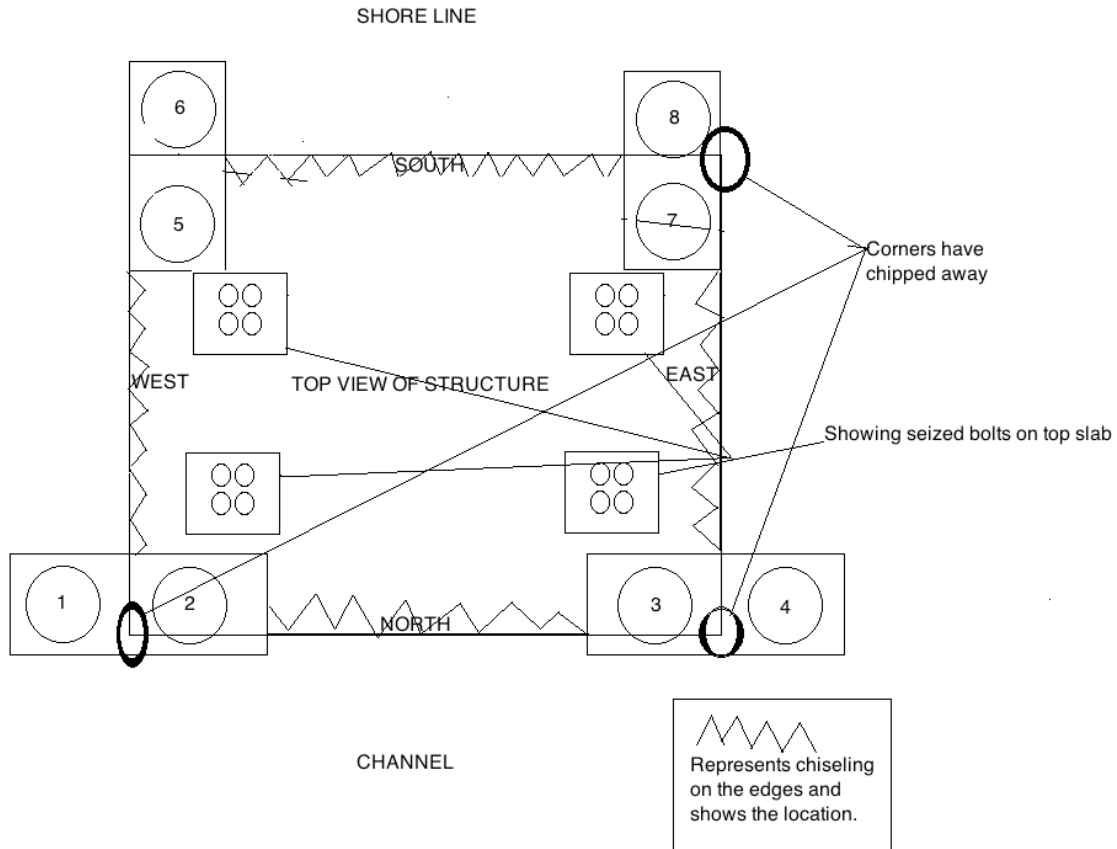
Top slab

**WATERLINE TO MUD LINE IS ROUGHLY 10' DEEP ON CHANNEL SIDE.**
