**INTERSTATE 40 BRIDGE  
(EXISTING)  
OVER THE ARKANSAS RIVER  
MUSKOGEE & SEQUOYAH COUNTIES, OKLAHOMA**

**VESSEL COLLISION RISK ASSESSMENT  
2022 UPDATE**

**STATE OF OKLAHOMA  
DEPARTMENT OF TRANSPORTATION**

**Modjeski and Masters, Inc.  
as Subconsultant to EST, Inc.**

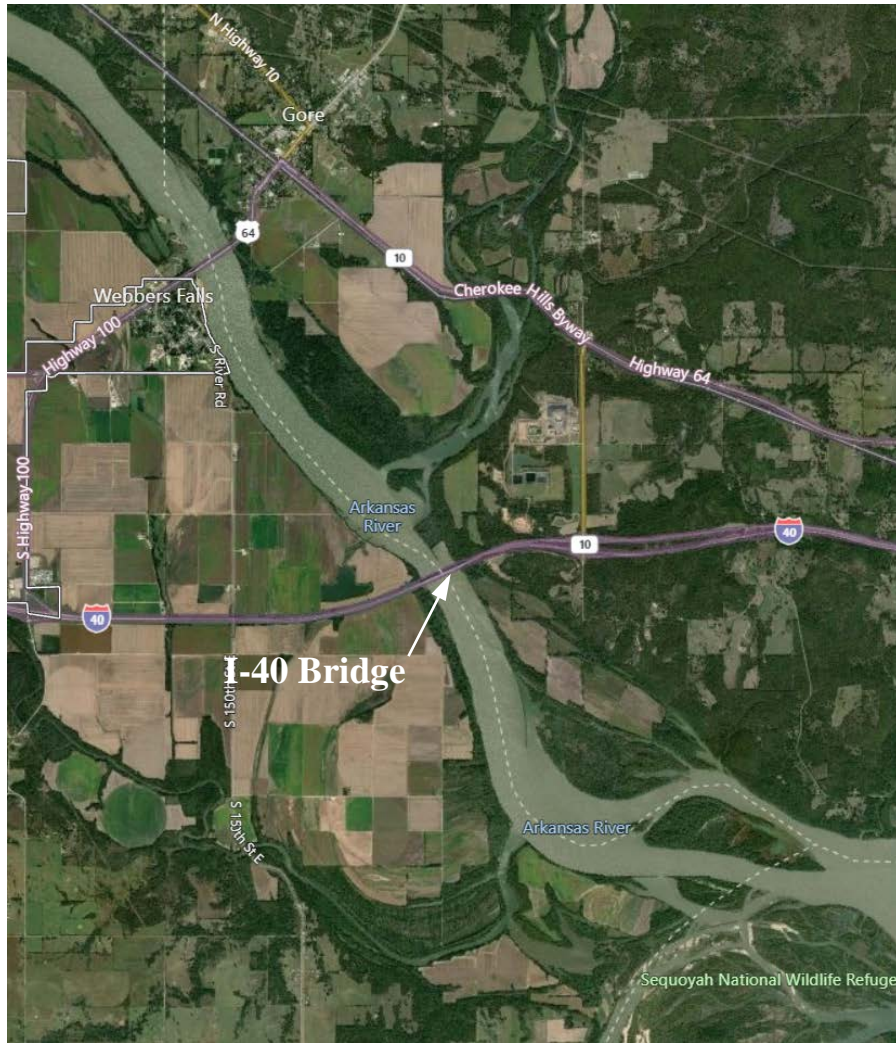
**Figure 2.1-1: Bridge Location**

The Interstate 40 Bridge is located in Muskogee and Sequoyah Counties, near Webbers Falls, Oklahoma, as shown in Figure 2.1-1. It crosses the McClellan-Kerr Arkansas River Navigation System (MKARNS), at river mile 360.3, between the Webbers Falls Lock & Dam (upstream) and the Robert S. Kerr Lock & Dam (downstream), within the Kerr Lake Conservation Pool. The navigation distance from the bridge to the Webbers Falls Lock & Dam is 6.3 river miles, and the distance to the

Robert S. Kerr Lock & Dam is 24.1 river miles. The SH-100 Bridge is located 2.8 miles upstream from the I-40 Bridge.

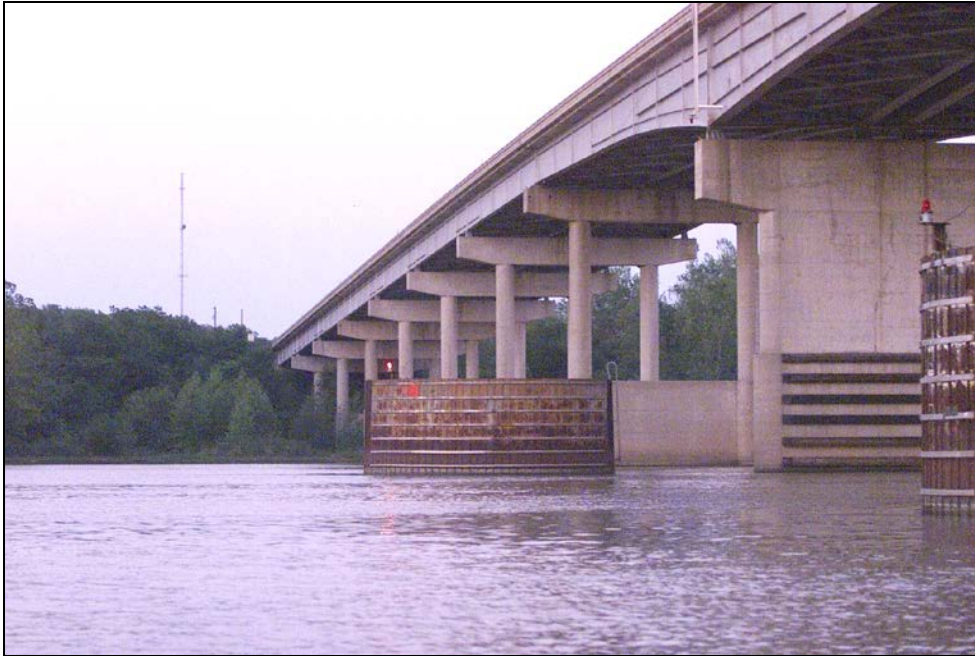
**Figure 2.4-1: Sheet Pile Dolphins Upstream of Piers 4 and 5**

The original bridge protection that included two 40-foot diameter steel sheet pile dolphins located directly upstream from the channel piers (Piers 4 and 5) is shown in Figure 2.4-1 and some of the additional 12-foot drilled shaft protection can be seen in Figure 2.4-2.

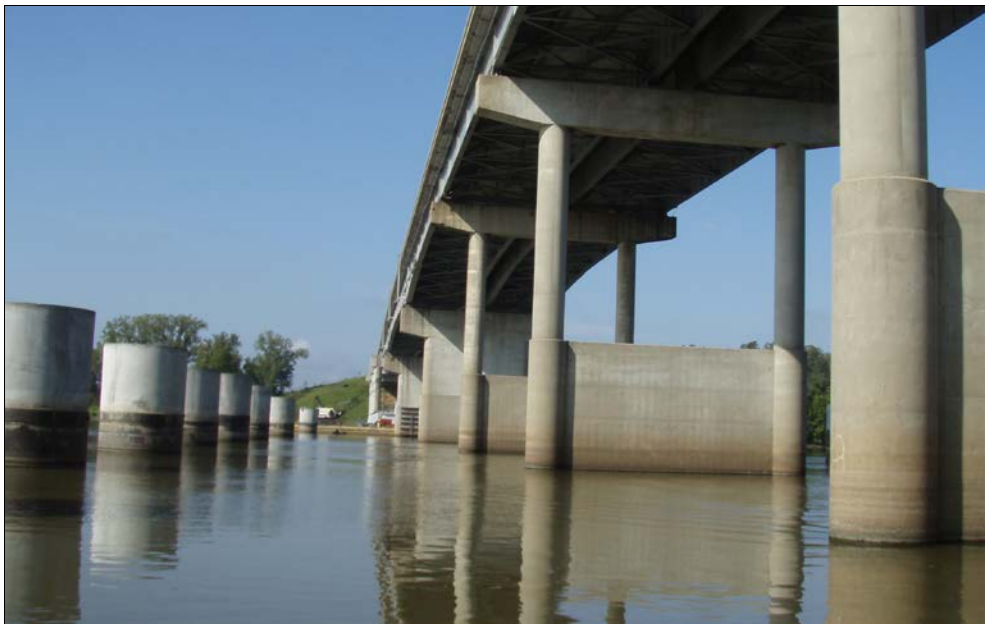
**Figure 2.4-2: View of the 12-Foot Drilled Shaft Protection on the Downstream Side of the Bridge**

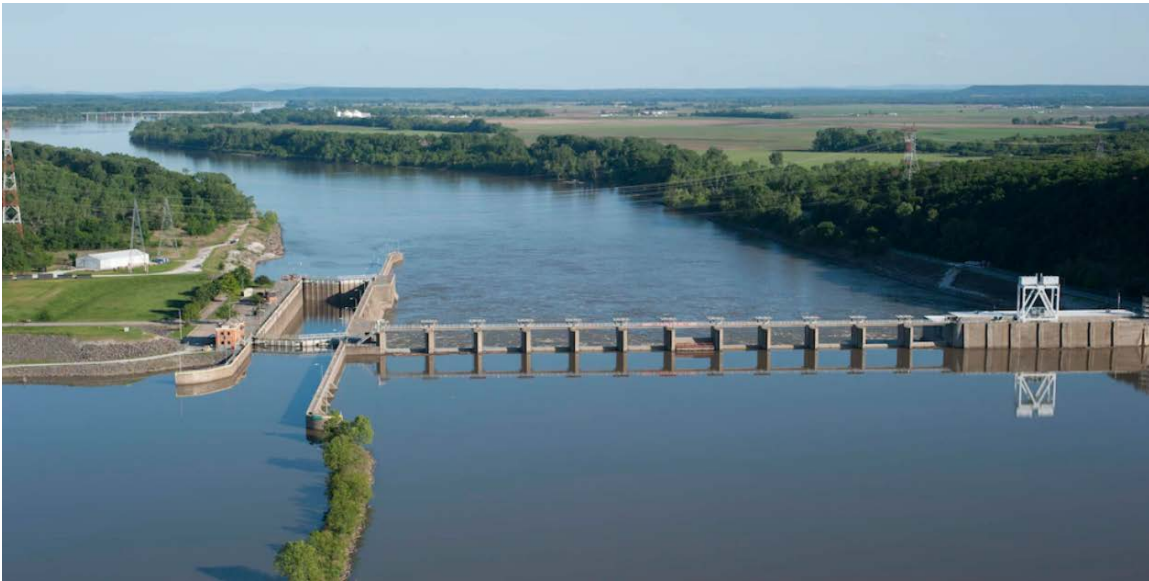
**Figure 2.4-3: View Webbers Falls Lock and Dam 16 Located 6.3 miles Upstream from the Bridge**

Figures 2.4-3 and 2.4-4 include views of the Webbers Falls Lock and Dam located 6.3 miles upstream from the bridge and the Robert S. Kerr Lock and Dam located 24.1 miles downstream from the bridge. These locks control the river conditions at the site and the access of drifting and out of control vessels to the bridge. They are also a good source of information on the vessel traffic passing the bridge.

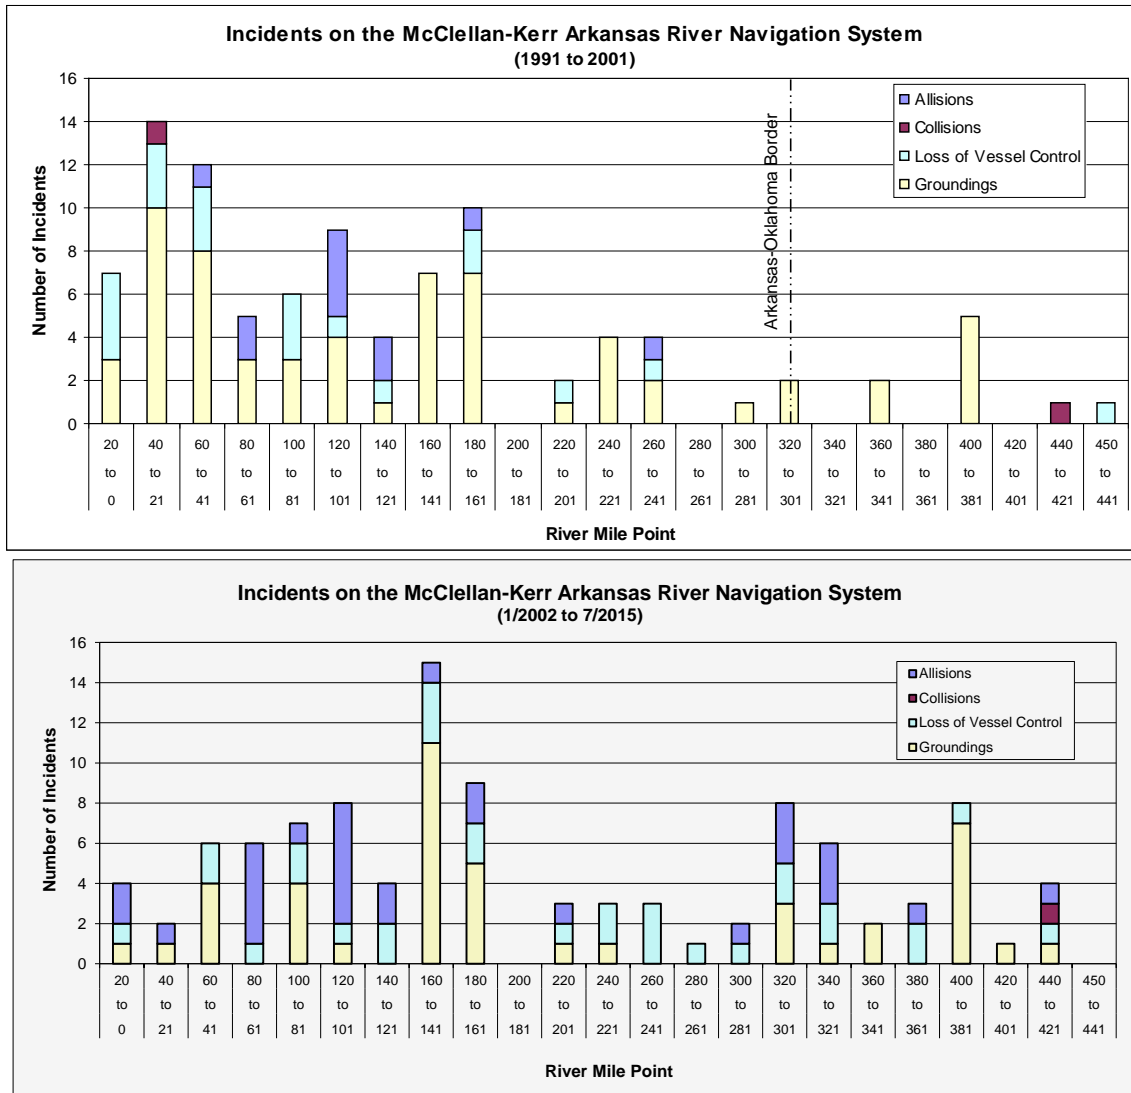
**Figure 3.2-1: USCG Accident Analysis (1991 to 2001 top and 1/2002 to 7/2015 bottom): Incidents on the McClellan-Kerr Arkansas River Navigation System by River Mile Range**

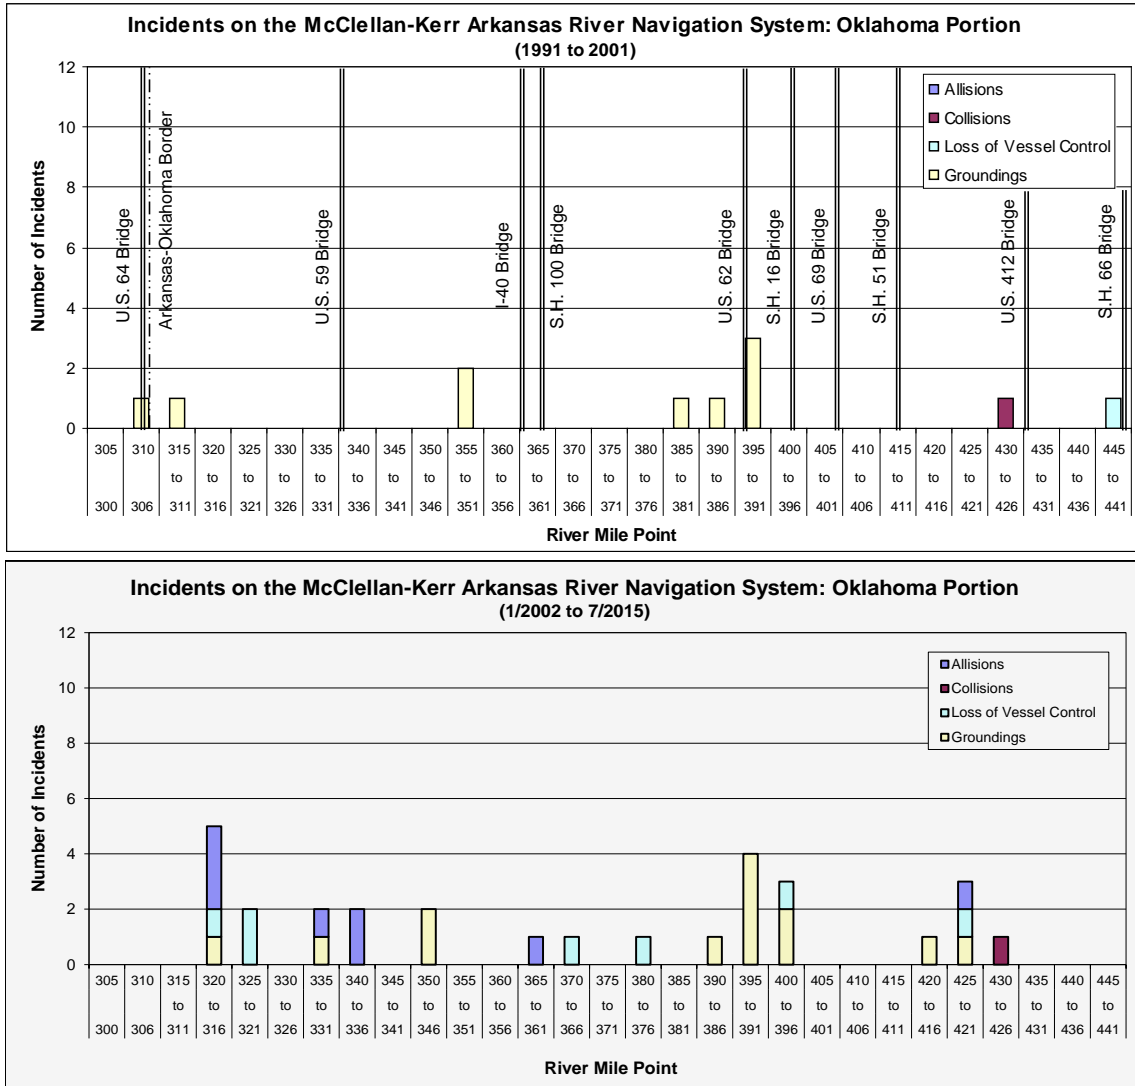
**Figure 3.2-2: USCG Accident Analysis (1991 to 2001 top and 1/2002 to 7/2015 bottom): Incidents on the McClellan-Kerr Arkansas River Navigation System by River Mile Range: Oklahoma Portion**

Figure 3.2-2 concentrates on the Oklahoma portion of the waterway, with additional lines symbolizing bridge locations. It shows that most of the incidents were groundings occurring away from bridge locations. The bottom plot in Figure 3.2-2 shows a wider mix of incident types along the waterway with most of the allisions and groundings occurring near or at locks, still away from bridge locations.

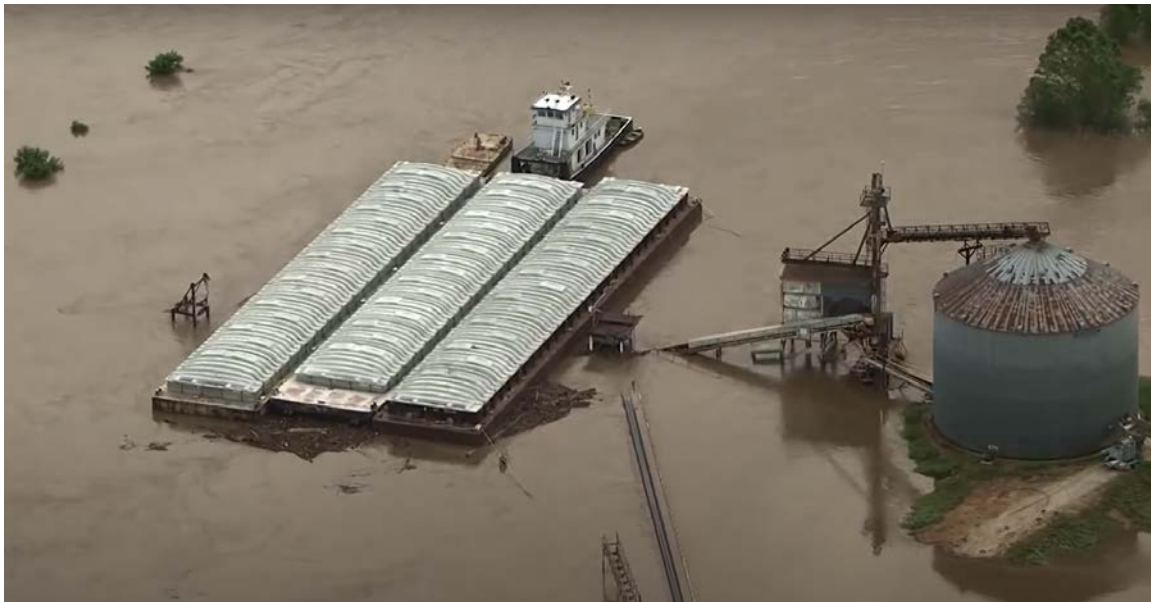
**Figure 3.2-1: View of Barges that Broke Free from the Consolidated Grain & Barge Facility During the 2019 Flood**

An example of a barge breakaway near the I-40 bridge involved barge MST-720 B, which broke free from the Consolidated Grain & Barge facility in Webbers Falls, Oklahoma on July 13, 2004, and drifted downstream. It was caught by M/V Fayville only about 3/4 of a mile from the I-40 Bridge. Barges broke free at this facility during the May 2019 flood as well (see Figure 3.2-1).

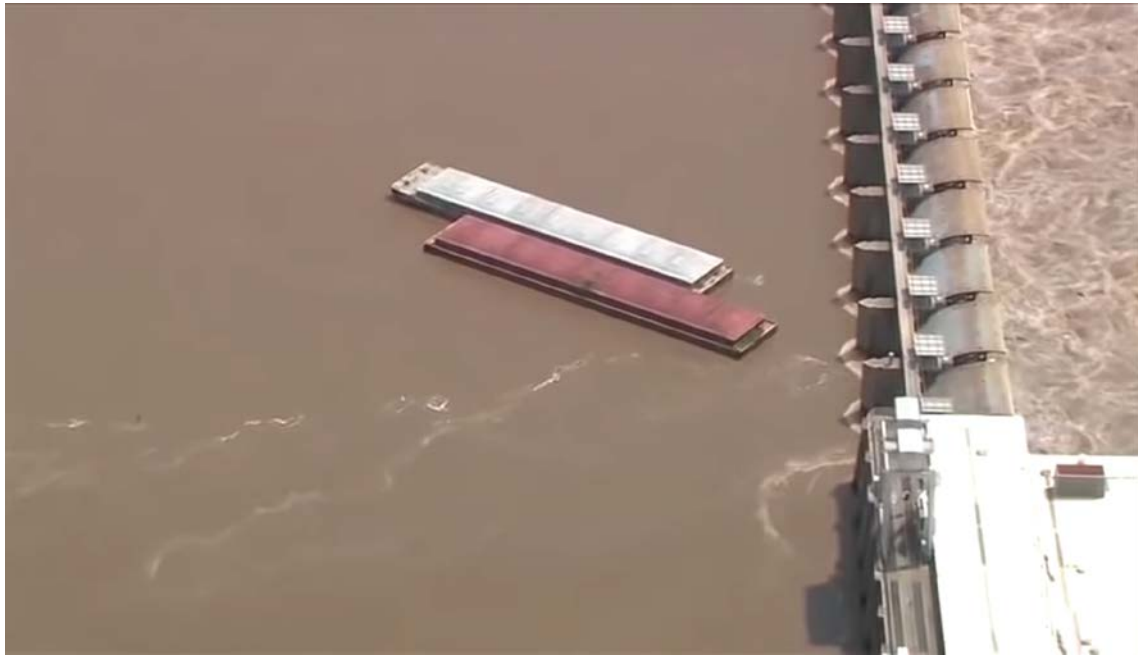
**Figure 3.2-2: Runaway Barges MTC 7256 and LTD 1140 Shortly Before and After Striking Webbers Falls Dam.**

The May 2019 flood caused another barge breakaway that resulted in an allision at the Webbers Falls Lock & Dam, when two loaded barges, MTC 7256 and LTD 11140, struck the Webbers Falls Dam. The barges broke away from a fleeting area on the Grand River in Muskogee, Oklahoma, during high flood waters and high river current. The river current velocity at Muskogee was about 5 ft/sec. There was no damage to the dam, but the two barges were a total loss, as shown in Figure 3.4-2.

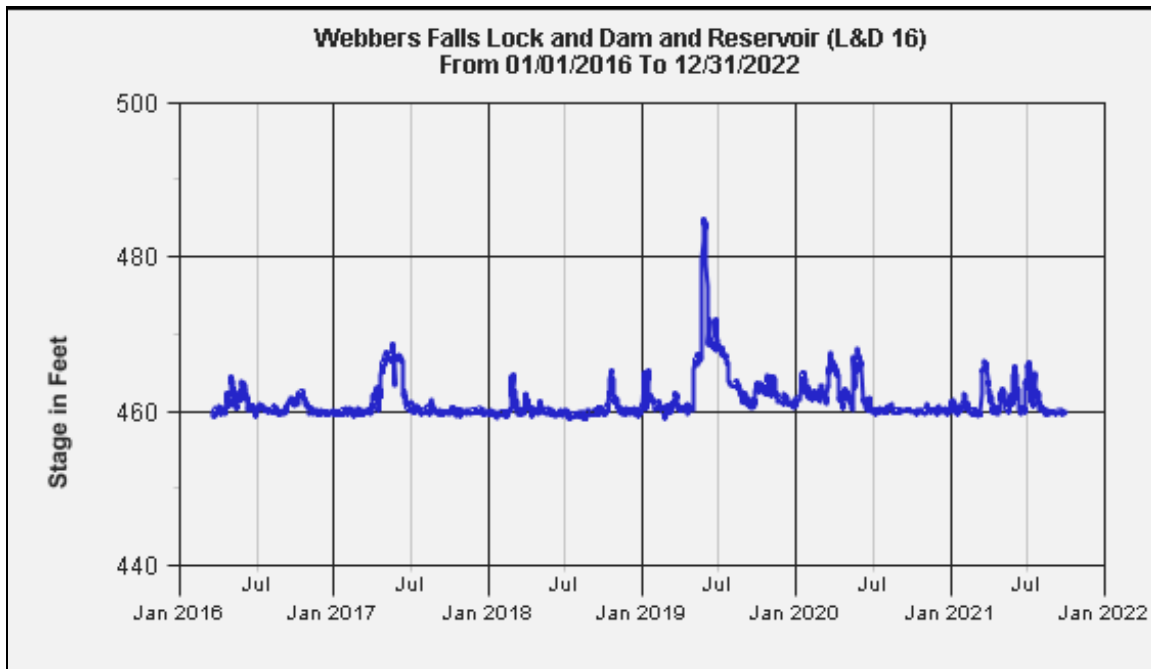
**Figure 4.3-1: Updated Pool Elevations at the Webbers Falls Lock and Dam from 1/1/2016 to 3/22/2022**

As noted in the 2005 Report, except for extreme events, water levels on the McClellan-Kerr Arkansas River Navigation System vary little since they are controlled by the 17 lock and dam structures. A comparison of the waterway data before and after the previous study report confirmed that during normal times water levels do not vary much, but it also showed a higher frequency of high-water events during the more recent time period. As a result an increased water level variability is apparent. This is shown in Figure 4.3-1, which is a representative hydrograph of the pool elevation readings at the Webbers Falls Lock and Dam. The pool flood stage at the Lock and Dam is 490.5.

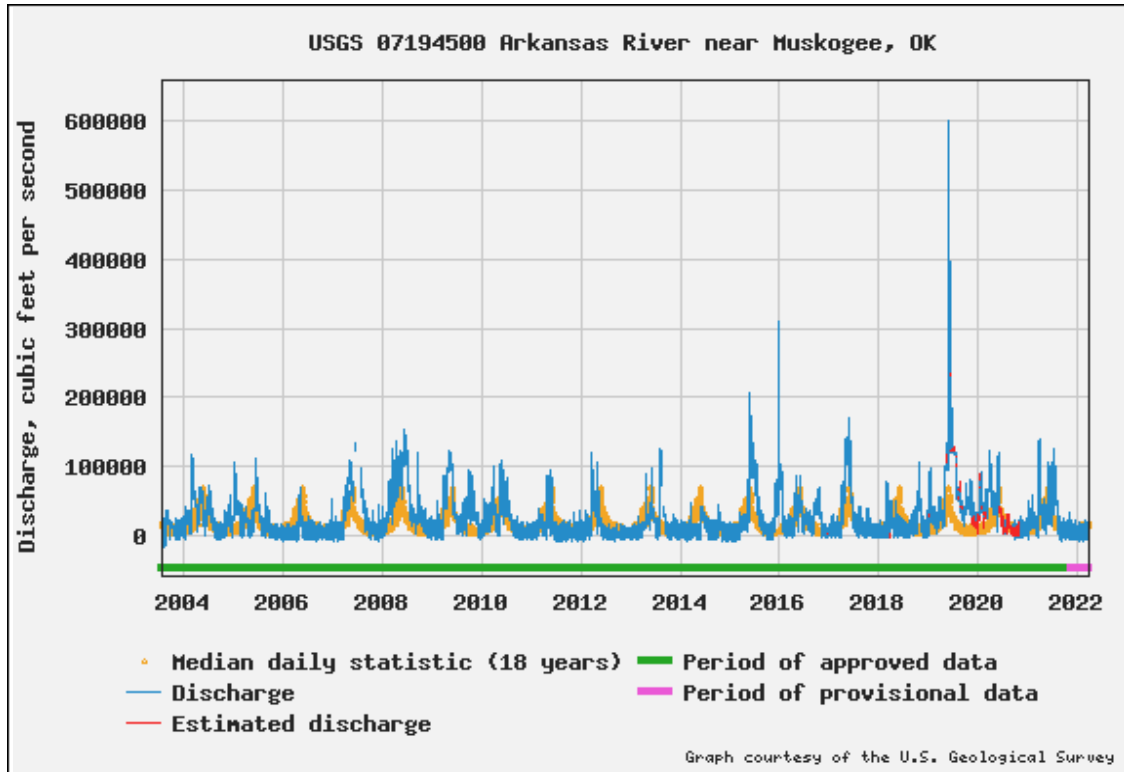
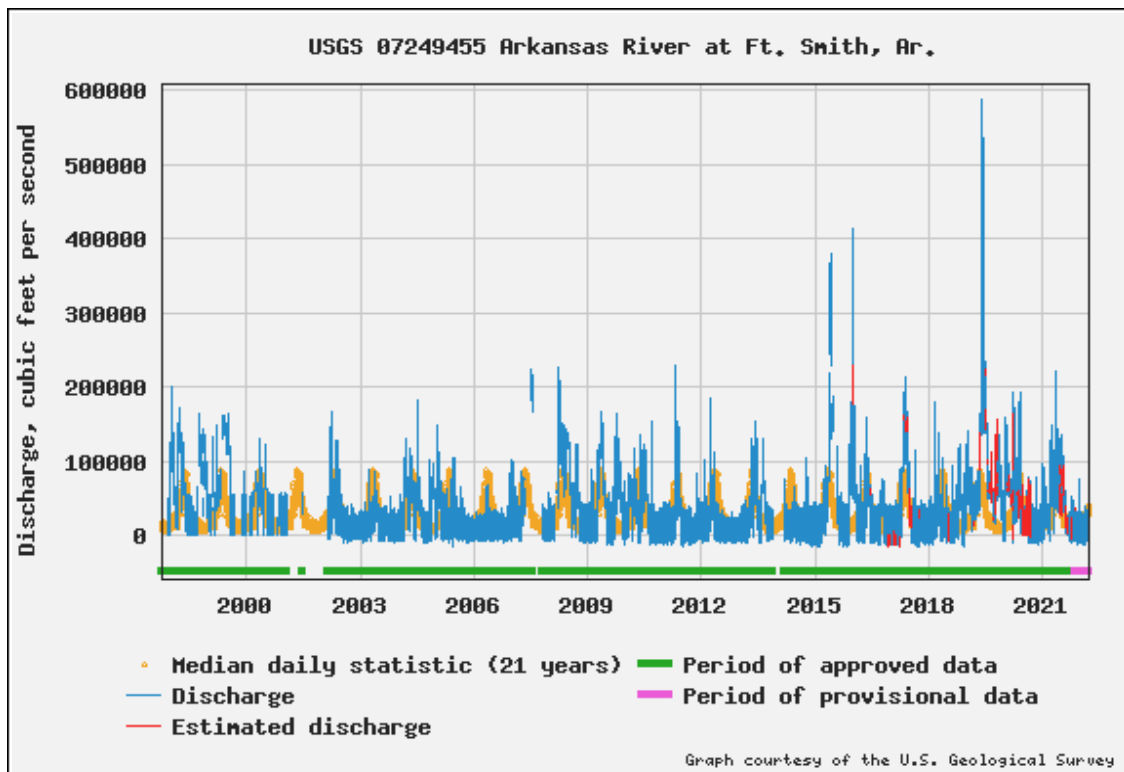
Figure 4.3-2: Historical Daily Discharges at Muskogee, OK (top plot) and Ft. Smith, AR (bottom plot)

The United States Geological Survey (USGS) operates a stream gaging station upstream from the bridge site, near Muskogee, Oklahoma and downstream of the bridge at Ft. Smith, Arkansas with comprehensive river data monitoring. Figure 4.3-2 shows historical daily discharge readings for these stations for the last 20 years or so. It shows the increased frequency of extreme events during the more recent times.

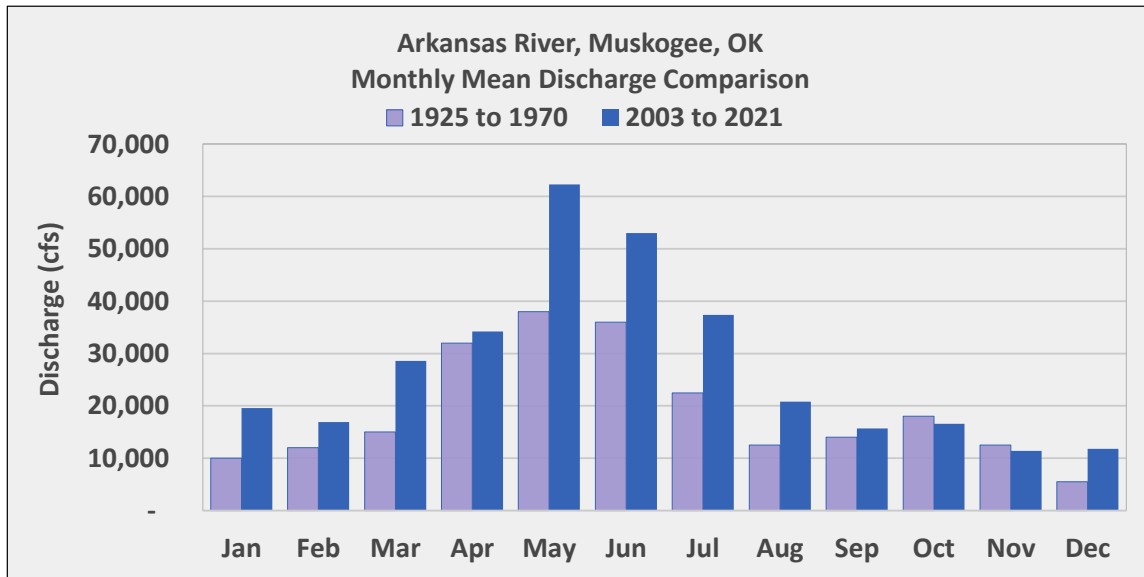
**Figure 4.3-3: Comparison of Mean Monthly Discharge Readings at Muskogee, OK Between Time Periods 1925 to 1970 and 2003 to 2021**

A comparison of the monthly mean discharge data before 1970 and after 2003 is shown in Figure 4.3-3. A significant increase in discharge can be noted during the high discharge months of May, June and July.

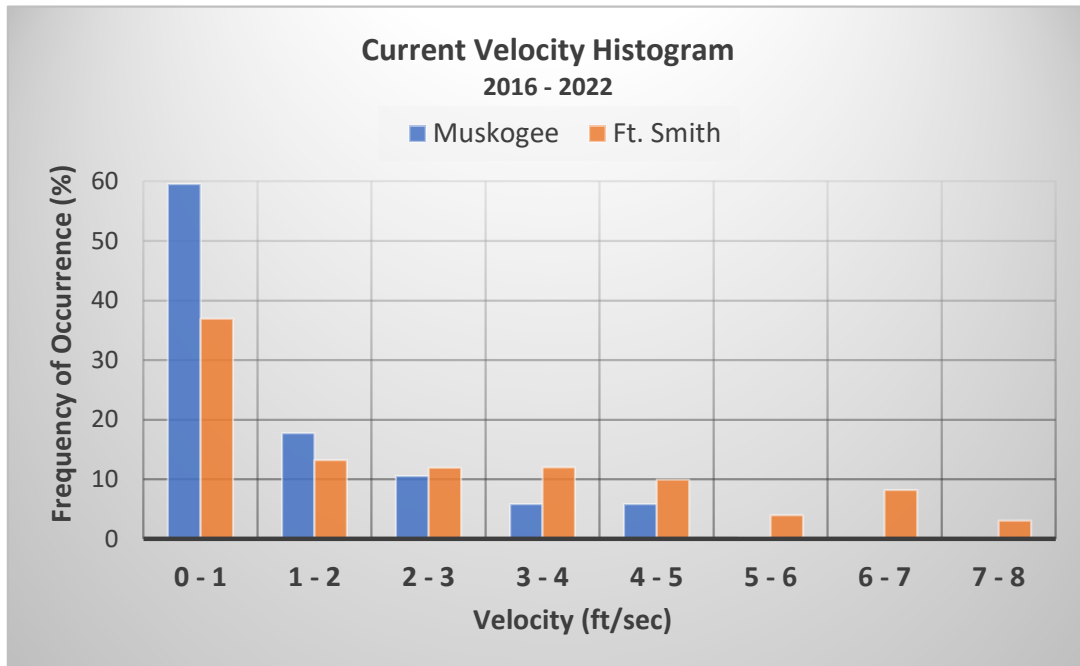
Figure 4.4-1 Current Velocity Histogram at Muskogee and Ft. Smith

Updated river current velocity data statistics are shown in Figures 4.4-1 and 4.4-2. Figure 4.4-1 includes a histogram generated from the daily current velocity data available between 2016 and 2022. It shows that the most frequent current velocities at Muskogee are below about 2.5 feet per second and that the current velocities at Ft. Smith are higher and more frequent. The probability distribution of the current velocity is included in Figure 4.4-2. For example, Figure 4.4-2 shows that the probability of exceeding a current velocity of 3 feet per second is about 10% at Muskogee and about 40% at Ft. Smith. Based on the current velocity data statistics, the use of 6 feet per second for design purposes for a high-water event seems to be reasonable.

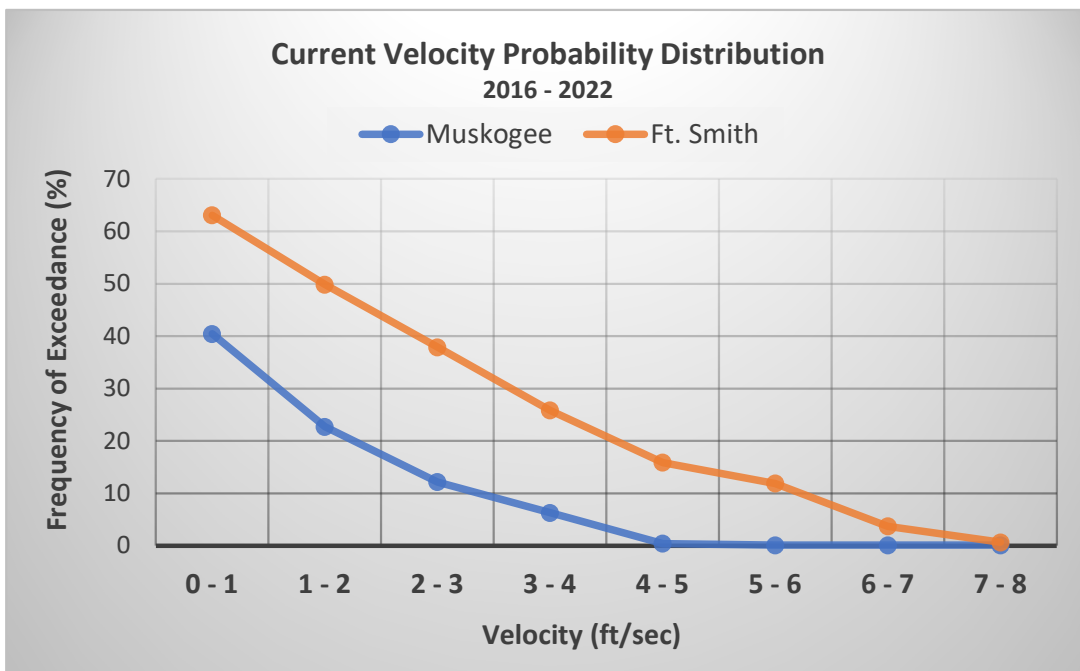
Figure 4.4-2 Current Velocity Probability Distribution at Muskogee and Ft. Smith

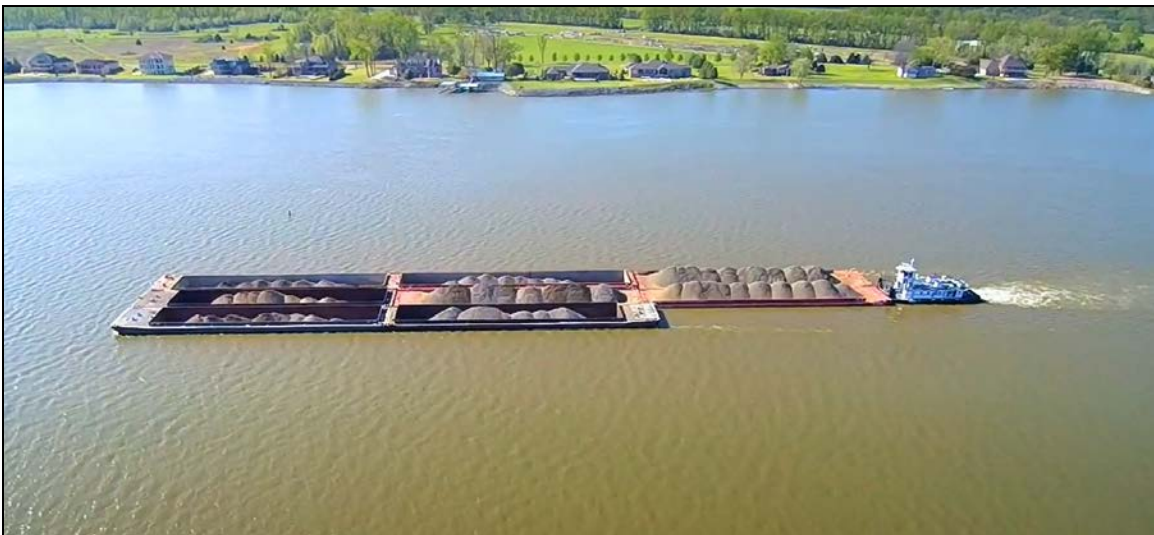
**Figure 5.2-2: Typical Hopper Barge Tow in Transit**

The vessel types on the McClellan-Kerr Arkansas River navigation system include mainly hopper and tanker barge tows. A view of a typical hopper barge tow in transit is shown in Figure 5.2-1, and a view of a typical tanker barge tow in a lock chamber is shown in Figure 5.2-2.

Hopper barges are typically 35 feet wide, 195 feet long and 12 feet deep and have a cargo capacity of about 1,700 tons. Large tanker barges are commonly 53 feet wide, 290 feet long and 12 feet deep, and have a dead weight of approximately 500 to 600 tons and a cargo capacity of up to about 3,700 tons. Thus, a typical tanker barge can carry over twice the tonnage of a hopper barge. The draft of both barge types can vary from 2 to 9 feet depending on their loading condition.

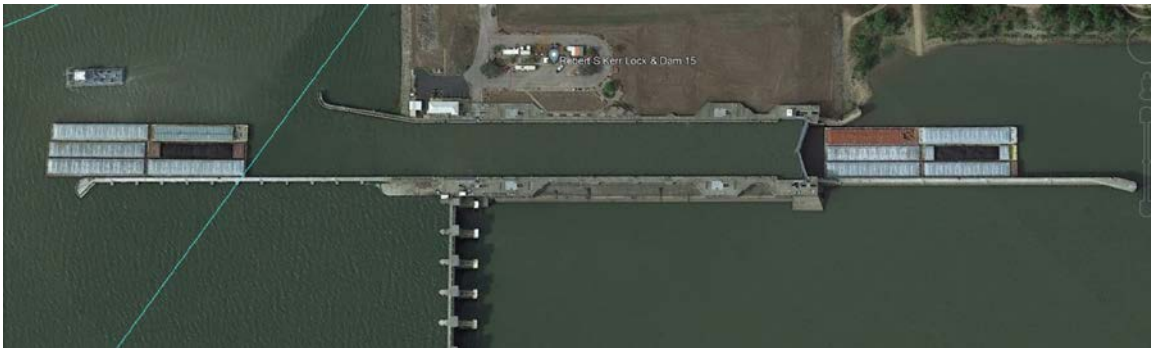
**Figure 5.2-5: Hopper Barge Tow at Robert S Kerr Lock and Dam 15**

Figure 5.2-5 shows a 12-barge hopper barge tow broken in two to fit the Robert S Kerr Lock limits, and Figure 5.2-6 shows a tanker barge tow broken to fit the Webbers Falls Lock limits.

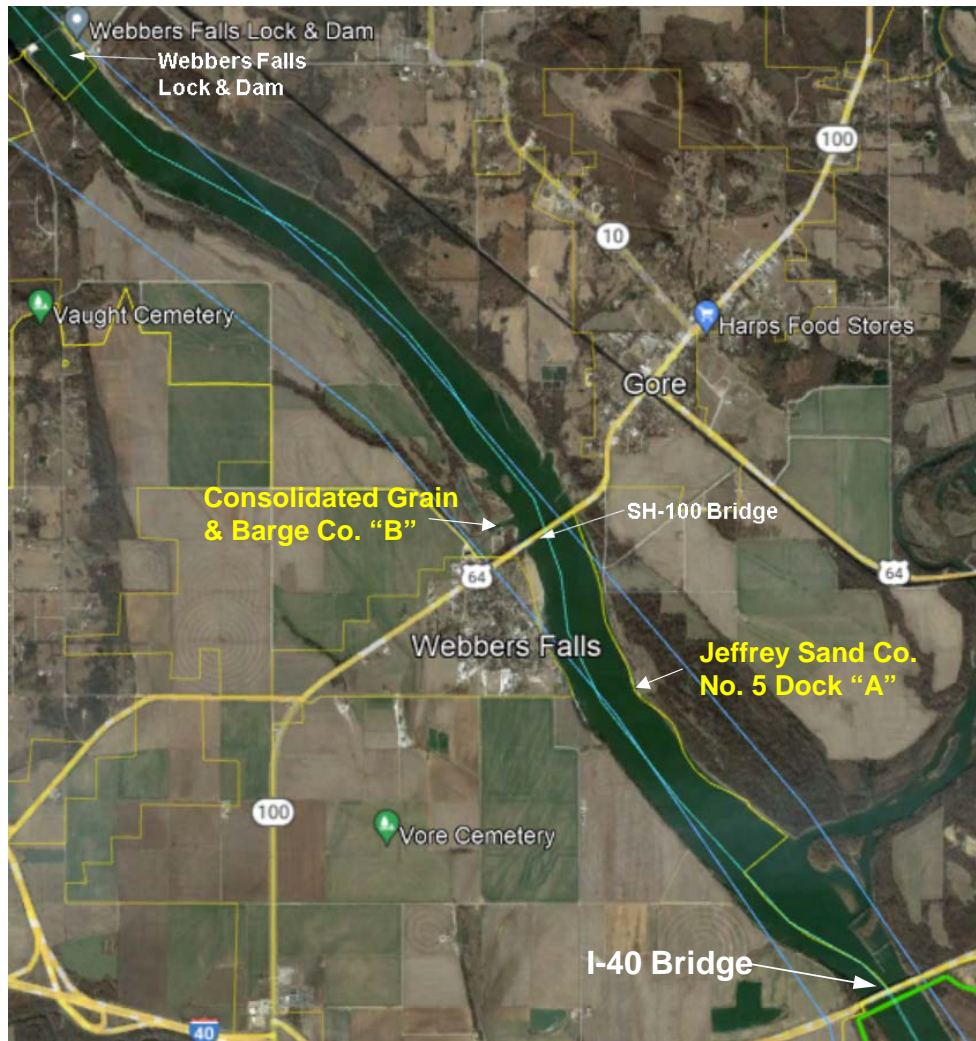
Figure 6.2-1: Location of Facilities Near the Bridge Site

The closest facilities to the bridge site include Jeffrey Sand Co Sand Plant No 5 Dock and Consolidated Grain and Barge Co Webbers Falls Dock (see Figure 6.2-1). They are both located upstream of the bridge and downstream of the Webbers Falls Lock and Dam.

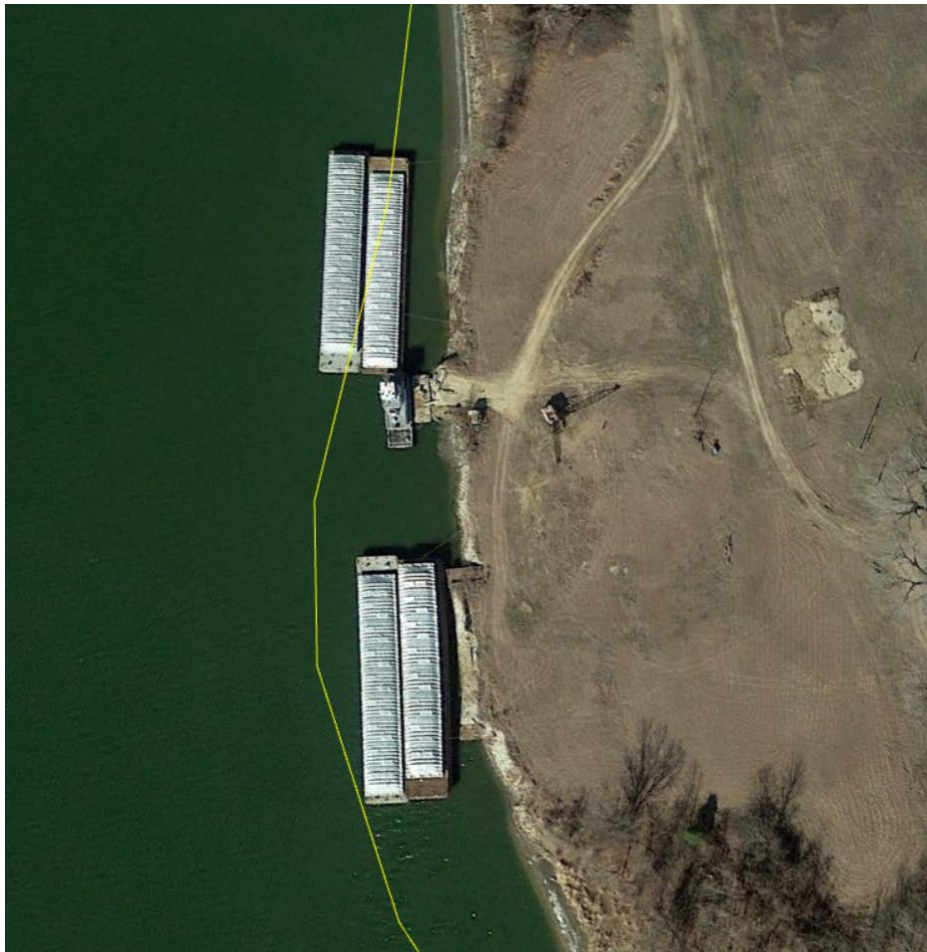
**Figure 6.2-2: View of Barges using the Jeffrey Sand Co Sand Plant No 5 Dock (Google)**

The Jeffrey Sand Co Sand Plant No 5 Dock is located at Mile 362.4, left bank, Arkansas River, Gore, approximately 0.6 mile below U.S. Highway 64 Bridge. The current owner is Jeffrey Sand Co., Inc. Phone: 501/945-4161. The commodities handled include Fertilizers, Sand, Gravel, Stone, Rock, Limestone, Soil and Dredged Material. It is not always operational. Figure 6.2-2 shows several barges using the facility in 2018 and Figure 6.2-3 includes a navigation chart showing the location of the facility relative to the bridge.

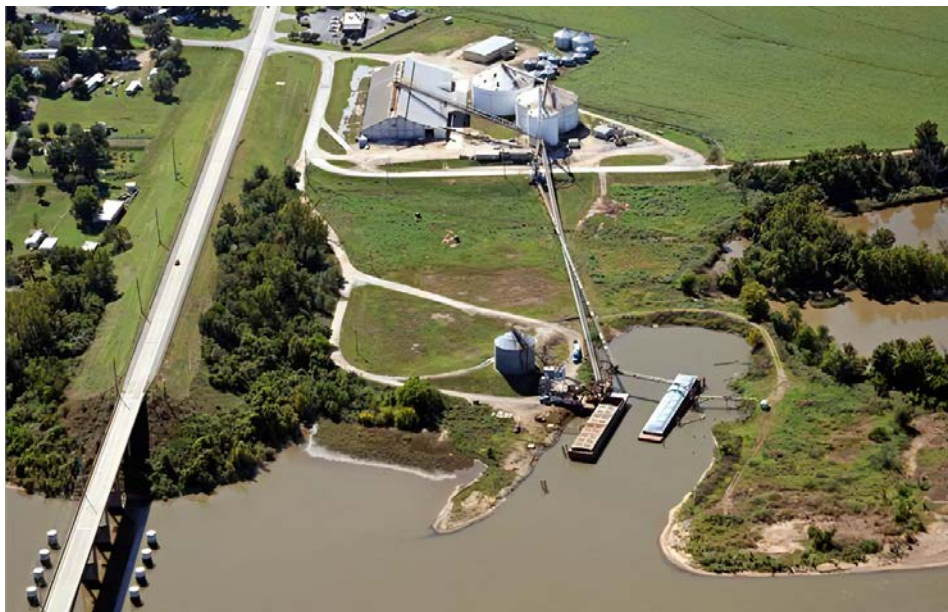
**Figure 6.2-4: View of the Consolidated Grain and Barge Co Webbers Falls Dock**

The Consolidated Grain and Barge Co Webbers Falls Dock is located at Mile 363.2, right bank, Arkansas River, Webbers Falls, above Oklahoma State Highway 64 Bridge. The current owner and operator is Consolidated Grain and Barge Co. Phone: 918/464-2296. The main commodities received include fertilizers and feed ingredients and the shipments are grain. The facility has a grain elevator consisting of four steel tanks. Its slip is 120 feet wide, with capacity for mooring six barges. An aerial view of the facility is included in Figure 6.2-4
