Frederick Hospital
Frederick, OK
Owner: Town of Frederick
Final Remediation Report

SITE CLEANUP ASSISTANCE PROGRAM

Brownfields performed sampling in September of 2024

- Asbestos containing material located in building
- A total of 4,700 sq ft of plaster, flooring, and transite removed
- A total of 2,100 linear ft of pipe runs removed
- Approximately 2500 gallons of hazardous materials
- Abatement completed in April of 2025

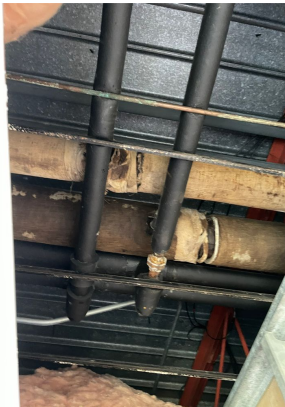
HA 12,14, & 83

This Homogeneous Area represents the **6" Hot/Cold Water Supply/Return – Runs** found throughout the Surgical Recovery Hall, X-Ray Department, Administrative Offices, Labor and Delivery and terminates back in the Surgical Department. No hard pack joints were identified. This material is classified as a friable thermal system insulation material. Samples were collected and tested according to Oklahoma Asbestos Regulations. This material tested **POSITIVE** for asbestos fibers. **10% Chrysotile**.

This Homogeneous Area represents the **2" Associated Pipe Runs** found throughout the Surgical Recovery Hall, X-Ray Department, Administrative Offices, Labor and Delivery and terminates back in the Surgical Department. No hard pack joints were identified. This material is classified as a friable thermal system insulation material. Samples were collected and tested according to Oklahoma Asbestos Regulations. This material tested **POSITIVE** for asbestos fibers. **30% Chrysotile**.

6" & 8" Hot/Cold Water Supply/Return Pipe Runs
and 2" associated pipe runs off the main lines
Throughout the Surgical, Labor & Delivery, Xray, and Ad-
min area

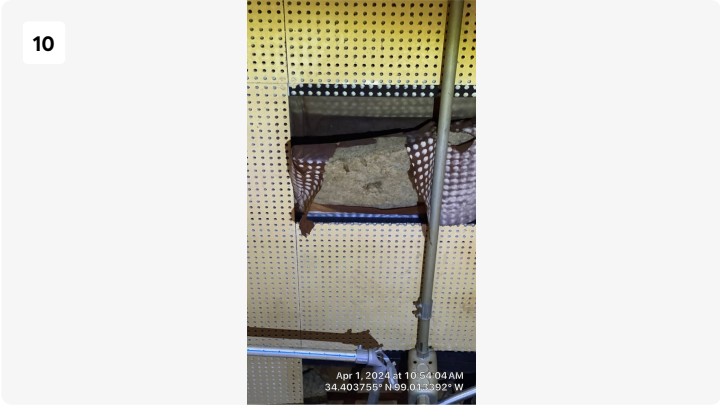
HA 28 Transite Ceiling Tile
in Kitchen

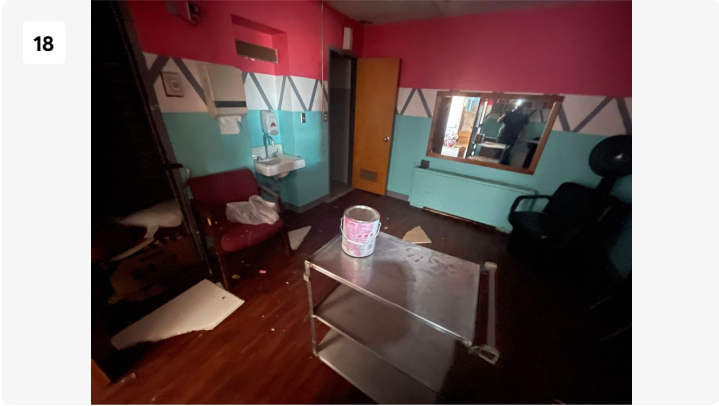
HA 69 - Tan linoleum
Hair Salon in the Physical Therapy Wing
Beneath the wood floor

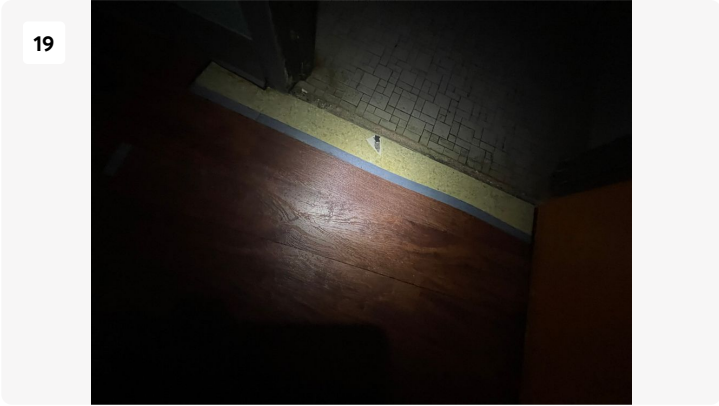
HA 69 - Tan linoleum
Hair Salon in the Physical Therapy Wing
Beneath the wood floor

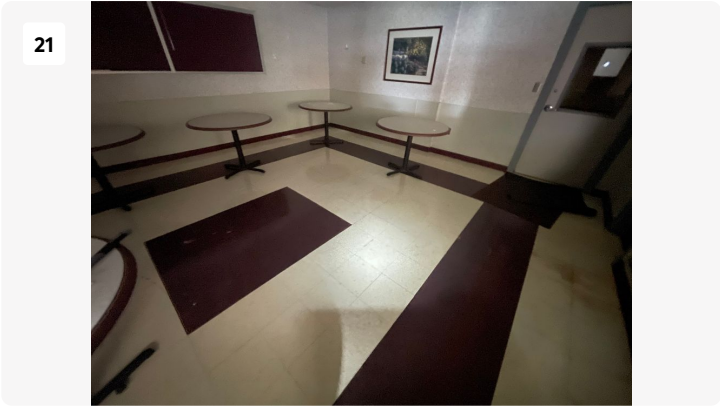
HA 80b Maroon Floor Tile in Cafeteria
2nd layer of floor tile beneath the Maroon Floor Tile positive

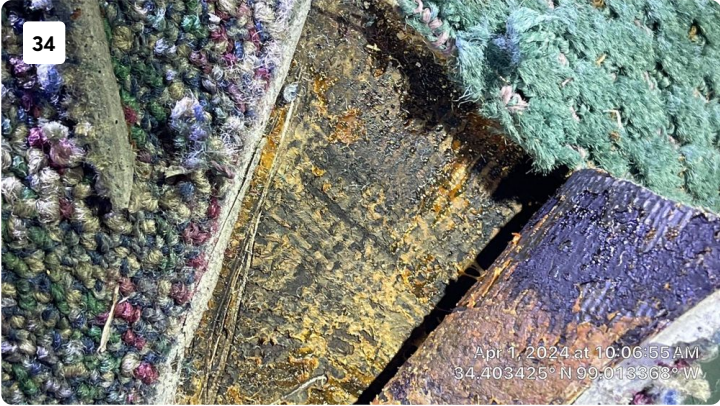
PACM Mastic Throughout

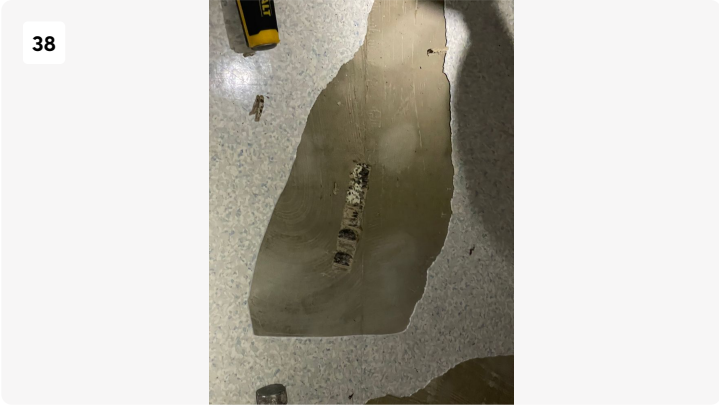
Black Mastic beneath the linoleum in the ER Hallway

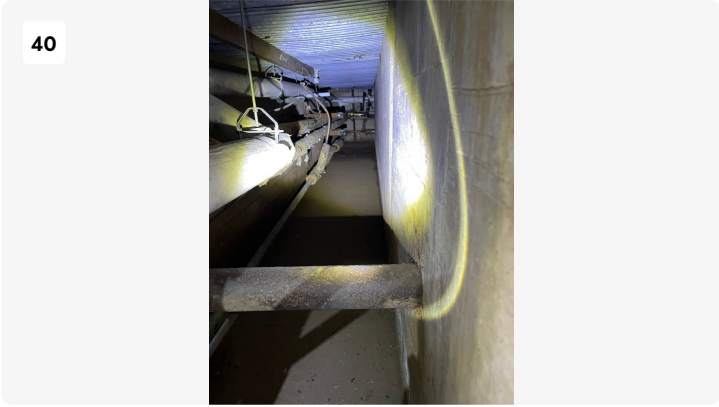
The underground chase in the Physical Therapy Gym had limited access and was not able to be fully inspected. Based on what could be visually inspected at the entrances to the tunnels along with squeeze tests performed, there was no suspect material identified.

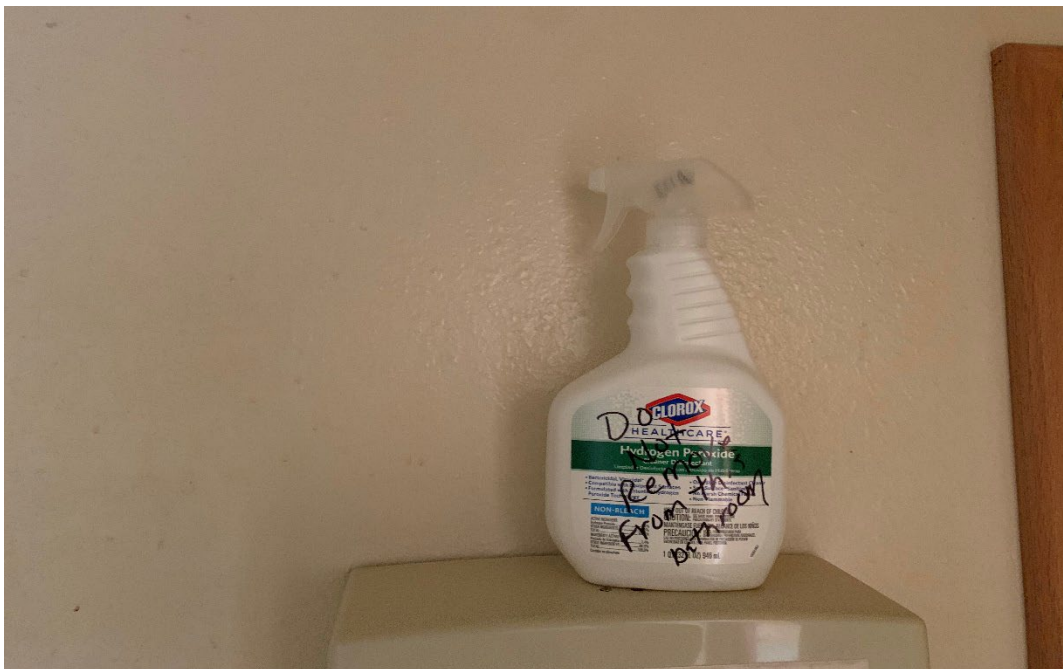
Room 332 - Clorox Hydrogen Peroxide

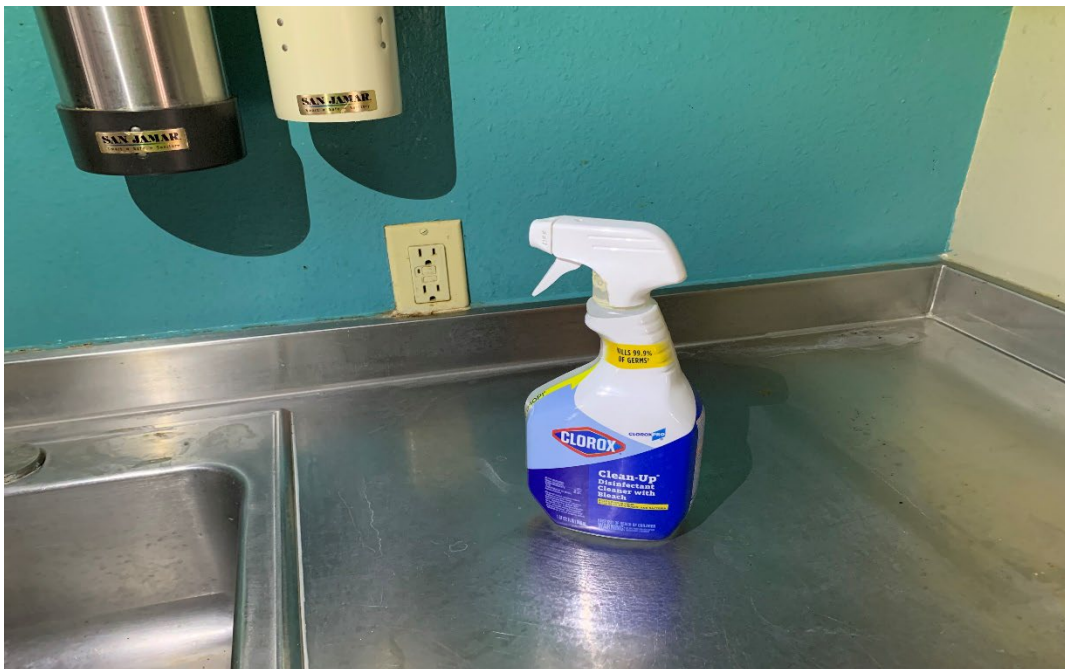
Dining Room - Clorox Bleach Disinfectant

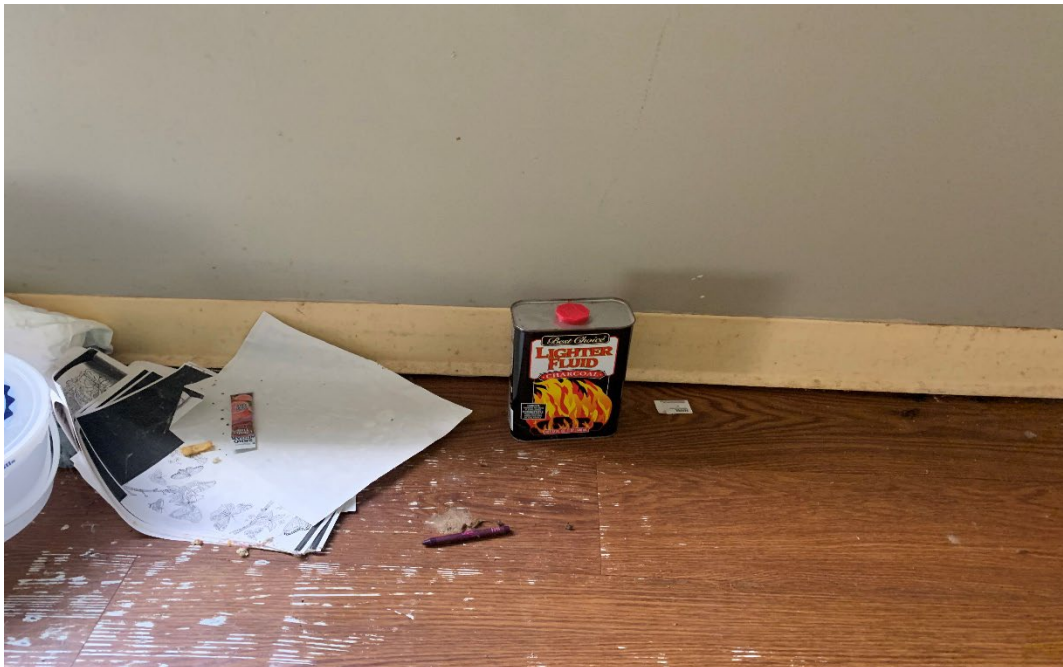
Break Room - Best Choice Lighter Fluid

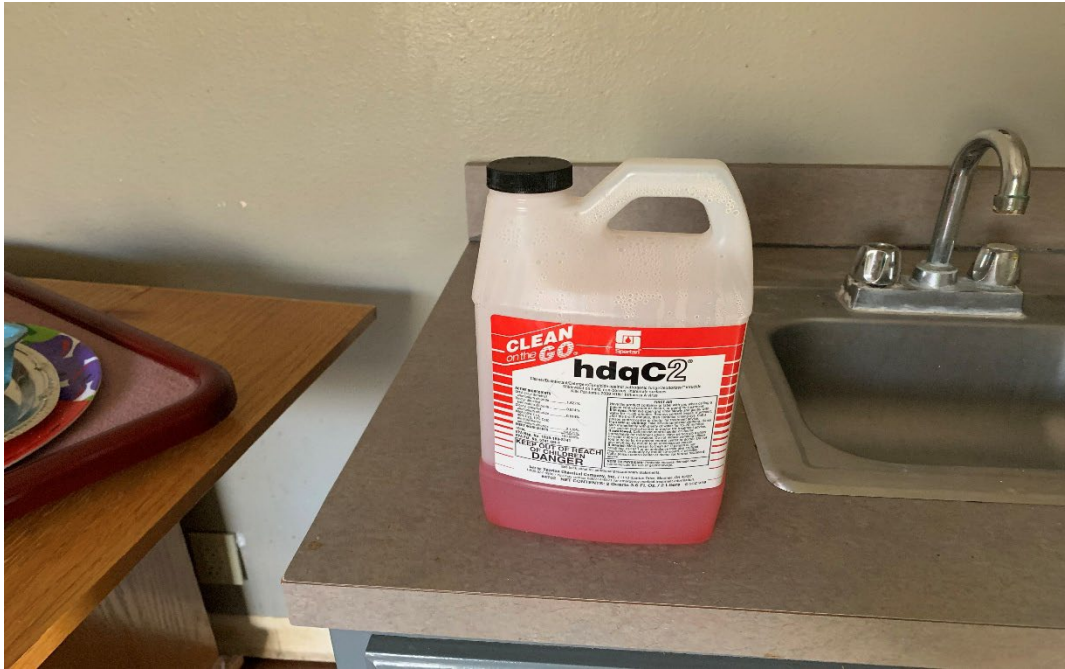
Break Room - hdqC2 Quaternary Cleaner

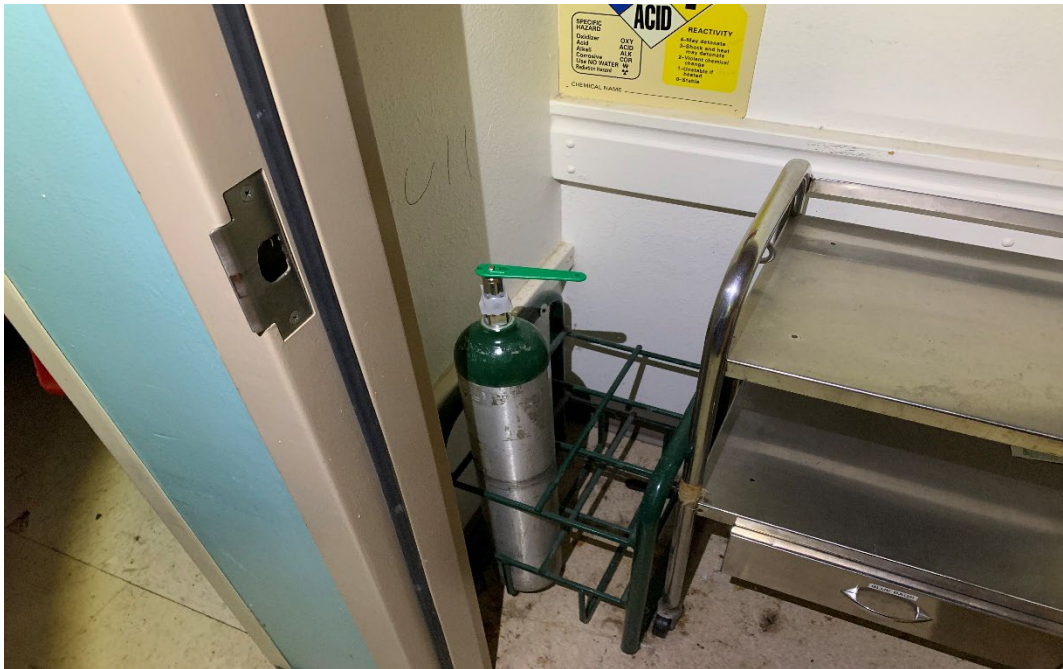
Oxygen Storage - Oxygen Tank

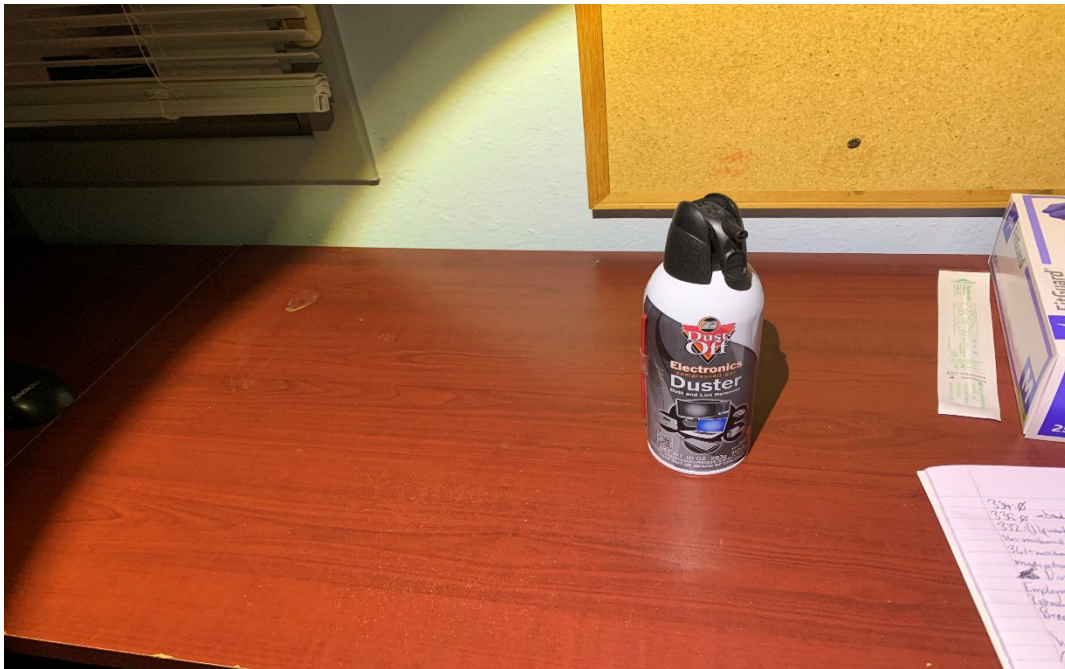
Office - Compressed GasDust & Lint Remover

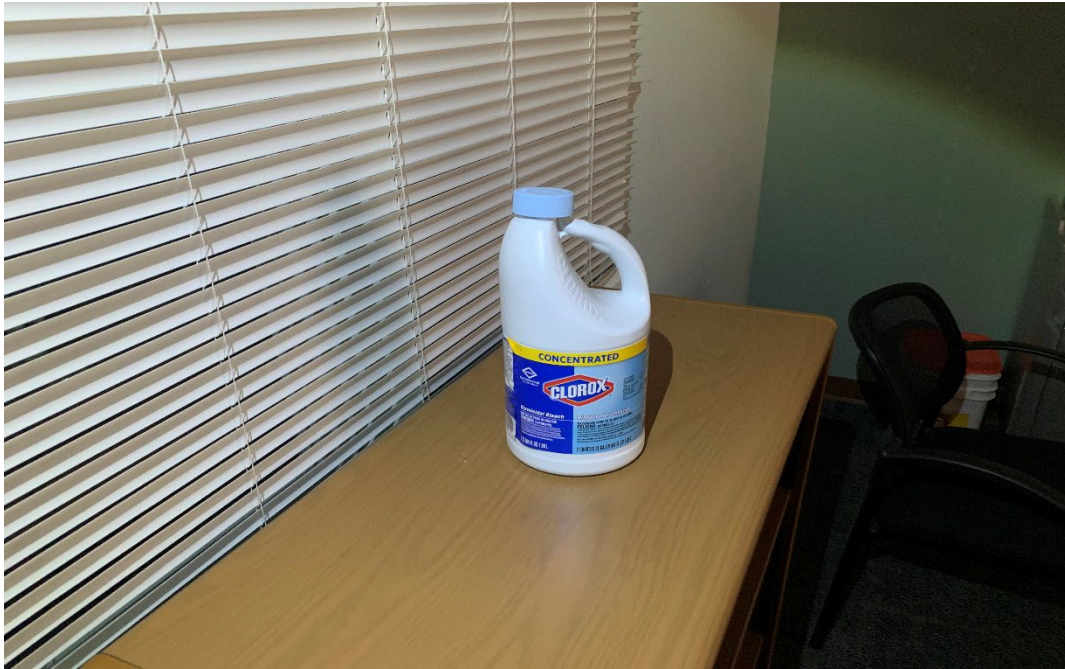
Director Office - Concentrated Clorox Bleach

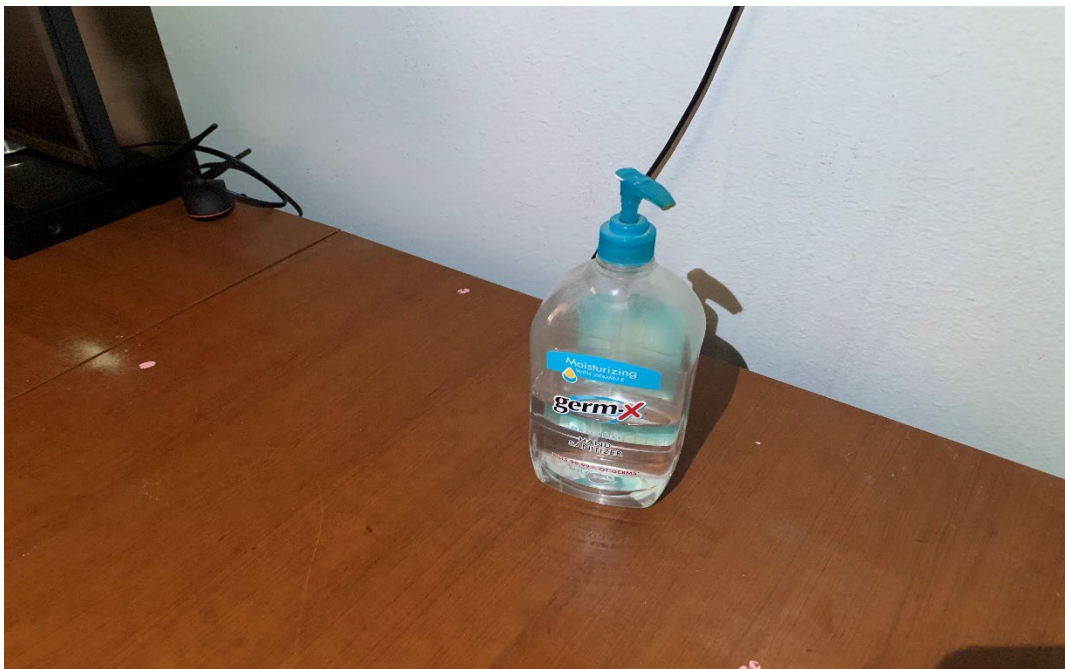
Director Office - Germ-X Hand Sanitizer

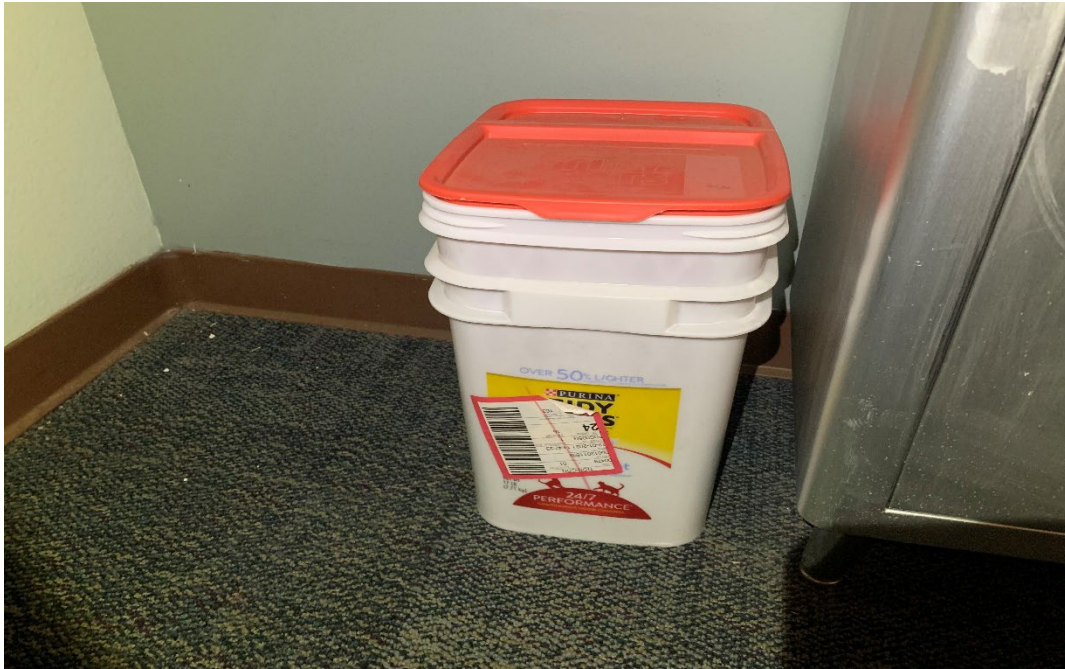
Director Office - Purina Cat Litter

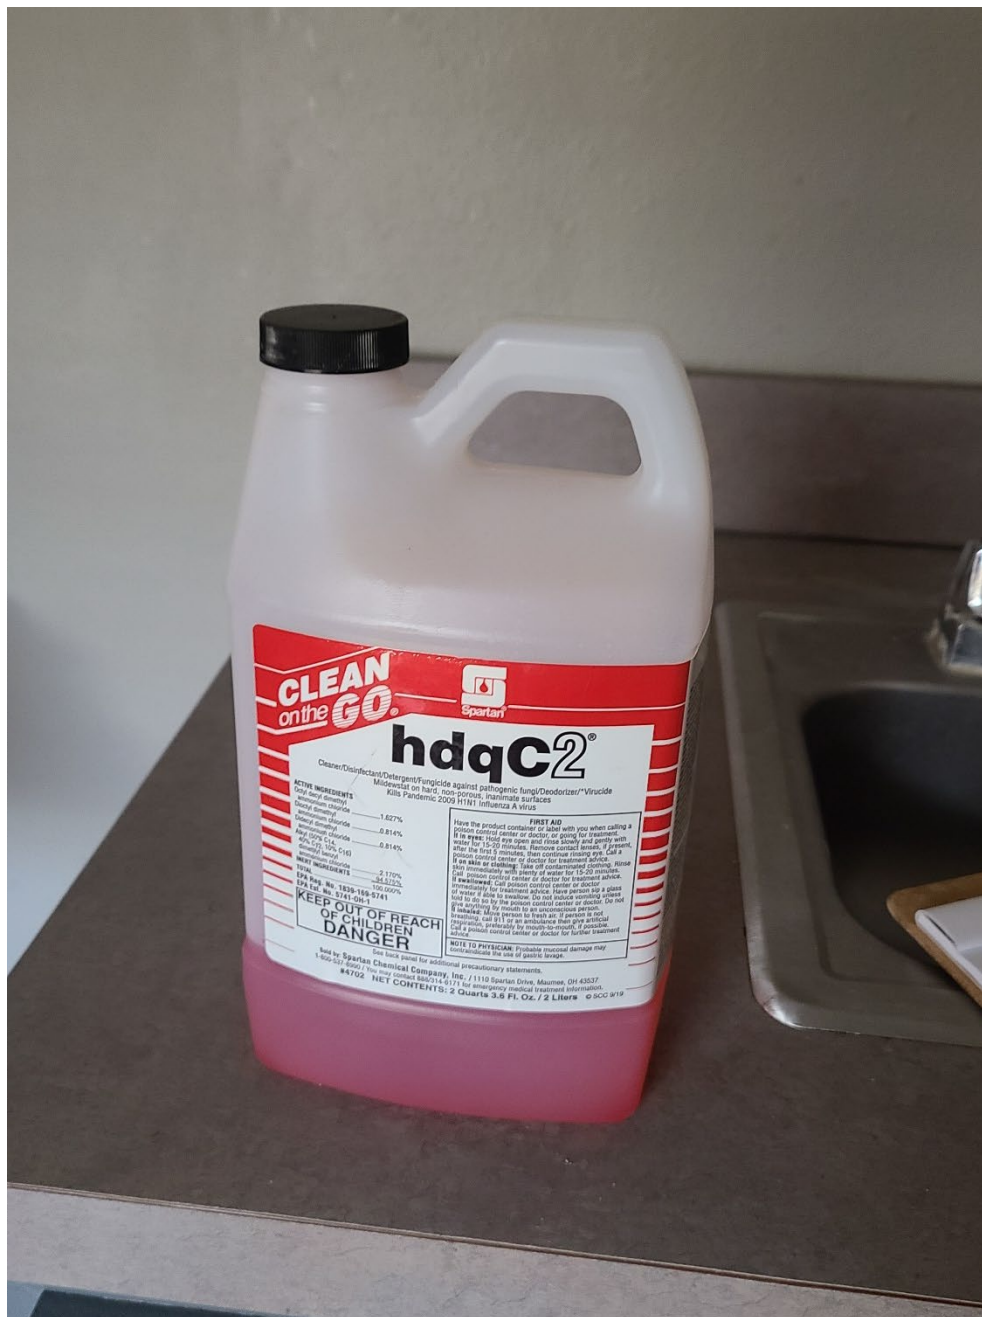
Quaternary cleaner in Dietary Department

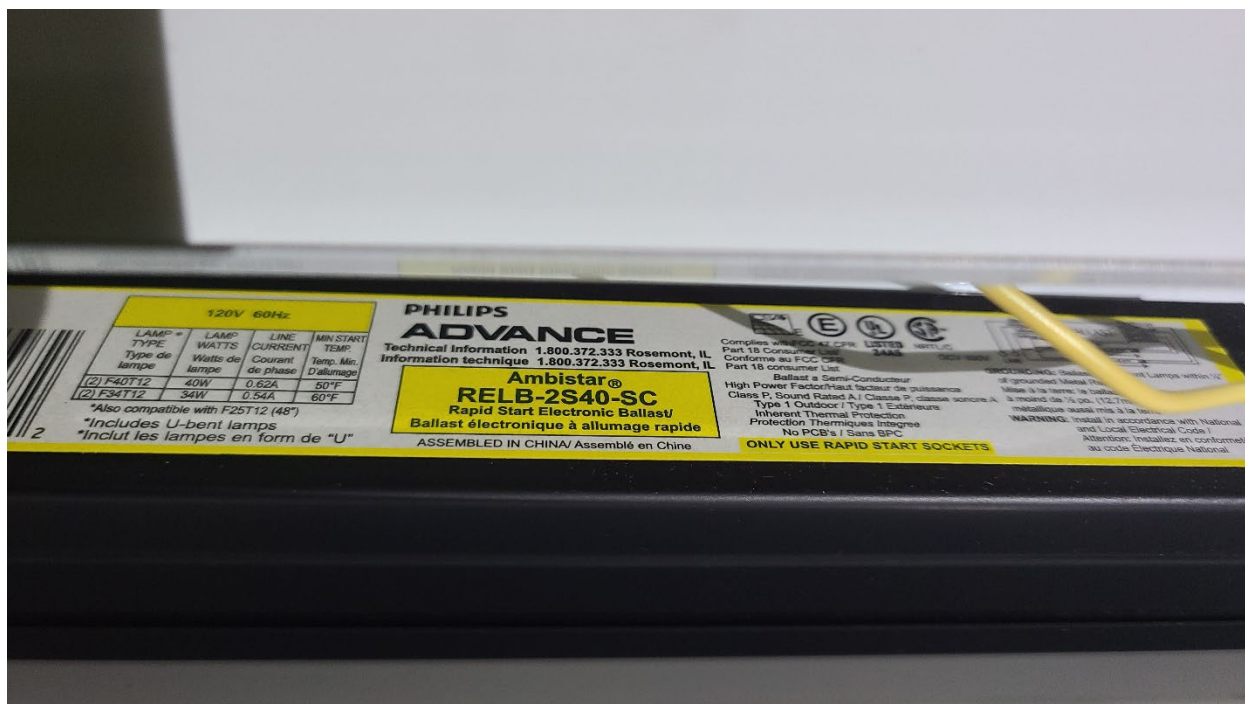
Fluorescent light fixtures were observed throughout the building. A representative number of lighting ballasts inspected in the building were labeled as containing "No PCBs." Any ballasts not specifically labeled as "No PCBs" or as "Electronic Ballast" should be assumed to contain PCBs.

Non-PCB ballast, typical

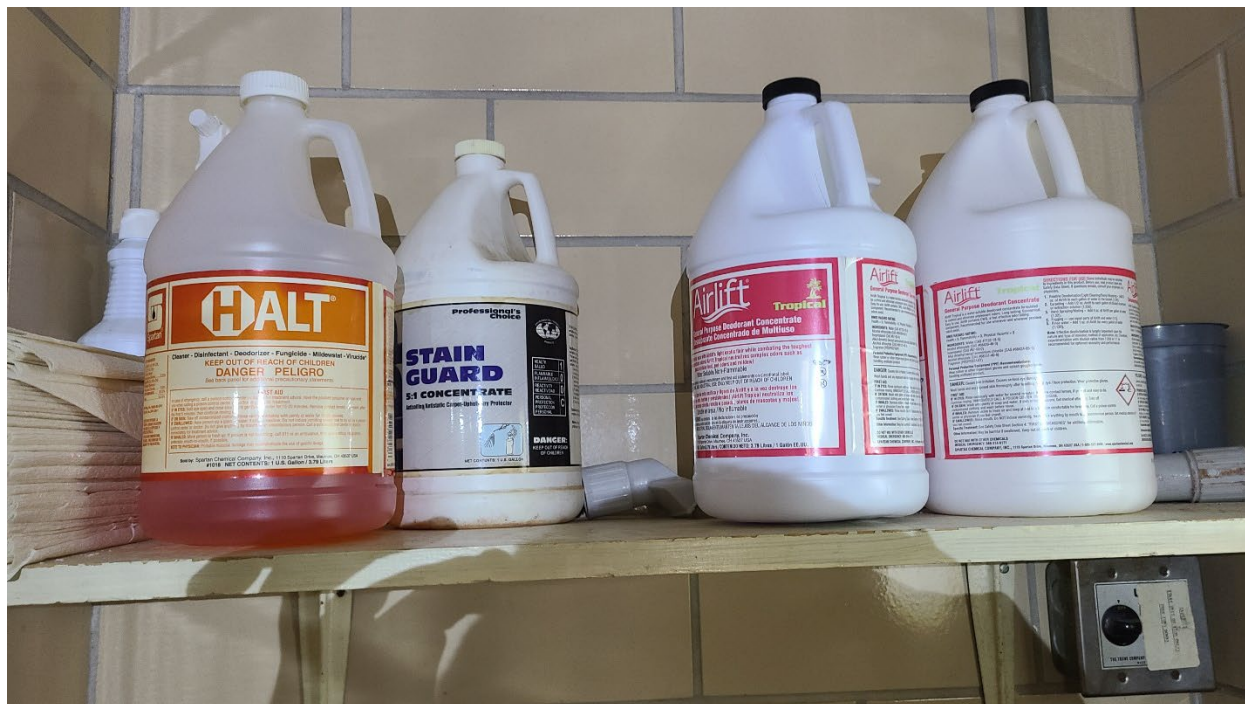
Miscellaneous storage, Dietary Department

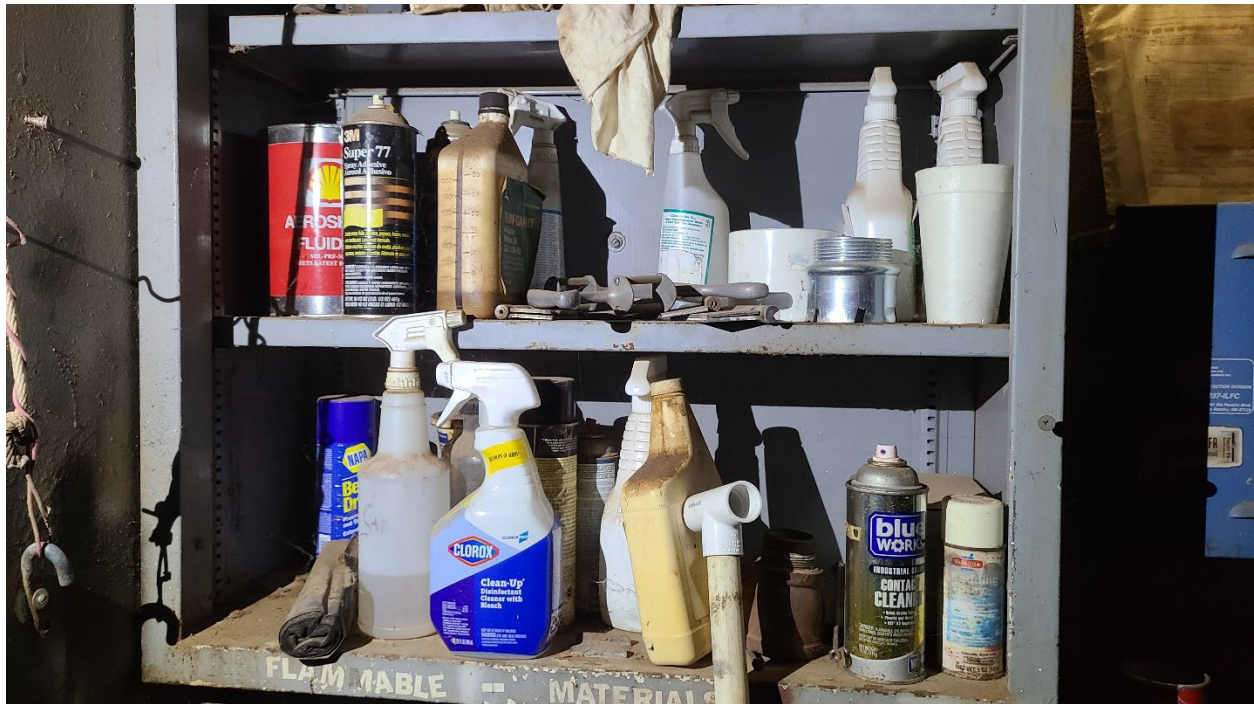
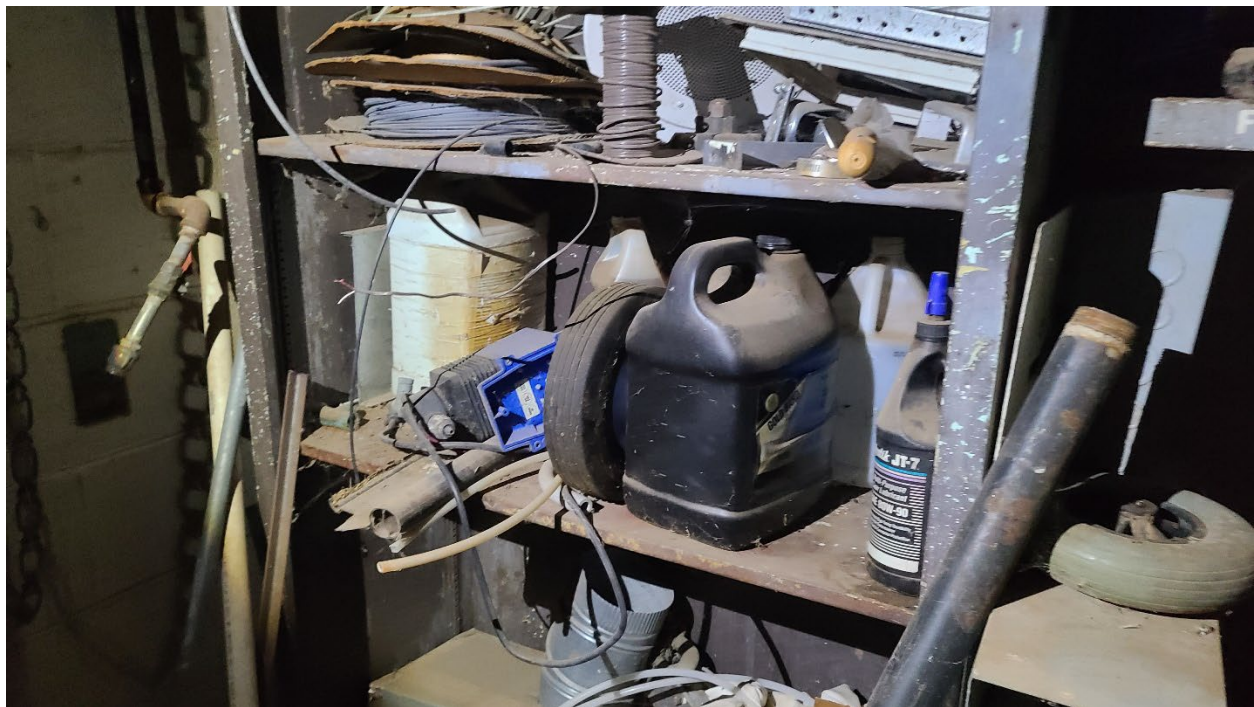
Miscellaneous storage, Boiler Room

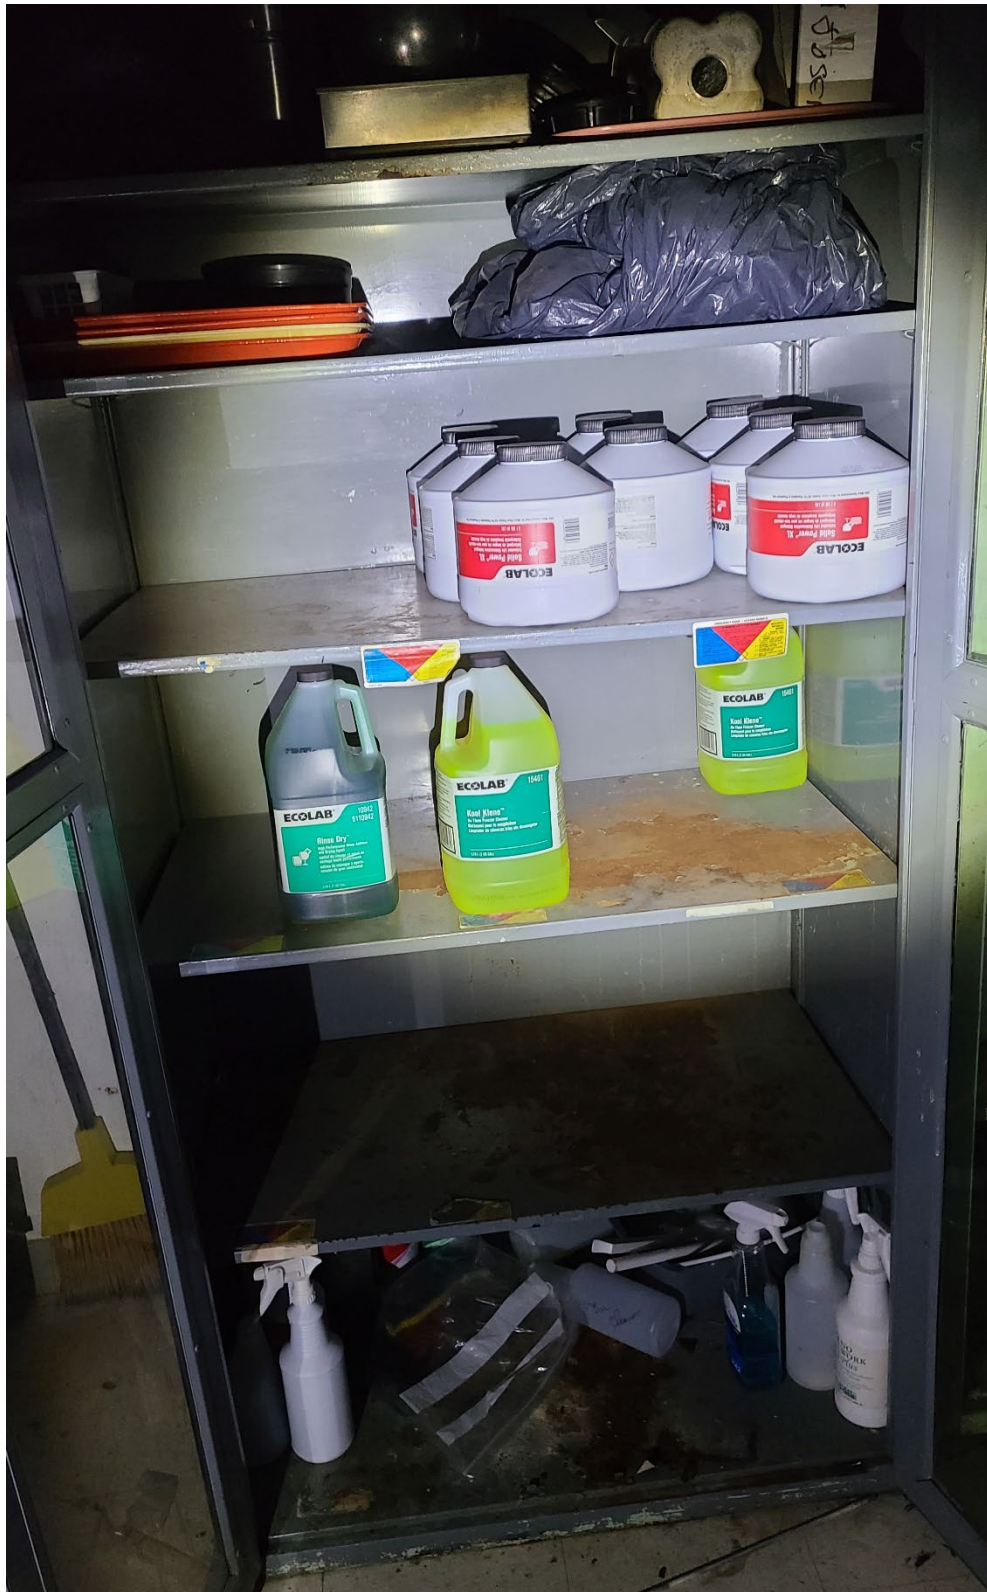
Miscellaneous storage, Housekeeping

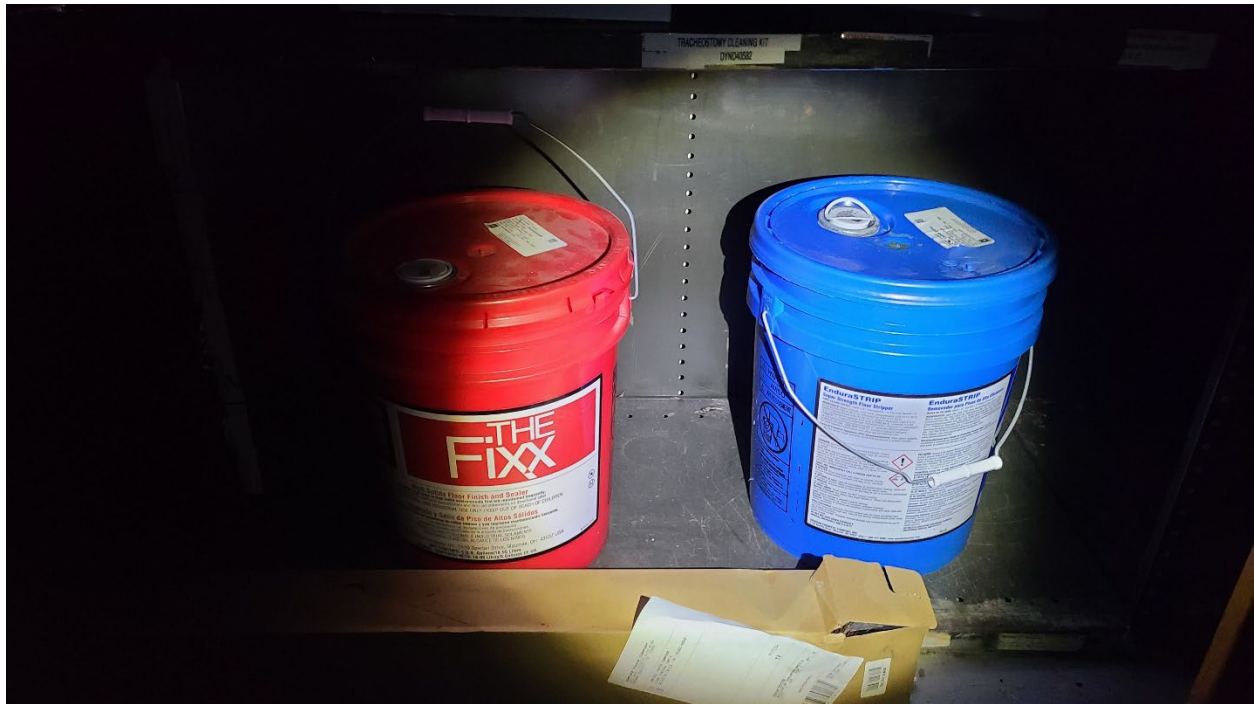
Floor stripper in Purchasing

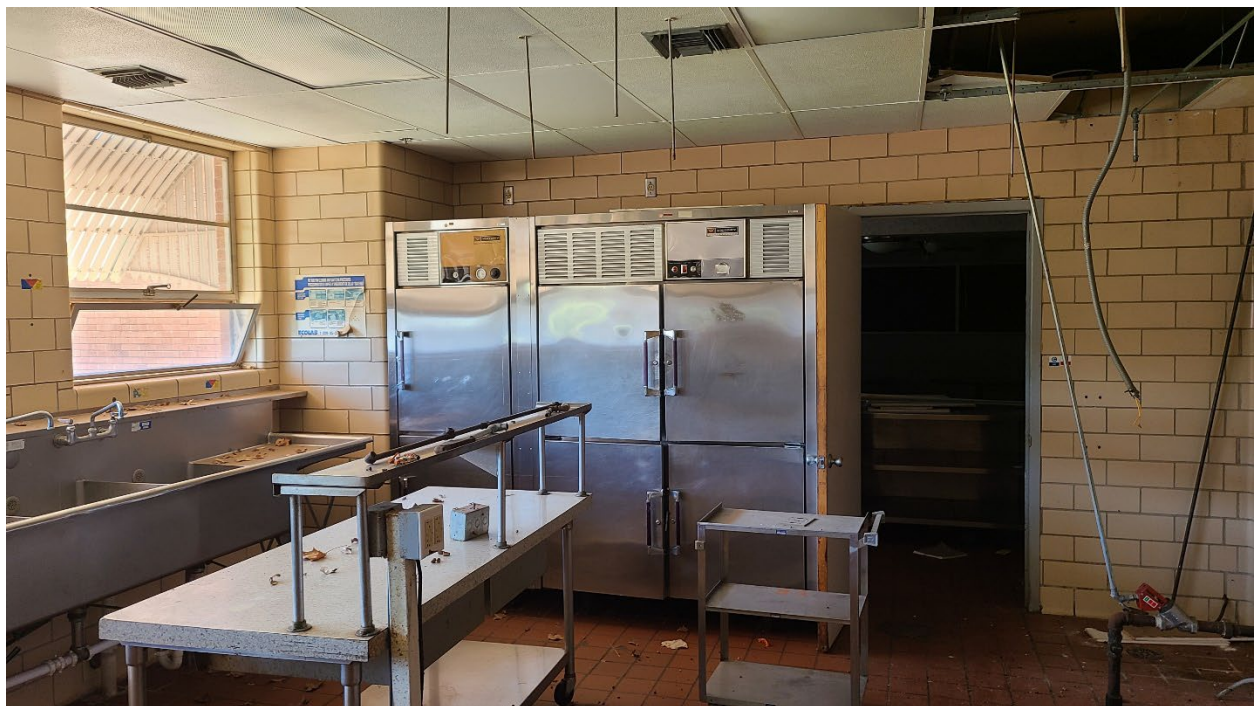
Six (6) rooftop level heating, ventilation and air conditioning (HVAC) package units were observed from ground level and in aerial imagery. Refrigeration fluids were not confirmed, however given the age of the building, R-22 (hydrochlorofluorocarbon based refrigerant), may be in use.

Reach-in coolers in Dietary Department

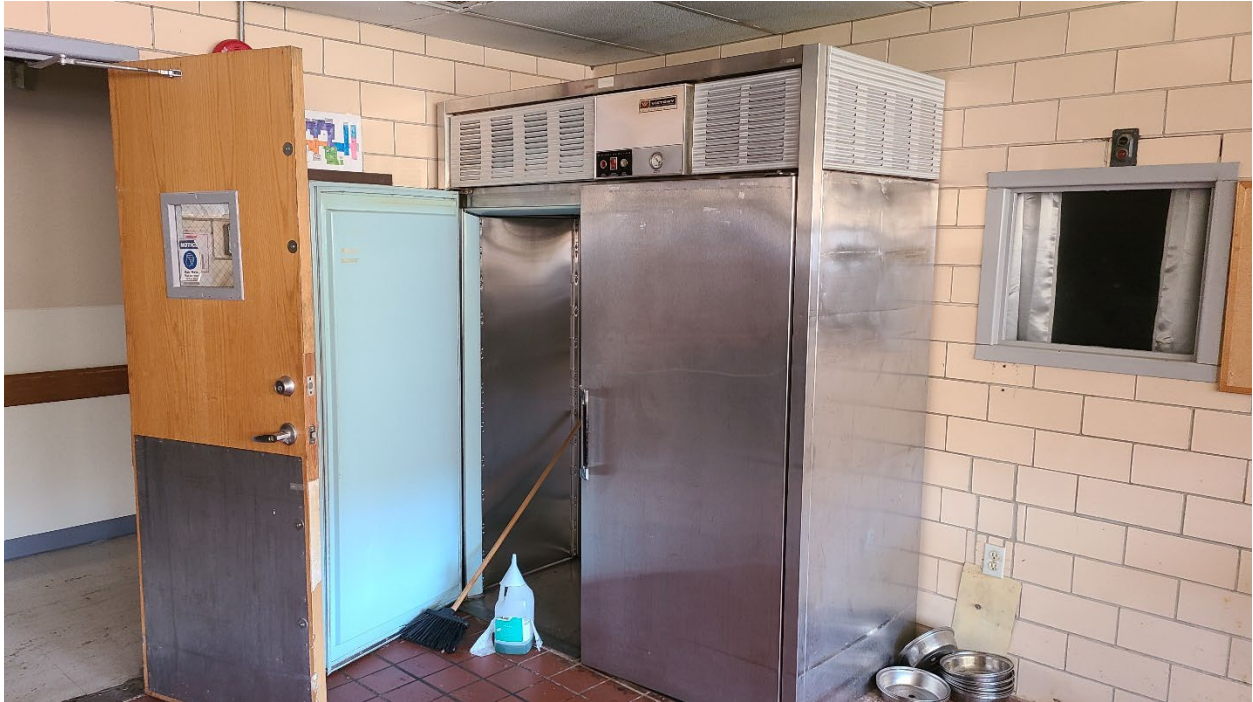
Reach-in cooler in Dietary Department

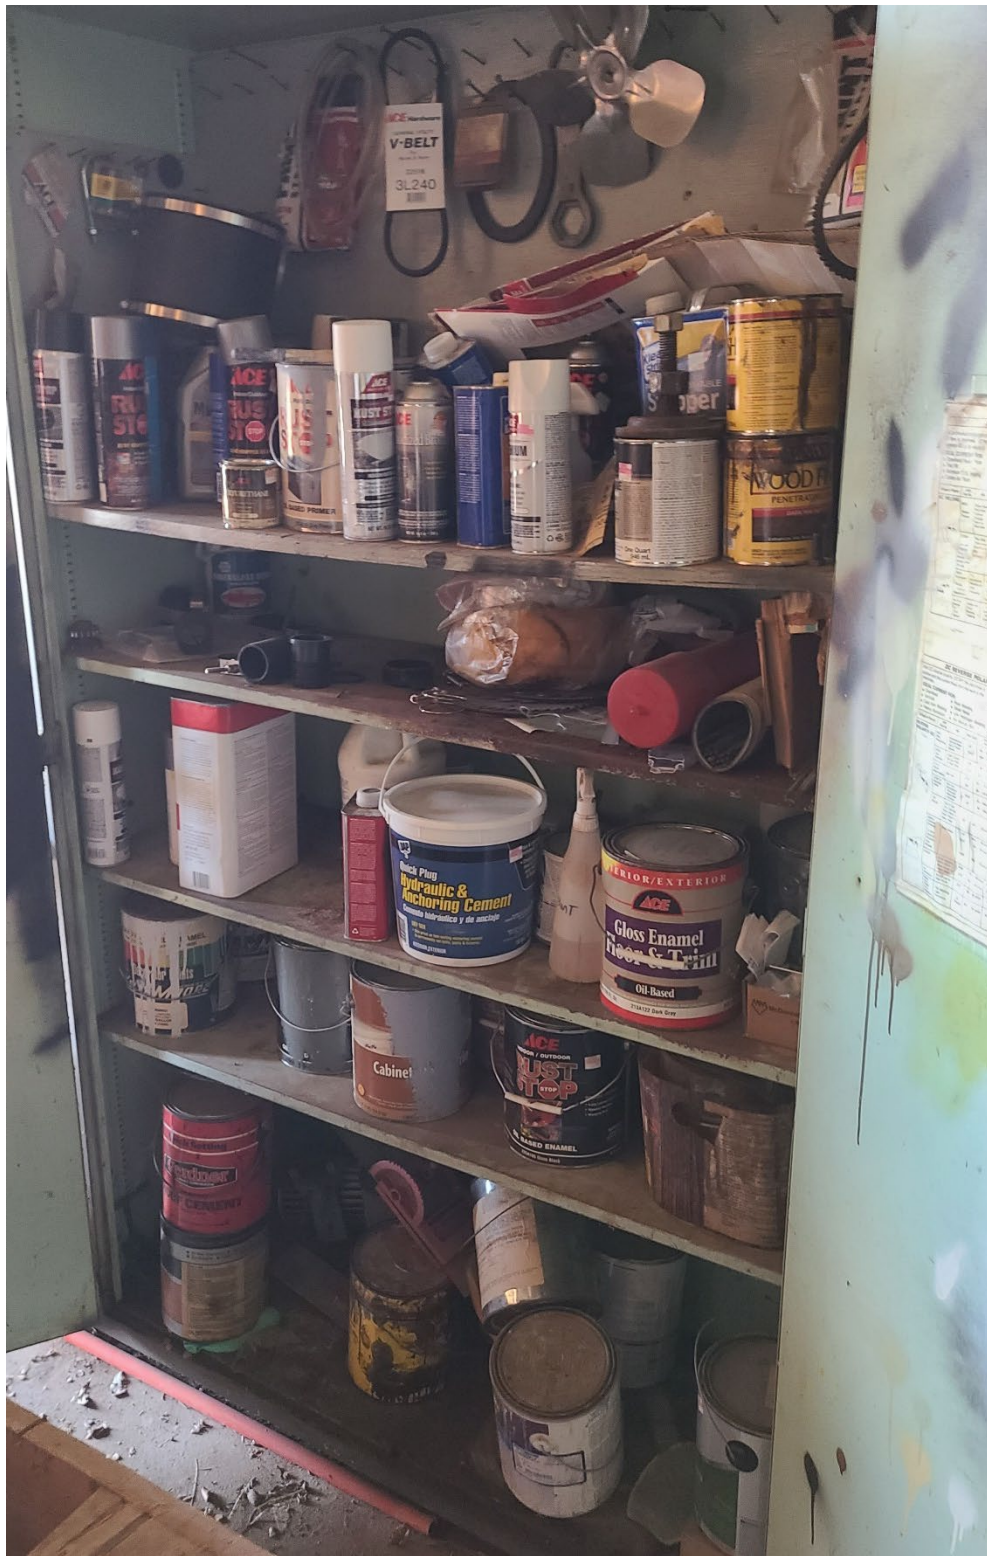
Boiler Room miscellaneous storage

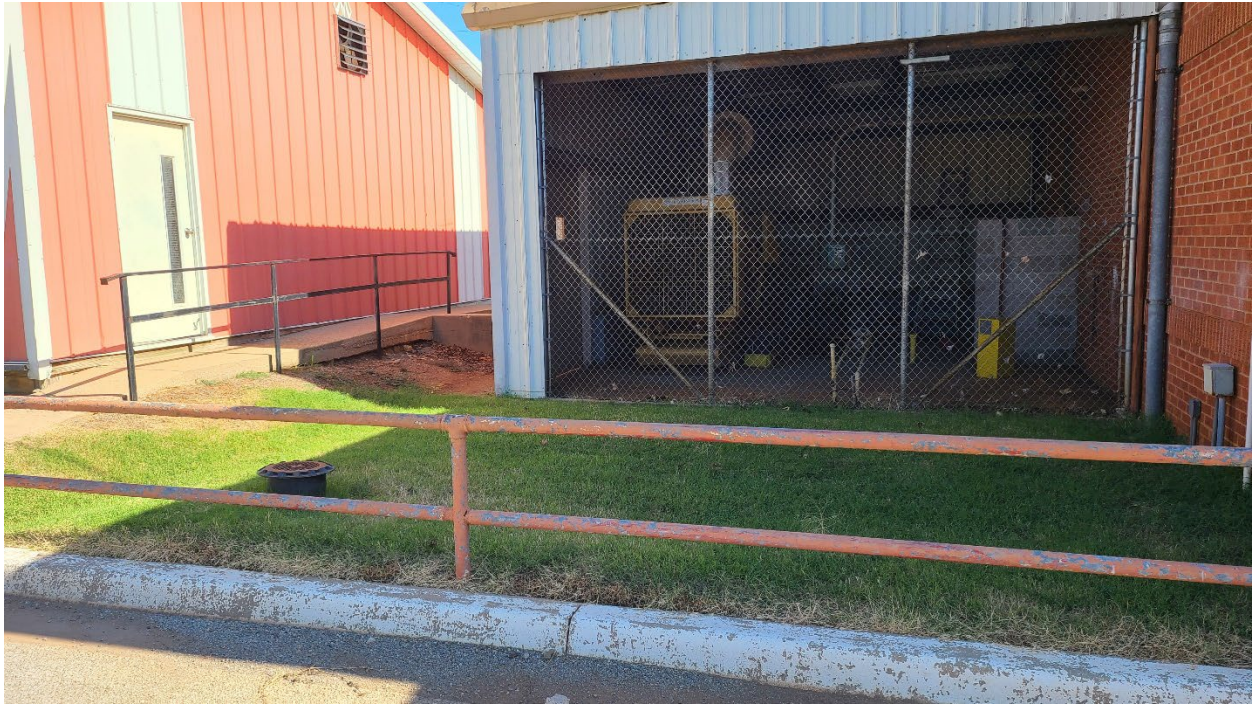
Diesel UST located adjacent to Boiler Room
